Study Report SR410 [2018]

Assessing the risk of non-compliant firestopping and smokestopping in New Zealand residential buildings undergoing alterations

Kevin Frank, Greg Baker and Jonathon MacIntyre

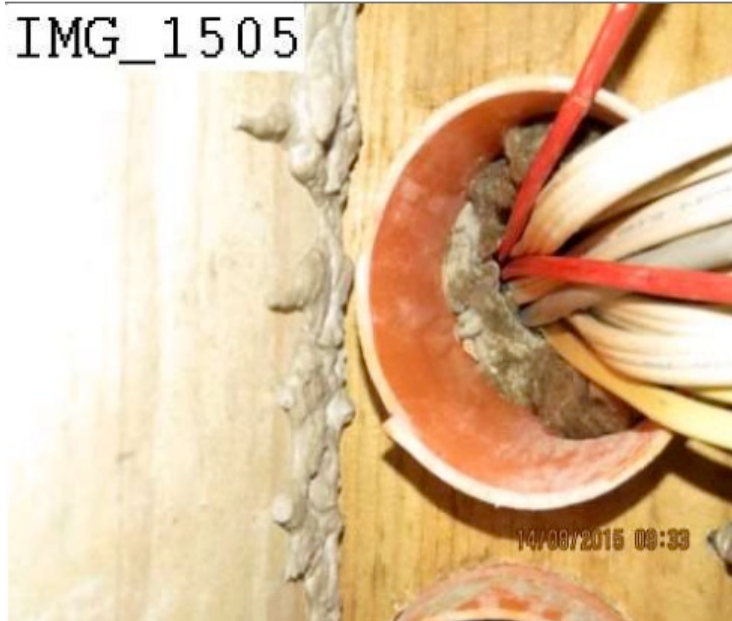
In this case, a cable bundle was installed in a timber/infill floor/ceiling assembly above a car park and below an apartment, as shown in Figure 56. The model inputs are shown in Figure 57.

Figure 56. Cable bundle through timber infill floor.

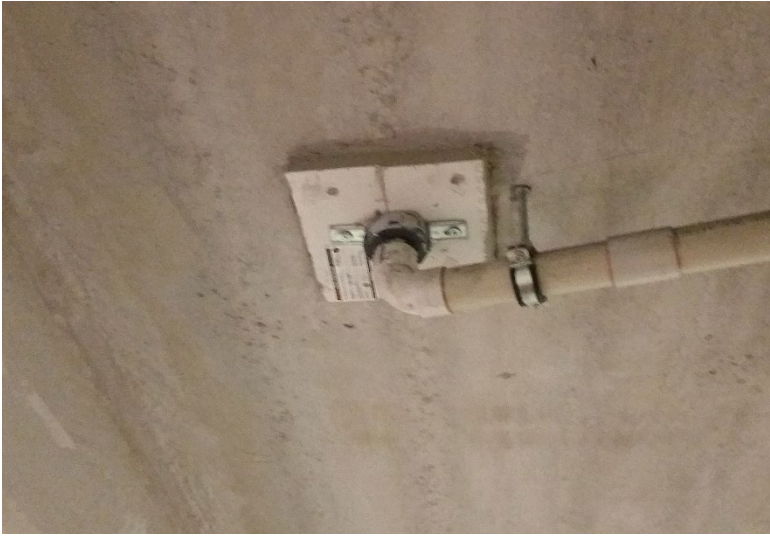
Figure 59. Plasterboard pattress covering a penetration through a concrete ceiling.

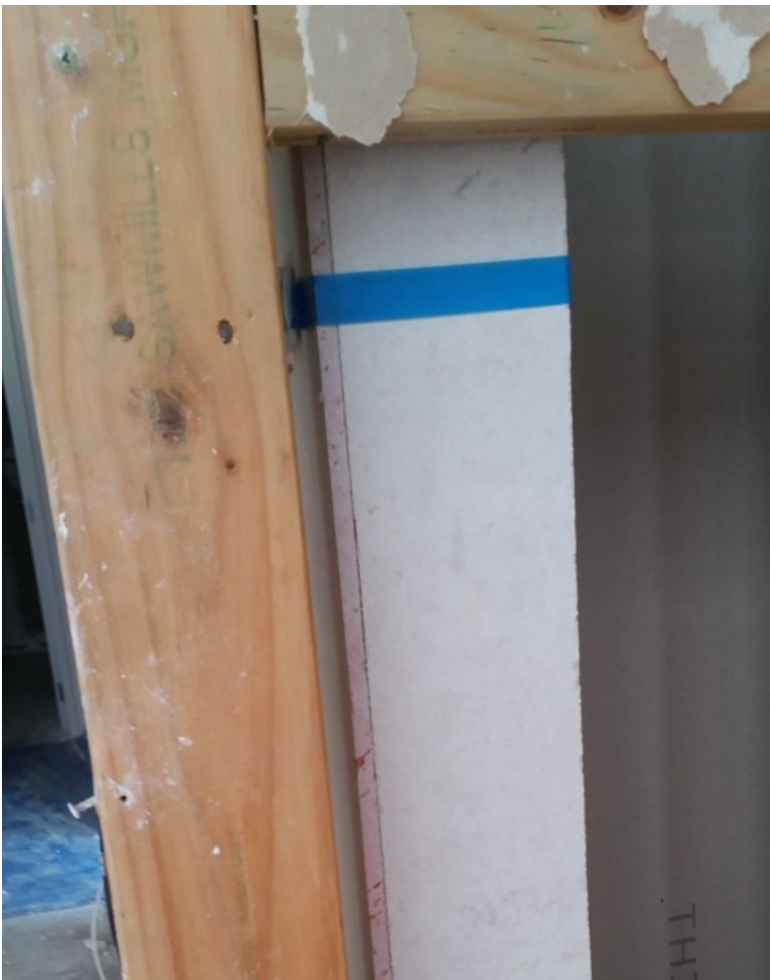
Figure 60. Plasterboard bulkhead held together with combustible plastic strapping.

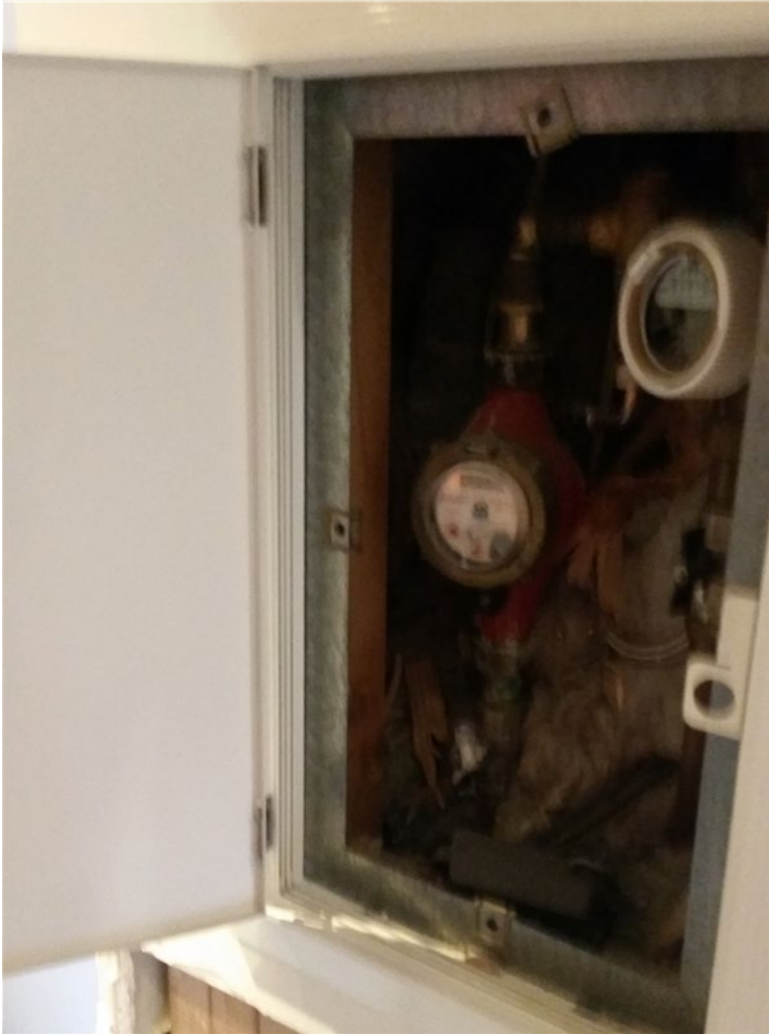
Figure 64. Non-rated access hatch into a full-height service shaft.

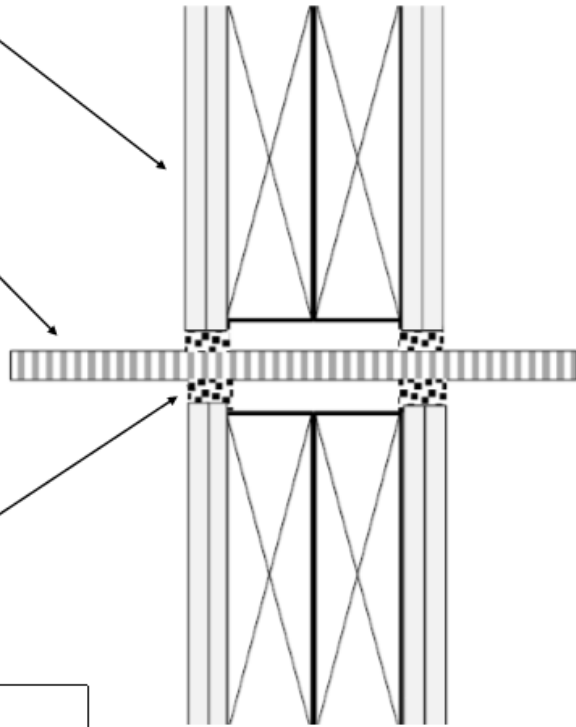
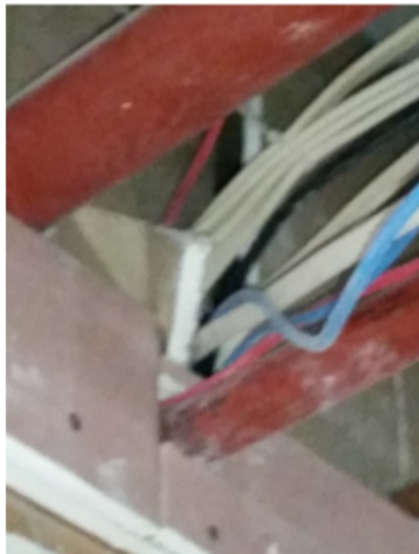
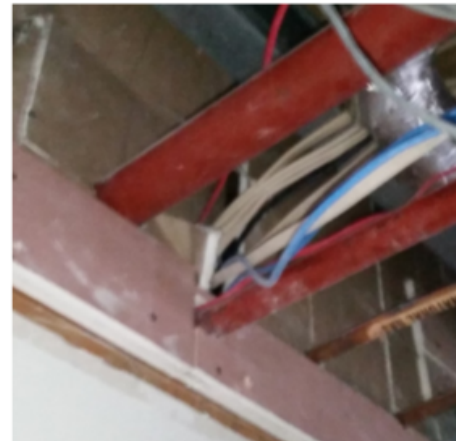
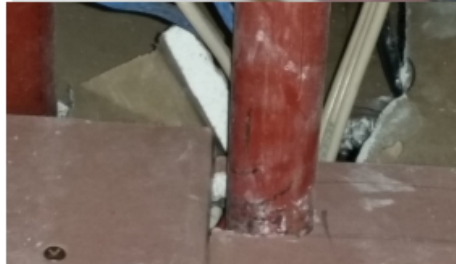
Sketch Number: 08
 Location: Corridor (Means of Escape)

Cavity Details:
 None Recorded/apparent
