BRANZ STUDY

***ANALYSIS OF INCIDENTS
INVOLVING OPEN FIREPLACES
AND SOLID FUEL HEATING
APPLIANCES DURING THE
WINTER OF 1987***

A. Woodside.

BRANZ Study Report SR11

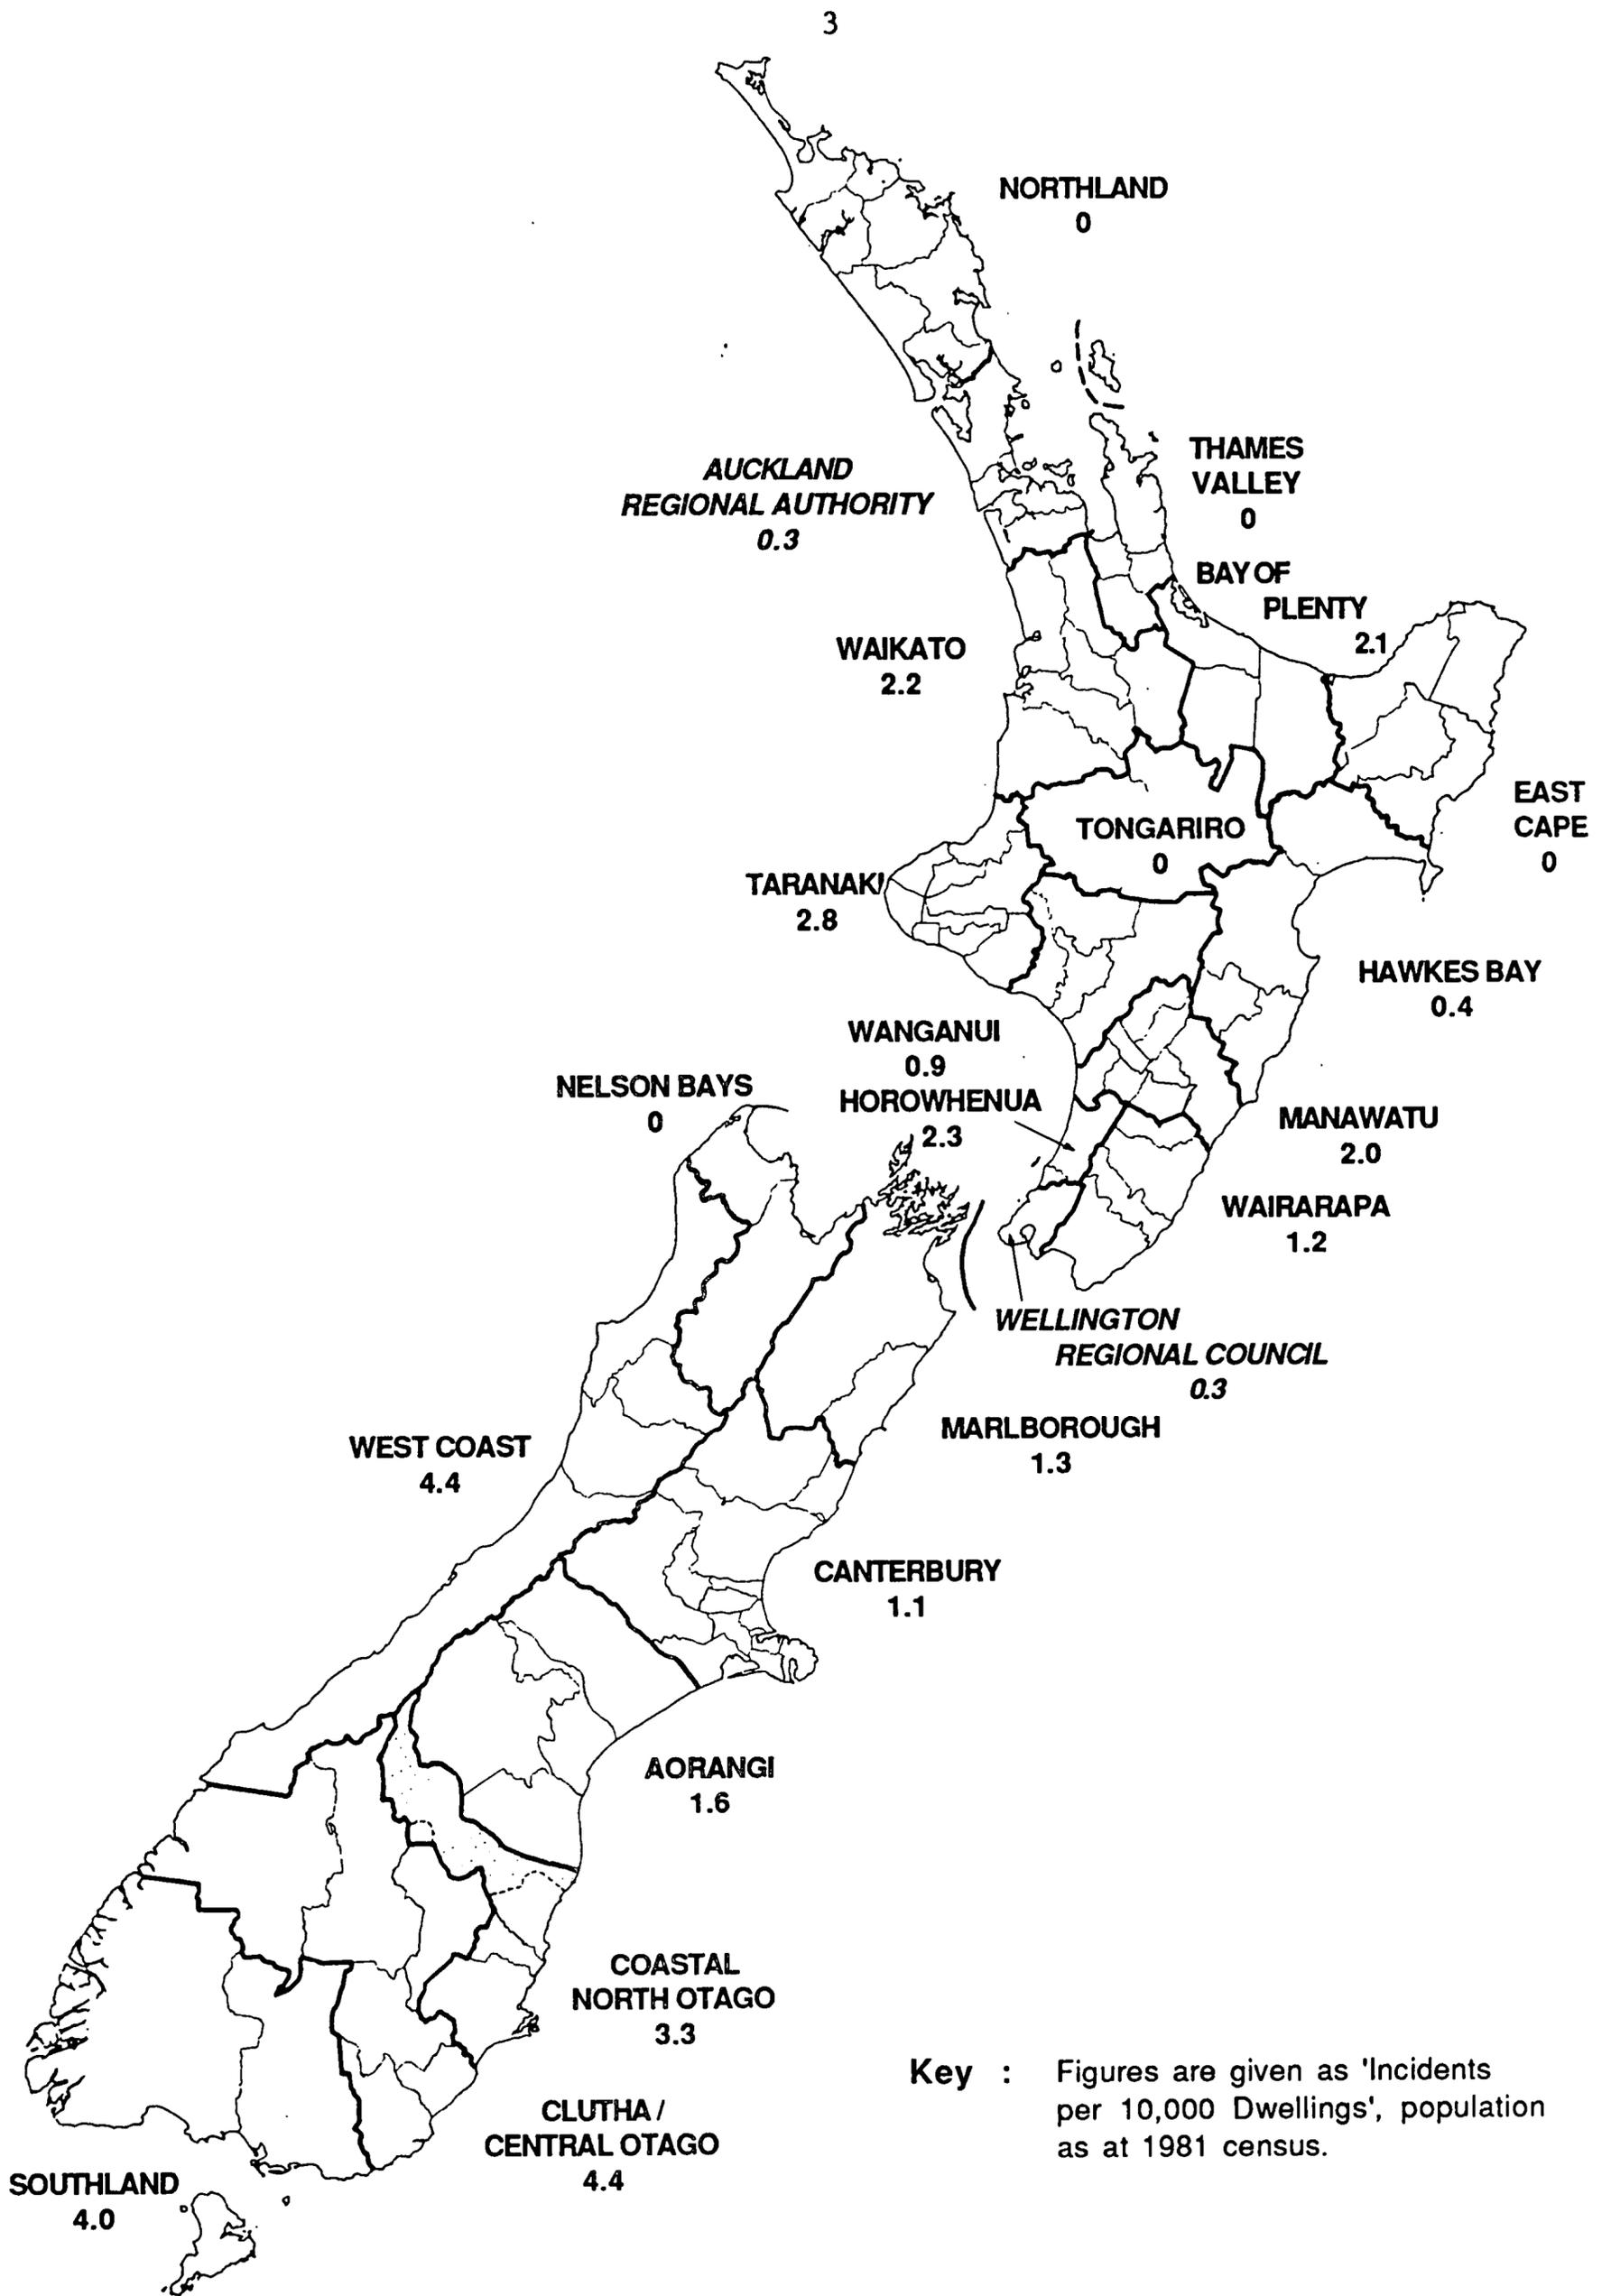
Figure 1 : Location of incidents

Key : Figures are given as 'Incidents per 10,000 Dwellings', population as at 1981 census.

The data in Figure 1 (opposite page) are derived from the New Zealand Census of Population and Dwellings 1981. Certain assumptions have been necessary:

The pattern of occurrence shown in Figure 1 may reflect a higher incidence of reporting from some areas rather than a real effect in terms of incident numbers. This may be due to a greater concentration of reporting personnel and/or a greater awareness of potential problems. For example, 1987 saw the reporting to BRANZ of about twice the number of incidents as in 1986, despite the generally held view that the winter of 1987 was comparatively mild throughout the country. Two thirds of the incidents did, however, take place during June and July.

Despite these potential anomalies, it is clear that from a regional viewpoint some areas of the country are much more likely to record incidents than others. It would be unwise to manipulate the data beyond a grouping into 'high risk' and 'low risk' categories. These would comprise:
