STUDY REPORT

SR 213 (2010)

Two-Year Field Exposure Corrosion Results

BRANZ Study Report SR 213

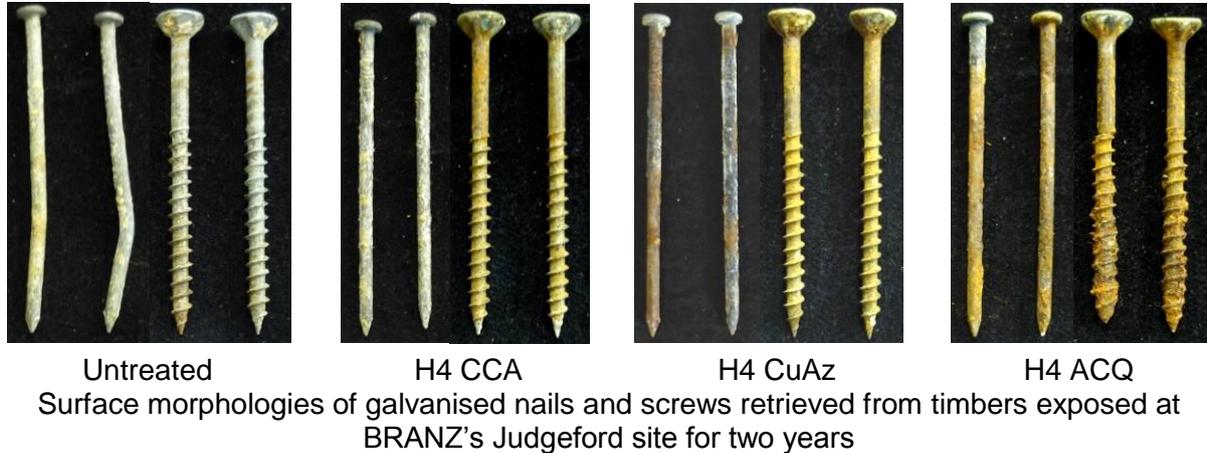
These morphological observations were also supported by mass loss measurements. Galvanised nails and screws in CuAz and ACQ treated timbers were losing their coatings at a higher rate than those in untreated and CCA treated timbers. In particular, timbers treated with H4 ACQ had a very high aggressivity towards the galvanised fasteners. The mass loss rate in H4 ACQ treated timber was anywhere

from two to four times higher than that in CCA and CuAz treated timbers. This is much the same as observations in the previous study (SR153: The Corrosion of Metallic Fastener Materials in Untreated, CCA-, CuAz- and ACQ-based Timbers and DC1396: Preservative Leaching and Metal Corrosion in CCA, ACQ, and CuAz Treated Timbers).

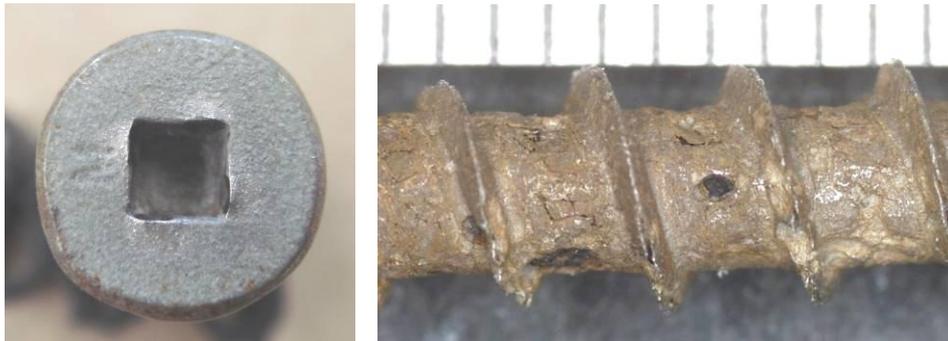
In comparison with hot-dip galvanised nails, rust was more pronounced on the galvanised screws driven into the same timbers. Thread areas appeared to be more vulnerable. Due to the presence of heavy rust, it was difficult to retrieve screws from the timbers. Some of the screws were broken. After the removal of corrosion products, it was found that on some screws, the treads were severely damaged in some areas, even to the extent of partial loss of thread. This might suggest that stresses associated with the driving-in process have damaged the zinc coating, introducing more physical defects into this area.

Morphologies of head and thread of a galvanised screw retrieved from H4 ACQ treated timber exposed at BRANZ's Judgeford site for two years

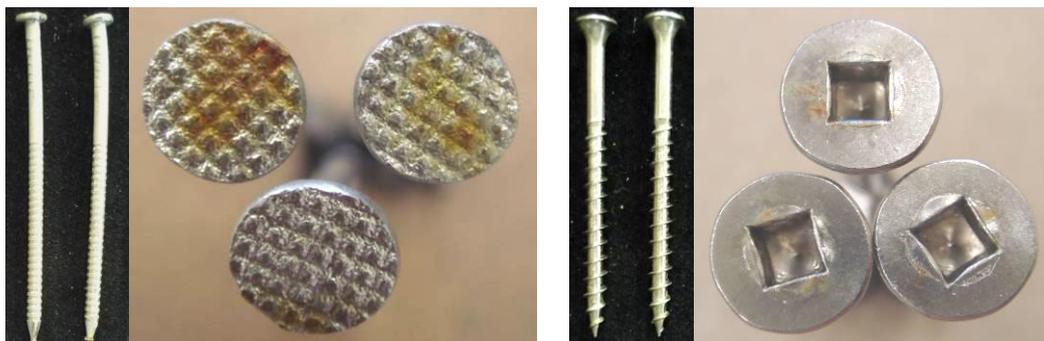
Unsurprisingly, stainless steel nails and screws performed very well in all combinations of preservative type and hazard class. No obvious signs of corrosion were found on the shaft/shank of the nails and screws. Very limited rust formation was occasionally found on the top surface of the nail head. It is believed that this is a result of local passivation breakdown induced by the hammering-in process and/or ferrous contamination from the hammer head.

Stainless steel nails and screws retrieved from H4 ACQ treated timbers exposed at BRANZ's Judgeford site for two years

These experimental observations are very similar to those obtained from the samples after one year of field exposure. A comparison between the conditions of the rust formed after one year and after two years also indicated that this localised corrosion was progressing extremely slowly. Based on the results obtained from field tests

carried out at the Judgeford site, BRANZ still recommends austenitic stainless steel (e.g. AISI 304 and 316) to ensure long-term durability in treated timbers (H3 and above) which will remain wet for a significant portion of their service life.
