# Testing the airtightness of residential roof spaces in three dwellings

Without proper management of indoor moisture, this can lead to a build-up of moisture and problems with mould. BRANZ has developed a measurement procedure to estimate the airtightness of residential roof spaces and has tested it on three buildings. This could be a useful tool to help determine roof ventilation requirements to avoid mould and moisture problems.

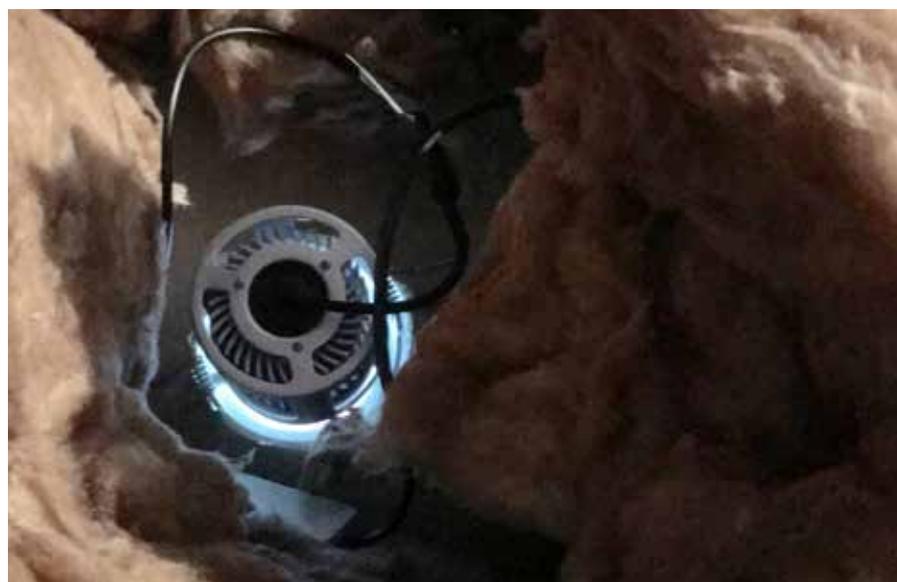
The square-stopped plasterboard ceiling would ordinarily provide a good air barrier, but it was penetrated by 22 older-style downlights. The gaps around these provide an easy pathway for moisture-laden air to move from the living areas into the roof space.

Other calculations point to the downlights as the main path by which downstairs air gets into the roof space. Additional leakage paths around the roof access hatch or extractor fans are likely to make up the difference.

This movement of moisture-laden air into an airtight space that leads to moisture accumulating are clearly the primary causes of the mould in the roof space. The median value for relative humidity in the roof space

The gap around a downlight in the Titirangi house is clearly visible.
