STUDY REPORT

SR 218 (2009)

Report on a Short Study Tour of Houses Following the 15 July 2009 Fiordland Earthquake

G.J. Beattie

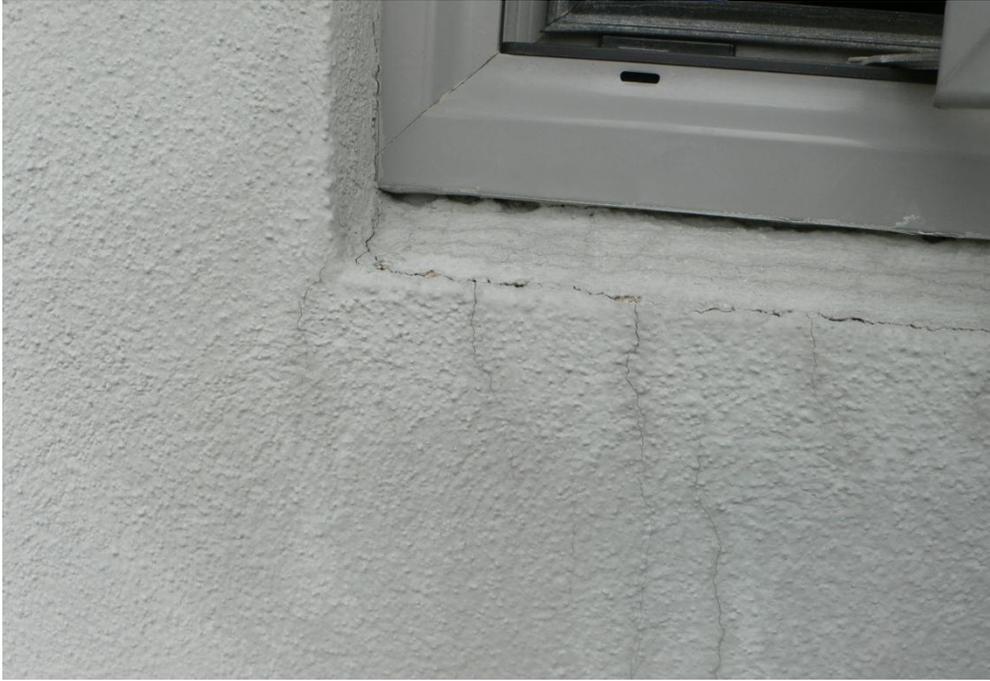
The EIFS claddings showed varied patterns of damage, from nothing to wide open cracks. Fine cracking of the thin plaster coating occurred quite regularly. Many of these cracks did not align with the corners of window or door openings, as would be expected if the walls had been racked by an earthquake. Rather, they were randomly disposed. This suggests that they are the result of shrinkage of the plaster coating. An example of such cracking is given in Figure 1.

Figure 1. Cracking of the plaster on the EIFS cladding

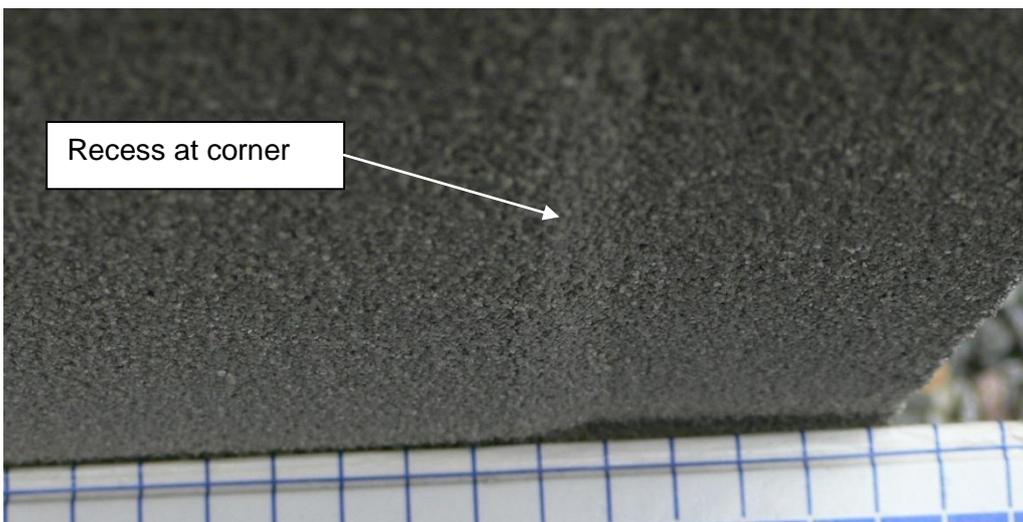
Well-formed corners in the EIFS cladding did not appear to sustain any damage from the earthquake. However, others did not behave as well. In one instance, it appeared that in forming the corner the applicator had not built up the plaster coating to the same level as the remainder of the wall, which may have weakened the detail. The observed recess could not be accounted for on the basis that the framing behind the area had shrunk as the crease was not aligned with the thickness of the framing and the recessed area was parallel to the body of the wall. A view of the recess and the effects of the recess are shown respectively in Figure 2 and Figure 3. In this particular instance, racking action in the plane of the right side wall in Figure 3 during an earthquake could have resulted in this damage occurring, although at other corners the flaking of the plaster was higher up the wall. There was no associated damage in the interior linings to confirm that sufficient movement of the structure had occurred to damage the exterior.

Figure 2. Recess at the corner of an EIFS wall

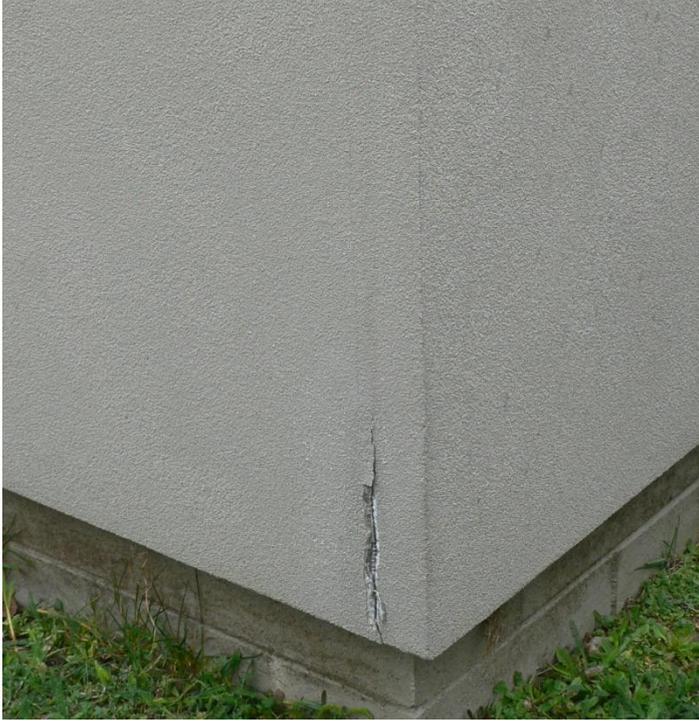
Figure 3. Damage at the base of the recess in the wall

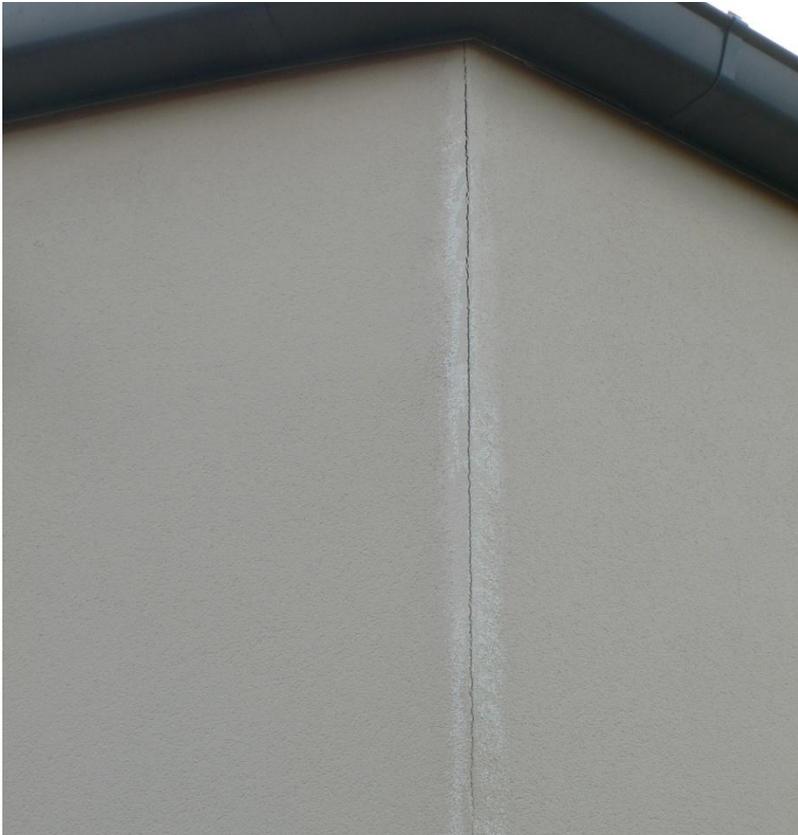
On other occasions, the cracking damage at a change of direction of a wall was not earthquake related. It is likely that there was no proprietary former section available for the obtuse angle of wall intersection, so no reinforcement was provided for the joint and it has cracked under temperature fluctuations (Figure 4).

Figure 4. Cracking at the joint between two walls not intersecting at right angles (note that temporary taping over the joint has been removed to reveal the crack)

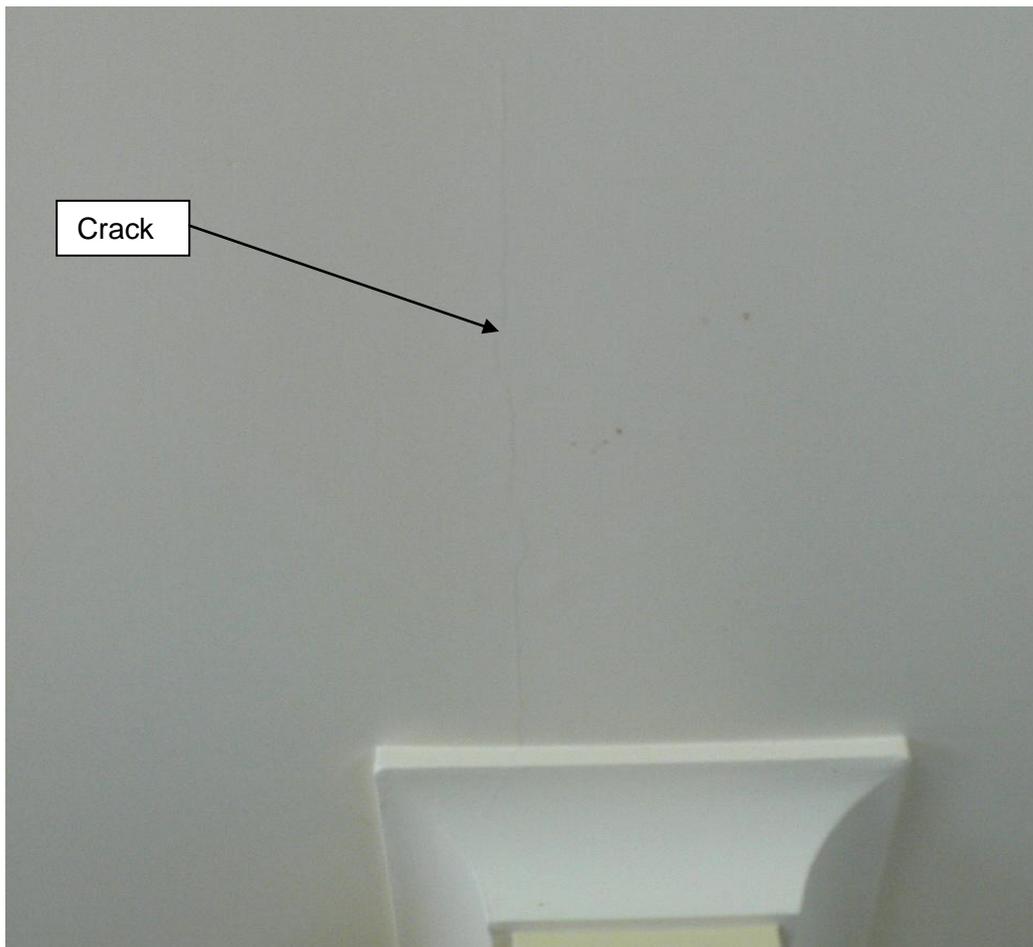
The wall locations were typical of what is often observed in houses with plasterboard interior linings, regardless of whether they have been subjected to an earthquake or not. It is BRANZ’s experience that these cracks are due to normal seasonal movements and occur generally on joints between plasterboard sheets, particularly if reinforcing tape has not been included in the joint when it was stopped. They normally have a similar width over their full length, but this is not always the case if the framing behind can restrain one end of the crack from opening. If the plasterboard has not been cut around openings, the crack will often form in line with the edge of the window frame. The age of this property would mean that the joints have likely been stopped with a paper tape insert, which strengthens the joint.

Typically observed cracks in the ceiling joints are presented in Figure 5. This crack has extended into the plaster cornice at the wall.

Figure 5. Fine ceiling crack extending across the ceiling from the end of an internal wall

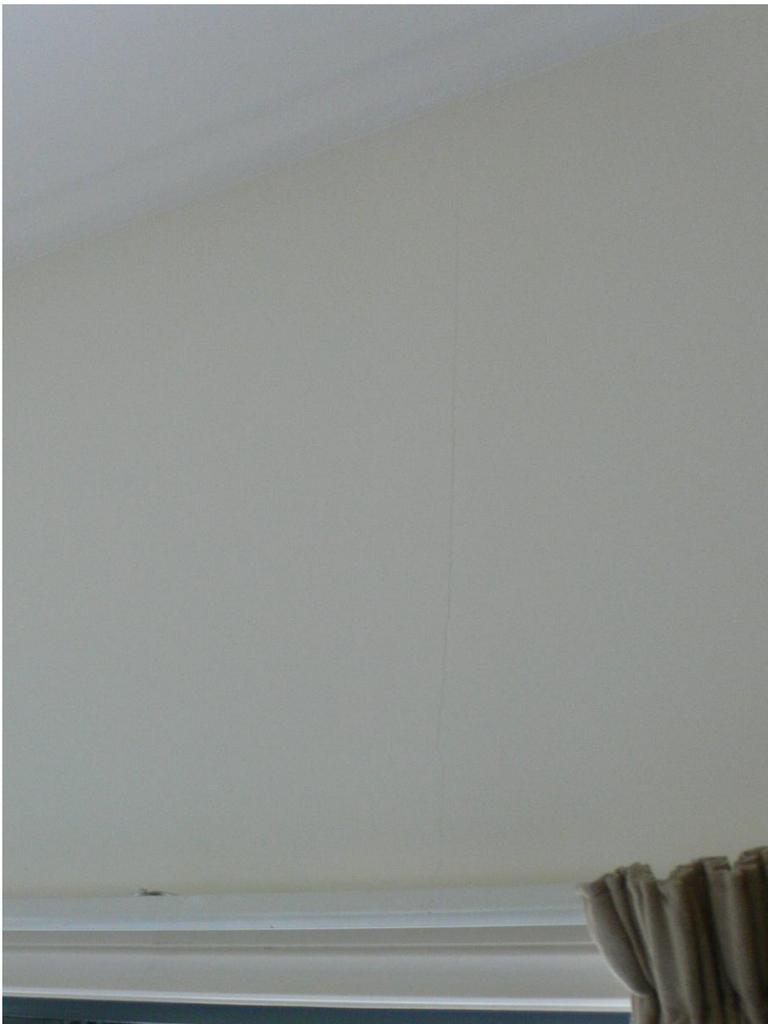
Considering first the single-storey property, there was a small amount of cracking in the plasterboard interior linings that was quite similar to that observed in the brick veneer house. The garage area was similar in size to the veneer house (approximately 6 x 6 m) and had similar cracking at joints between the lining sheets. Three fine cracks were observed in the wall, one at a corner and the other two remote from a corner. One of these commenced at the top corner of a doorway and the other above an opening in an exterior wall. The cracks were fine (0.1 to 0.2 mm) and of even width over their length (Figure 6).

Figure 6. Crack in the wall above a door head

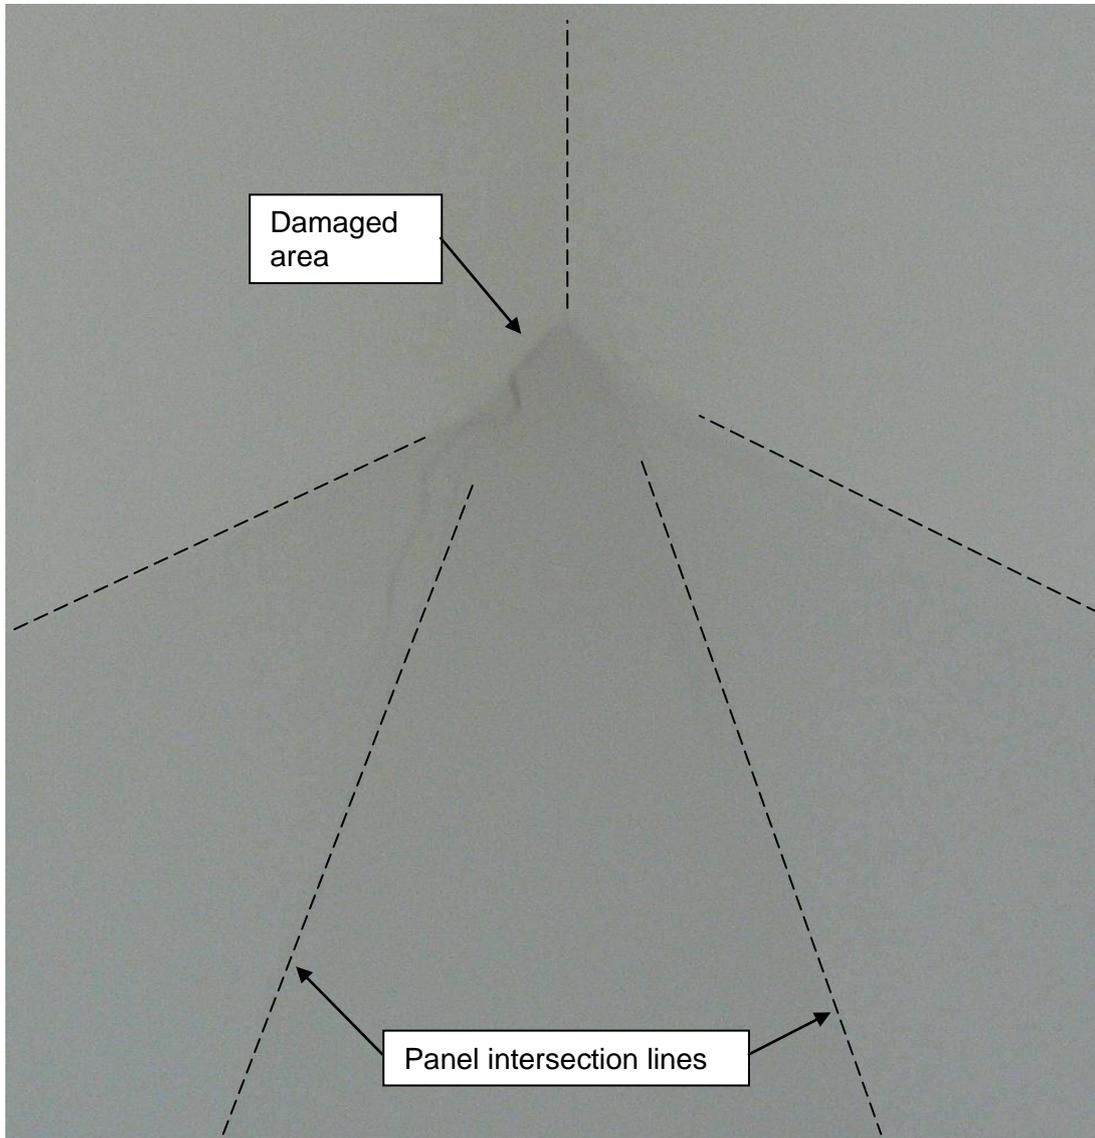
Figure 7. Cracking damage at the apex of a ceiling where the lining intersects at several angles

In all of the cases of Figure 7 to Figure 10 the damage is likely to have been caused by the earthquake.

In Figure 7 the ceiling is over a tall room with potential flexibility due to the height and light bracing. The apex of the ceiling, with the multiple faceted panels, is also a difficult area to reinforce the stopping at corners.

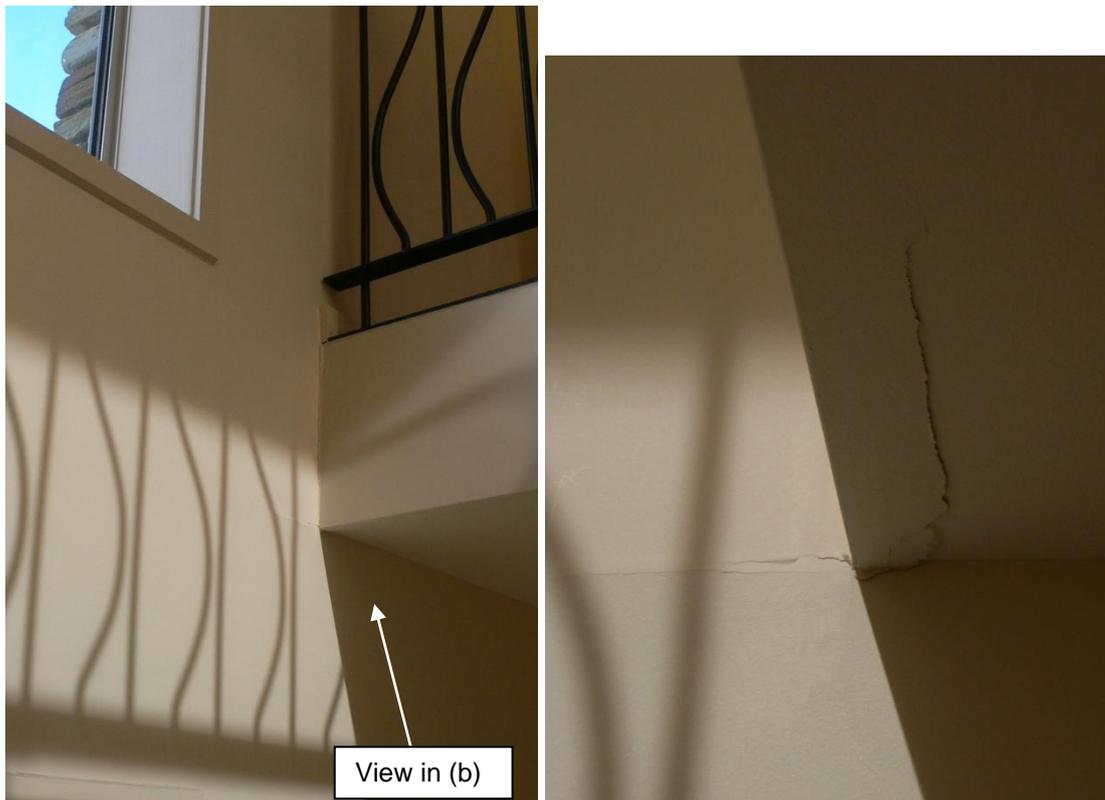
The damage shown in Figure 8 is very likely to have been caused by the more flexible two-storey tall structure described in Figure 7 clashing with the relatively rigid first floor diaphragm, which terminates part-way along the two side walls of the room. The differential movement between the structural types is likely to have caused the observed damage to the plasterboard.

Figure 8. Damage at the intersection of a mezzanine floor with a two-storey high wall

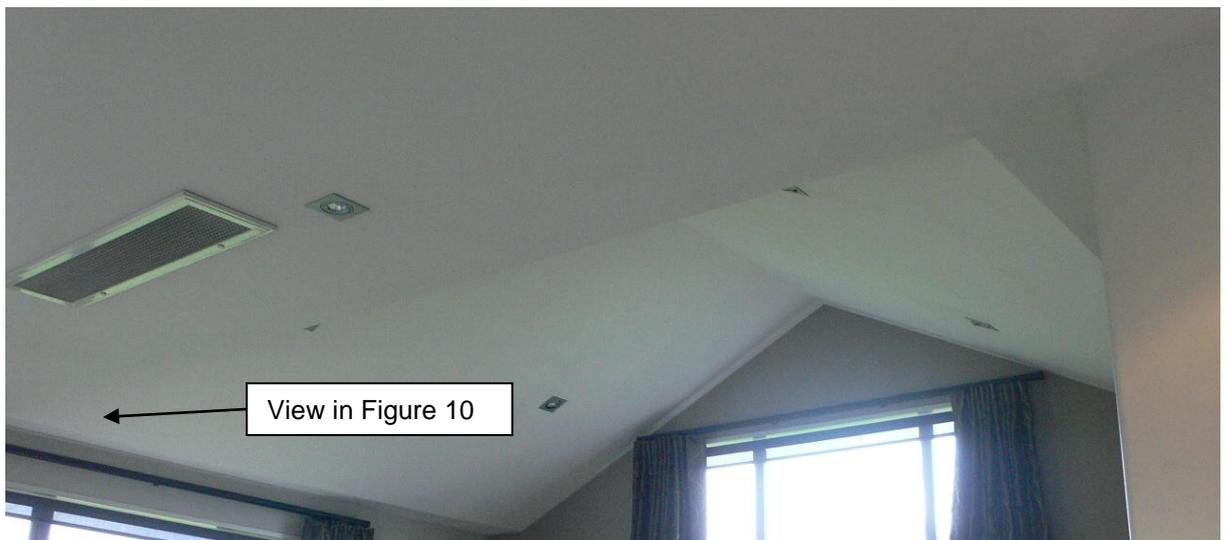
The example in Figure 9 and Figure 10 is of a change to the ceiling line from a flat ceiling over a large (but less than the unbraced area limits of NZS 3604) open plan lounge/dining/kitchen area to an alcove with a vaulted ceiling. Even though the alcove is a not large enough to be classified as a “wing” in NZS 3604, there is a potential for the alcove to “pivot” at its intersection with the main structure in earthquake motion from a certain direction. Because the ceiling step is a discontinuity in an otherwise effective “diaphragm”, a stress concentration has occurred, leading to cracking of the joints in the plasterboard ceiling and the adjacent wall lining (Figure 10).

Figure 9. Cracks where the ceiling form changes from flat to vaulted

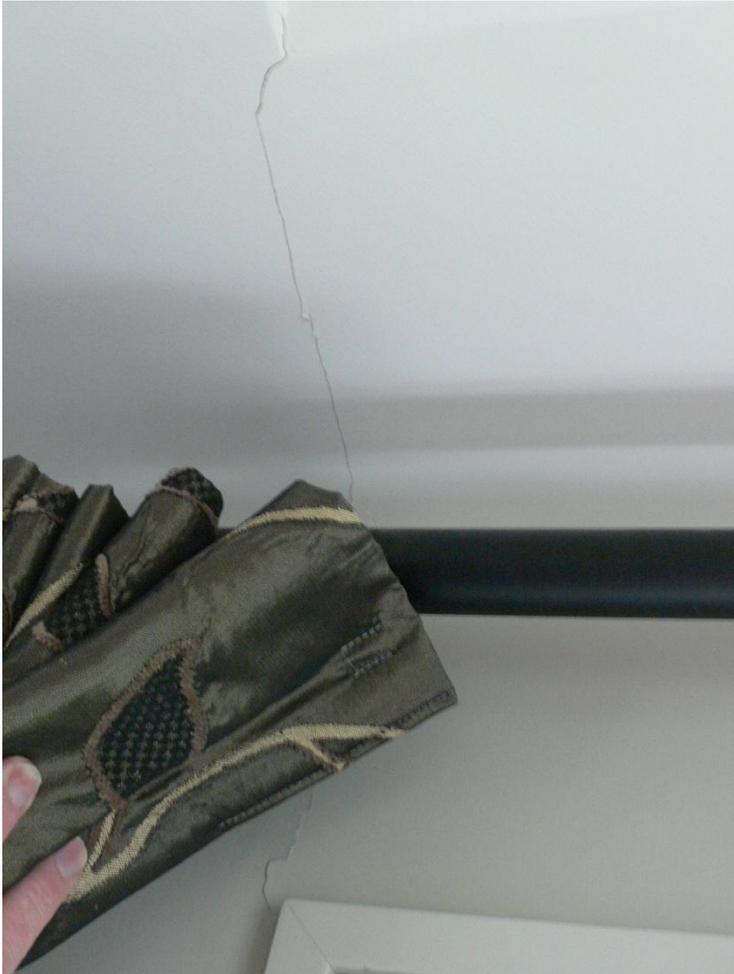
Figure 10. Close up of one of the cracks in Figure 9.
