Consent documentation quality for new housing

BRANZ Study Report SR355

Abstract

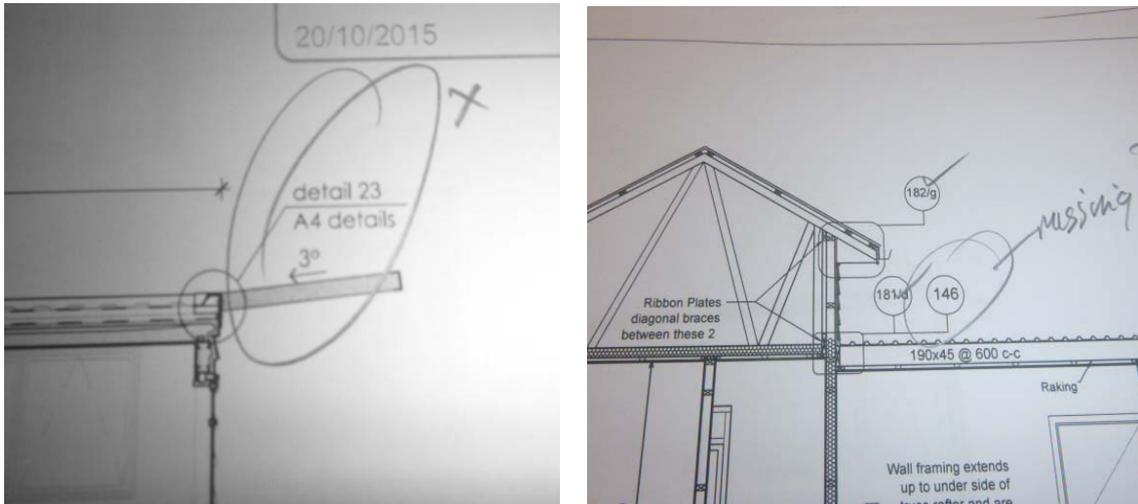
Details are referenced but are missing or are not applicable.

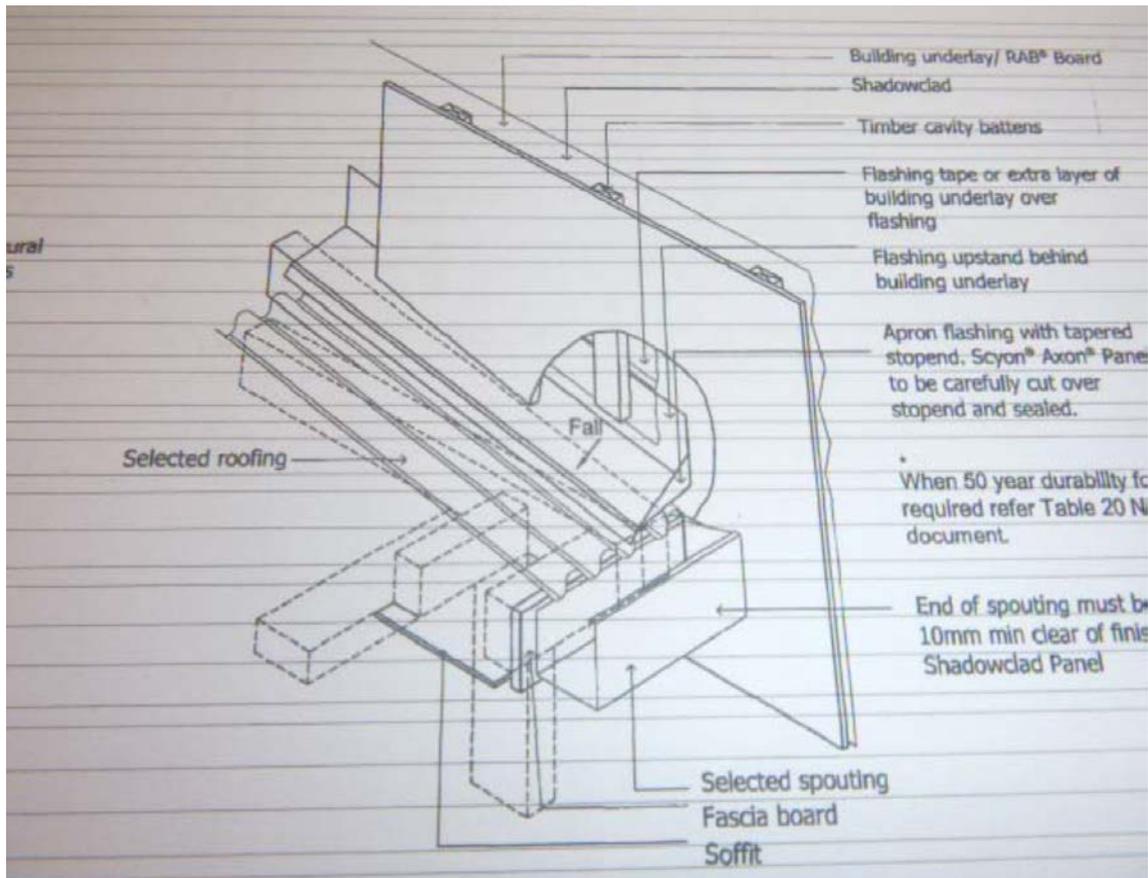
Helpful 3D detail, but clarity is adversely affected by the horizontal lines.

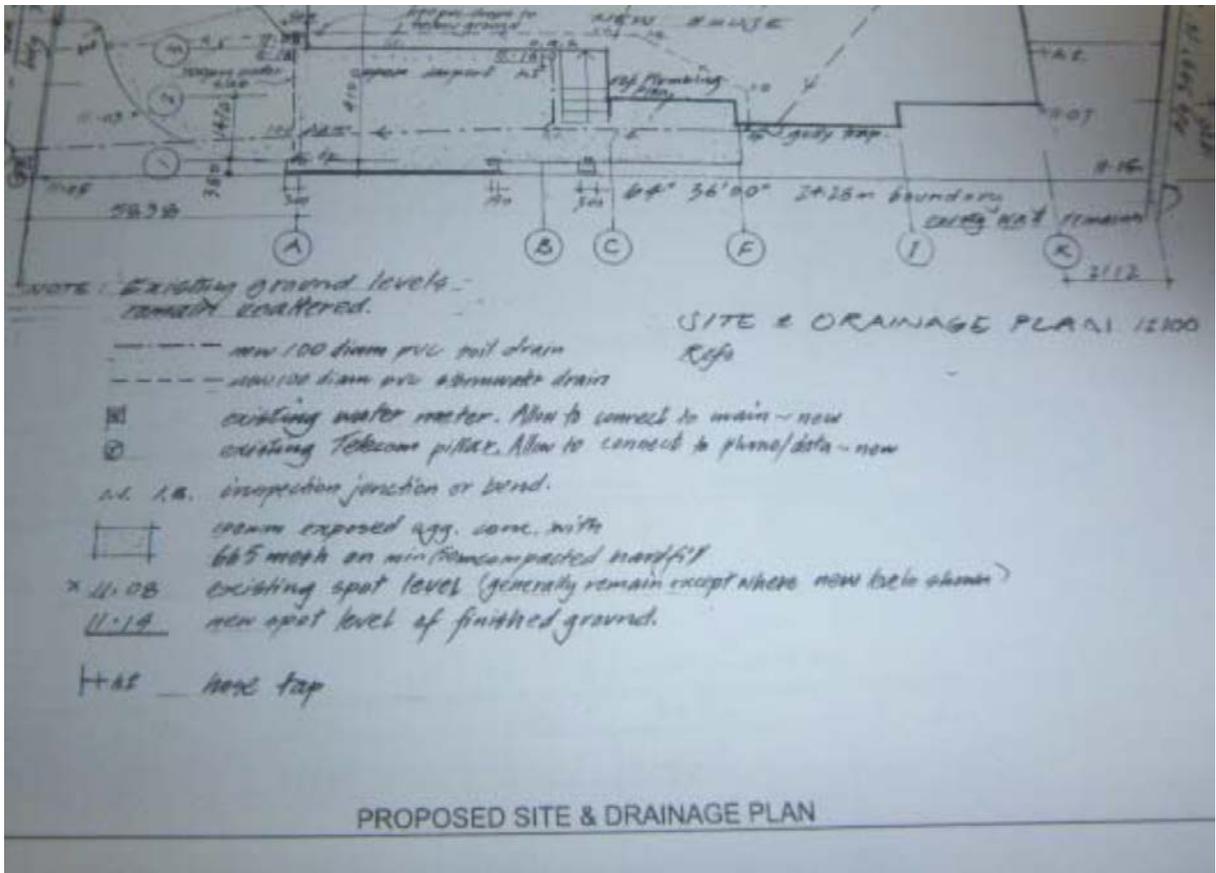
Handwritten notes can be difficult to read.

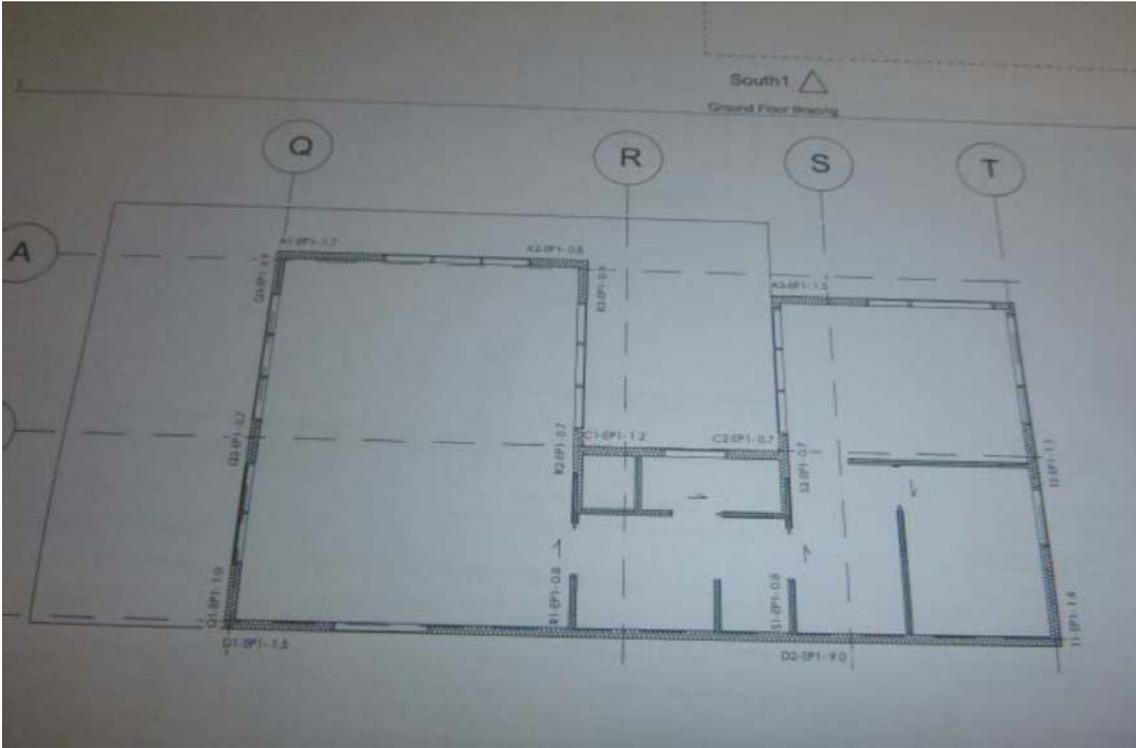
Bracing plan has no key to the bracing type.

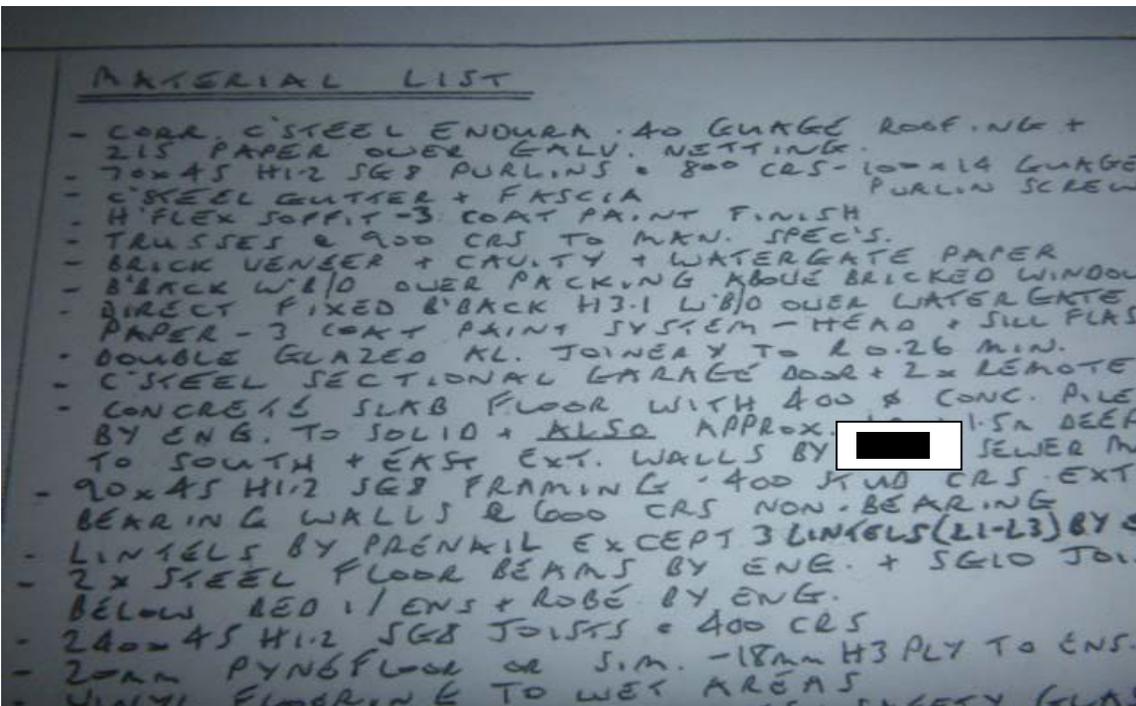
A materials list is good to have but can be difficult to read.

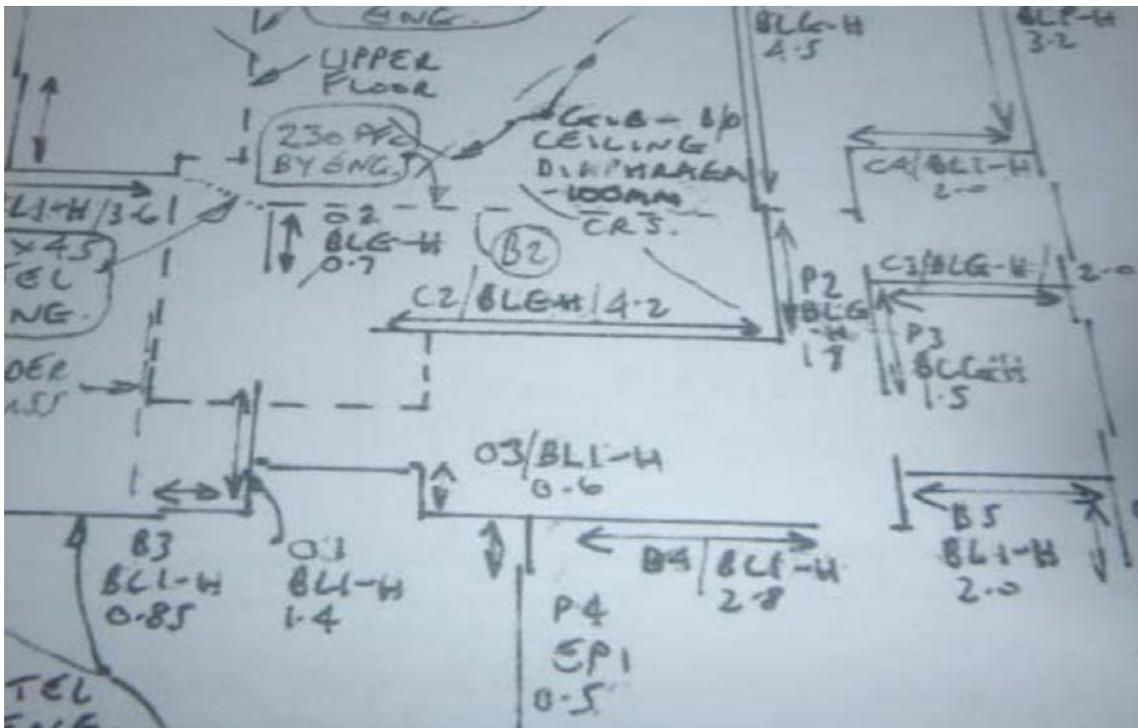
Bracing plan is very difficult to read.
