Positional material deterioration over the building envelope of a building in a geothermal area

BRANZ research is finding that the corrosive effects of different micro-environments around a building can differ significantly from each other and from the surrounding atmospheric environment. This Research Now reports on a building subject to Rotorua's geothermal atmosphere. Research Now: Positional corrosion #1 and #2 reported on research carried out on a test building on the BRANZ campus at Judgeford, near Porirua, while Research Now: Positional corrosion #3 covers a building very close to the marine influences of Auckland Harbour.

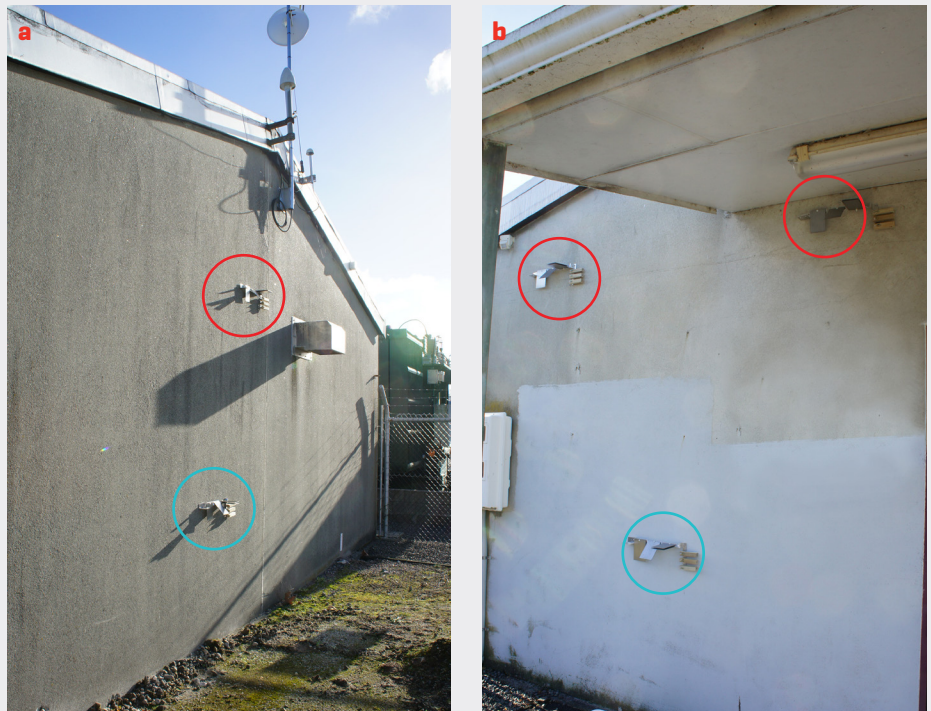
- a low position approximately 1 metre from the ground and fully exposed to the weather on the northeast and southeast walls with no eaves (Figure 1a)
- a high position approximately 2.6 metres from the ground and fully exposed to the weather on the northeast and southeast walls (Figure 1a)
- an exposed position and a sheltered position approximately 2.6 metres from the ground and an exposed position approximately 1 metre from the ground on the southwest wall (Figure 1b).

Figure 1. The monitoring positions on the Arawa substation building in Rotorua.
