Energy efficiency in the New Zealand housing stock

This Research Now describes the findings around energy efficiency from the BRANZ House Condition Survey 2015. The survey results show large opportunities to improve the energy efficiency of New Zealand's existing housing stock.

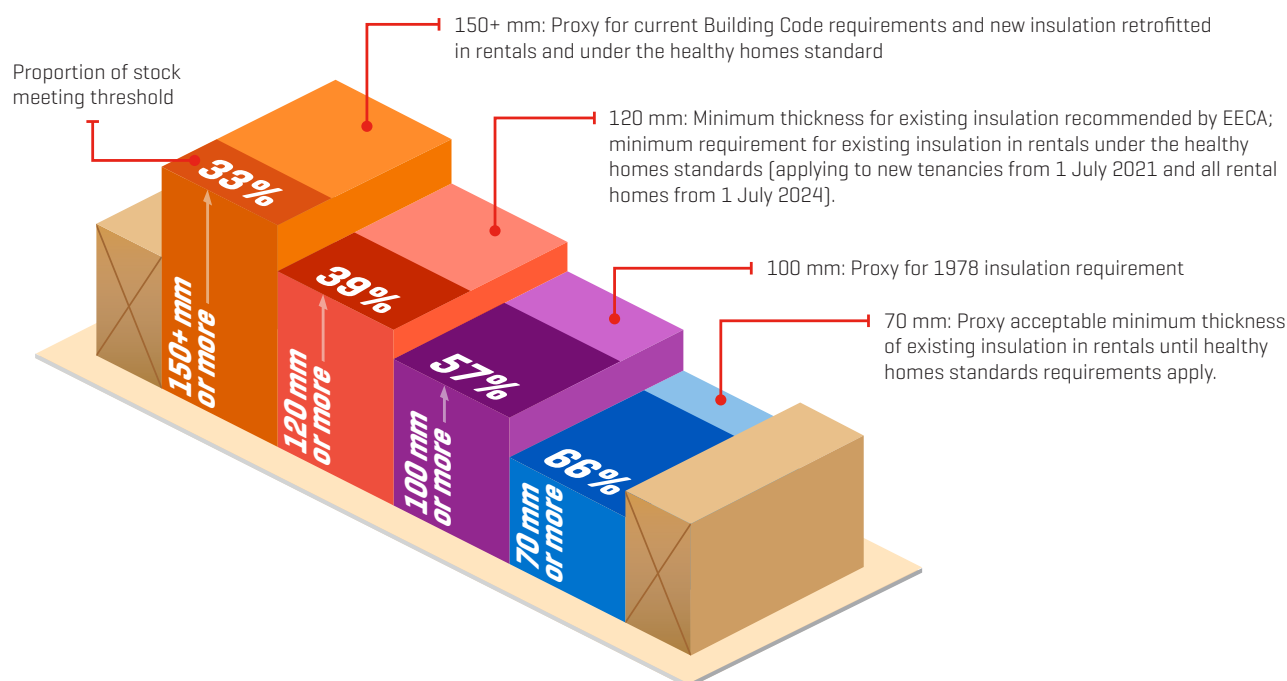
For ceiling insulation, the government's Energy Efficiency and Conservation Authority (EECA) recommends a minimum depth of 120 mm across at least 80% of the accessible roof space. Just 39% of houses had ceiling insulation that met this requirement (Figure 1). Around half of houses had at least one defect such as gaps in insulation (31%) or insulation settling (22%), not fitted properly (16%) or displaced (11%).

Figure 1. The proportion of houses where ceiling insulation depth meets a particular requirement.

The findings suggest that around 47% of houses (representing 740,000 dwellings) could benefit from additional insulation in the roof space, and 28% of houses with a subfloor cavity (representing 290,000 dwellings, 19% of all houses) could benefit from additional insulation of the subfloor. Combined, over half the housing stock (53%, representing 830,000 houses) could benefit from retrofitted roof or subfloor insulation or both. (Percentage figures do not always add to 100% because some roof or subfloor areas were not accessible to inspectors.)

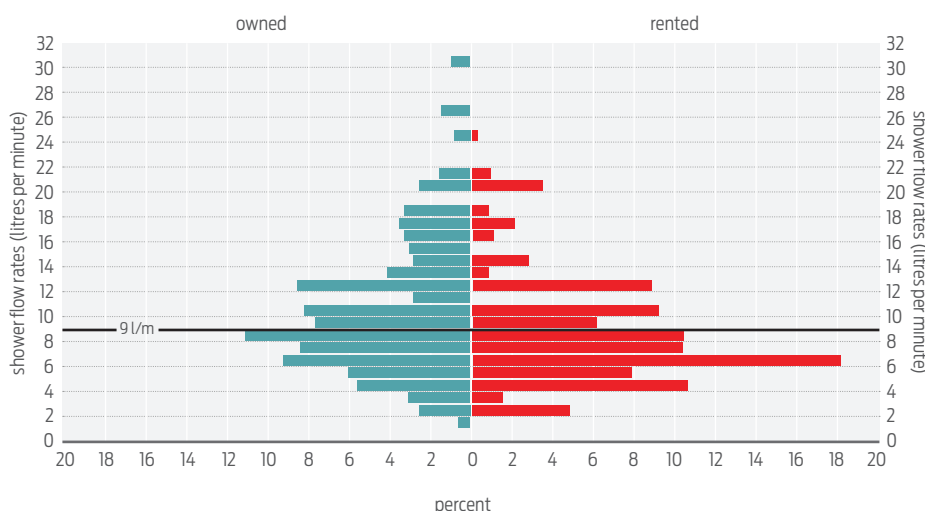
EECA recommends a shower flow rate of 9 litres per minute or less, but in many houses, rates are higher: 46% of houses had at least one shower with a flow rate greater than this,

and nearly 15% of showers exceeded 15 litres per minute (Figure 2). Higher flow rates were more likely in:

Figure 2. Proportion of showers with flow rates greater than the recommended 9 litres per minute.

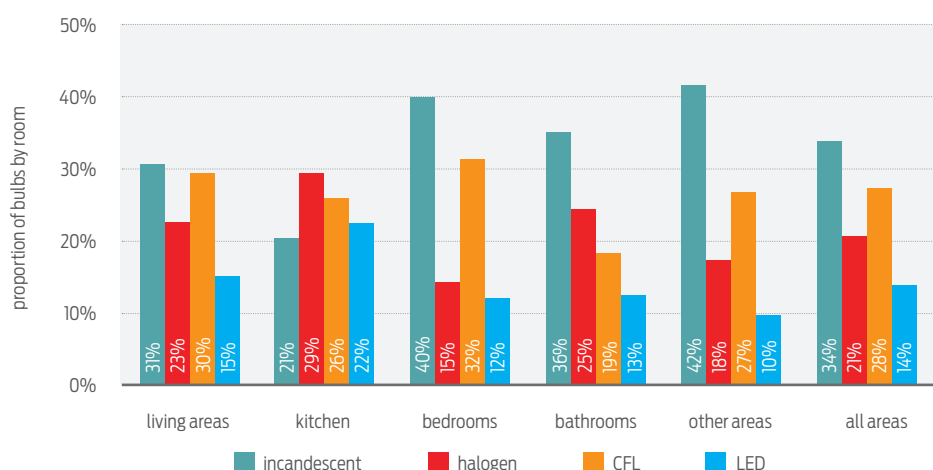
- Owner-occupied houses had an average of 27 **light bulbs**, rental properties an average of 15. This extrapolates to over 35.1 million light bulbs in New Zealand houses - 26.9 million in owner-occupied houses and 8.3 million in rentals. The average number for houses built since 2000 was 33 compared to 18 for houses built in the 1980s. Overall, the less-efficient incandescent bulbs accounted for just over one-third (34%) of all bulbs (Figure 3).

Figure 3. Proportion of different types of light bulb by room.
