## The state of our subfloors

The subfloor areas of New Zealand houses are too often in poor repair. The results of the BRANZ House Condition Survey 2015 matched the findings of earlier surveys, showing a need in particular to clear subfloor vents to allow effective ventilation and replace missing or corroded fixings and fasteners.

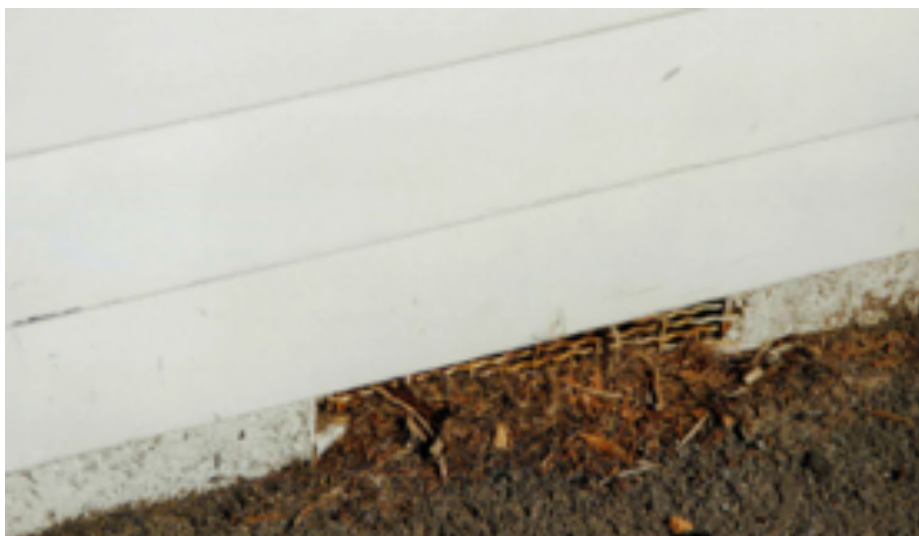
Work by house owners - creating new paved driveways or paths beside the house or building new garden beds below house walls

Subfloor vents are one of the house components most likely to be assessed as being in poor or serious condition.

- is likely to be a major cause of subfloor vent blockages.

- Clearing away garden plants, mulch or soil blocking subfloor vents and reducing the soil level if necessary.
- Clearing away materials stored under the house that may be blocking vents or preventing good ventilation.
- Installing a vapour barrier on the ground beneath the house to reduce subfloor moisture levels.
- Installing missing fixings or replacing corroded fixings on piles and bearers/joists.

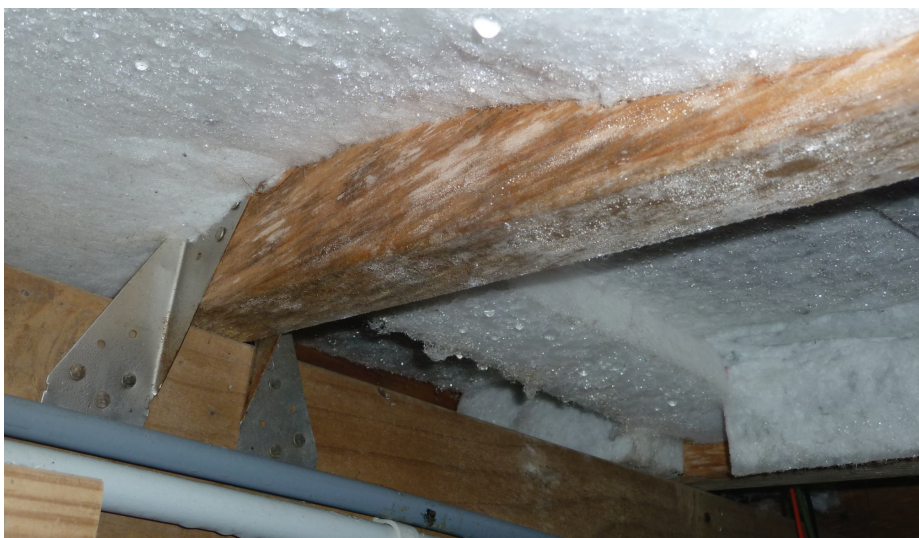
Poor subfloor ventilation can lead to problems with excess moisture.
