STUDY REPORT

SR 304 (2013)

Post-Earthquake Performance of Passive Fire Protection Systems

P. C. R. Collier

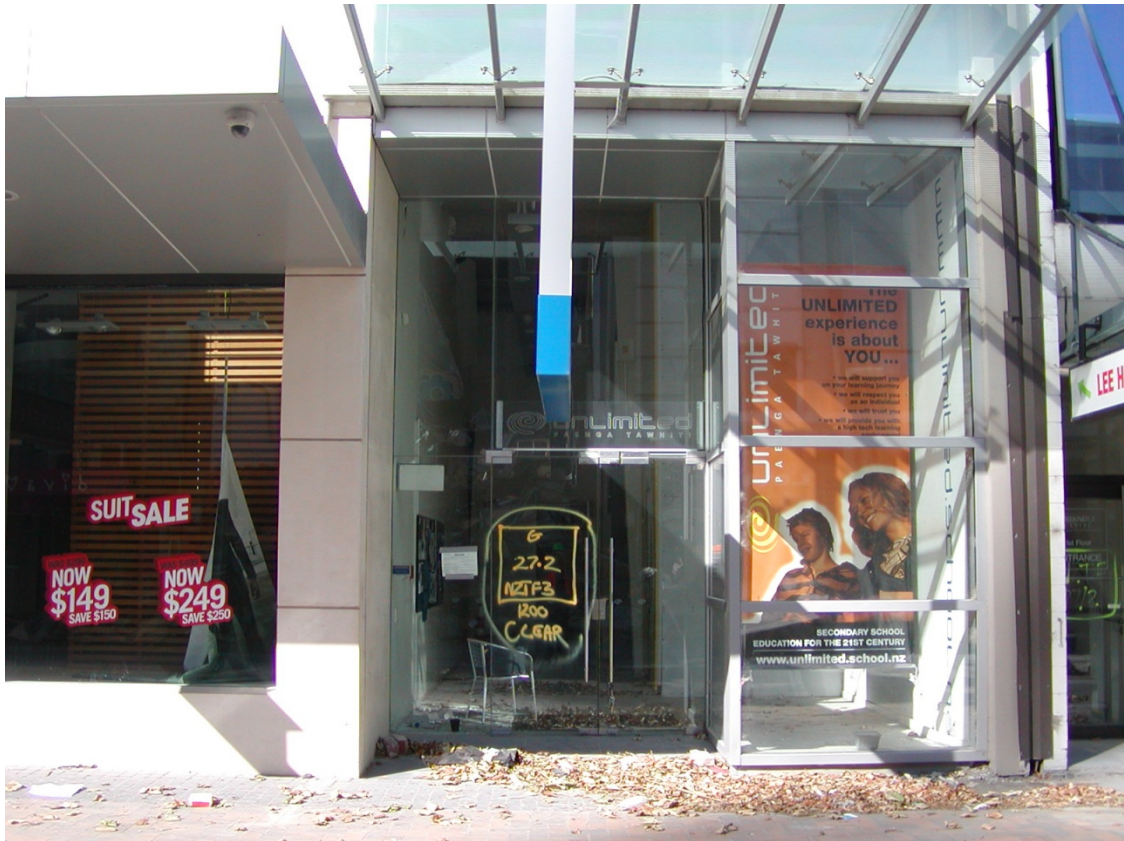
Figure 5: Fire wall between retail store and entrance lobby

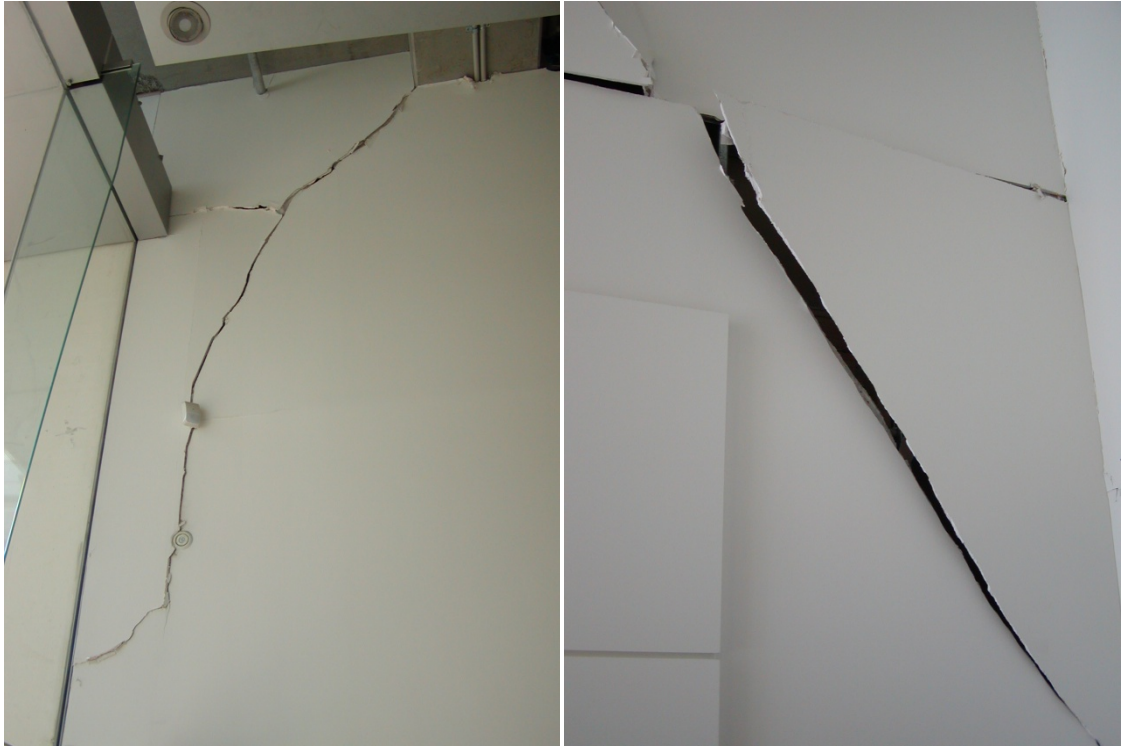
Inside the entrance lobby the plasterboard is extensively cracked at end and top corner as shown in Figure 6.

Figure 6: Severe cracking at opposite ends of the 30/30/30 firewall inside the entrance lobby

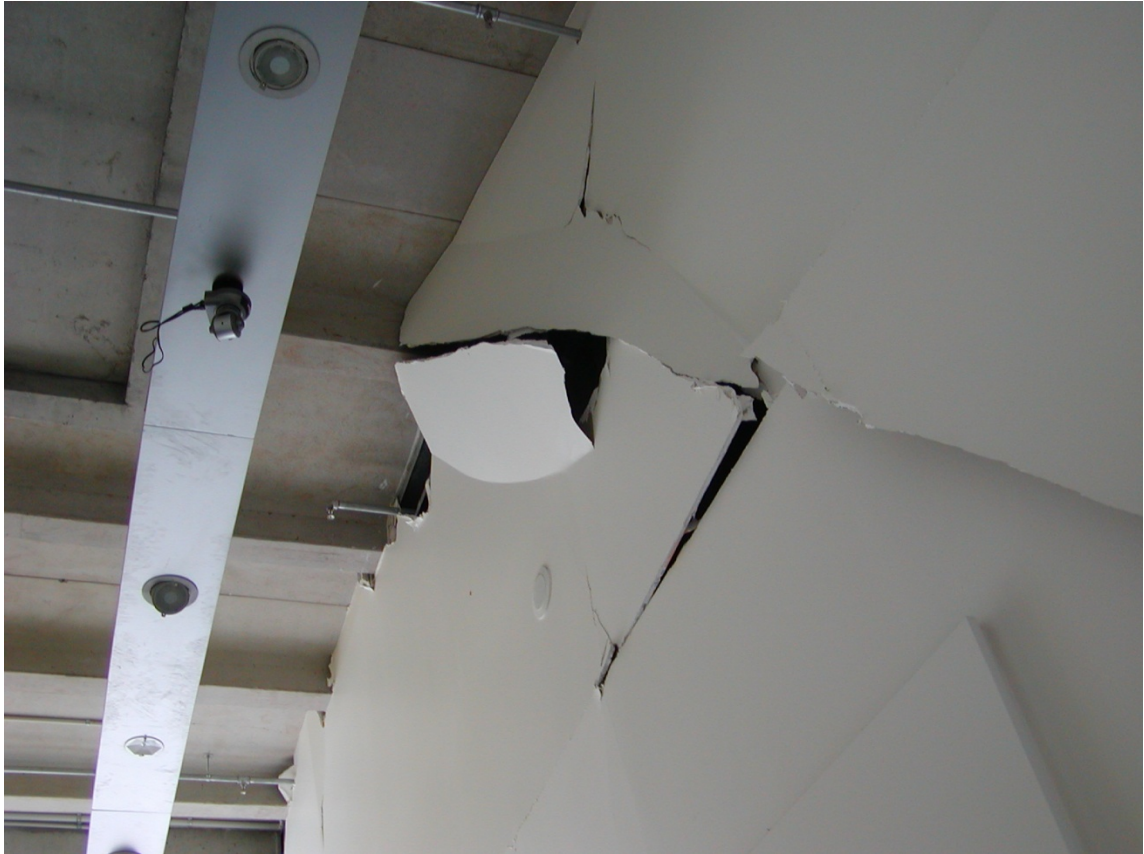
The cracking and detachment of the plasterboard on the top edge of the lobby side of the wall is shown in Figure 7.

Figure 7: Top edge of entrance lobby firewall

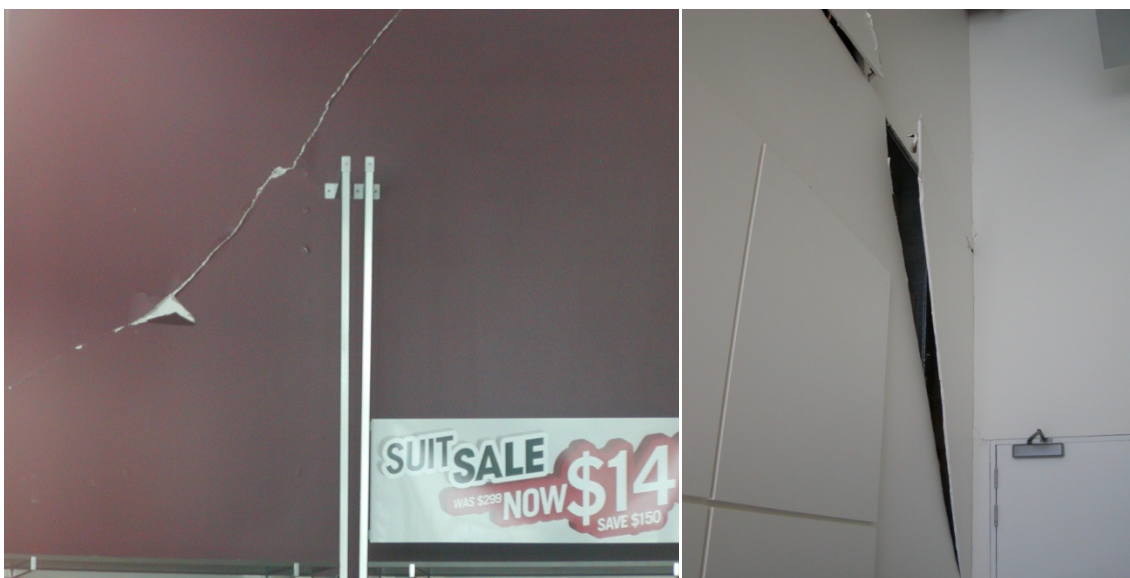
On the retail store side of the wall the lining is cracked on opposite sides as shown in Figure 8.

Figure 8: Opposite sides of firewall left to right, retail store and lobby

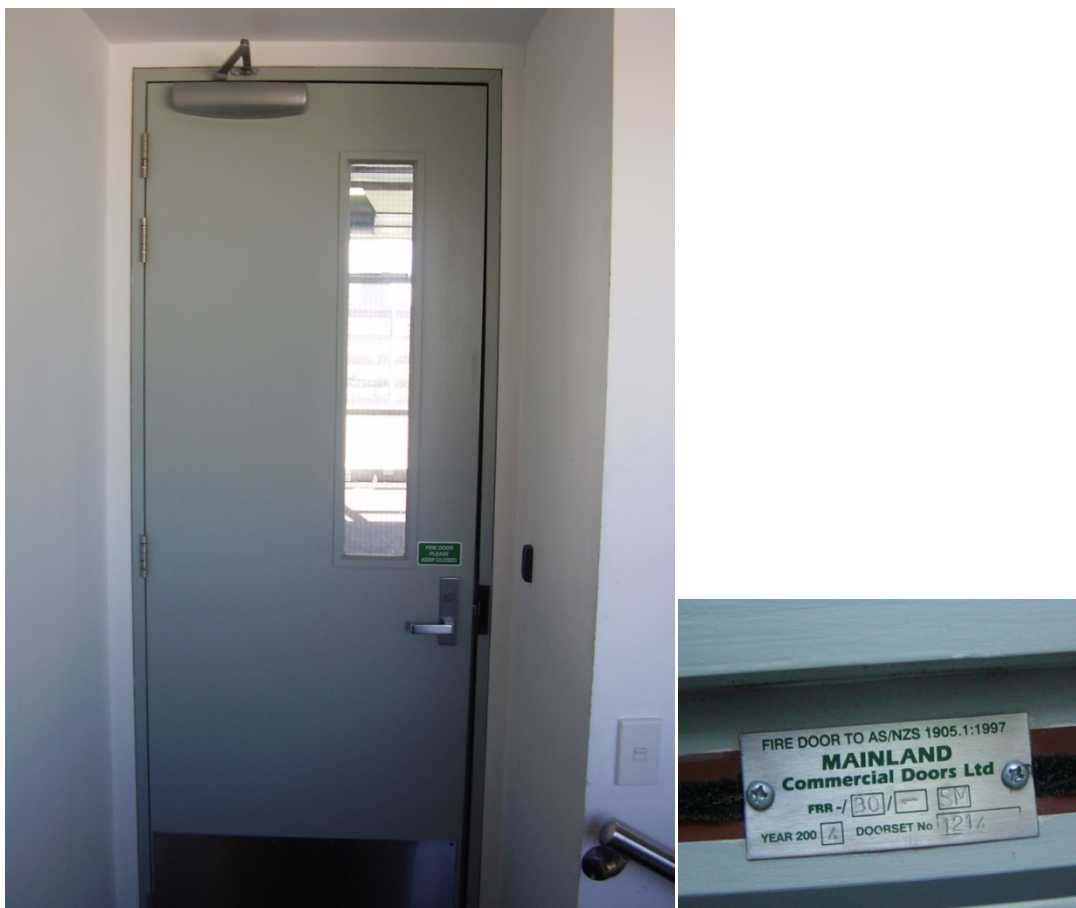
Figure 10: Fire door between stairwell and floor, -/30/- SM view from the stairwell side, intumescent strip is included to achieve smoke control

Fire doors were one area of focus for the site inspections, with a range of damage being observed. In Figure 10, the gap down the door jamb has increased from 2-3 mm originally to 4-16 mm after the earthquakes and the gap at the top right corner had increased to 7 mm. For all but the smallest of increases in gap from the original 2-3 mm that the doorset passed the required fire resistance test, the intumescent seal is unlikely to expand enough to fill the gap and the fire resistance will be significantly compromised.

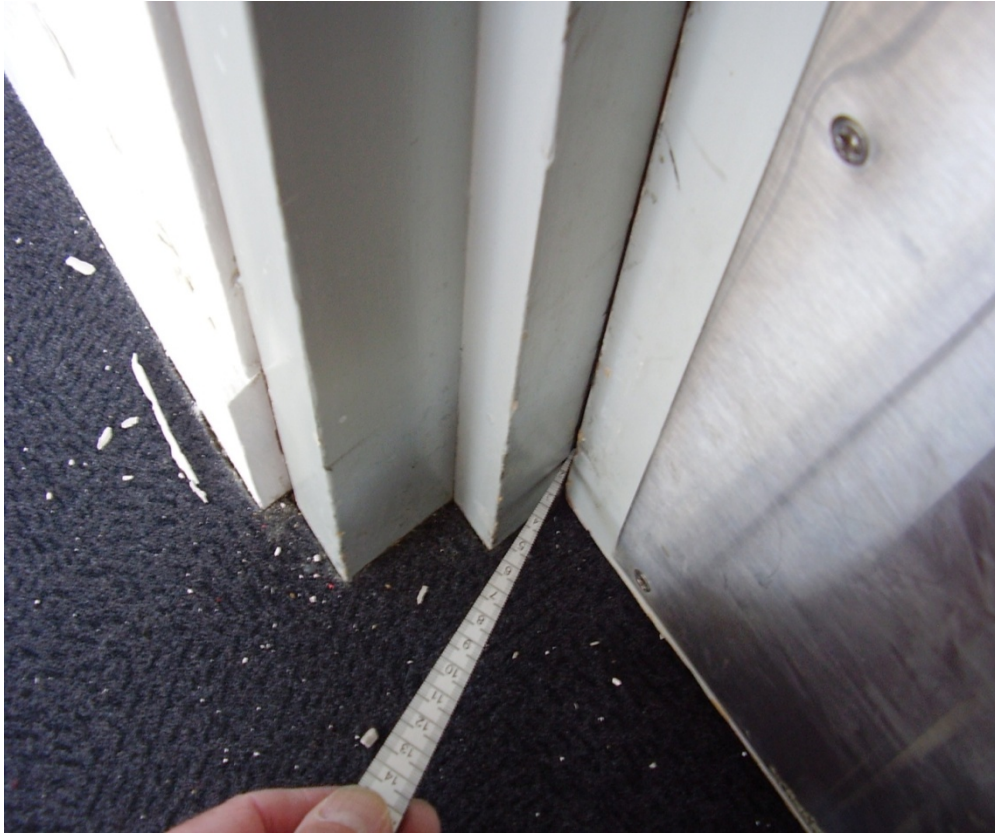
Figure 11: 1.5 mm gap between door stop and leaf

On the other side of the same door where the “leaf-to-frame” gap was 16 mm at the bottom there was a 1.5 mm gap (see-through) between the leaf and the door stop as shown in Figure 11. In exposure to fire, especially from the office space side, it is likely that only minimal deflection of the door leaf on heating will be required to result in a rapid opening of the gap, allowing smoke into stairwell. Integrity failure is also deemed to have occurred if the gap increases to greater than 6 mm.

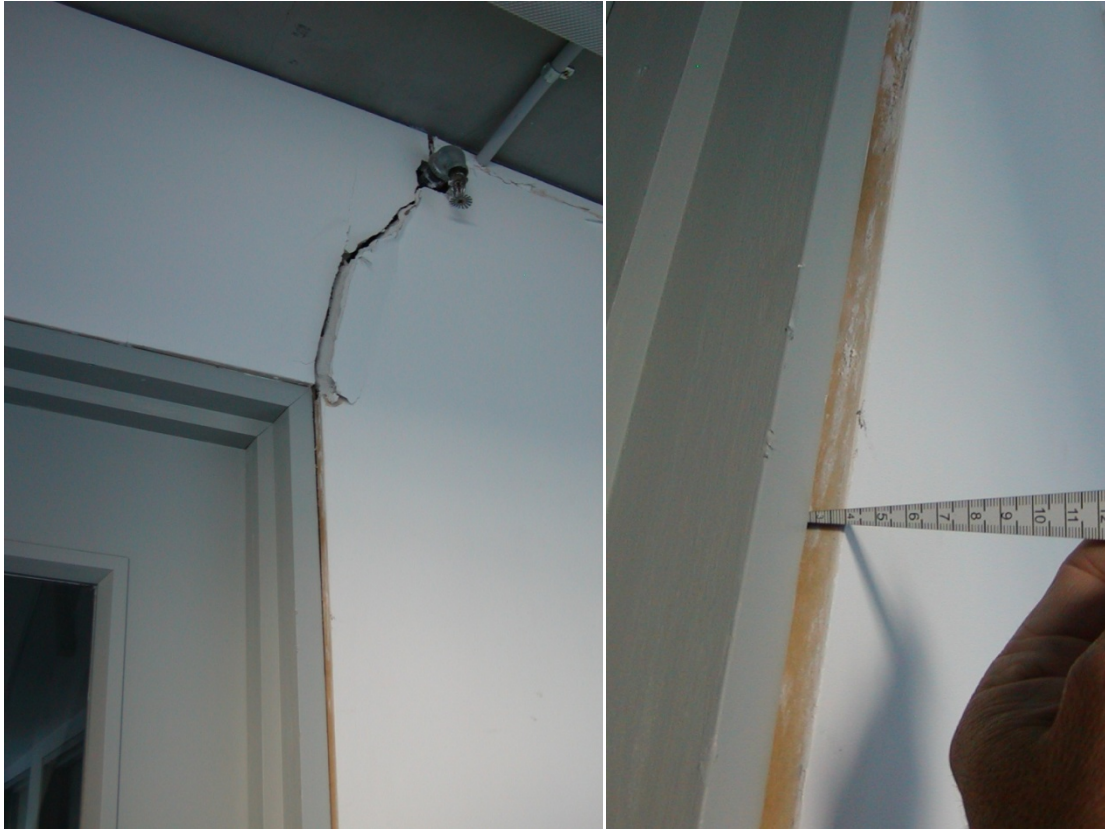
Figure 12: Cracked and displaced lining on stairwell side of door frames

Damage to plasterboard was also observed around door frames particularly at the top corners. Figure 12 shows damage to the fire-rated lining at the head of the door and a 7 mm displacement between the lining and door frame. If movement of the door frame is greater than clearances around the leaf, then the fracture and displacement of the plasterboard lining is more likely. In some cases the door leaf-to-frame clearances may return to their near original position but the displacements during the event have extensively damaged the plasterboard.

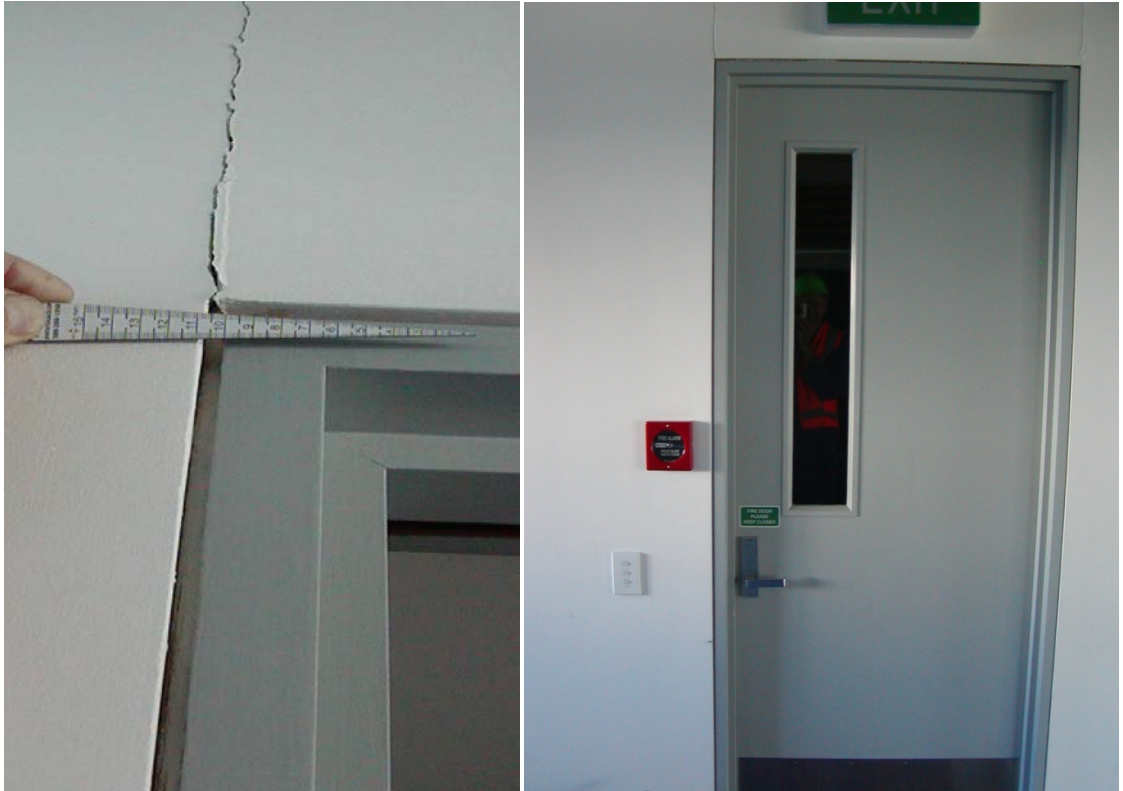
Figure 13: Vertical crack on plasterboard above door frame and 7 mm gap between plasterboard and door frame

Plasterboard tends to open gaps where there is a joint between sheets formed over double studs above door frames (Figure 13).

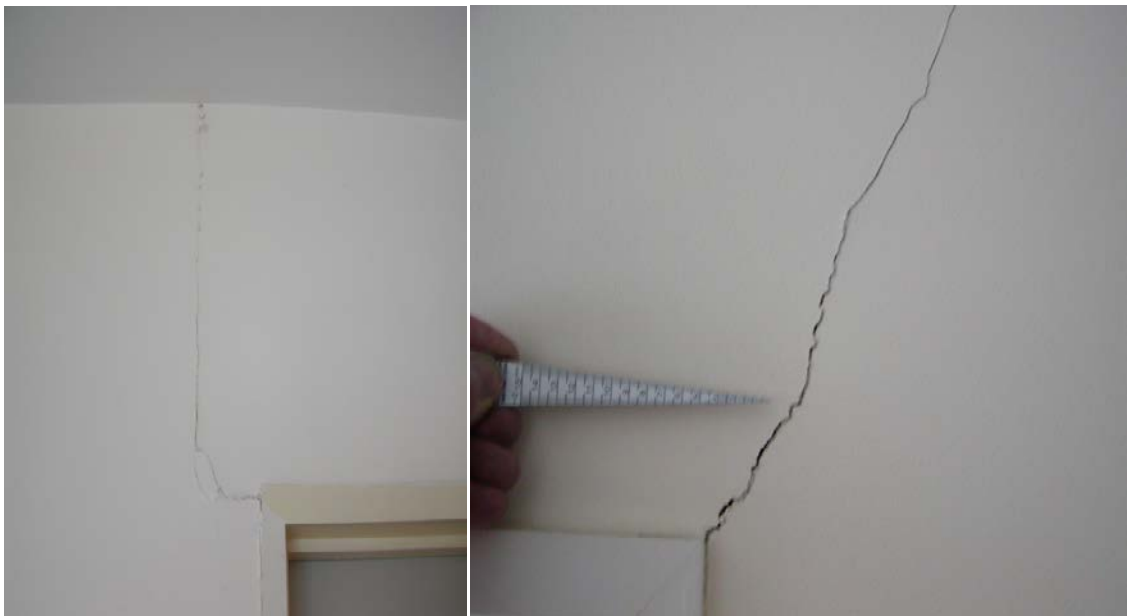
Figure 14: Lining sheets separating on one side and diagonal cracking on the other

In a number of instances a diagonal crack on one side of a door frame was matched by a vertical crack on the other and the gap opening size could be quite different, Figure 14 being a good example.

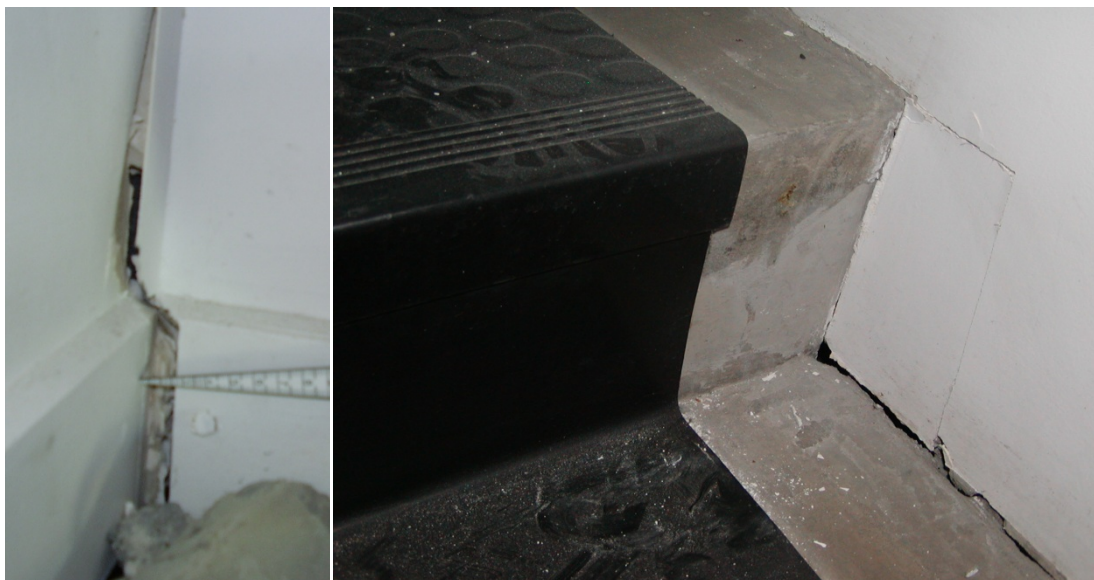
In the protected stairwells the plasterboard lining sustained some damage as well, typically it was in wall-to-wall internal corner junctions with gaps opening to up to 15 mm on landings between stair flights as well as tread-to-wall gaps opening 5 to 10 mm as shown in Figure 15.

Figure 15: Stairwell plasterboard damage in corner and on stair tread

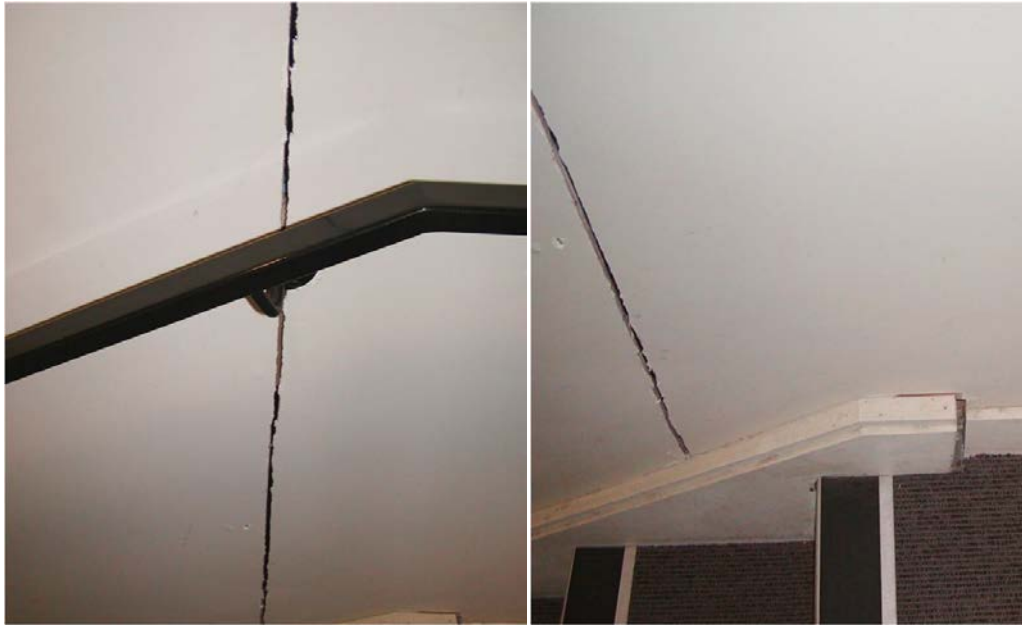
Figure 17: Vertical crack of ~4 mm at lining junction over double studs and opening of gap between stair flight and wall

Although not necessarily confined to stairwells, some instances of vertical openings at plasterboard joints were observed where double studs are covered by lining sheets that also join over the double stud. This type of joint, also found above doors and windows, is particularly prone to opening up in normal service and more so in earthquakes as shown in Figure 17 and provides a ready path for the transport of hot gases and eventually fire.

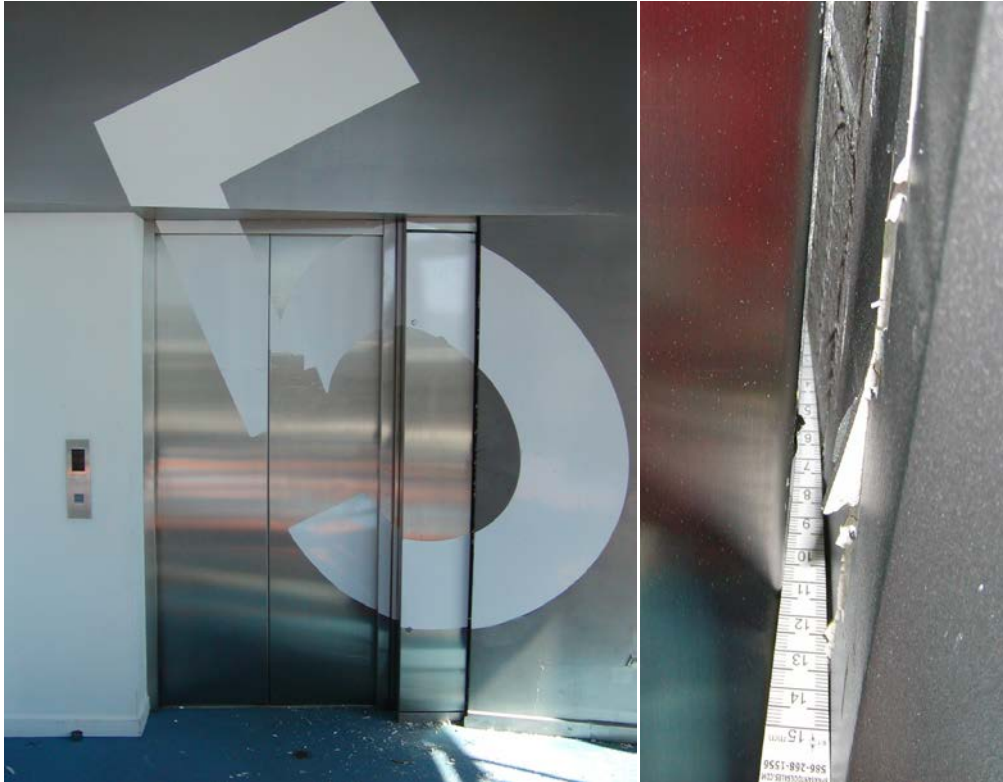
The observation that only the level 5 elevator doorset showed noticeable damage not unexpectedly demonstrates that with different levels of building subjected to different displacements in earthquakes – and this concurs with the findings for the building surveys in general – the degree of damage on PFPs can vary considerably. Such is the randomness of earthquakes it is not possible to predict where the damage is going to occur.

Figure 18: Top floor elevator doorset and 10 mm gap on right hand side

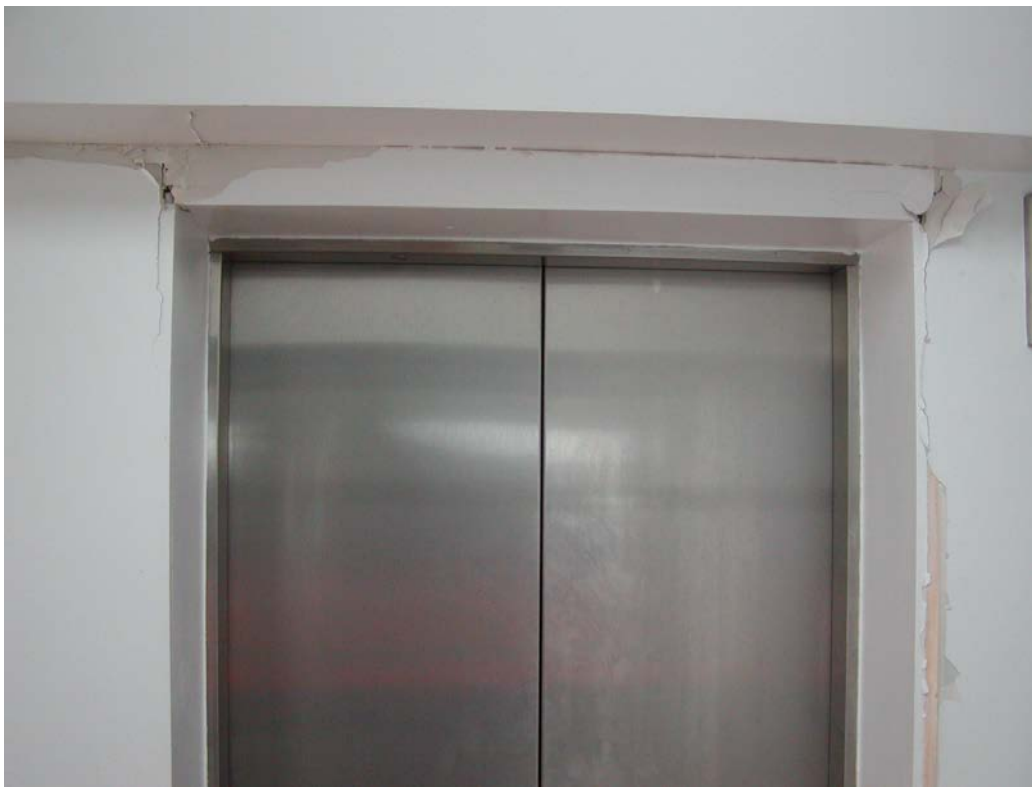
Figure 19 shows an elevator doorset in an apartment building that has similar damage around the frame as recorded for swing doorsets.

Figure 19: Cracking of plasterboard surrounding an elevator doorset
