# **STUDY REPORT**

**SR 335 (2015)**

## **New house construction quality survey 2014**

**I.C. Page**

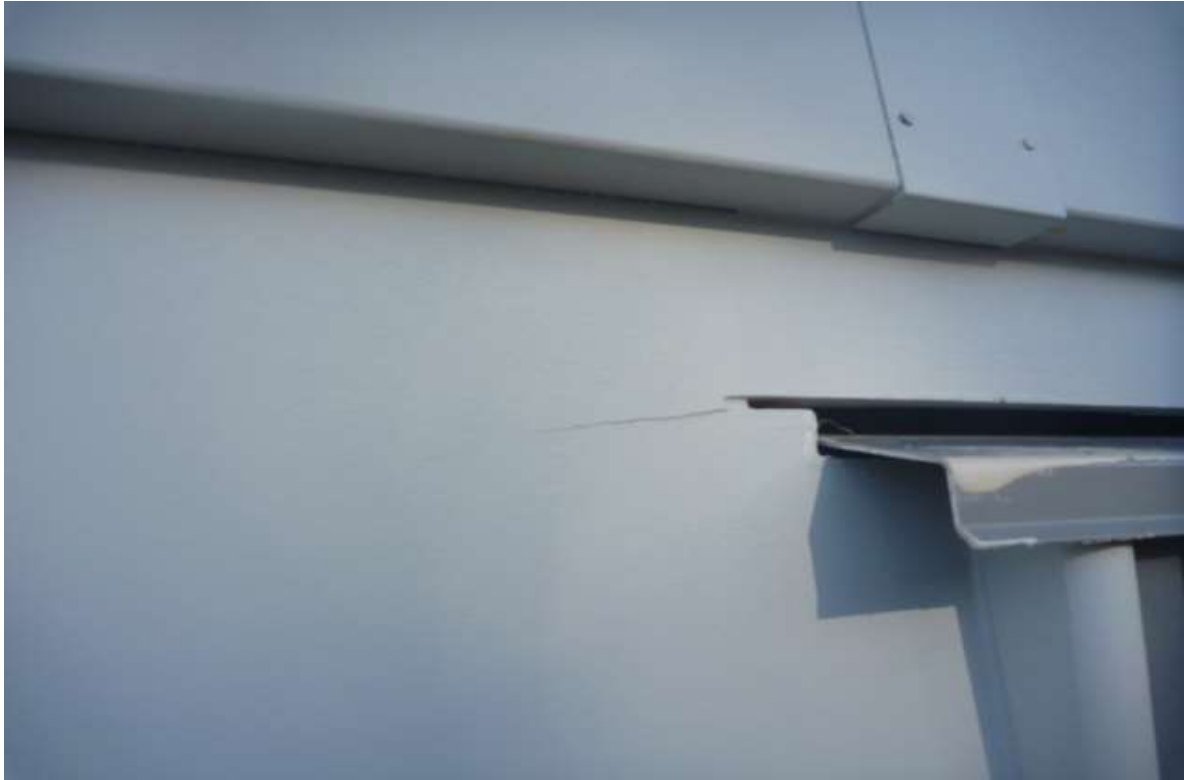
Over-cutting of weatherboard for the flashing. No stop-end was visible behind the cladding. Weatherboard is split.

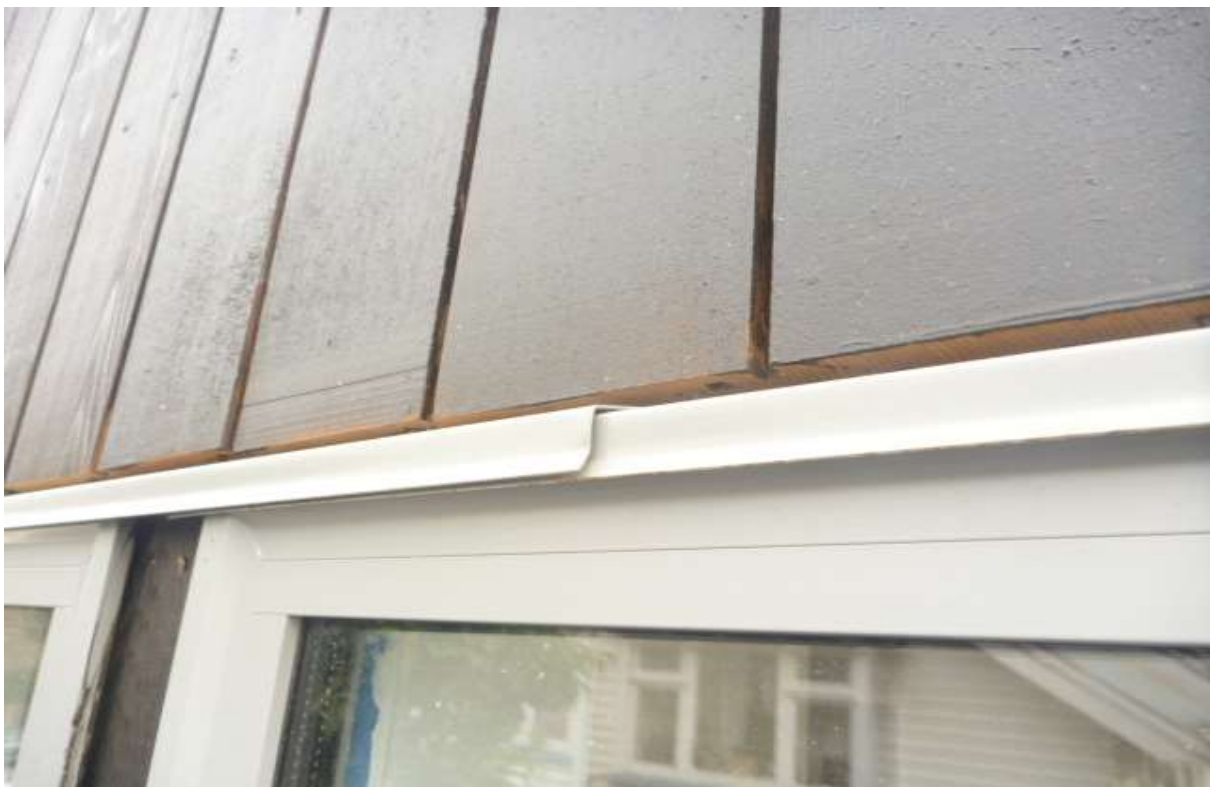
Poor junction of the flashing allowing moisture entry. Bottom edge of cladding needs painting.

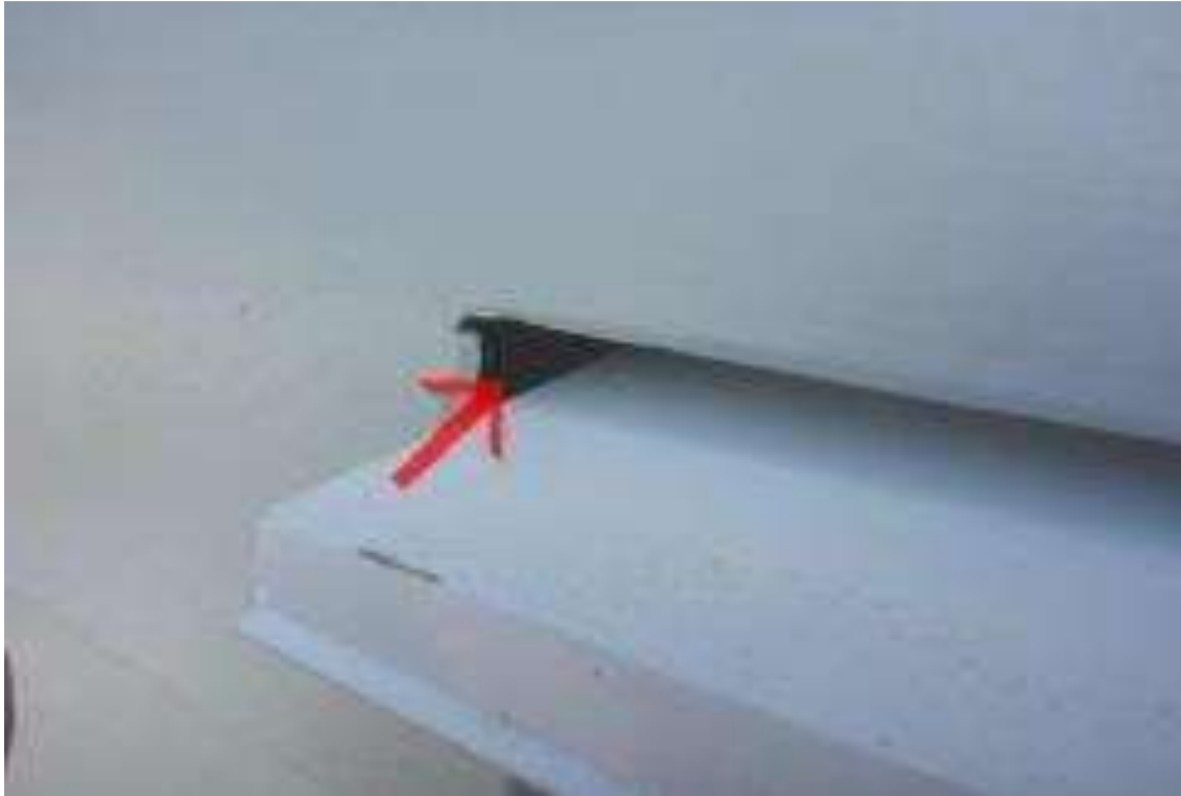
No stop-end on head flashing

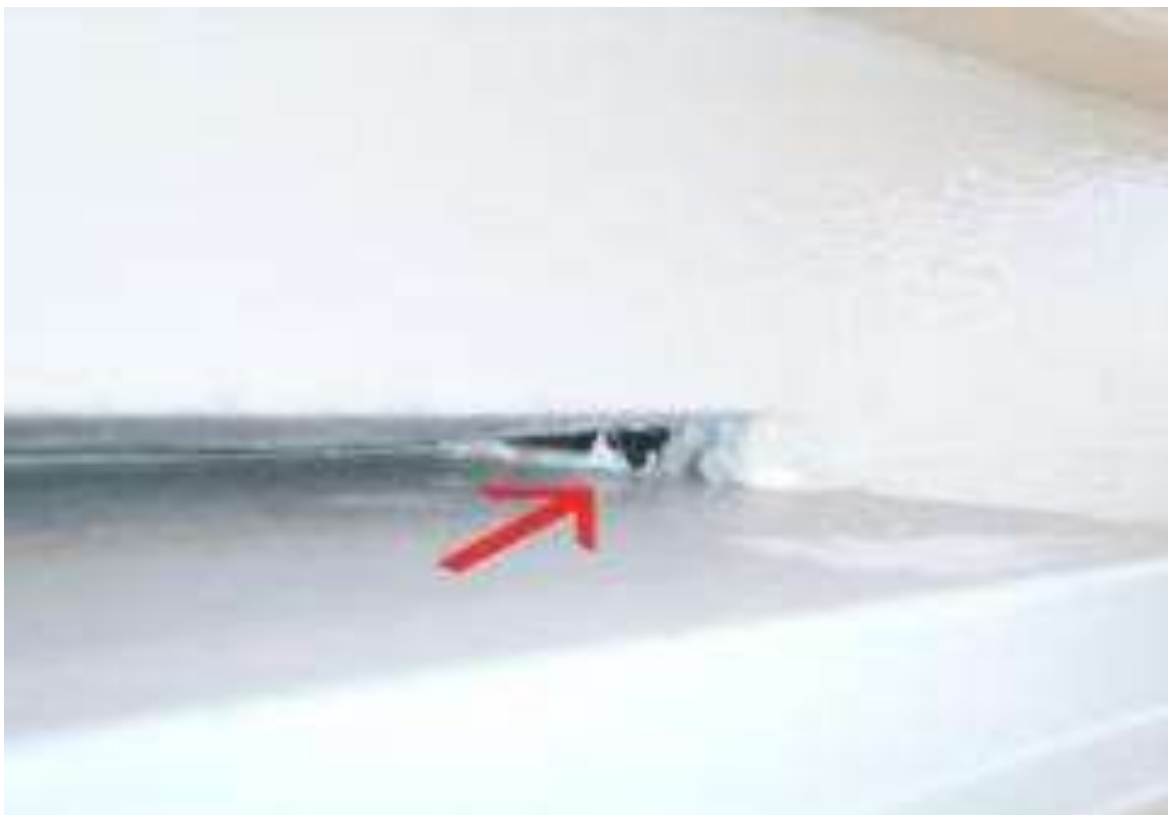
No sealing at the end of the head flashings

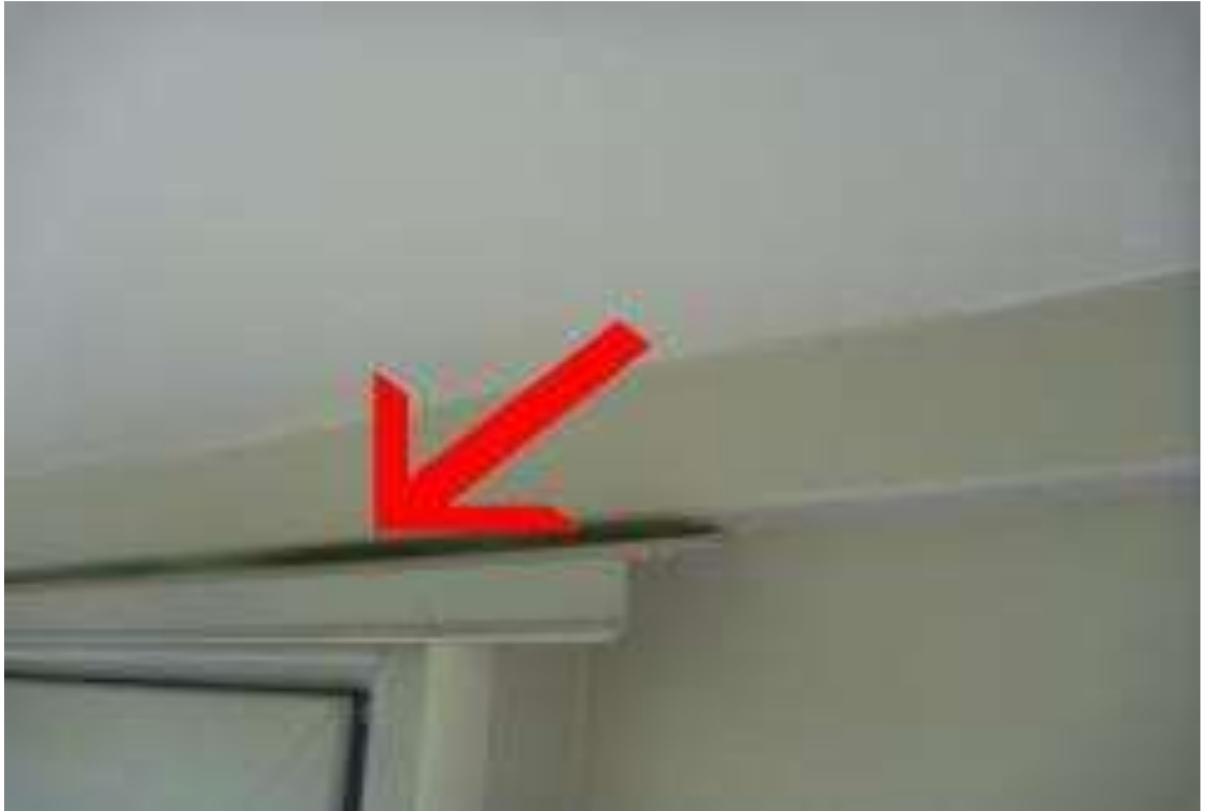
Inadequate clearance between cladding and head flashing

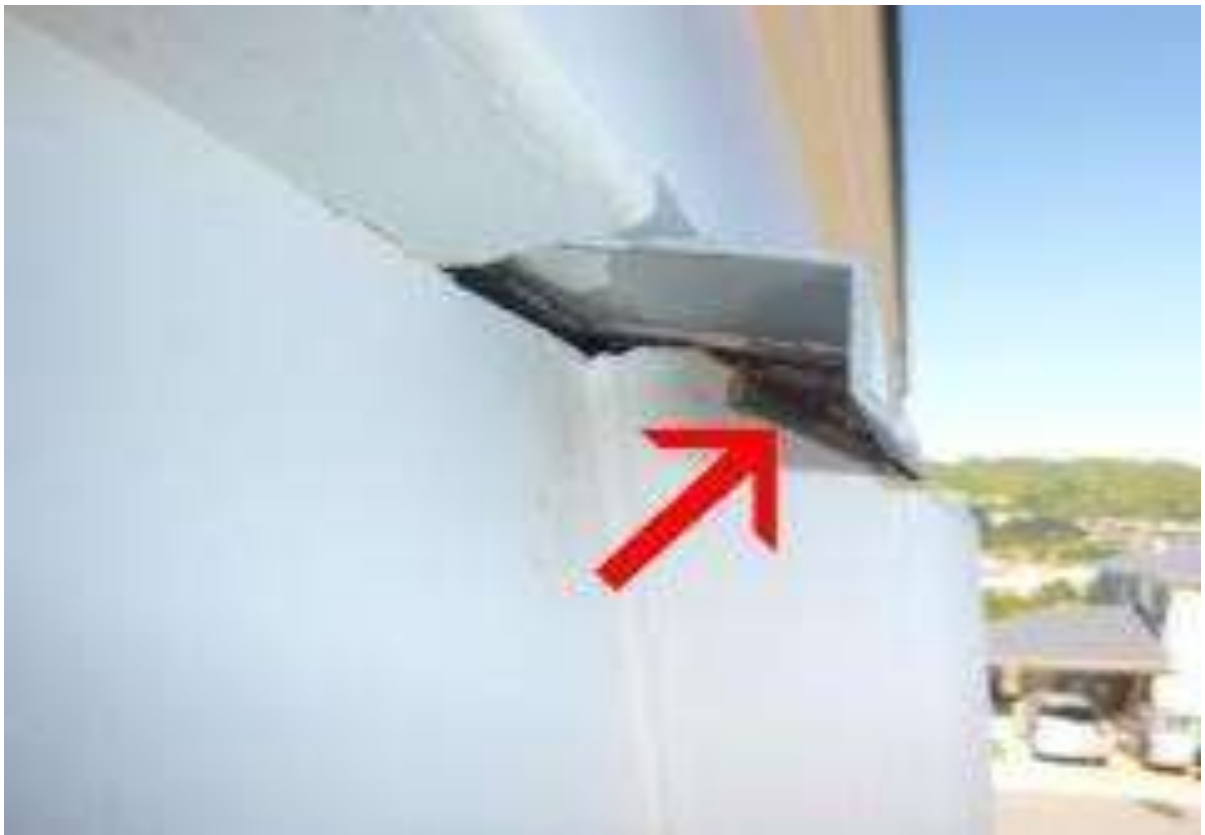
Head flashing does not cover scribe, unpainted and poorly cut scribe.

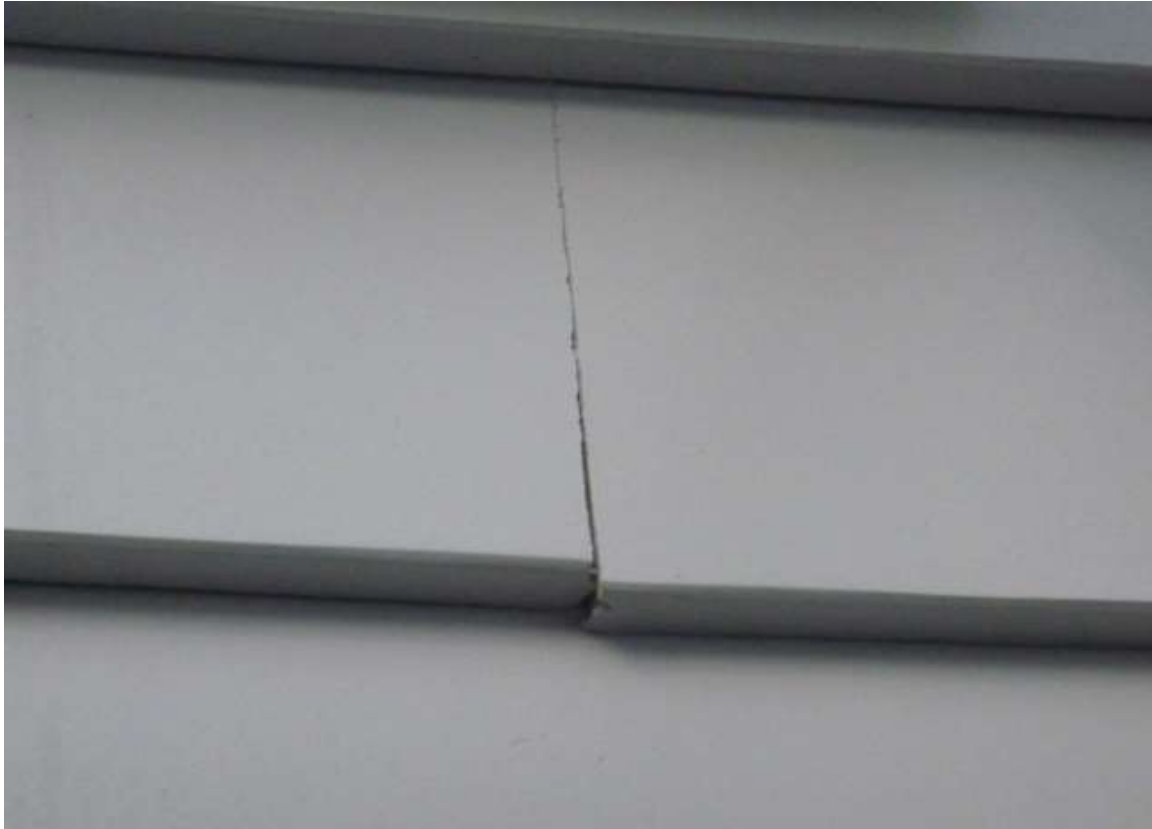
Poor weatherboard junction potentially allowing moisture penetration.

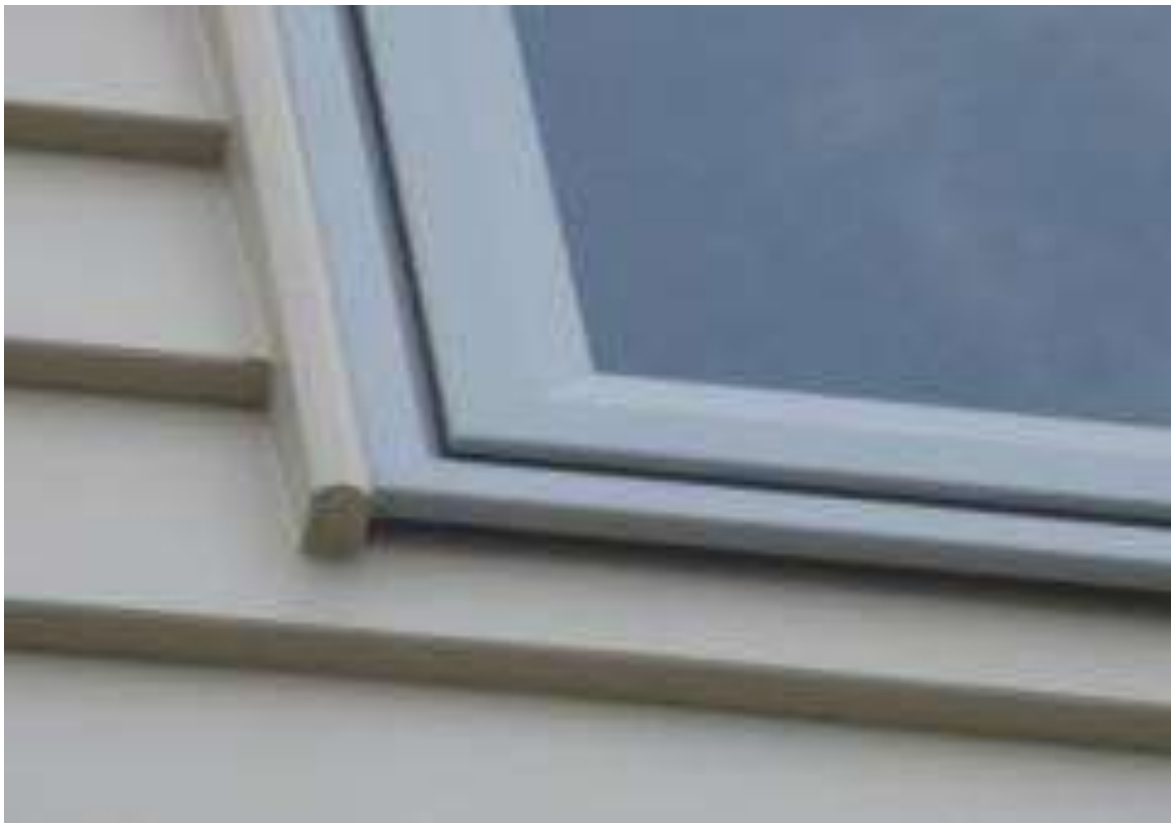
Window frame should to be firm against timber fillet at the window bottom.

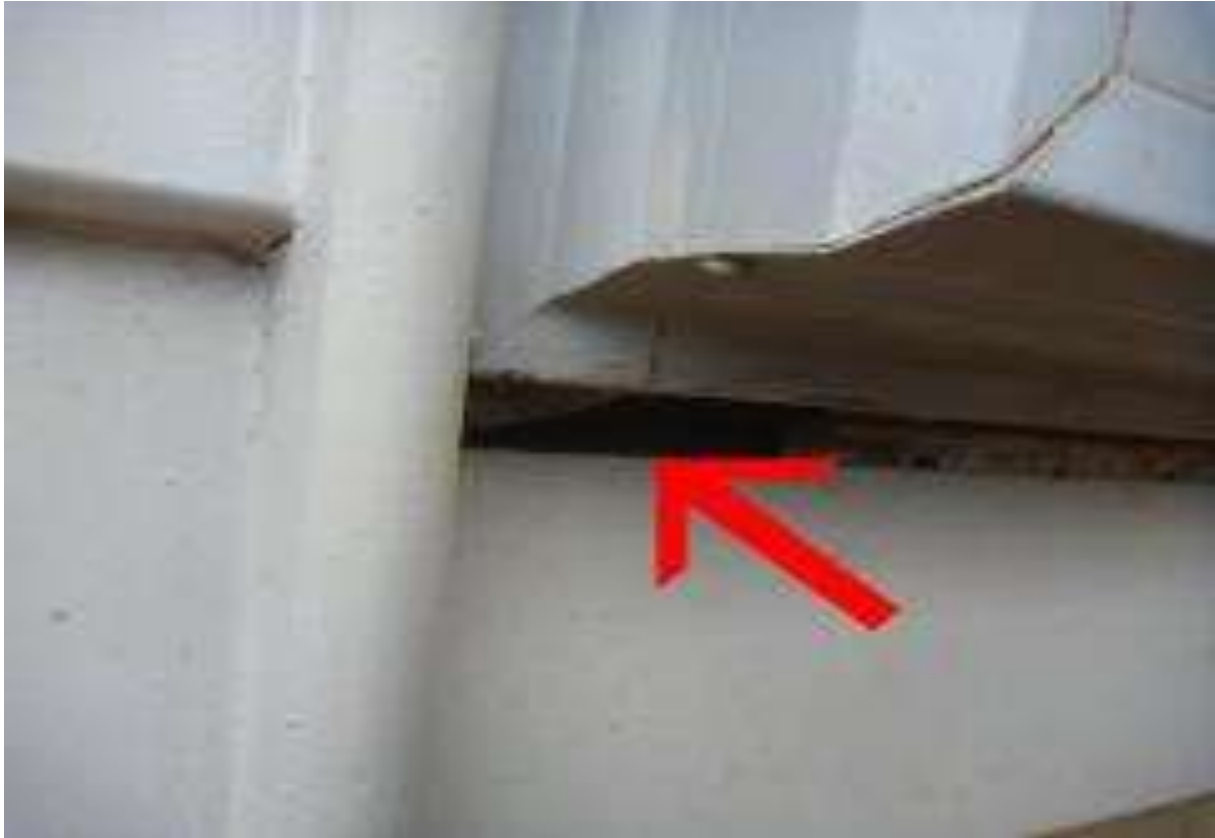
Gaps between the window frame and the cladding

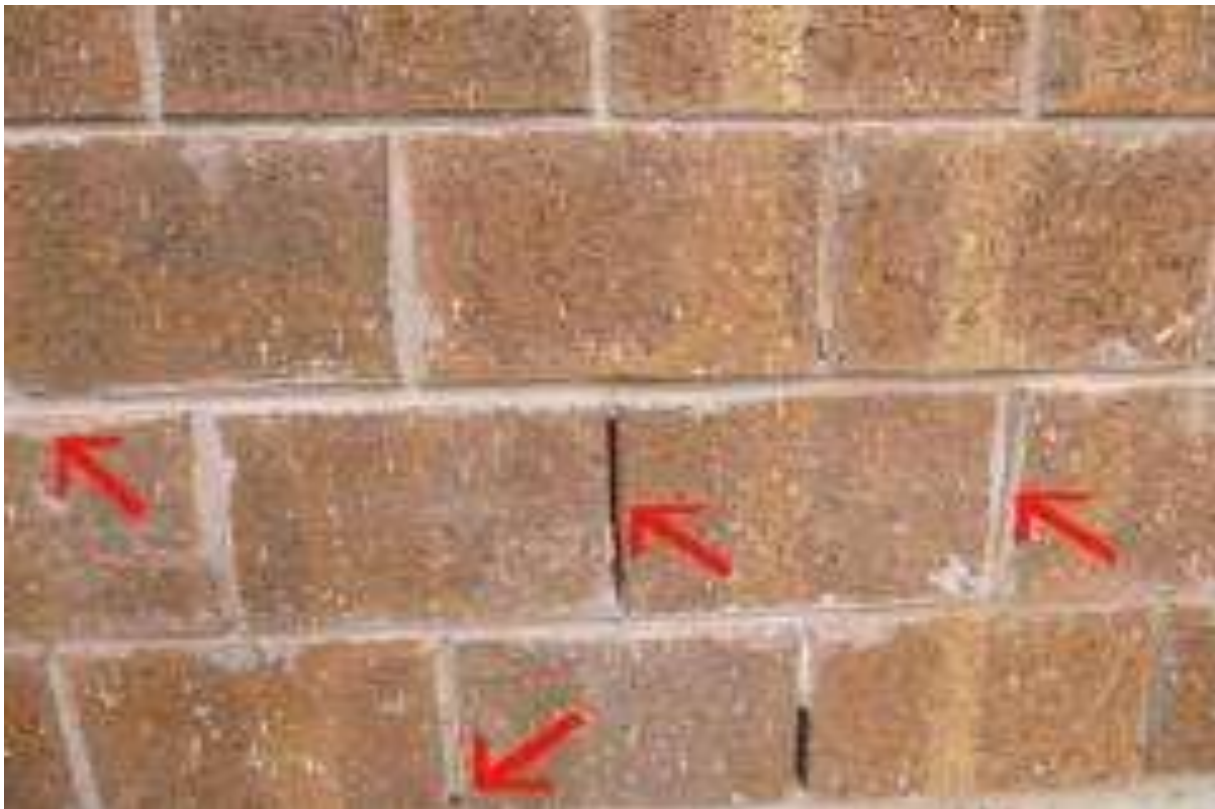
Missing mortar and poor finish

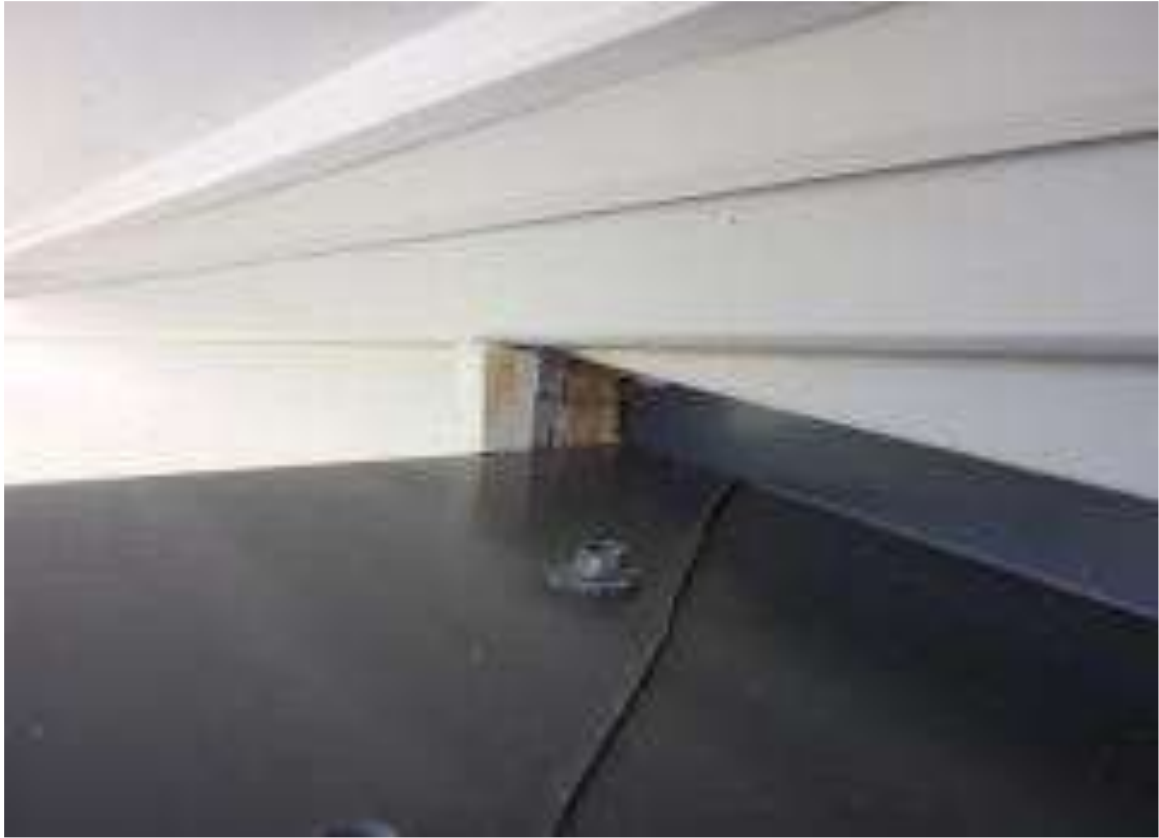
Apron flashing incomplete at corner with exposed timber.

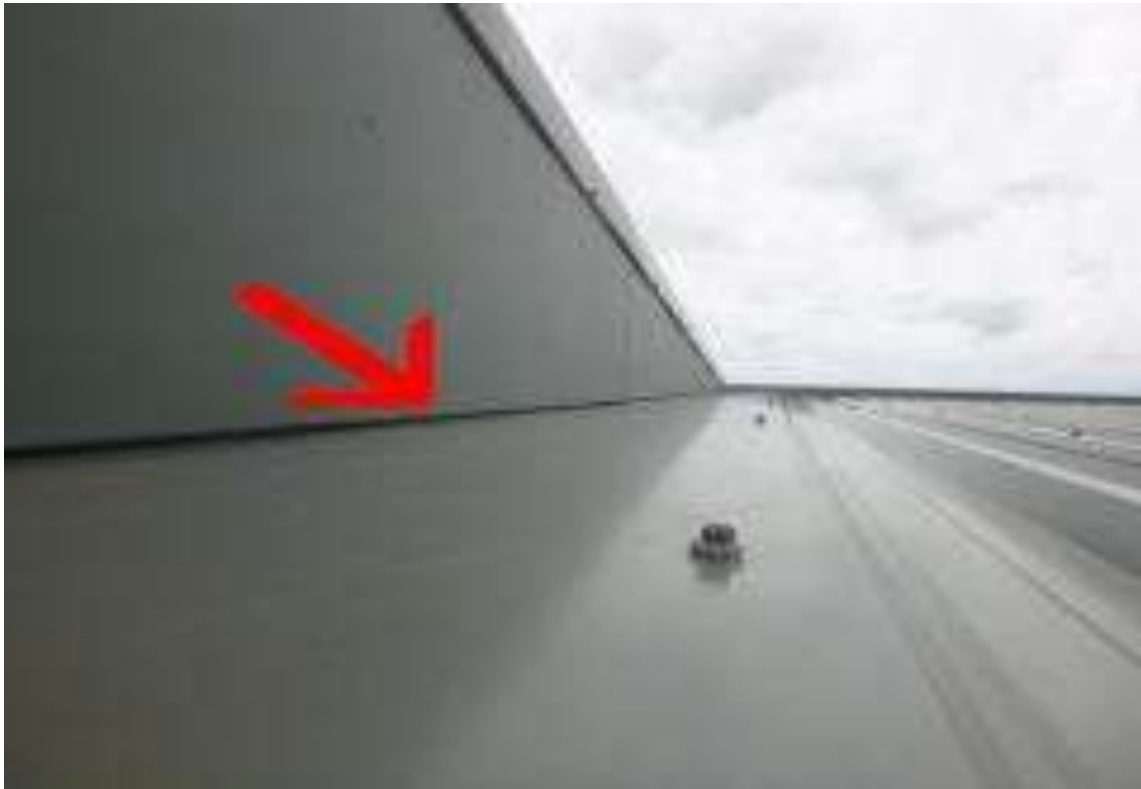
Inadequate clearance between the cladding and to the apron flashing

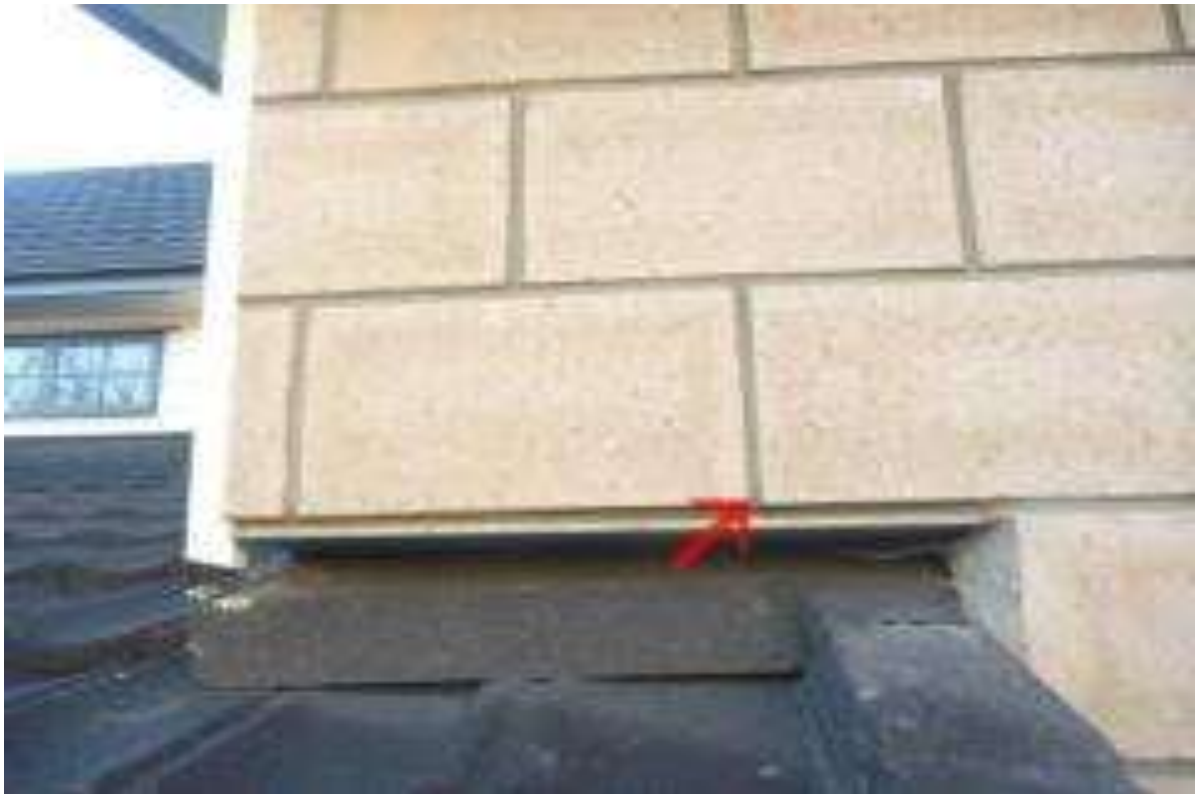
No weep holes in brick cladding on the lintel. Downpipe needs a spreader at the bottom.

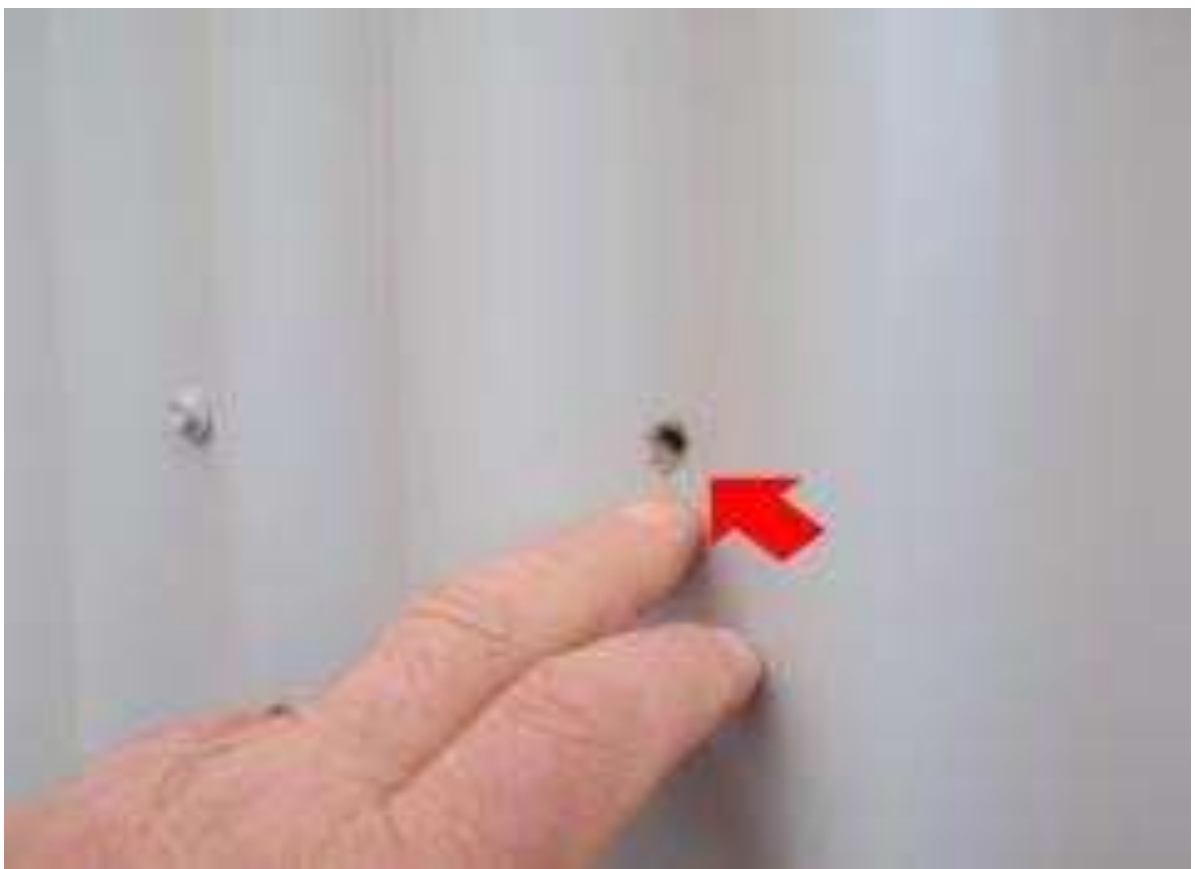
No sealing of hole on vertical corrugated sheet steel.

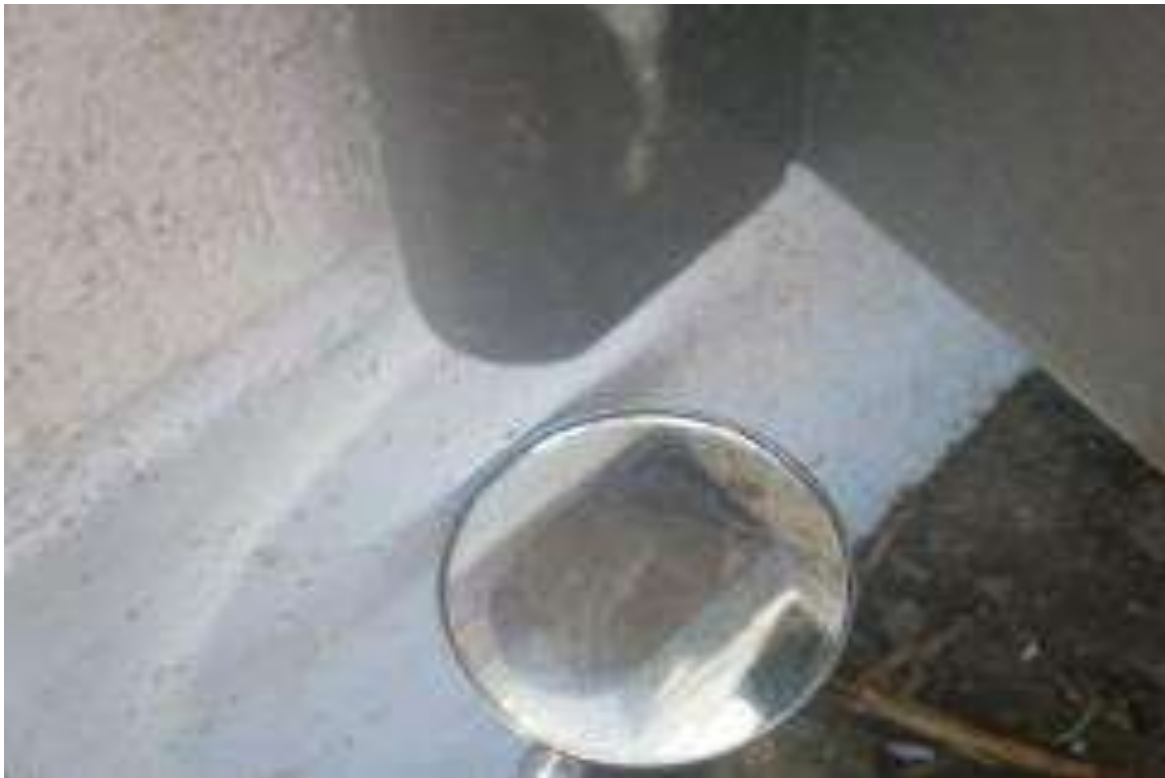
Underside of scribe is not painted.

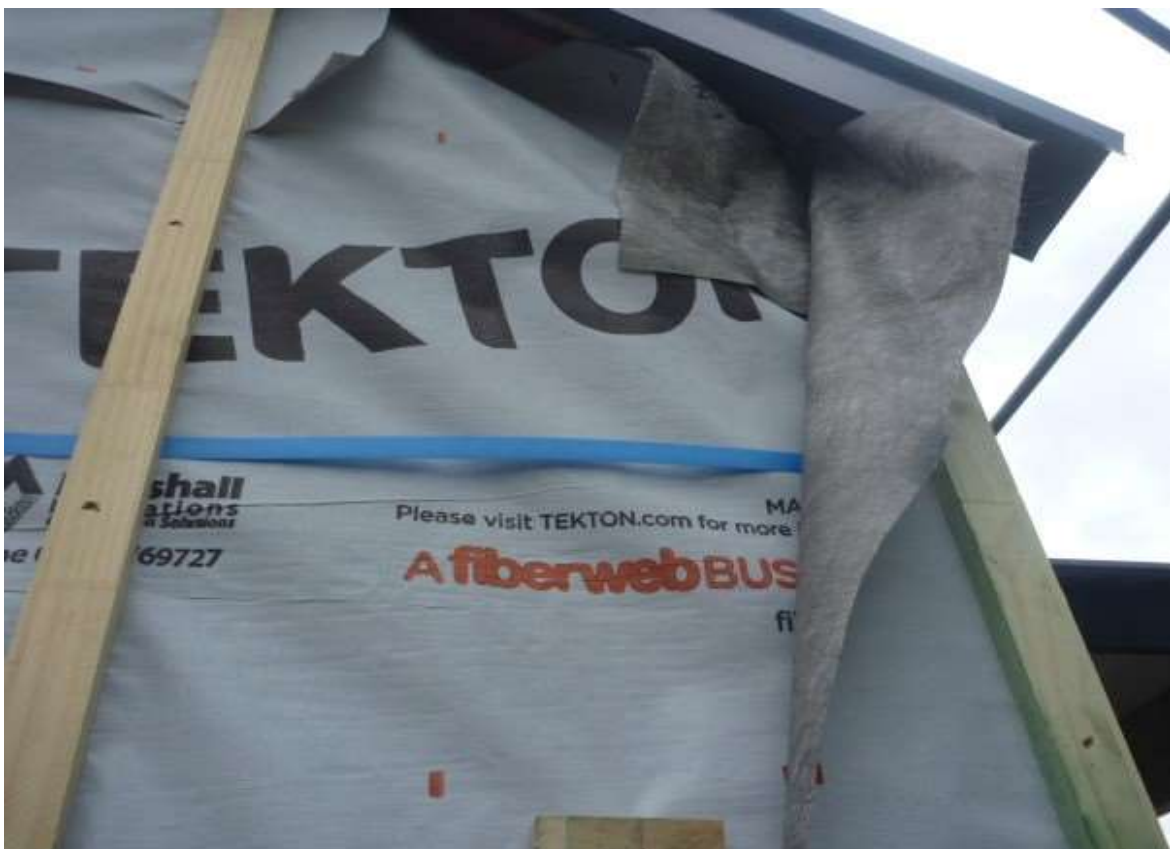
Wall underlay – Too loose. Torn and not taped. Cut short at bottom. Inadequate overlaps. Spacing between straps more than 300mm when studs over 450mm centres, or nil straps. Straps installed vertically instead of horizontally. All these faults could enable insulation to touch the cladding, causing wicking of moisture. Insulation pushing out wrap excessively was found to be uncommon, but it is a potential compliance issue.

Loose underlay

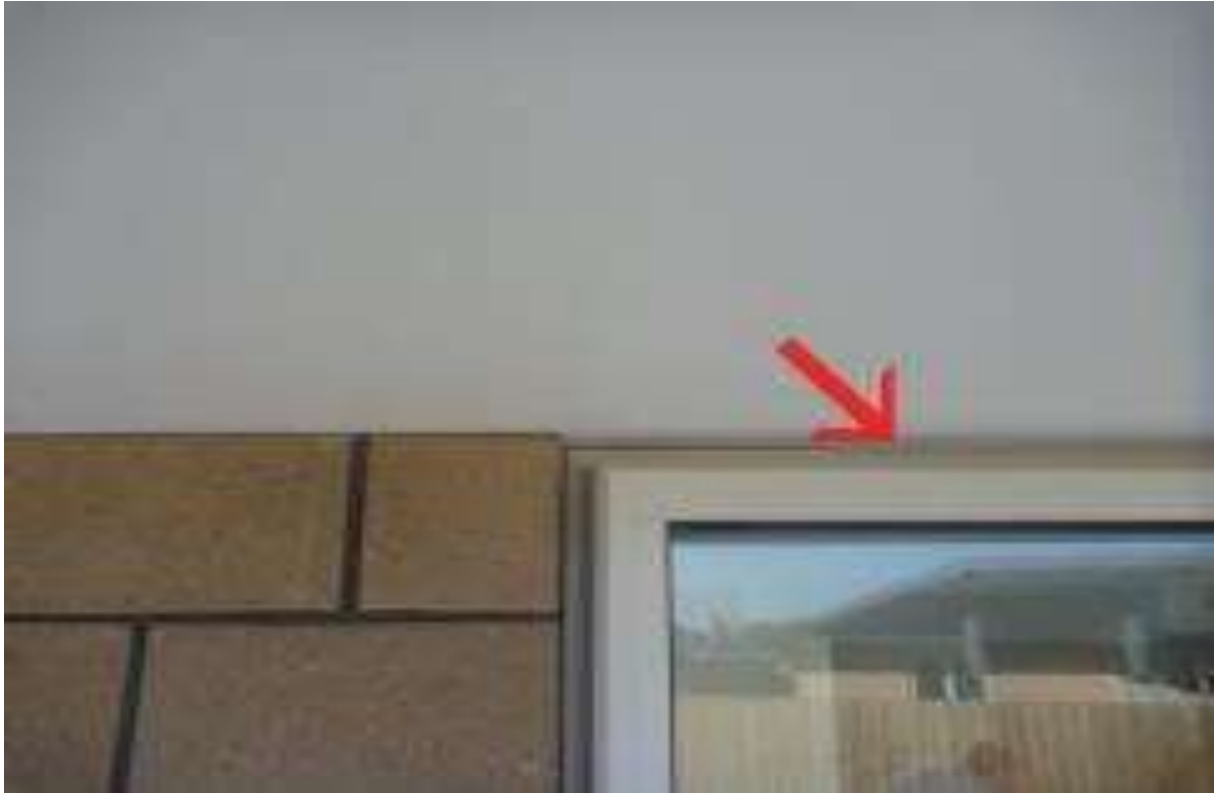
Soffit timber beading – no beading at the junction of the soffit with the top of the wall cladding or where the window frame touches the soffit. There is a potential moisture entry problem, though the junction is usually protected from the weather by the eaves.

No bead between soffit and window frame

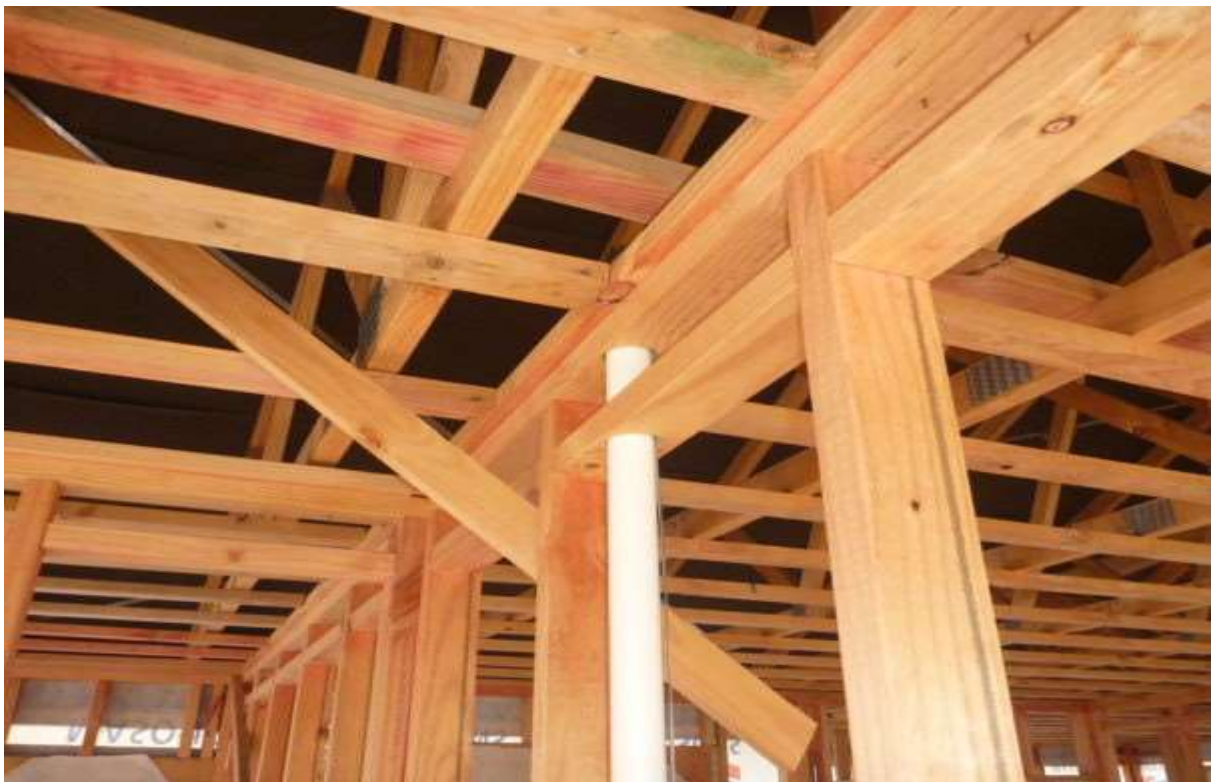
Un-reinforced top plate cut-out.

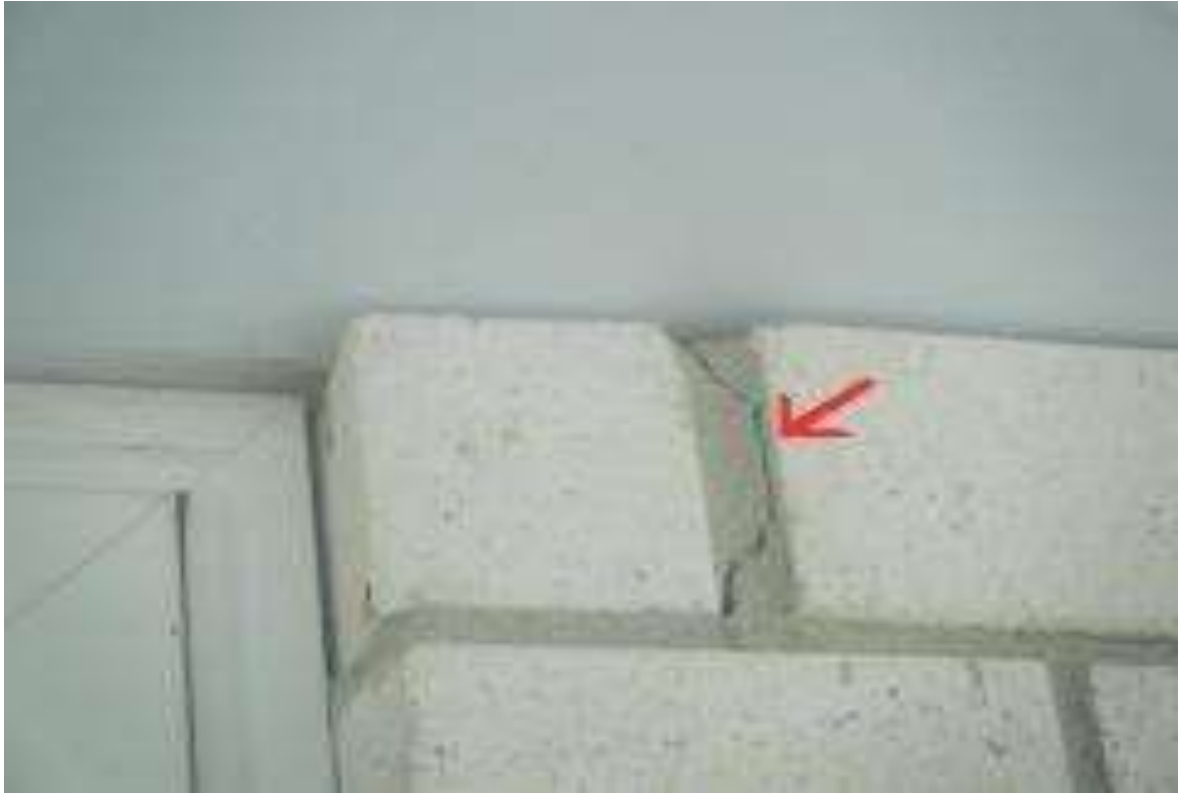
Loose clay brick.

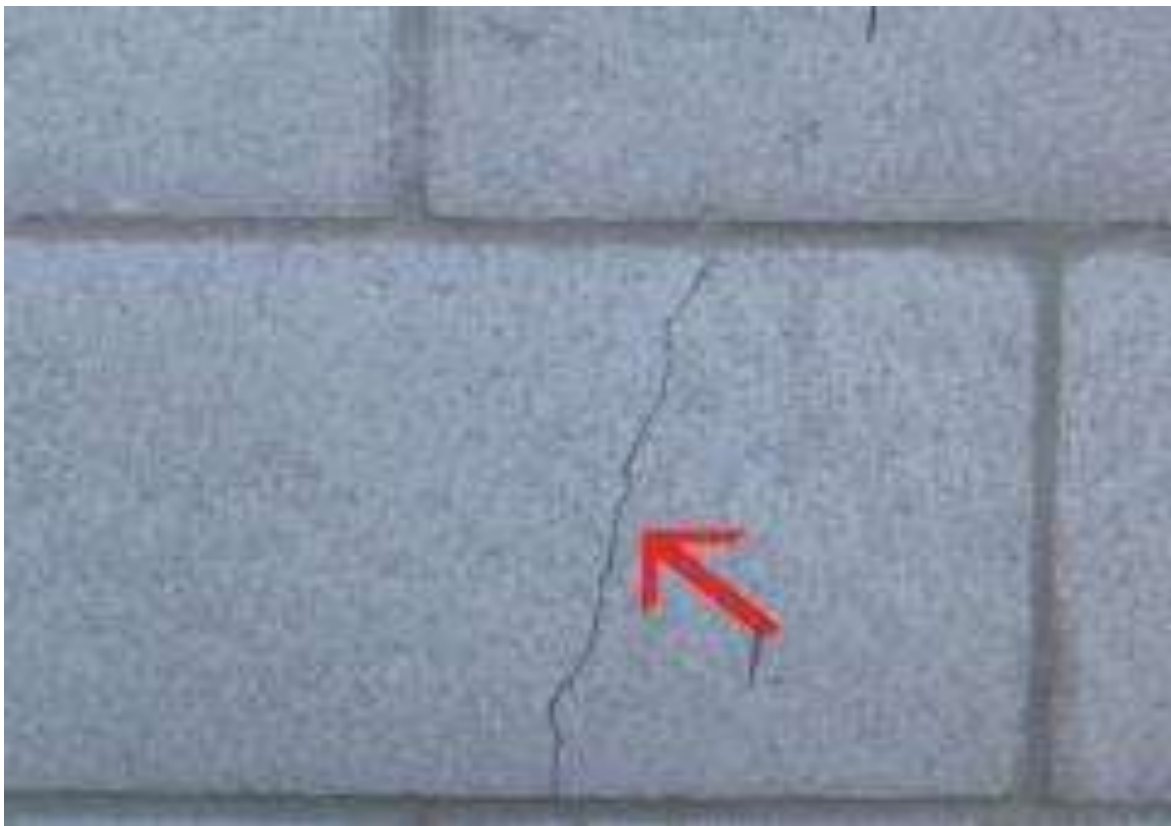
Cracked masonry block.

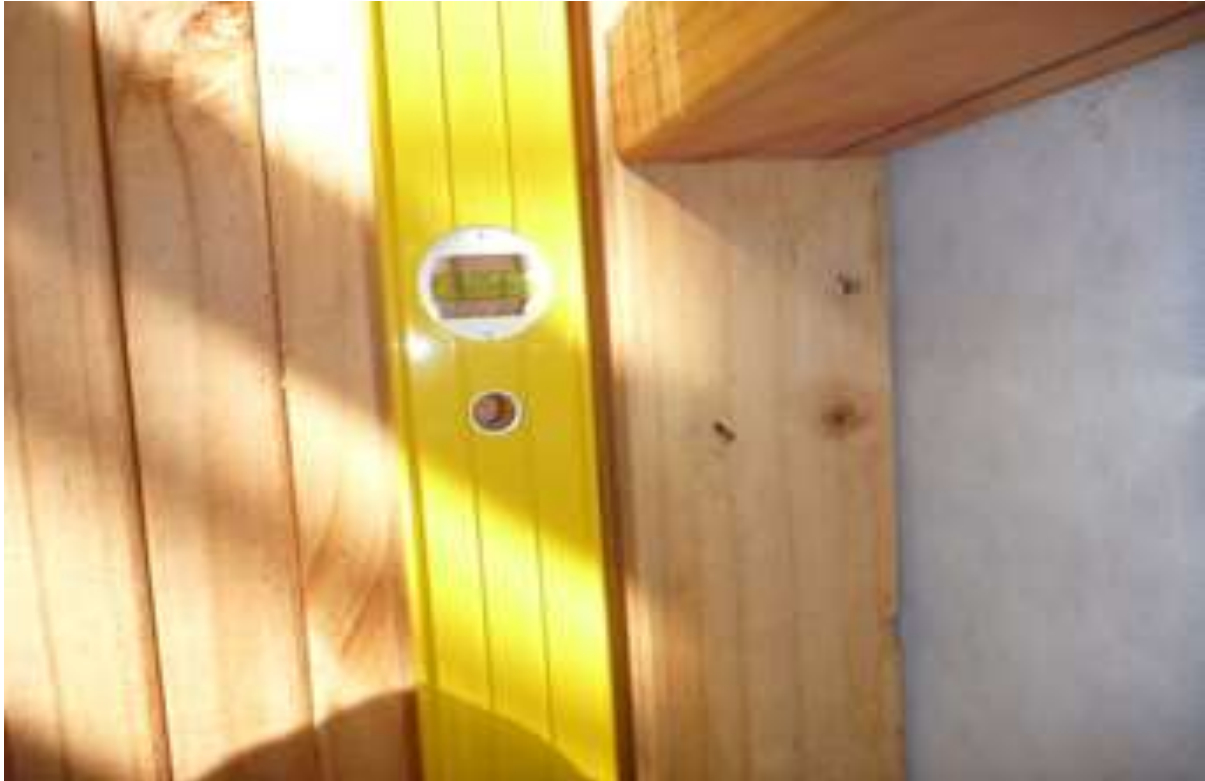
Bowed wall frames were found in about 40% of house inspections. In most cases it was only just over the 5mm per 2.4m stud height that is allowed in NZS3604, and was for one or two walls only. This may cause appearance problems. However in a few cases it was well over the 5mm on some of the walls. This could be a structural hazard, though it has been shown in the chart as an aesthetic or quality defect. This also raises the issue of quality of timber framing in general, with anecdotal reports from older builders saying that more frame straightening is done now than in the past.

Over 5mm bow in the stud.

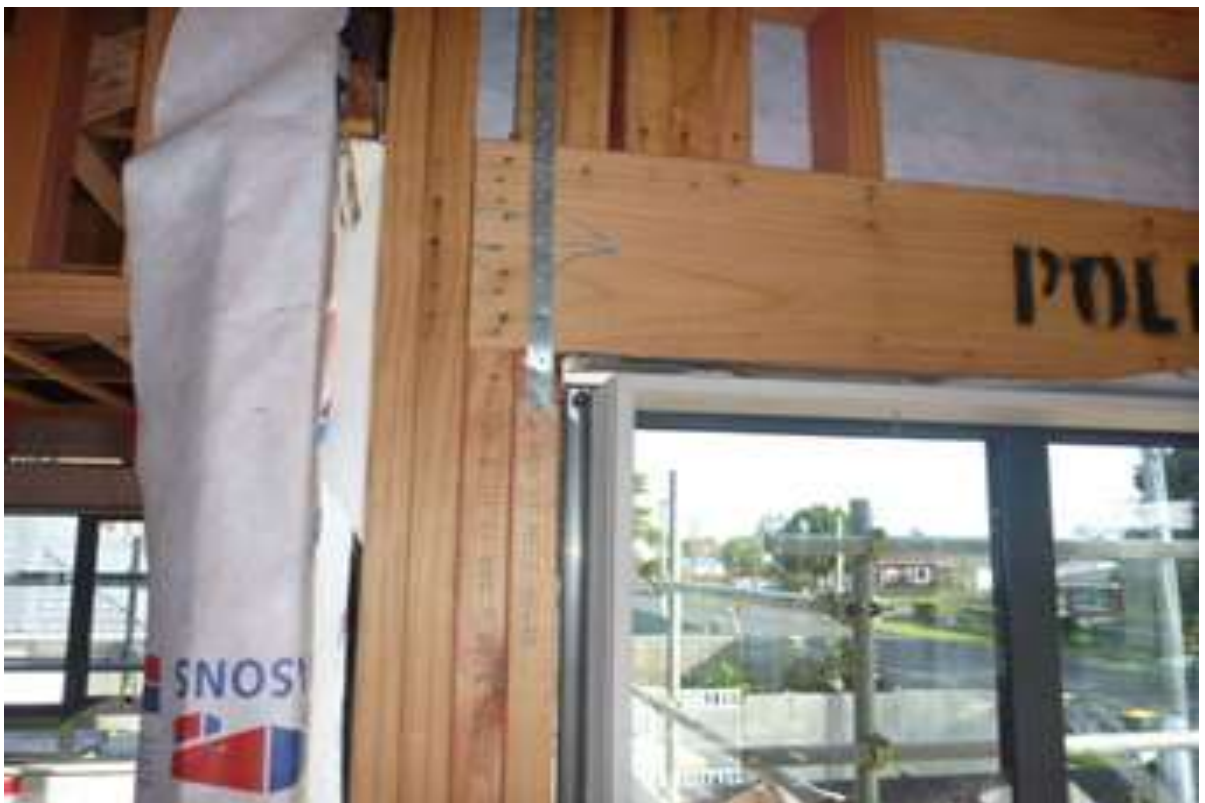
Lintel strap is incorrectly positioned.

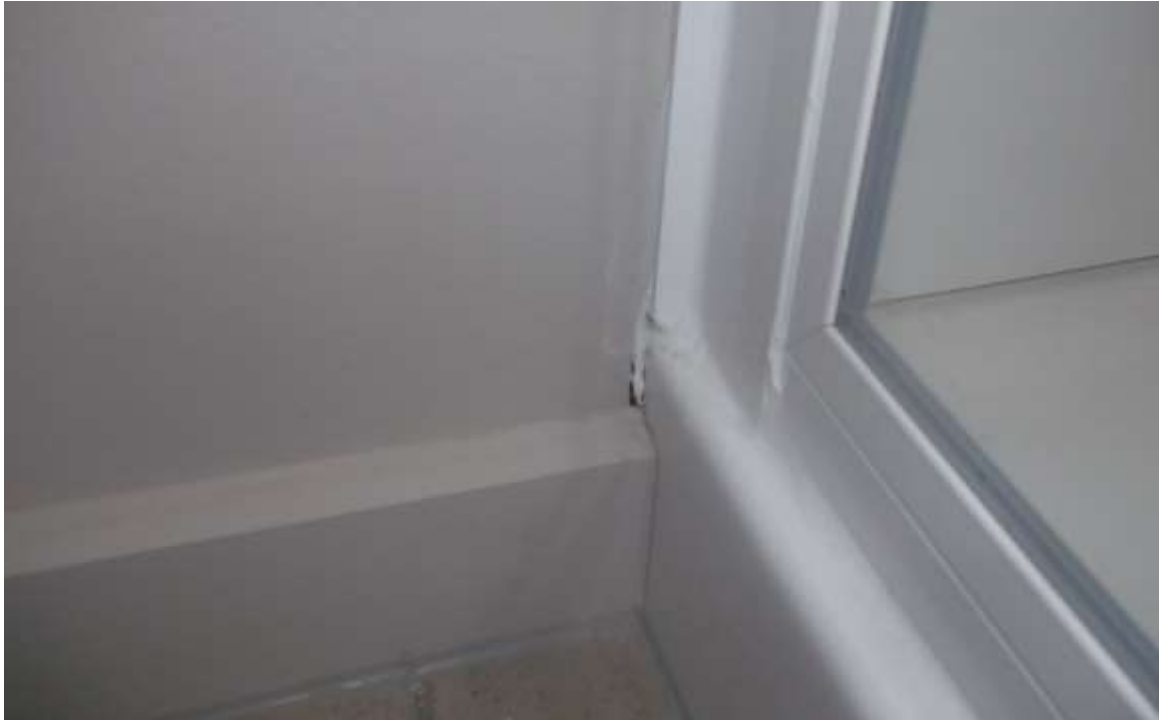
Poor sealing between the shower frame and the plasterboard.
