# **STUDY REPORT**

**SR 335 (2015)**

## **New house construction quality survey 2014**

**I.C. Page**

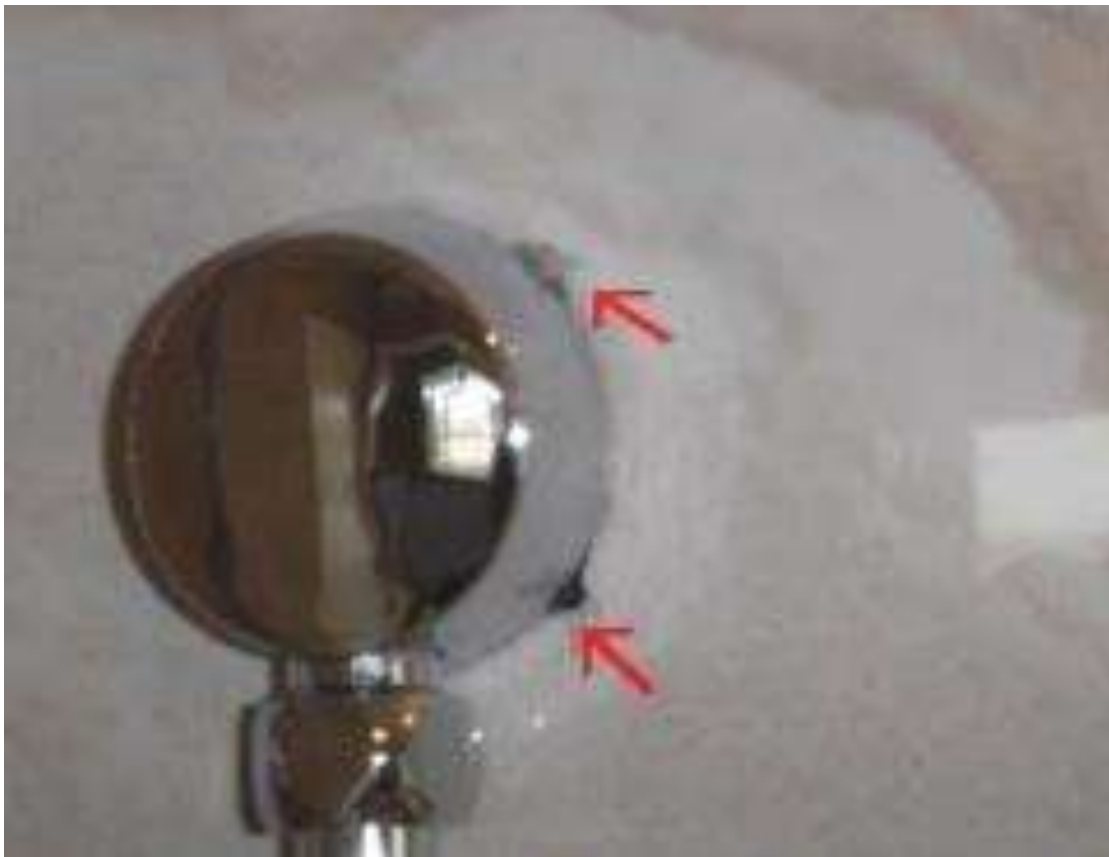
Shower lining with gaps around the pipe inlet

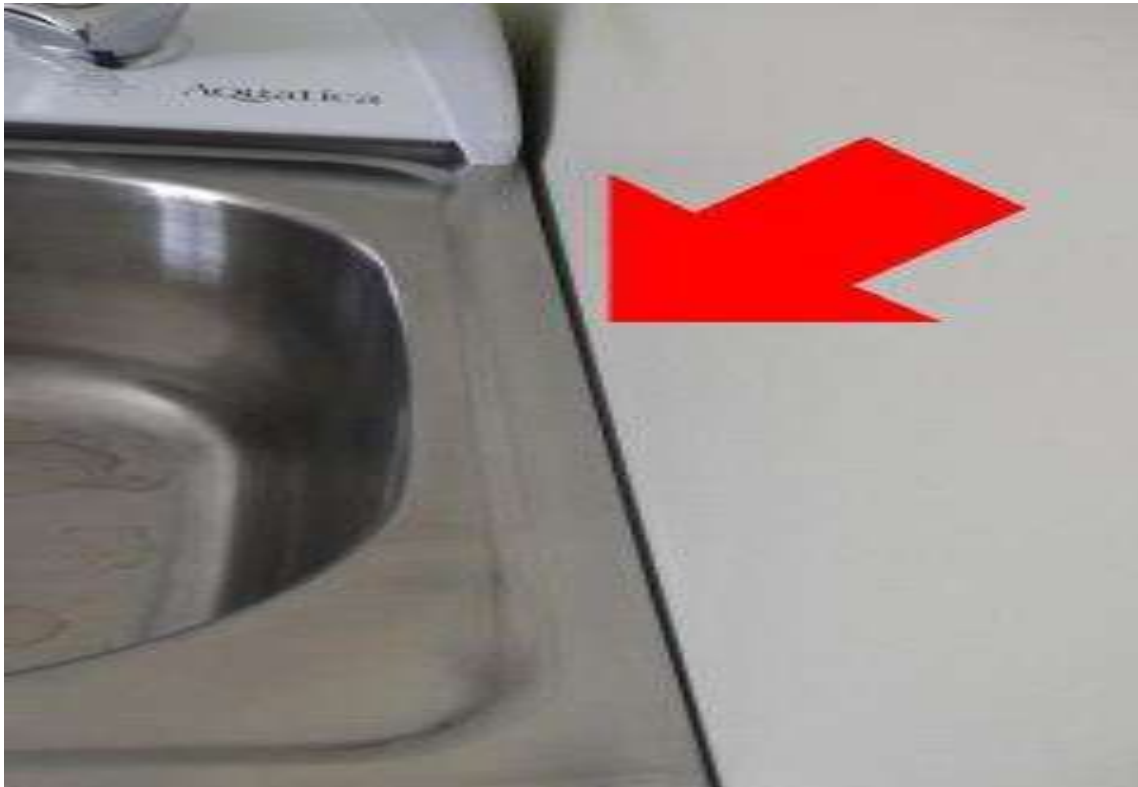
No seal at sink-wall junction.

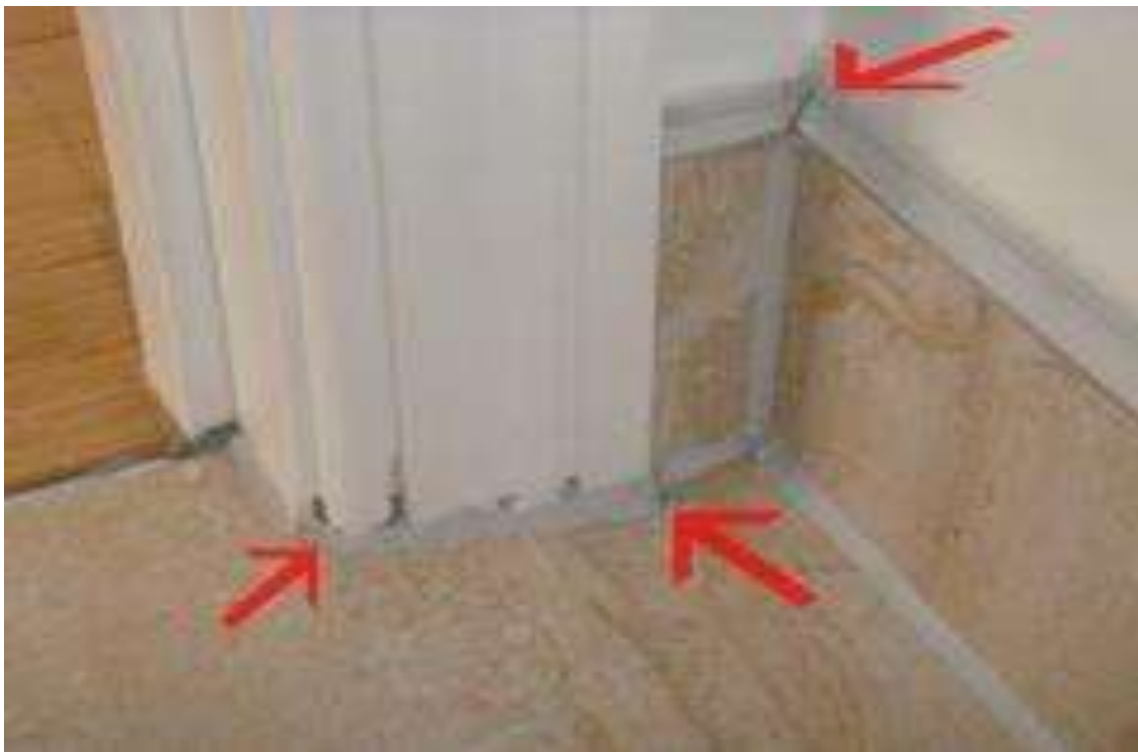
Poor finishing in toilet area.

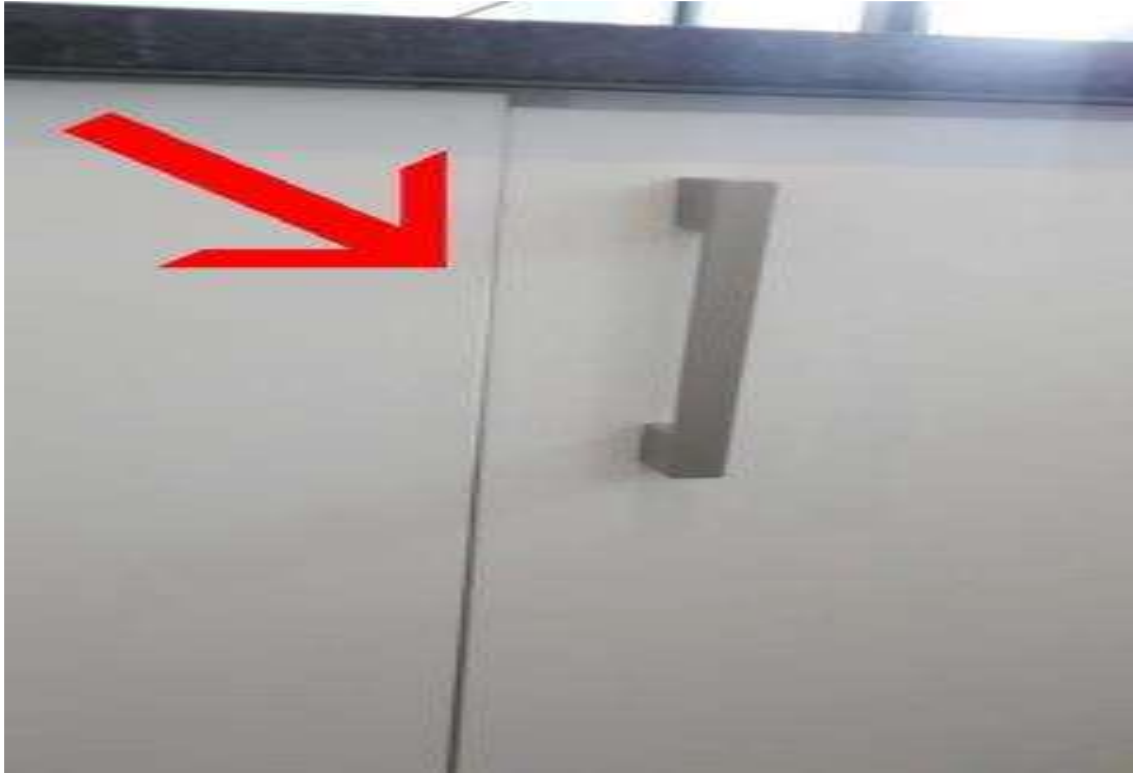
Ill-fitting cupboard door

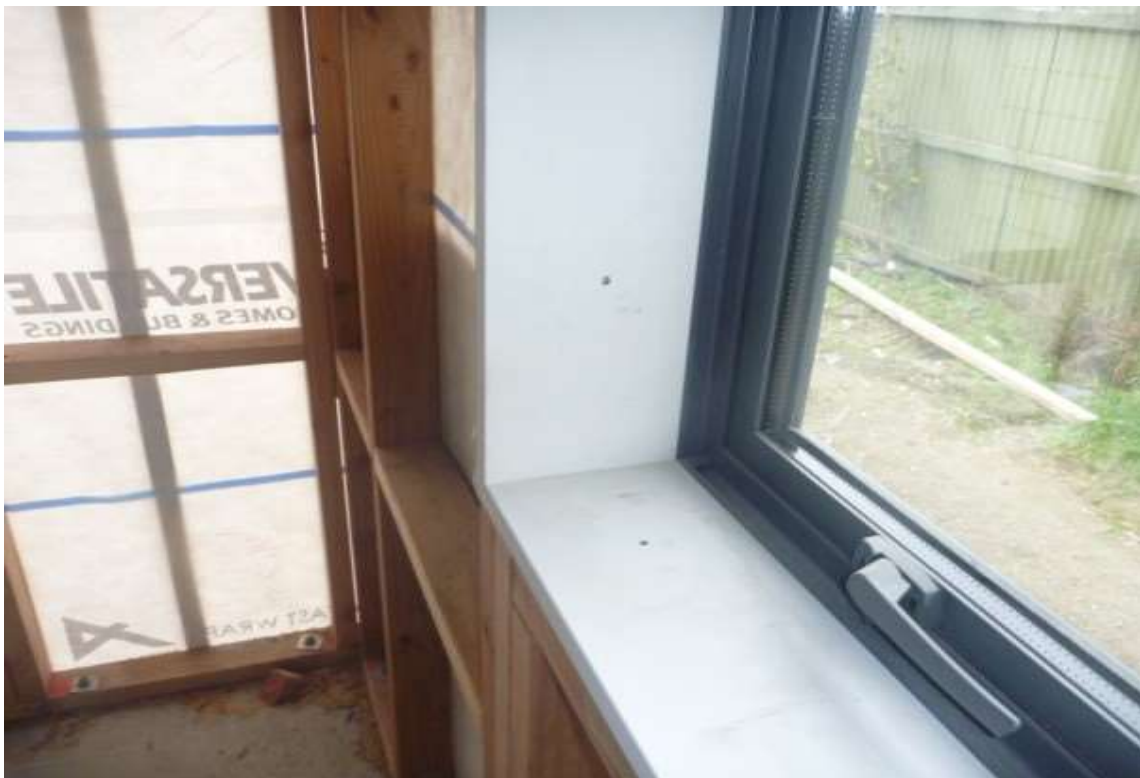
The most common compliance defect related to the fixing of the windows to the frame. It appears many builders are not aware of the 2011 amendment to the fixing requirements as set out in E2/AS1 clause 9.1.10.8.

Inadequate fixing of window jamb to framing

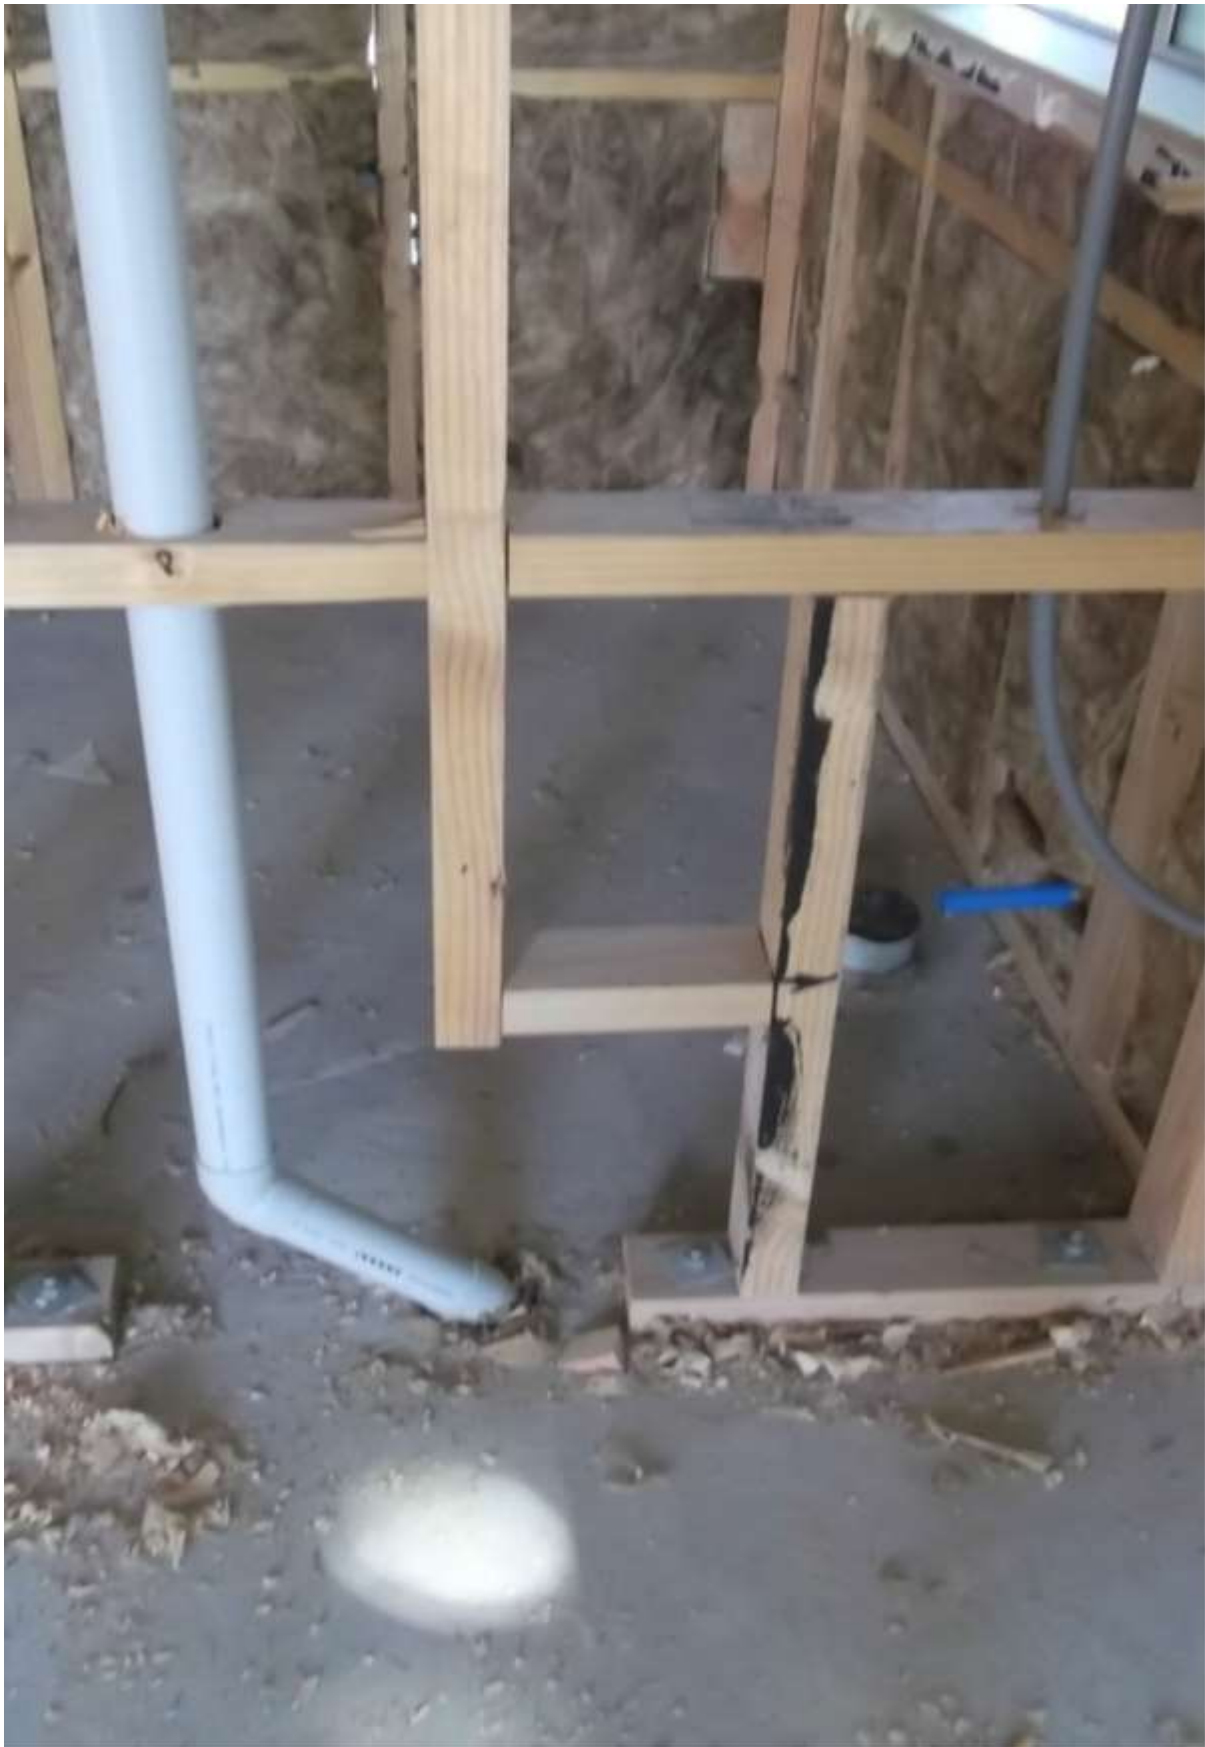
A large cut-out which the builder said would be repaired (but repairs are unlikely to be adequate due to the geometry). Appears to be a bracing wall re HD bolts.

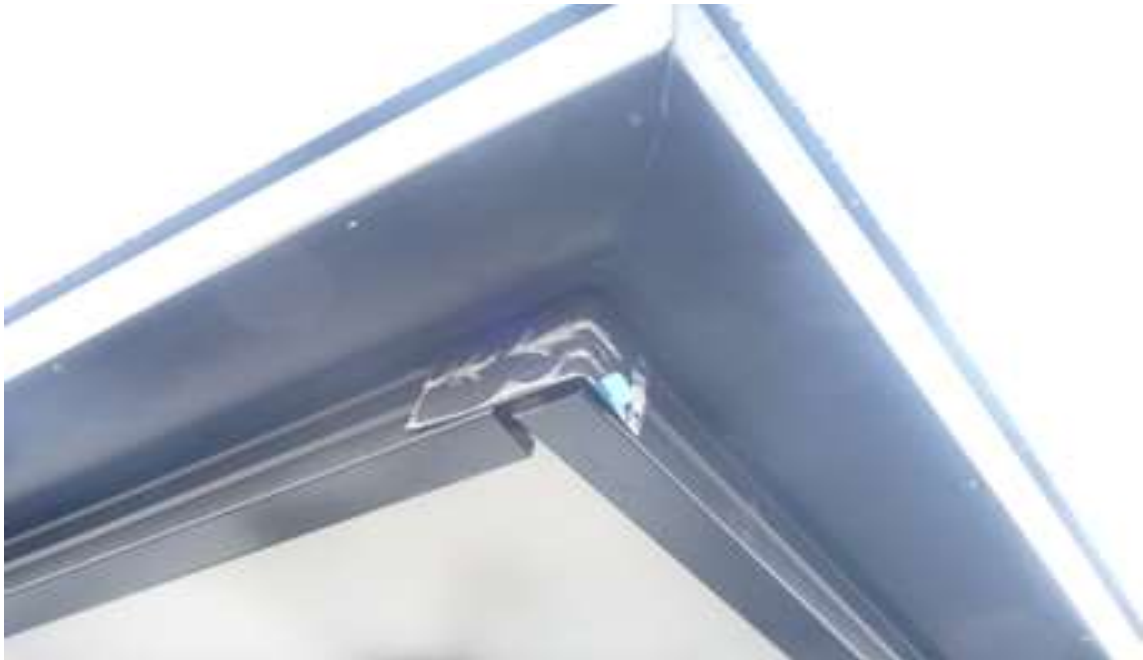
Untidy workmanship at the fascia junction.

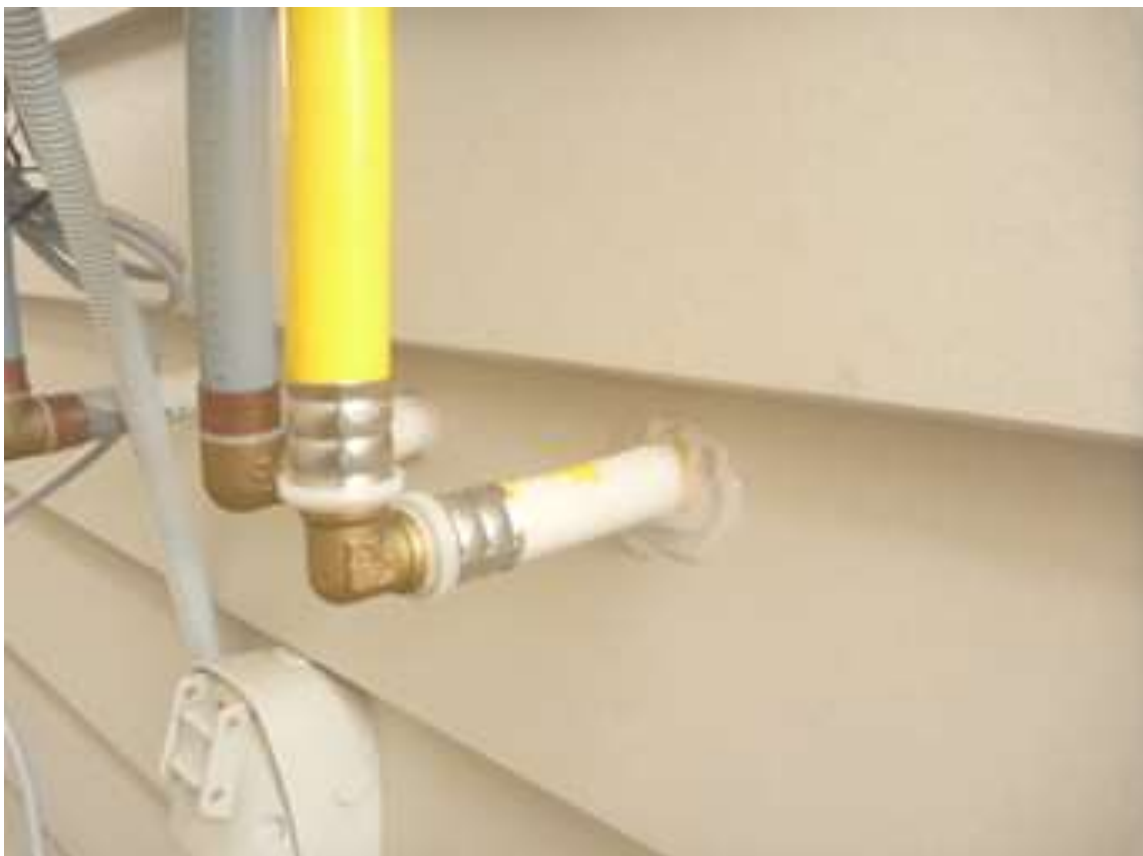
Sealant around penetrations should have an escutcheon to protect the sealant.

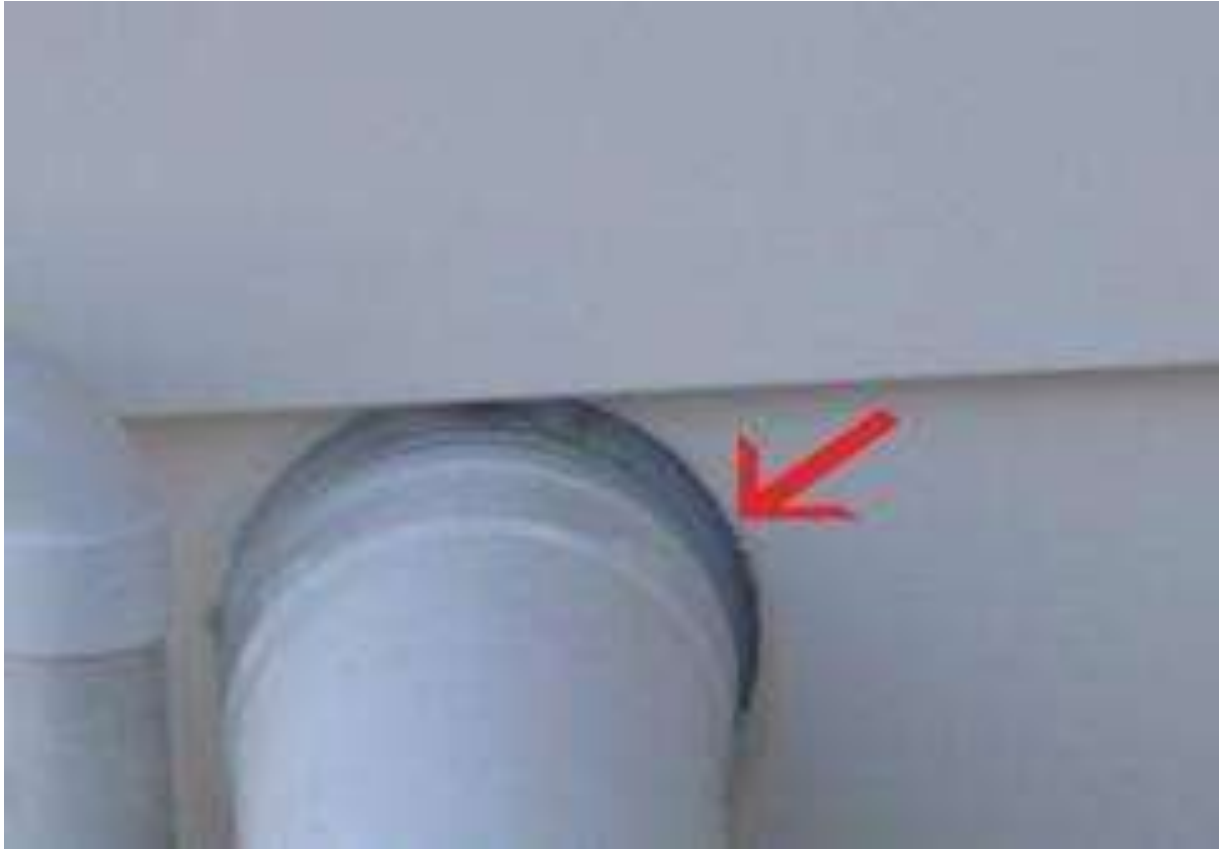
No sealing of the pipe cladding penetration.

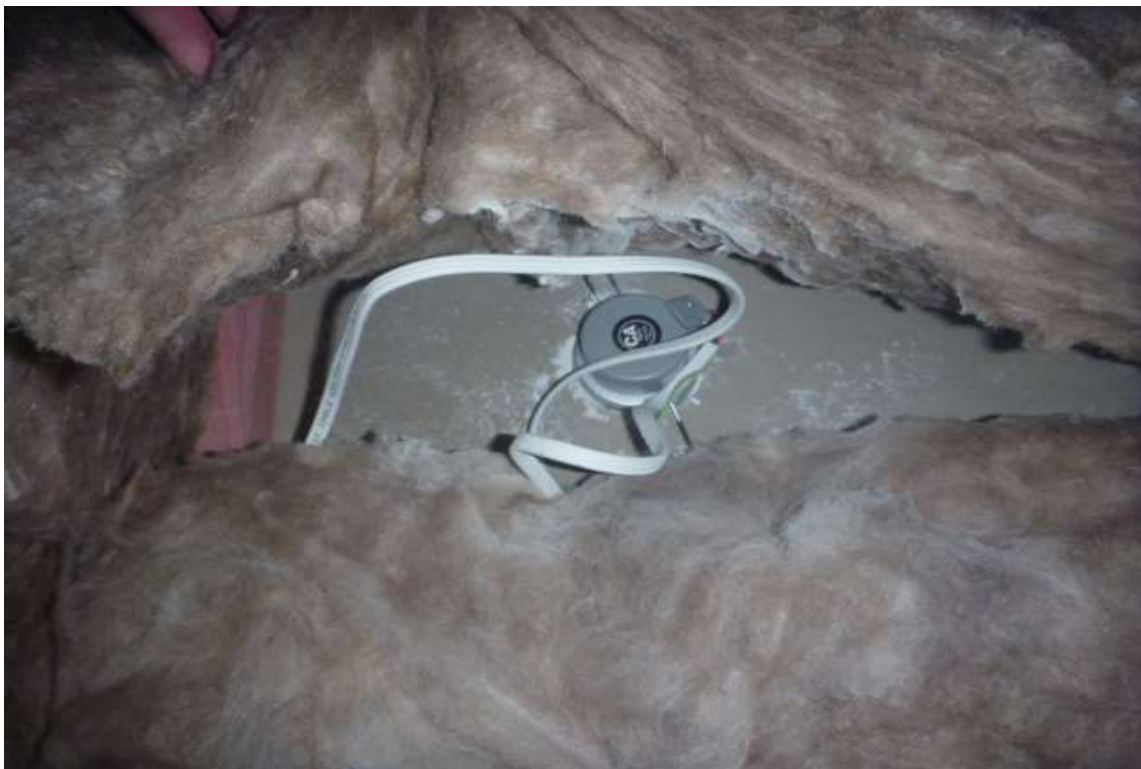
Excessive clearance. Downlight has a CA 135 mark so rated insulation could abut the can.

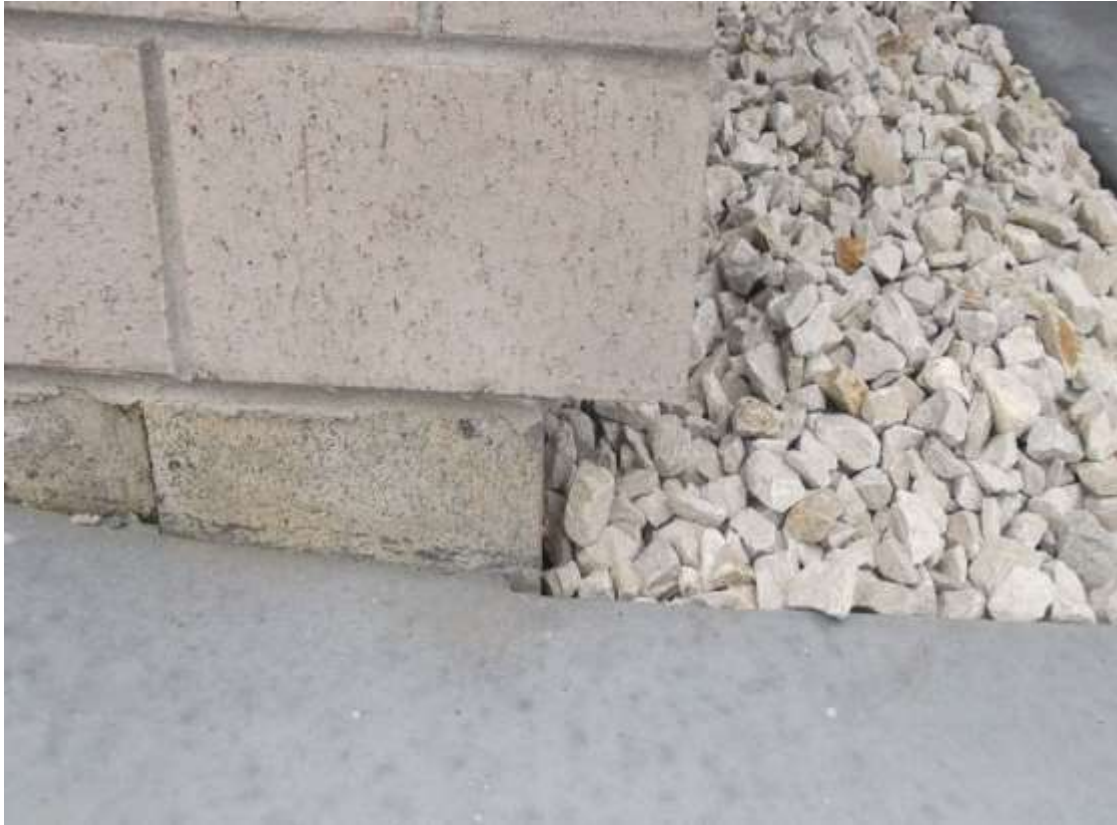
Poor foundation work, or alternatively blocks should have been cut to fit the slab.

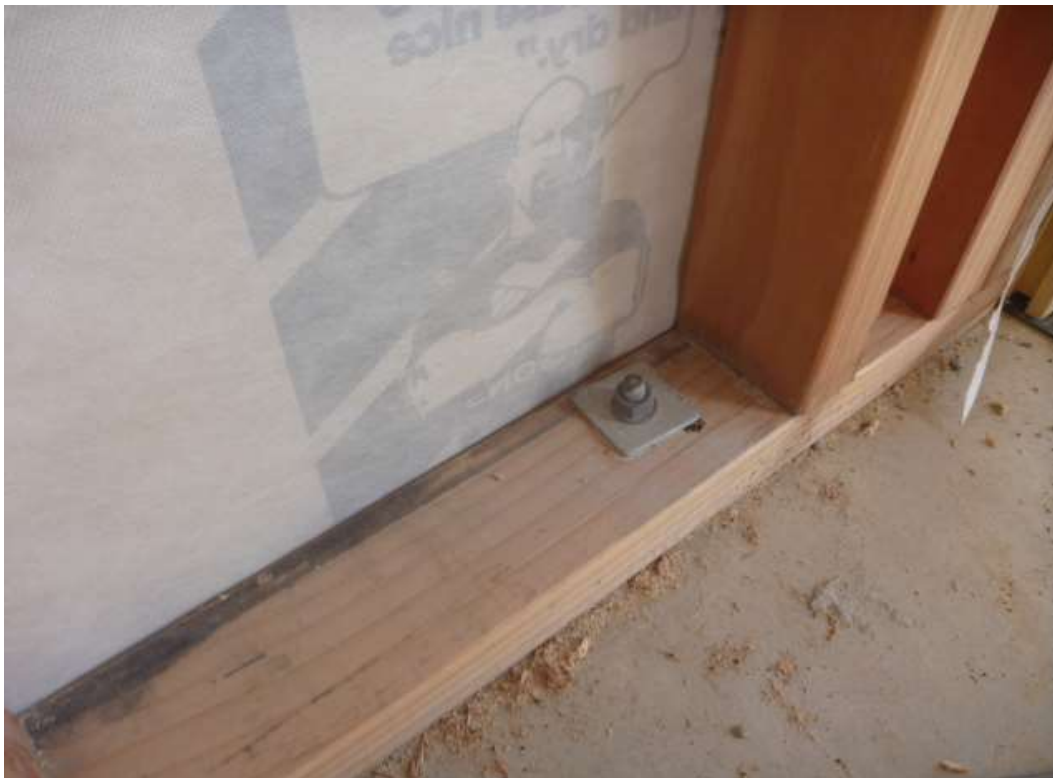
HD bolts – Holding down bolts in the floor slab are too close to the slab edge. Generally several of these were observed in houses with this defect. Isolated 1 or 2 HD bolts close to the edge may be OK from a structural viewpoint but several of these raises compliance issues.

Holding down bolt is too close to the edge of the slab.
