BULLETIN

December 2003

NUMBER 444

LESSONS FROM THE 1987 EDGECOMBE EARTHQUAKE

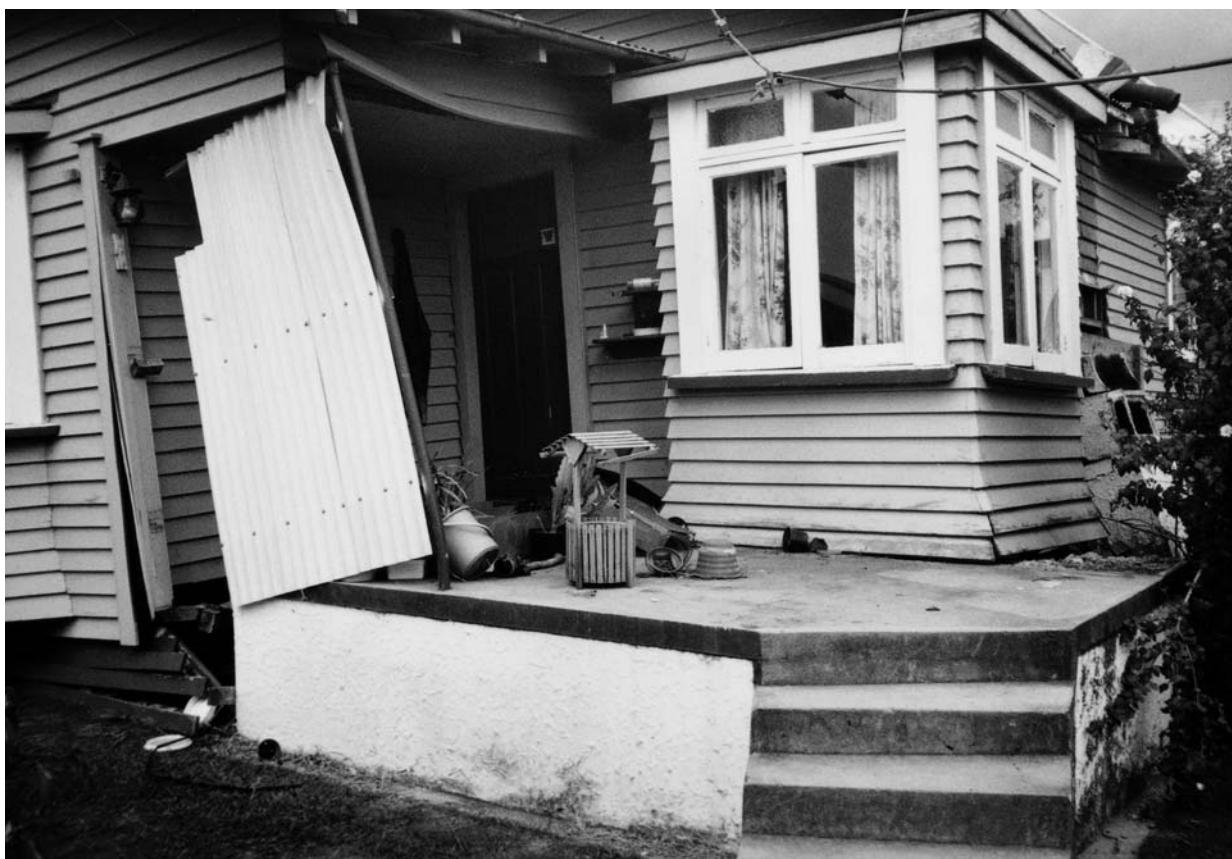
Figure 1: Houses built before NZS 3604 frequently used unbraced piles and jackstuds. Movement and partial collapse was common with about 30 houses moving on their foundations. The result was that many seriously damaged their superstructure and services.

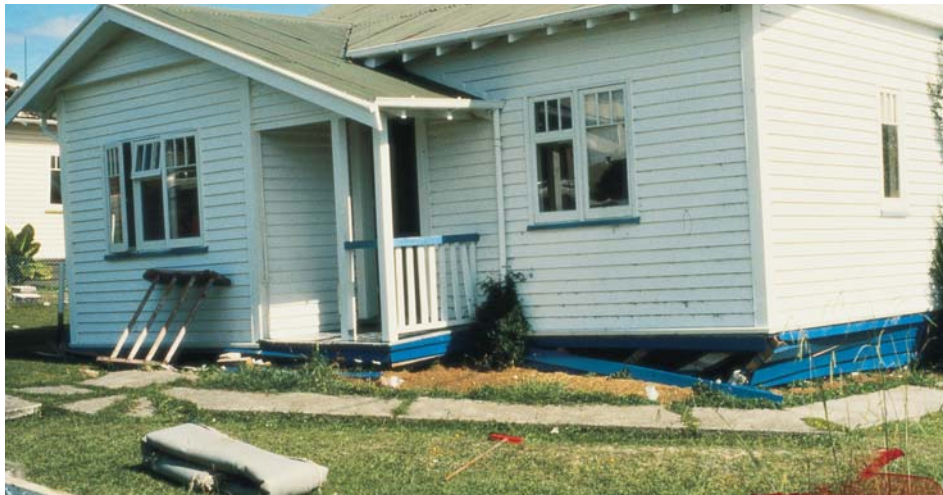
Figure 2: Many anomalies were seen and probably resulted from the effects of variable soil conditions giving rise to differing building movement in the earthquake. A near identical house next door to this one remained on its foundations and largely undamaged.

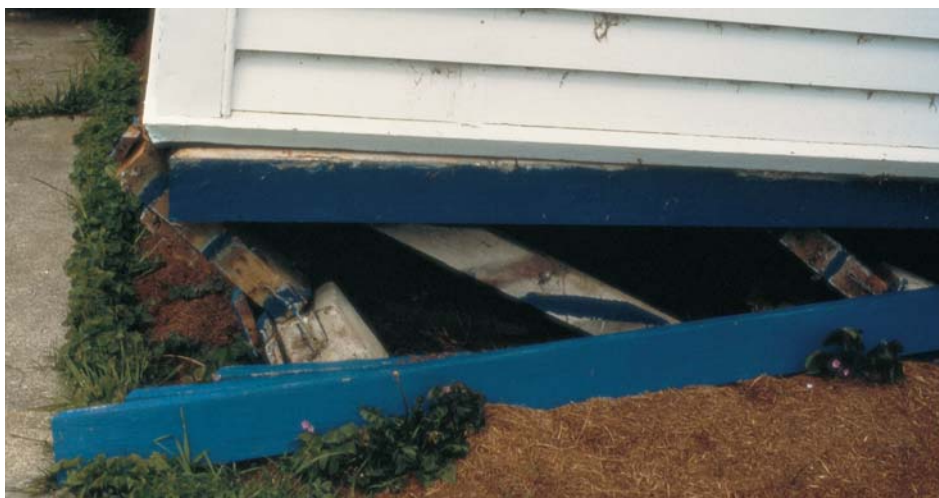
Figure 3: This subfloor consists of concrete piles with jackstuds. This detail would not comply with the bracing requirements of NZS 3604. The number of braces and the nature of their connections in this house were insufficient to withstand the imposed earthquake load from the house. (This is a close-up of the house shown in Figure 2)

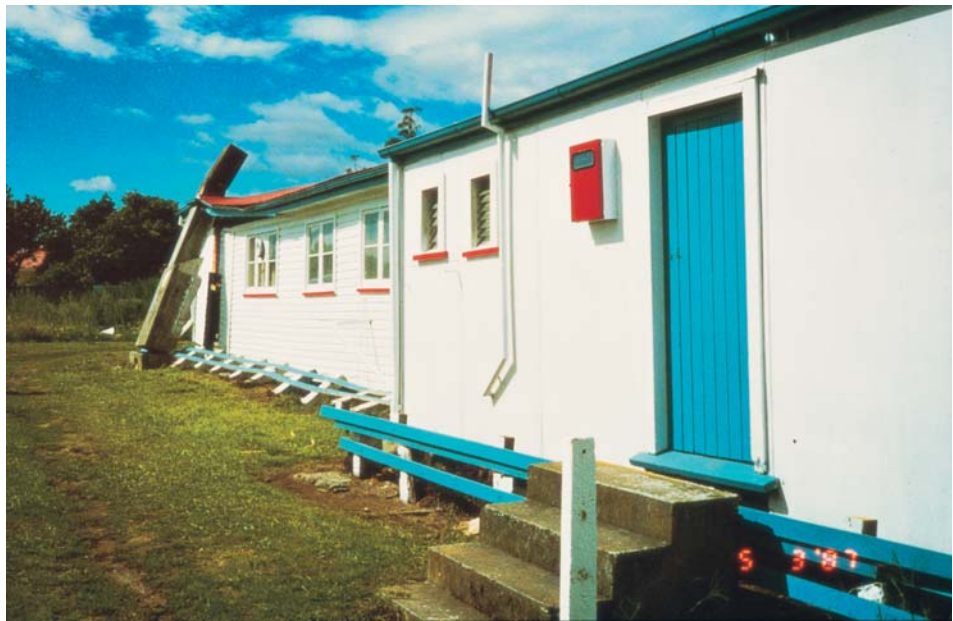
Figure 4: Ordinary piles are not able to resist lateral loading. Anchor piles or braced piles are now required for this purpose. The Te Teko Returned Services Association Hall rolled over on its piles, while the chimney base and steps remained in place.

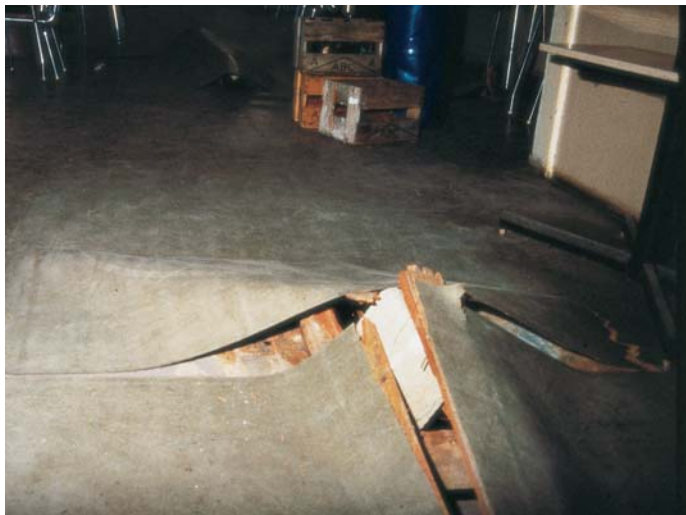
Figure 5: The floors of several structures which fell off their foundations, were punctured by interior piles that remained upright as the building fell.

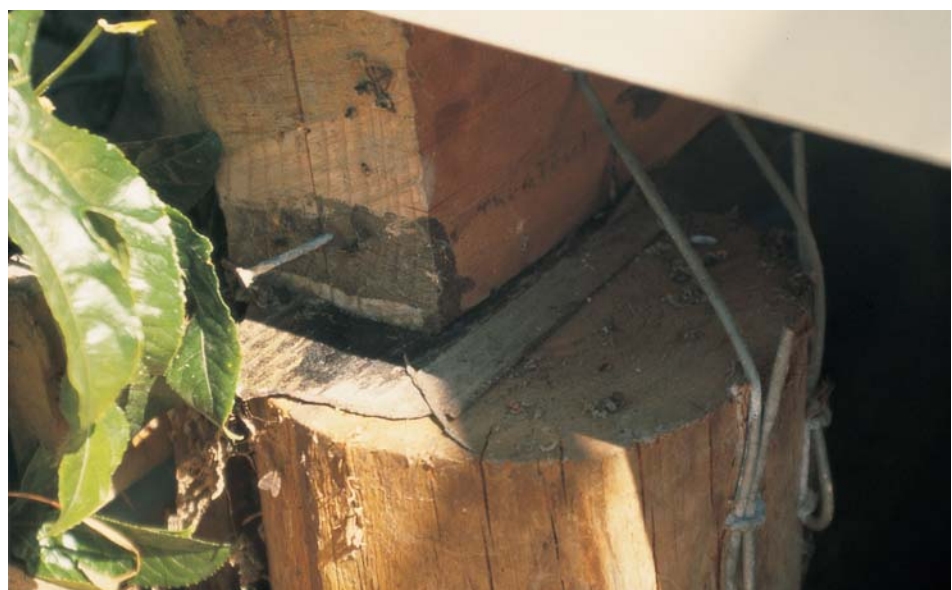
Figure 6: Some houses were founded on driven timber piles to overcome soft foundation conditions. Movement of up to 50mm was observed between the bearers and the piles. NZS 3604 requires a 6kN connection in this situation, which clearly was not provided here. This connection is one that is still commonly not carried out correctly, even in houses built today.

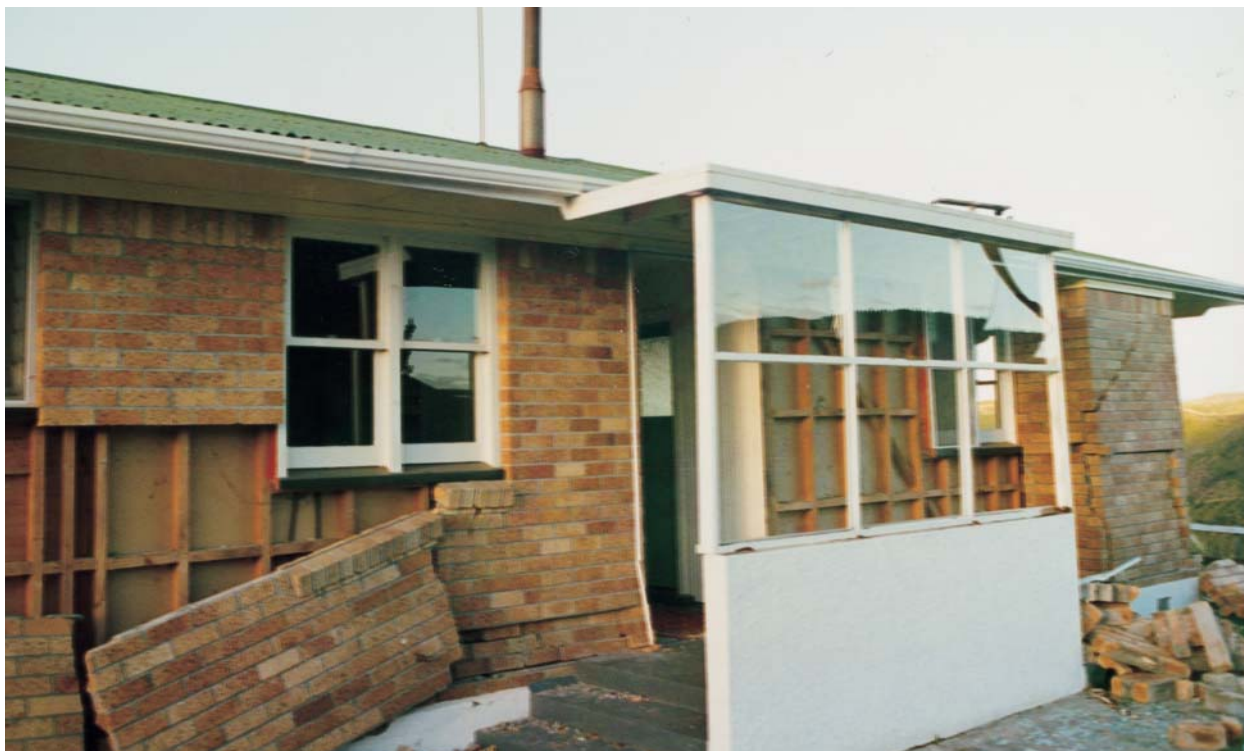
Figure 7: This house, on the foothills at Awakeri, suffered substantial damage to its foundations and brick veneer. The floor system was independently supported on unbraced piles and was not tied to the perimeter walls. Lateral displacement of the house battered the veneer, dislodging it from its seating on the perimeter wall.

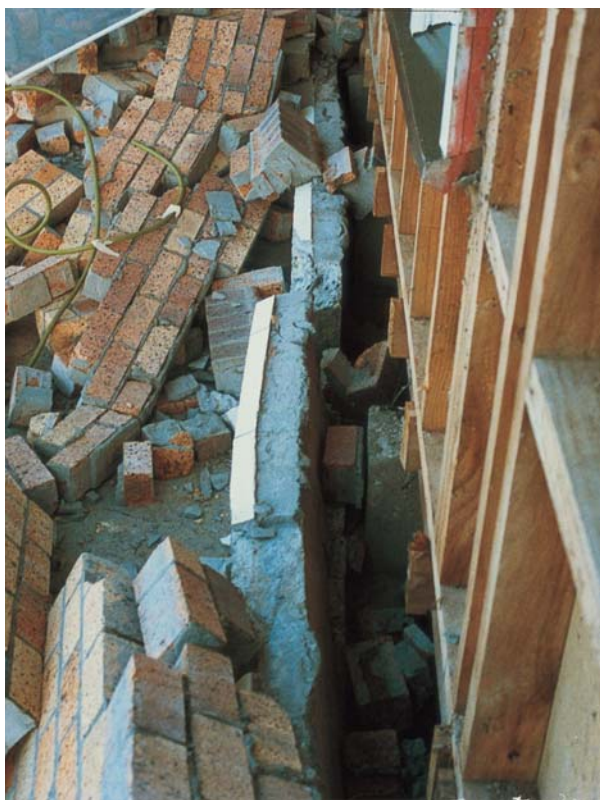
Figure 8: Provisions for lateral support of foundation walls are intended to prevent this happening. The joists should be connected to a plate bolted to the top of the foundation wall.

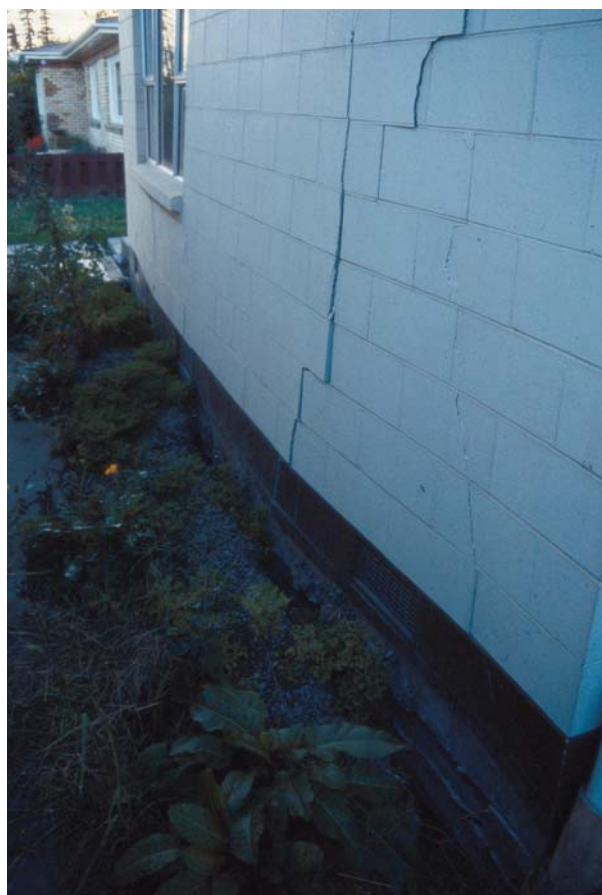
Figure 9: The damage to this wall of a block of three flats occurred when the flats moved as a unit and compressed the soft ground adjacent to the end of the walls. When the building stopped moving, the corners of the end wall (which were connected to the sidewalls) had returned to their original position, but the centre of the end wall (which was not connected to the floor) remained displaced.

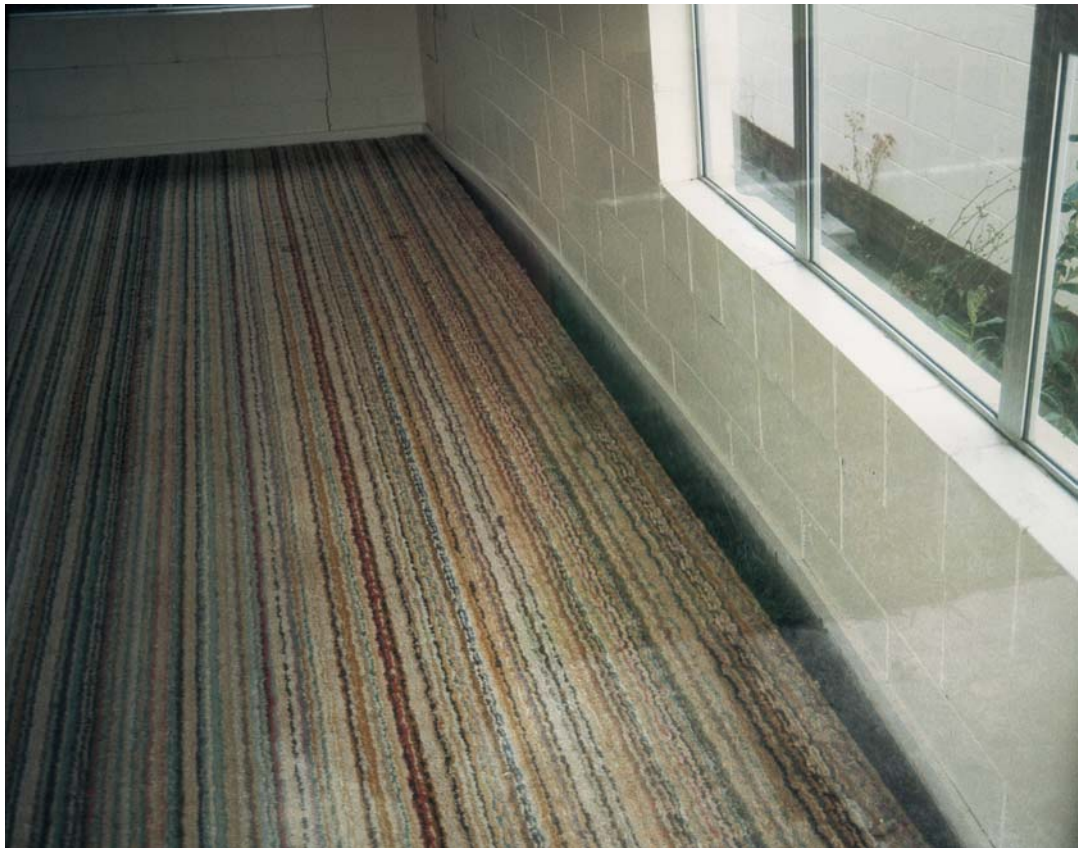
Figure 10: NZS 3604 and NZS 4229 still permit floor slabs not to be connected to foundation walls for single-storey buildings providing they are 'contained' within the foundation walls. Here, the floor in the flats (refer to Figure 9) has separated from the end wall when the middle of the wall has not returned to its original position, leaving a significant gap.

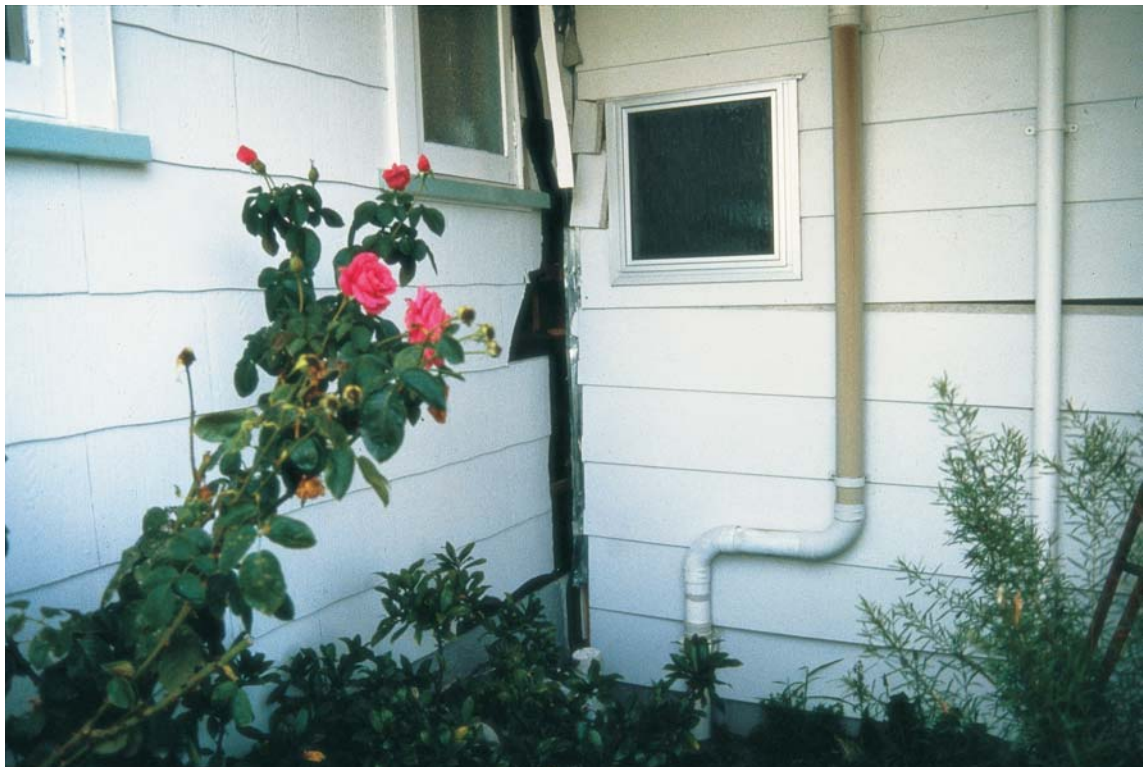
Figure 11: Some houses and additions were built partly on piles and partly on slab-on-ground. Often there was damage at the junction between these types of construction because each type moved differently. This is a particularly vulnerable feature of alterations and additions if there is not adequate connection between the old and the new.

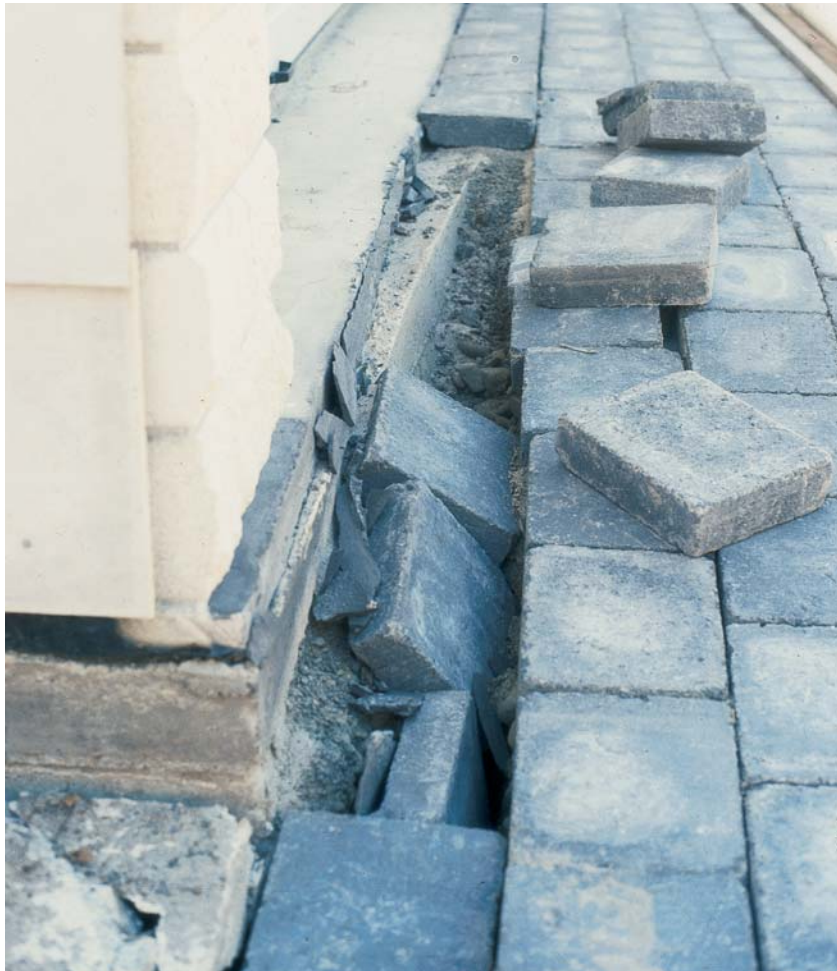
Figure 12: Soft ground in the area resulted in subterranean movement. The floor slab of this garage moved laterally, displacing the adjacent paving slabs.

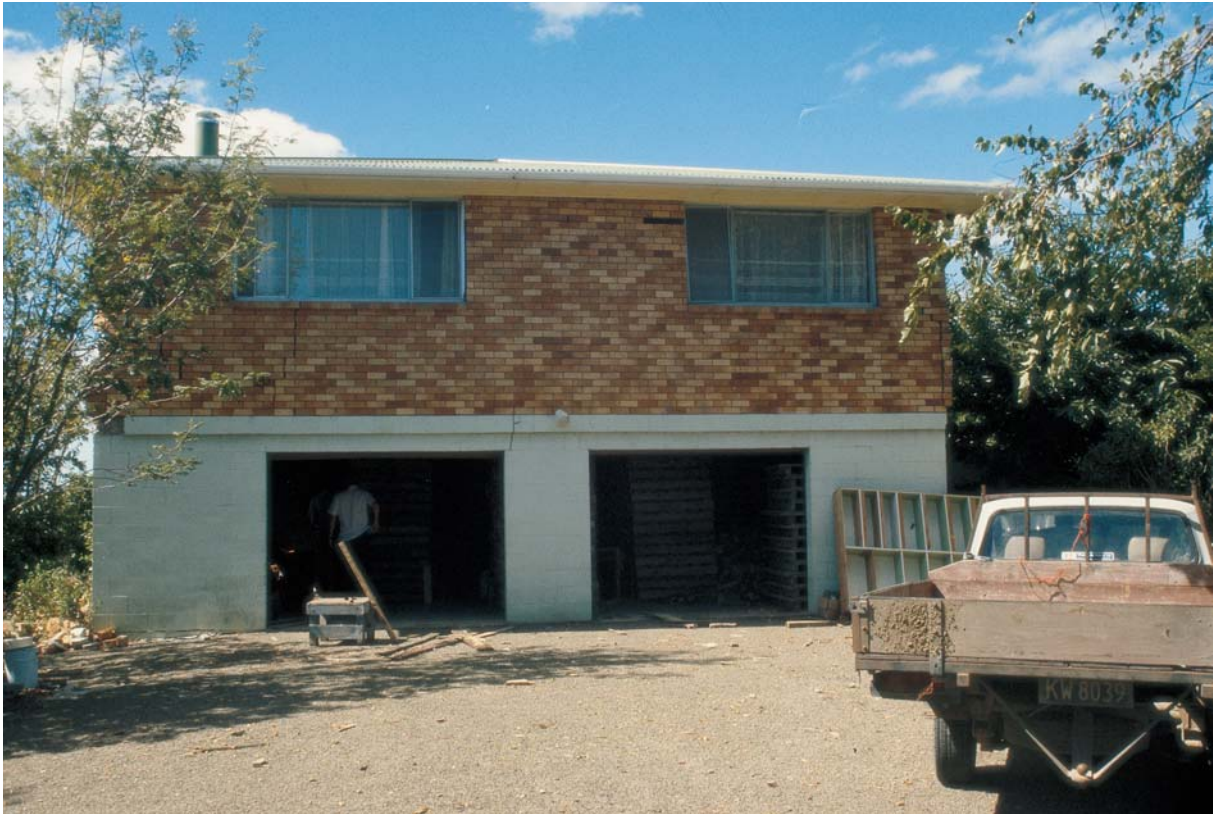
Figure 15: Reinforced concrete masonry structures generally performed well. Among those that did not, was this house built in the mid 1960s on the Rangitaiki Plains. Some cracking of the concrete masonry lintel beam and the brick veneer can be seen on this elevation.

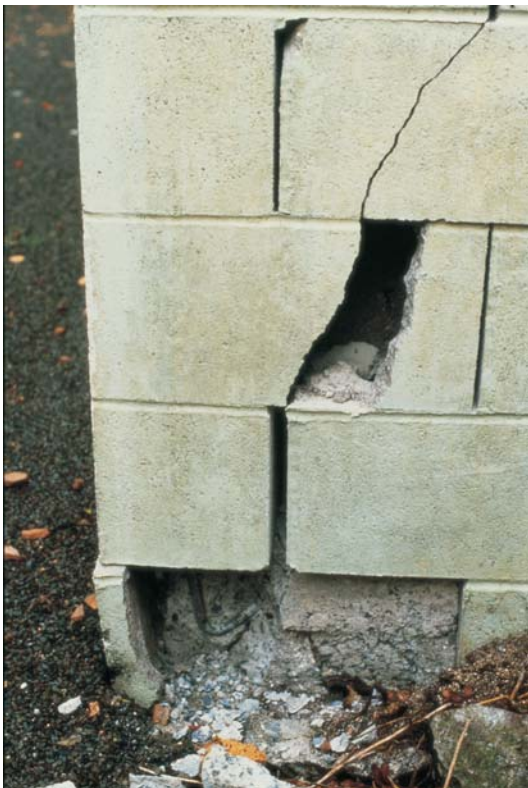
Figure 16: The lower storey concrete block masonry was reinforced both horizontally and vertically with plain mild steel rods. Despite the reinforcing, cracking occurred in several places at the corners.

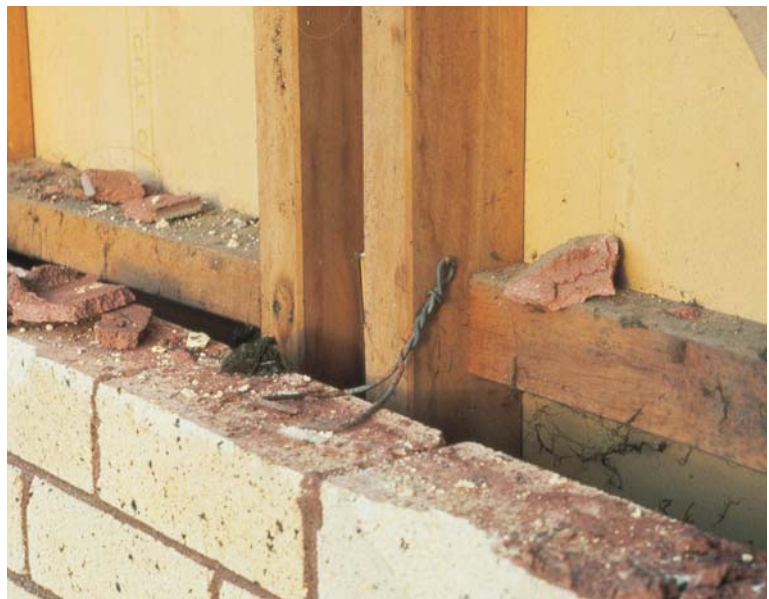
Figure 17: This type of wire tie, which was in common usage, is no longer permitted. As can be seen, they did not succeed in their role of tying the brick veneer to the timber-framed wall.

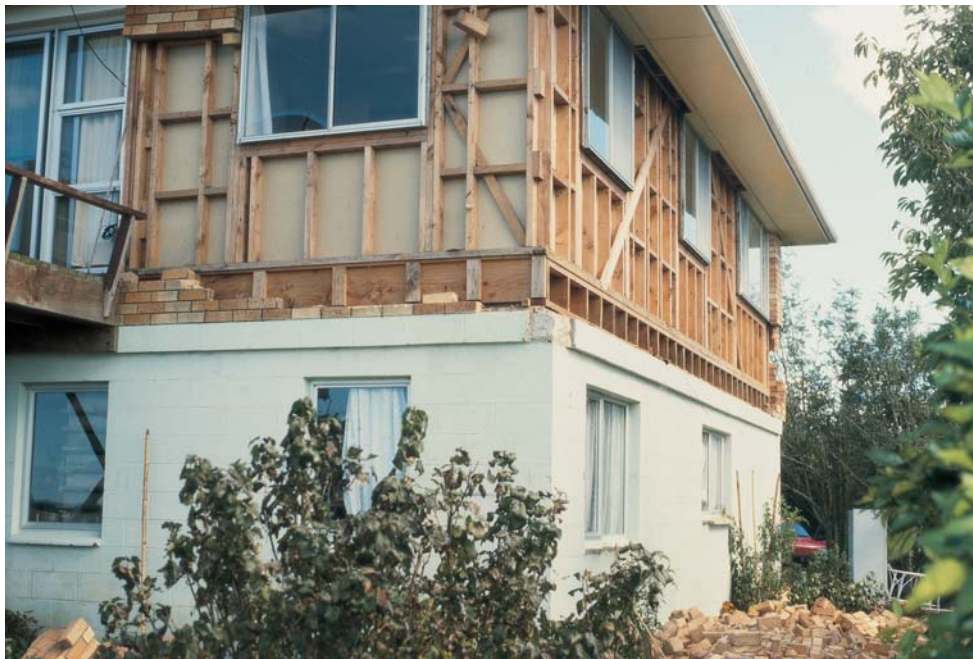
Figure 18: A view of the rear of the house reveals the extent of the brick veneer failure. Note that the windows have remained intact despite the severe shaking the building has suffered.

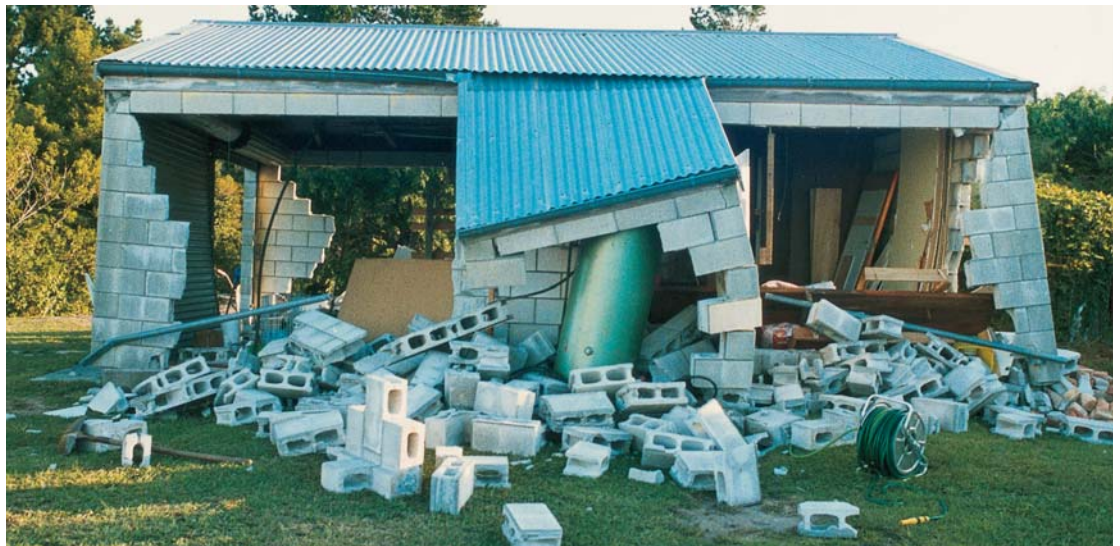
Figure 19: The minimum reinforcing requirements of NZS 4229 are intended to prevent the total disintegration of masonry structure as shown here.

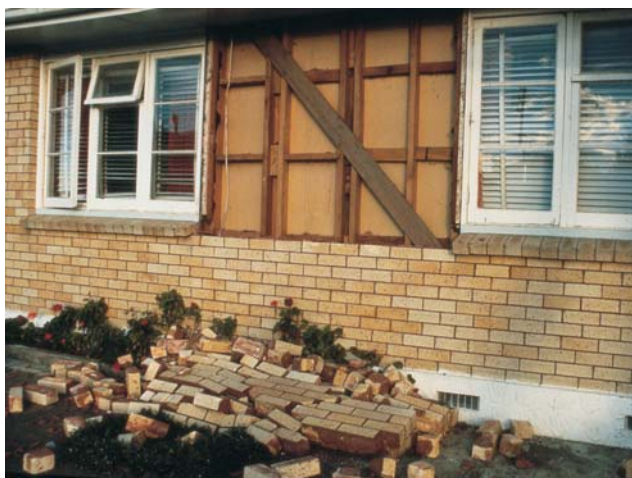
Figure 20: Brick veneer panels between windows were particularly vulnerable, yet the windows nearly always remained intact.

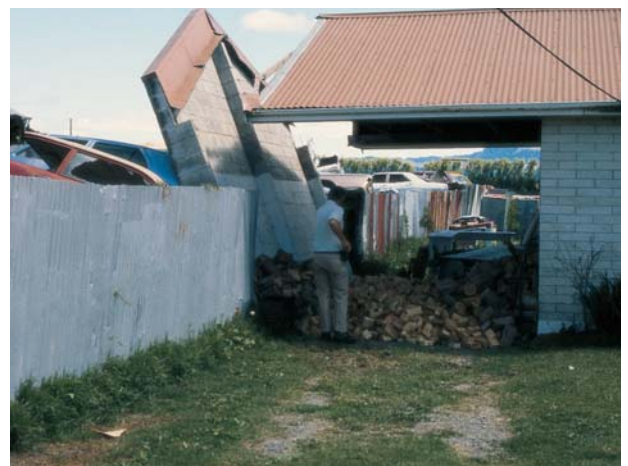
Figure 21: This masonry firewall on a boundary did not have adequate fixing to the roof framing or a foundation from which it could cantilever and stand alone.

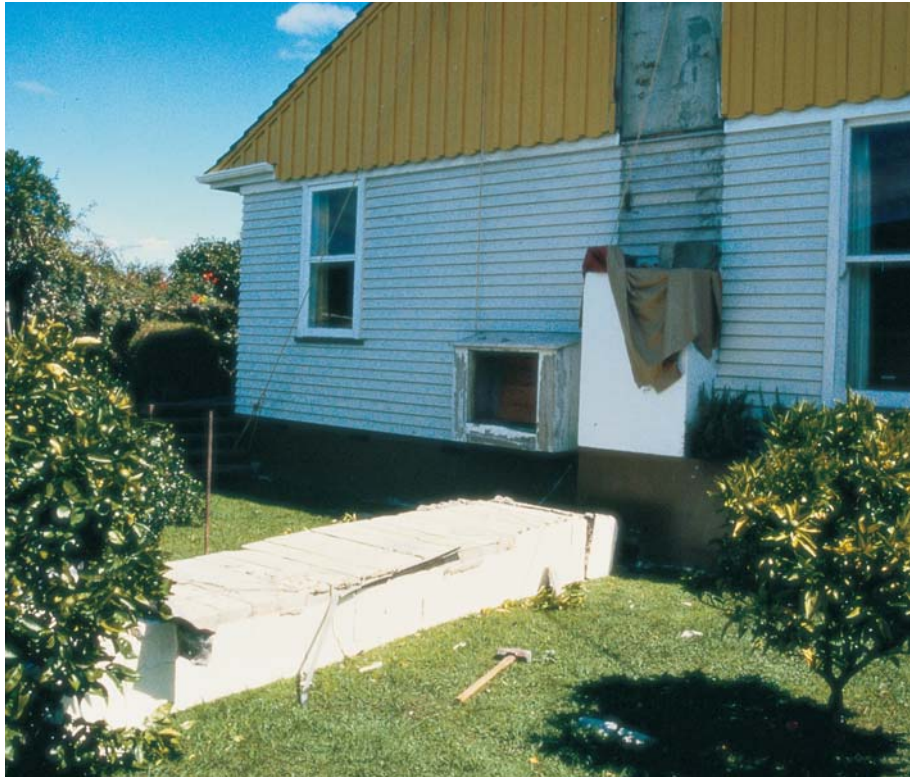
Figure 22: Many precast concrete chimneys collapsed. External chimneys that were not well connected to the buildings generally fell outwards. The Acceptable Solution B1/AS3 to the Building Code requires masonry chimneys to be reinforced and tied to the building at roof level. NZS 3604 provides for the extra bracing demand on the building structure. The introduction of these requirements mean that there should be much less failure than evidenced in the Edgecumbe earthquake.

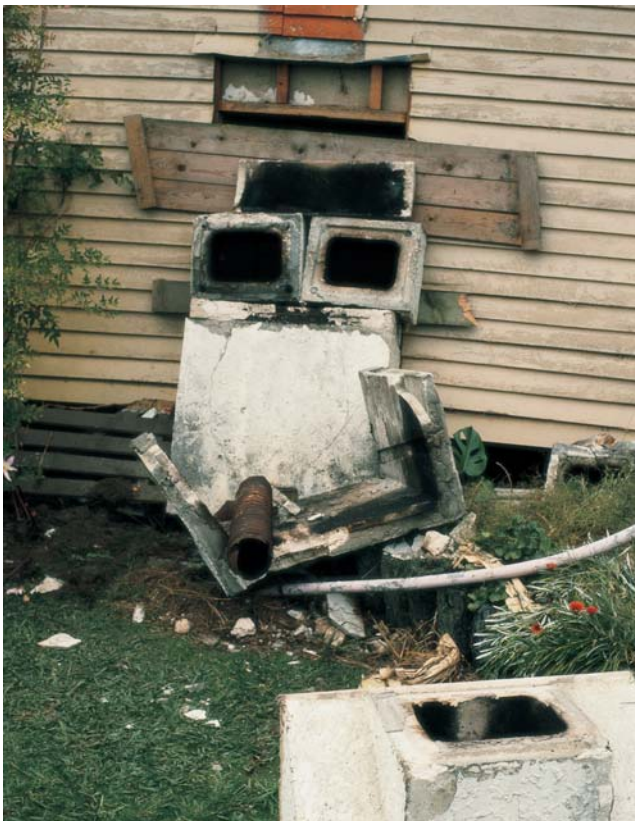
Figure 23: Many chimneys that failed were found to have no reinforcing in them, and the individual elements separated as the chimney collapsed.

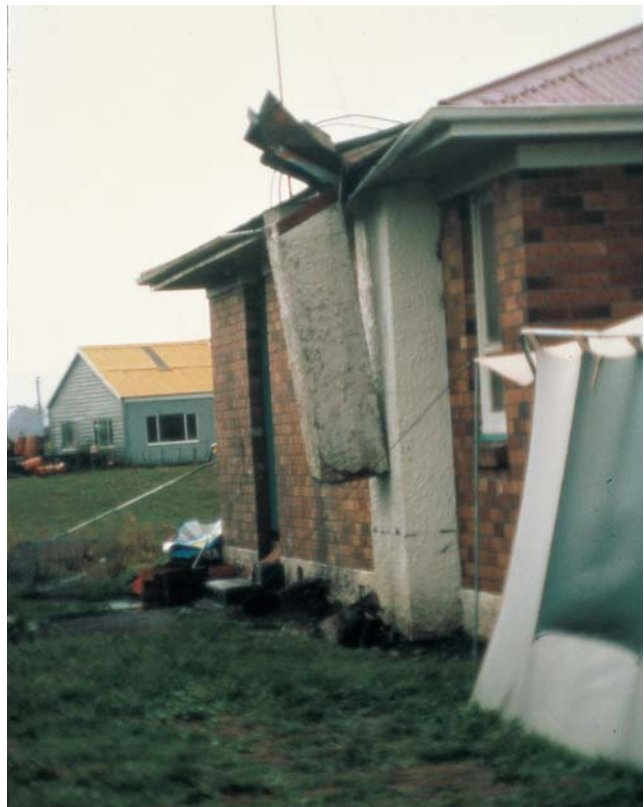
Figure 24: In some instances, reinforcing steel was present but the grout had not penetrated along the full length of the steel, as shown in this example.

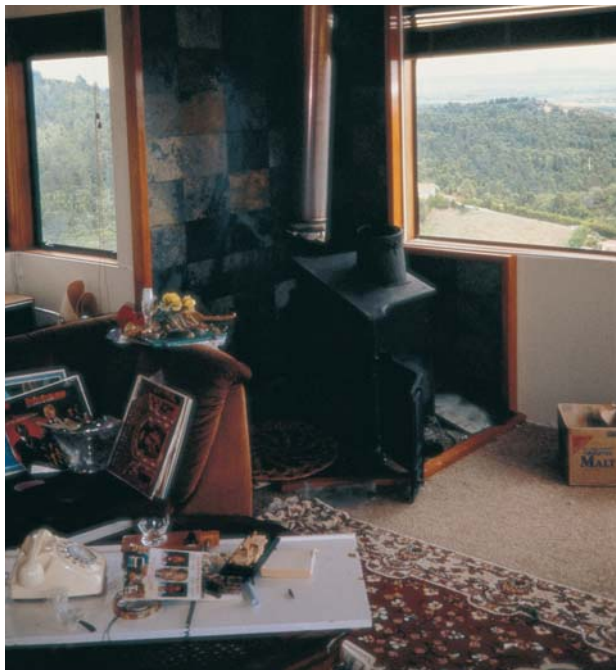
Figure 25: Wood-burning stoves, both free standing and in-built, were displaced by the earthquake. The need to adequately fix these appliances to the floor was clearly demonstrated as many stoves were standing on smooth hearths and when shaken they moved easily, tearing free from their flue and, in some instances, tipping over and spilling the contents of their fire boxes.

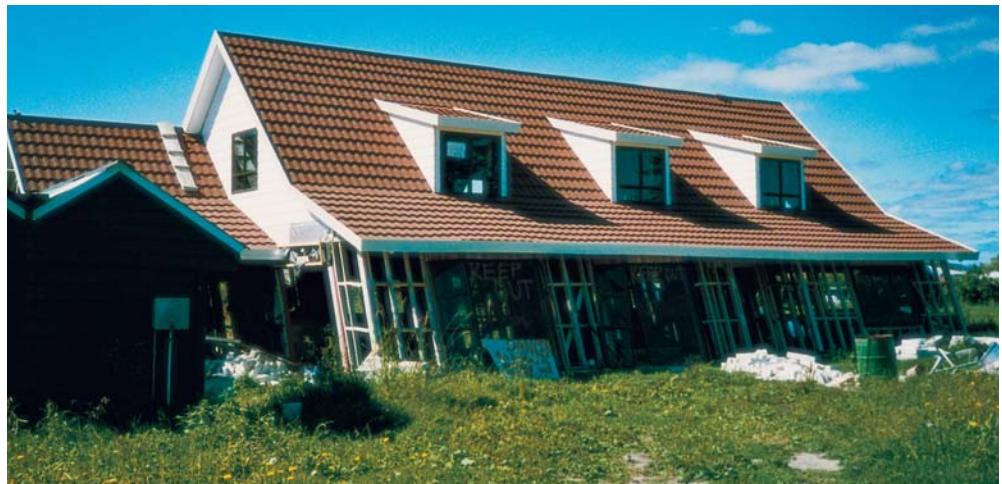
Figure 26: Unlined houses are particularly vulnerable to lateral loading from either earthquake or wind actions. The contribution of the internal linings to the resistance to lateral load, and the need to ensure adequate nailing of the lining, is shown by the near collapse of this unlined house.

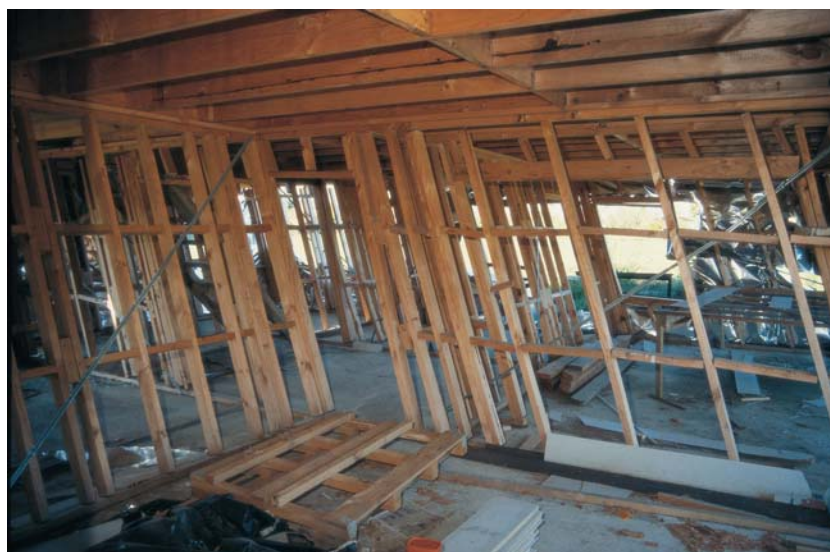
Figure 27: Inside the house the internal metal angle braces were insufficient to handle the earthquake loads from the relatively heavy upper-storey.

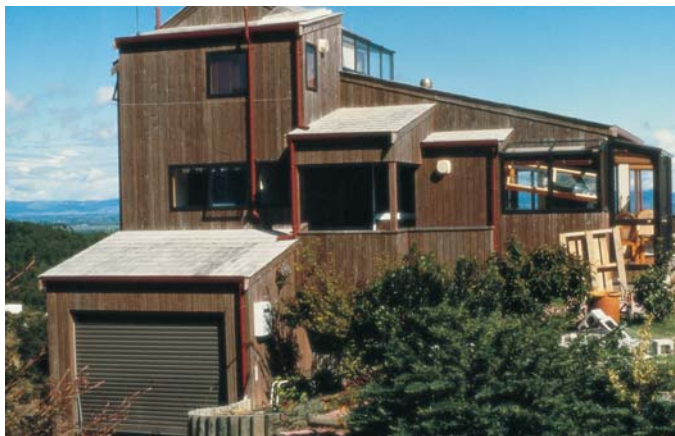
Figure 28: This split-level house, overlooking Whakatane, has been constructed on a pole platform, and from this view appears undamaged.

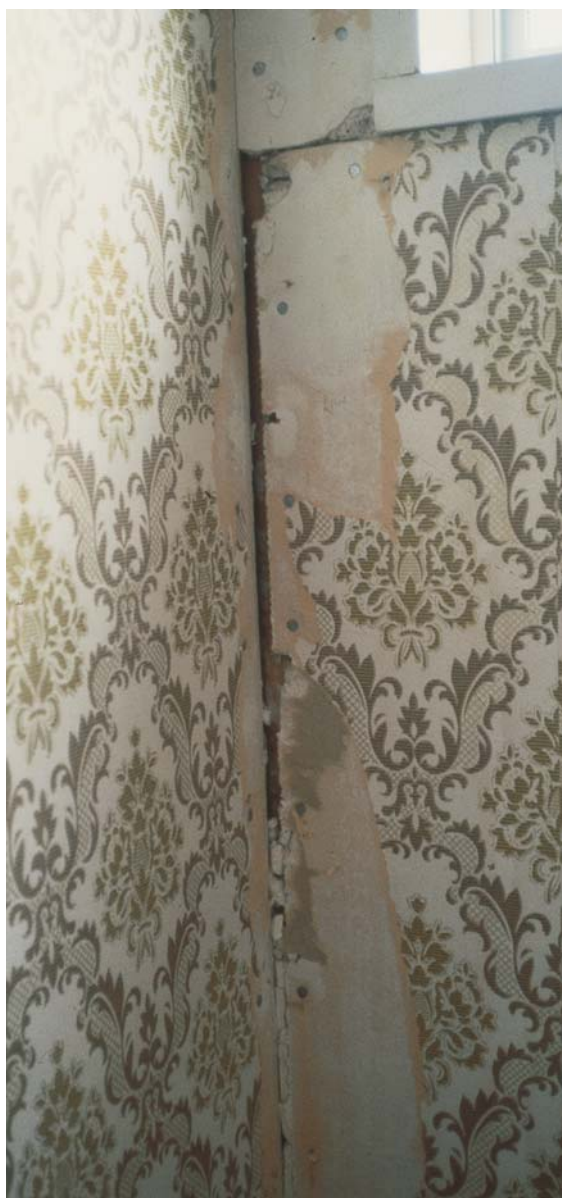
Figure 30: Walls of different height moved differently, often resulting in cracked wall linings and fractured plaster joints.

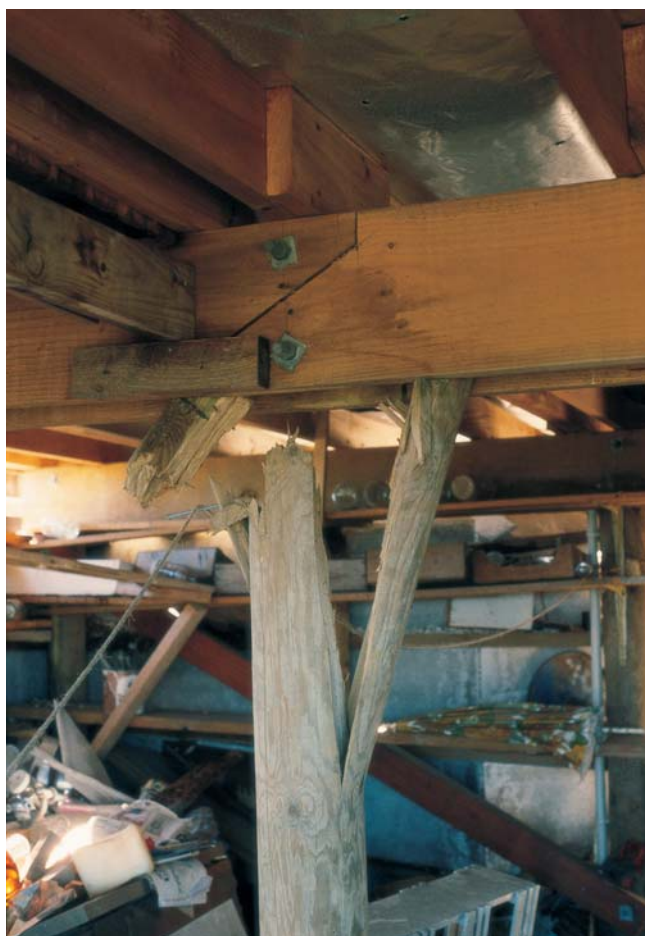
Figure 29: The pole supports acted as cantilevers and were unbraced. This internal pole, fractured below the beam. The split-level floor reduced the effectiveness of the floor diaphragm action. NZS 3604 now requires a bracing line at all discontinuities of the floor level.

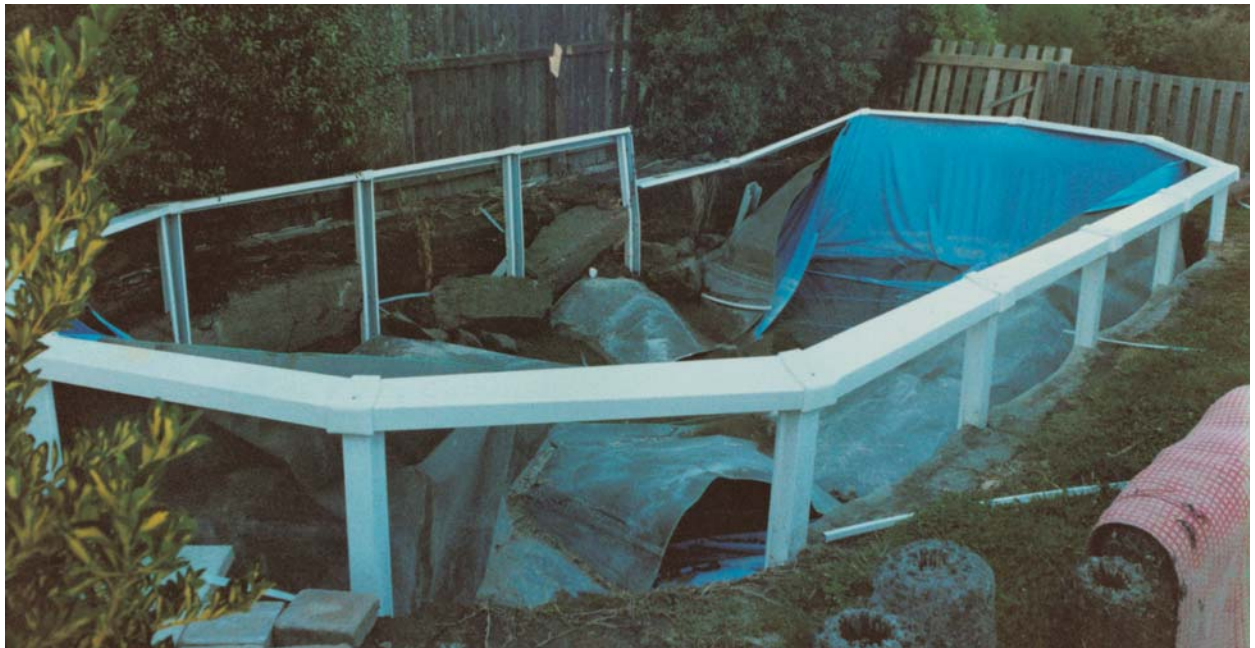
Figure 31: Water-containing structures experienced substantial damage during the earthquake. Many pools were badly damaged in the area. Water was described as being 'thrown' from pools in Edgecumbe.

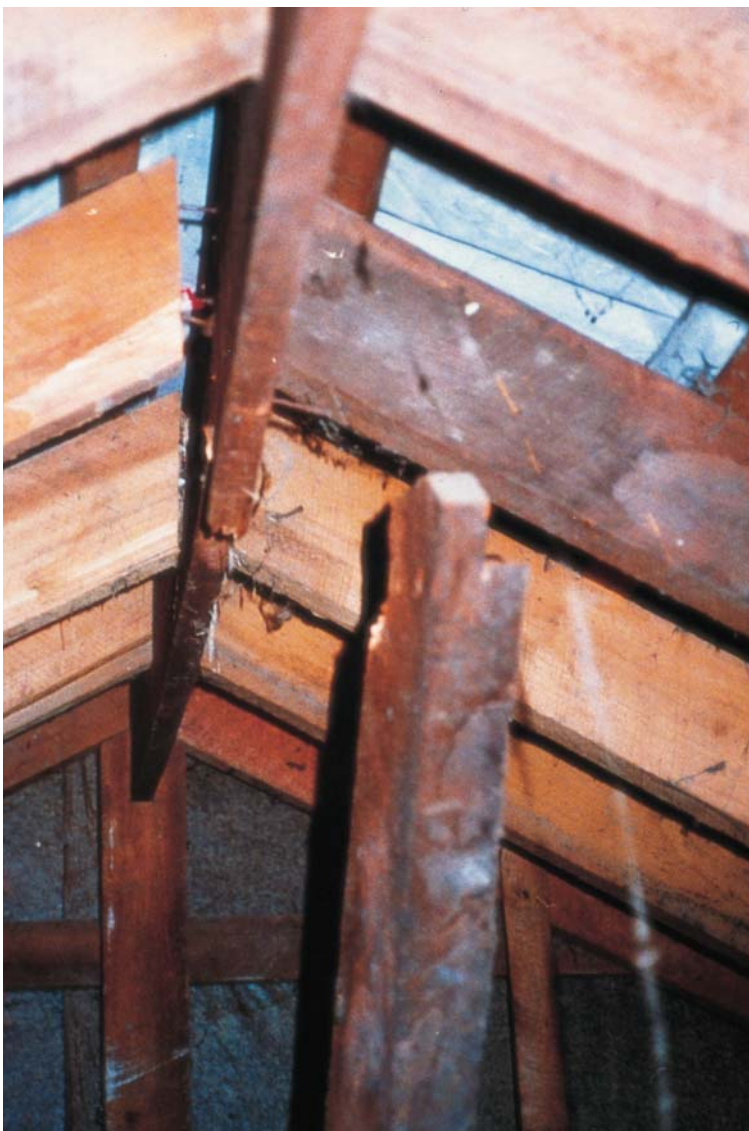
Figure 32: In this gable-ended concrete tiled roof, the nailed connections between the diagonal roof braces and the ridge board failed. The end of the brace was fixed to the ridge board directly below a rafter. When the brace was loaded in compression, it raised the ridge board, pushing the rafter out of place.
