BULLETIN

ISSUE 546

HOUSE CONDITION SURVEY – EXTERNAL ENVELOPE

April 2012

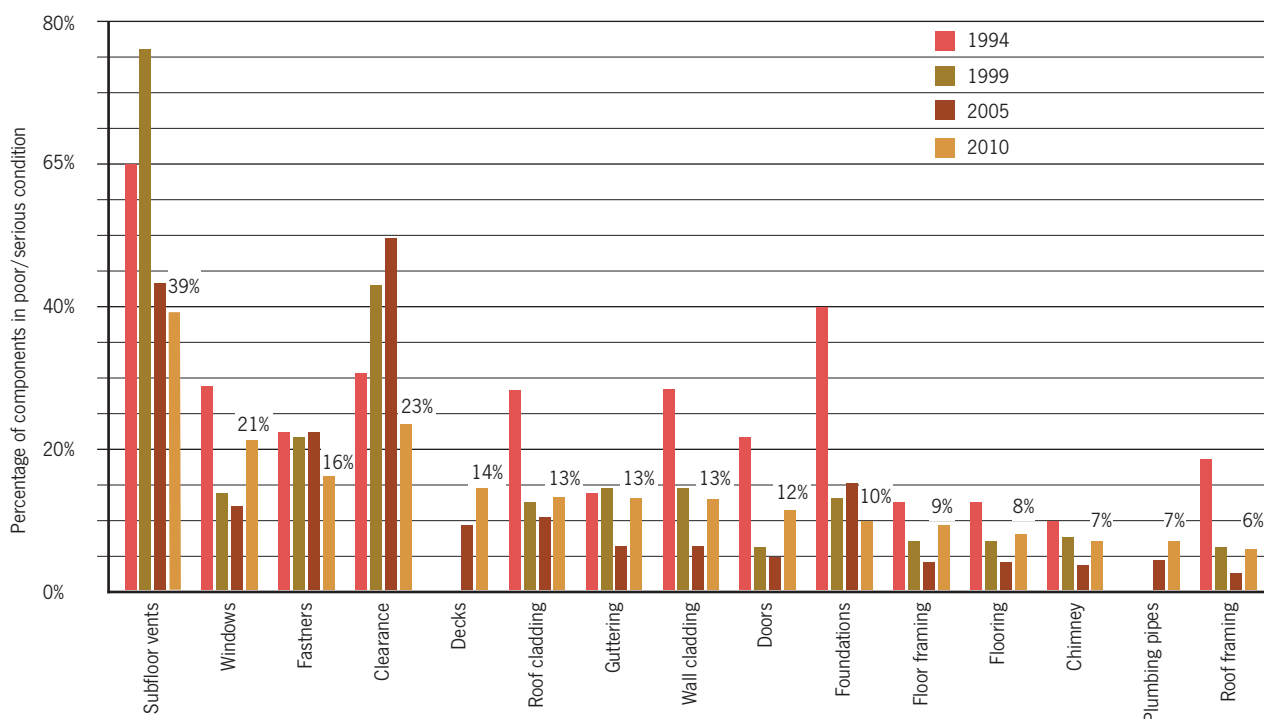
Figure 2. Envelope component condition ratings.

5.0.1 Average condition ratings were assessed for components in order of increasing severity (Figure 2).

5.0.2 The average condition of houses across all age groups was 3.7 out of 5.

5.0.3 As expected, newer homes have the highest average component condition (4.3), while houses built in the 1950s have the poorest average condition (3.4). Houses older than this have slightly higher average component ratings, partly reflecting the renovation of bungalows and villas.

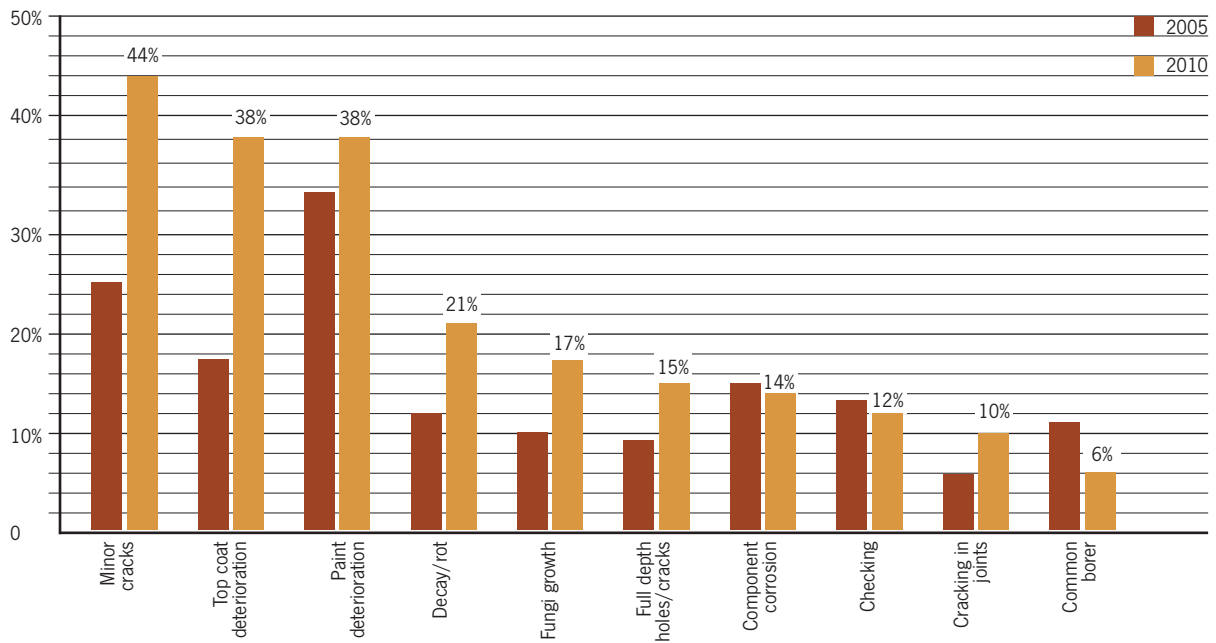
Figure 6. Defects in timber weatherboards.

6.3.3 The most common defects found in timber weatherboards are shown in Figure 6, masonry veneer and concrete block in Figure 7.

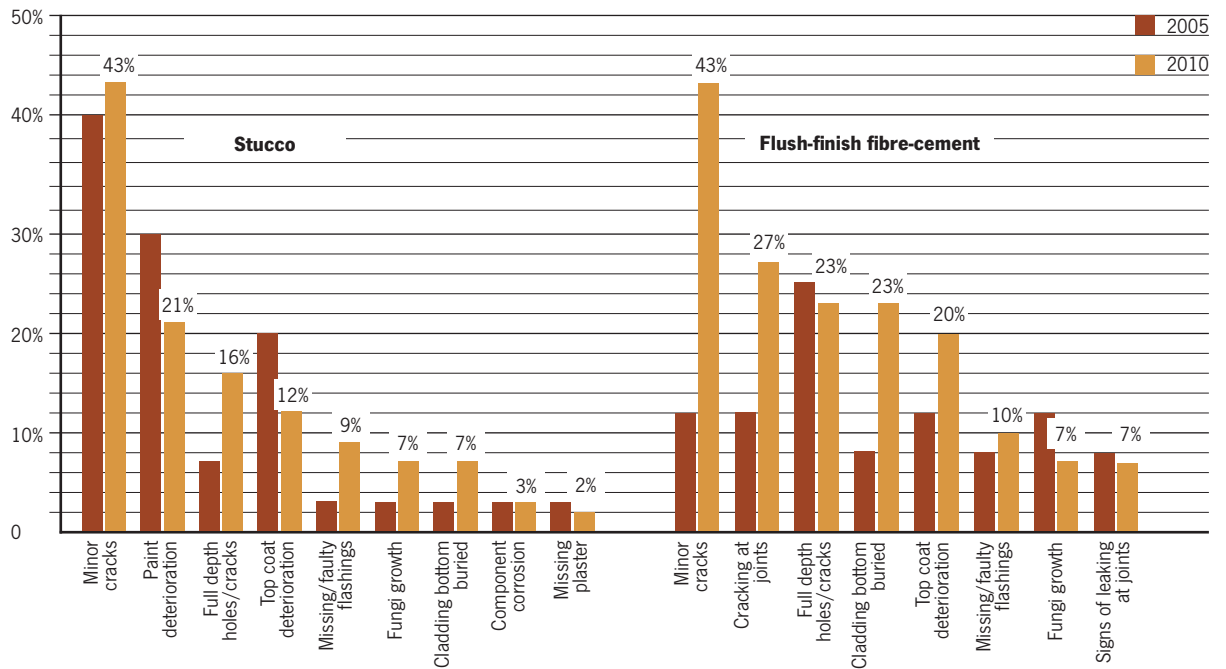
Figure 8. Defects in monolithic claddings.

6.3.4 The results for monolithic cladding (Figure 8) should be treated with caution, as the survey assesses condition from the cladding's external appearance: establishing the true condition requires destructive

testing. The surface appearance may conceal underlying issues.

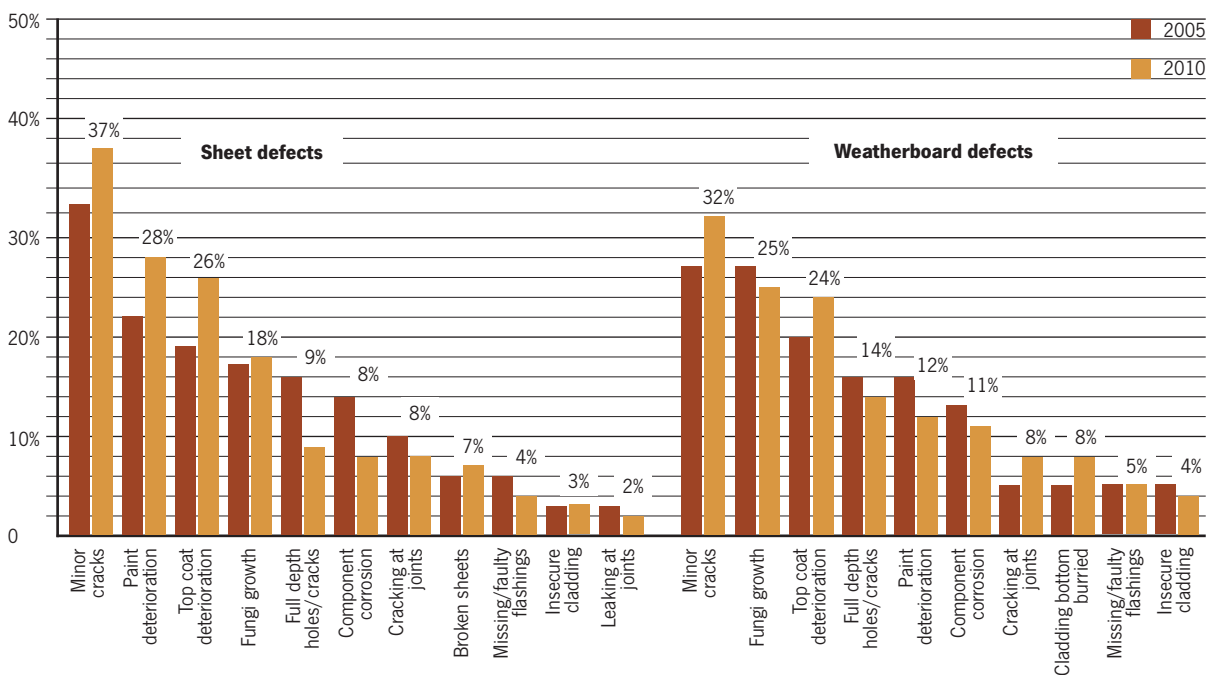
Figure 9. Fibre-cement wall cladding defects – sheet and weatherboard.

6.3.5 The defects in other fibre-cement claddings are shown in Figure 9.

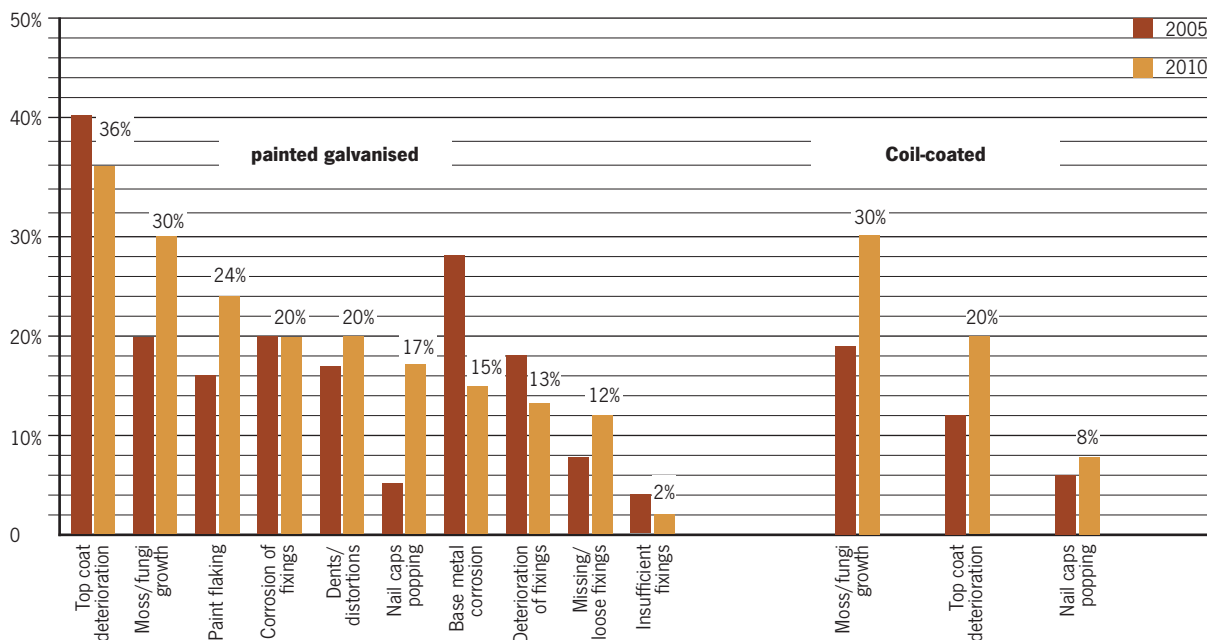
Figure 10. Defects in profiled steel roofing.

6.4.1 Profiled steel roofing is the most common roof cladding, present on over half of the houses in the sample. The most frequently observed defects are shown in Figure 10.

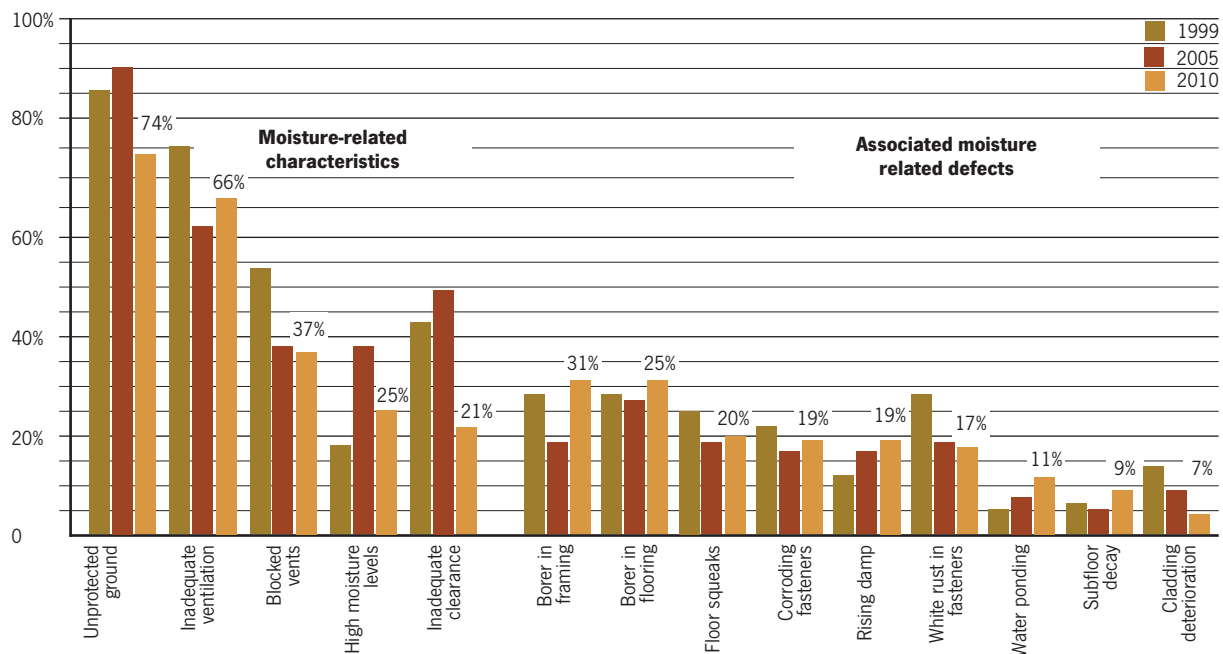
Figure 11. Moisture-related defects in subfloor.

6.6.2 In 8% of houses with subfloors, the moisture content of the subfloor framing was over 20%, placing it at greater risk of decay and other damage (Figure 11).

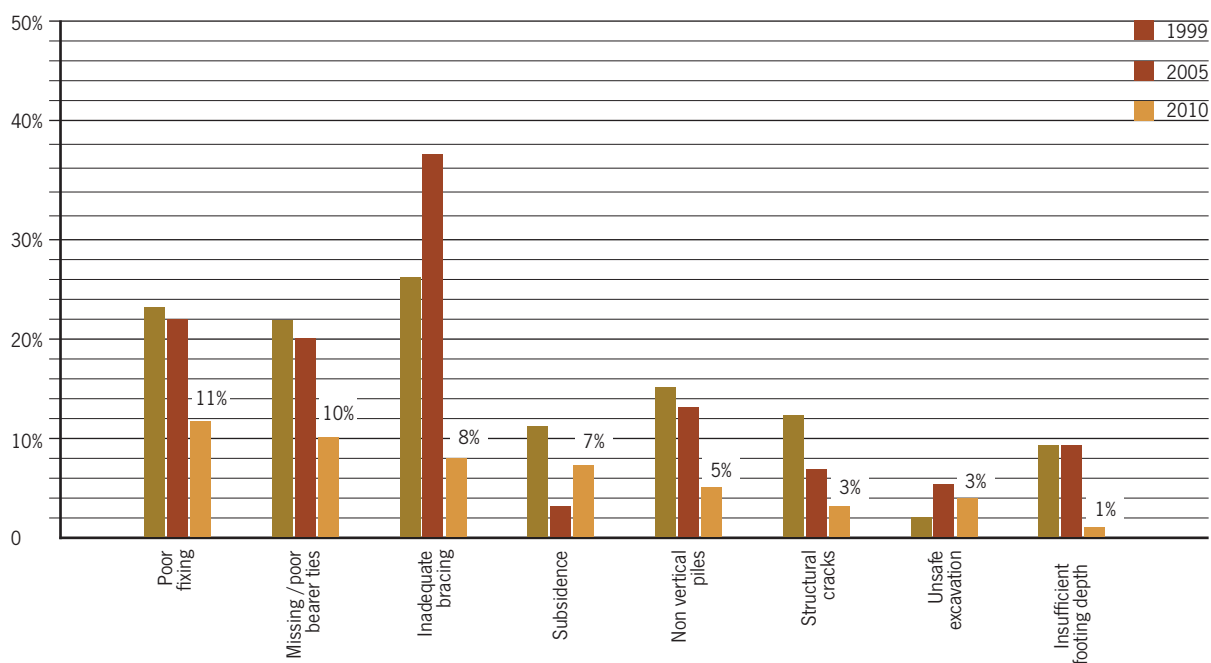
Figure 12. Non-moisture related subfloor defects.

6.6.3 Non-moisture related defects were common in the sample of houses with accessible subfloors (Figure 12). Any particular subfloor may have more than one defect.

6.6.4 Over 20% of houses had no specialised fasteners between concrete piles and framing timbers. Pre-1940s houses were built before these fasteners were common. Seven percent of the sample falls into this category, and still have no (or inadequate) subfloor fasteners. However, 15% of houses built after 1940 do not have specialised fasteners.

6.6.5 Since the 1999 survey, the percentage of pre-1940 houses without specialised fasteners has fallen from nearly 70% to 34%. This could be the result of retrofitting of these subfloor areas.
