ISSUE 548 BULLETIN

REPAIRING PLASTERBOARD AFTER AN EARTHQUAKE

June 2012

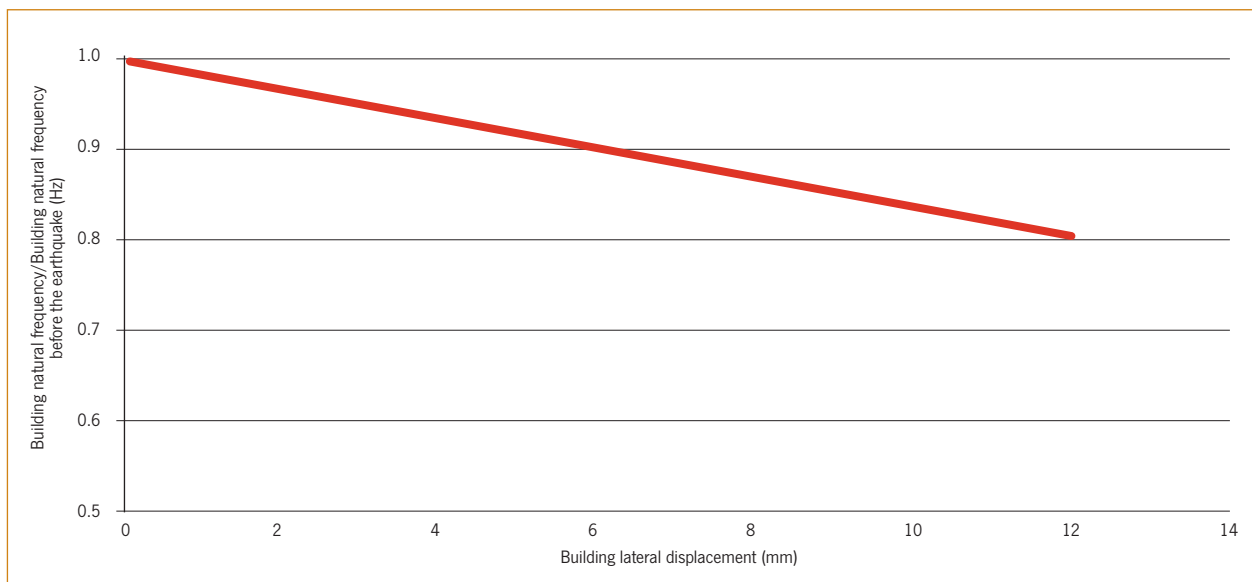
Figure 5. Building natural frequency relative to its natural frequency before the earthquake, as it is racked to greater displacements

3.2.2 As the building racks further, the natural frequency reduces relative to its natural frequency before the earthquake (Figure 5) because the building becomes more flexible. The effectiveness of the repair method can be judged by the regain in natural frequency achieved.

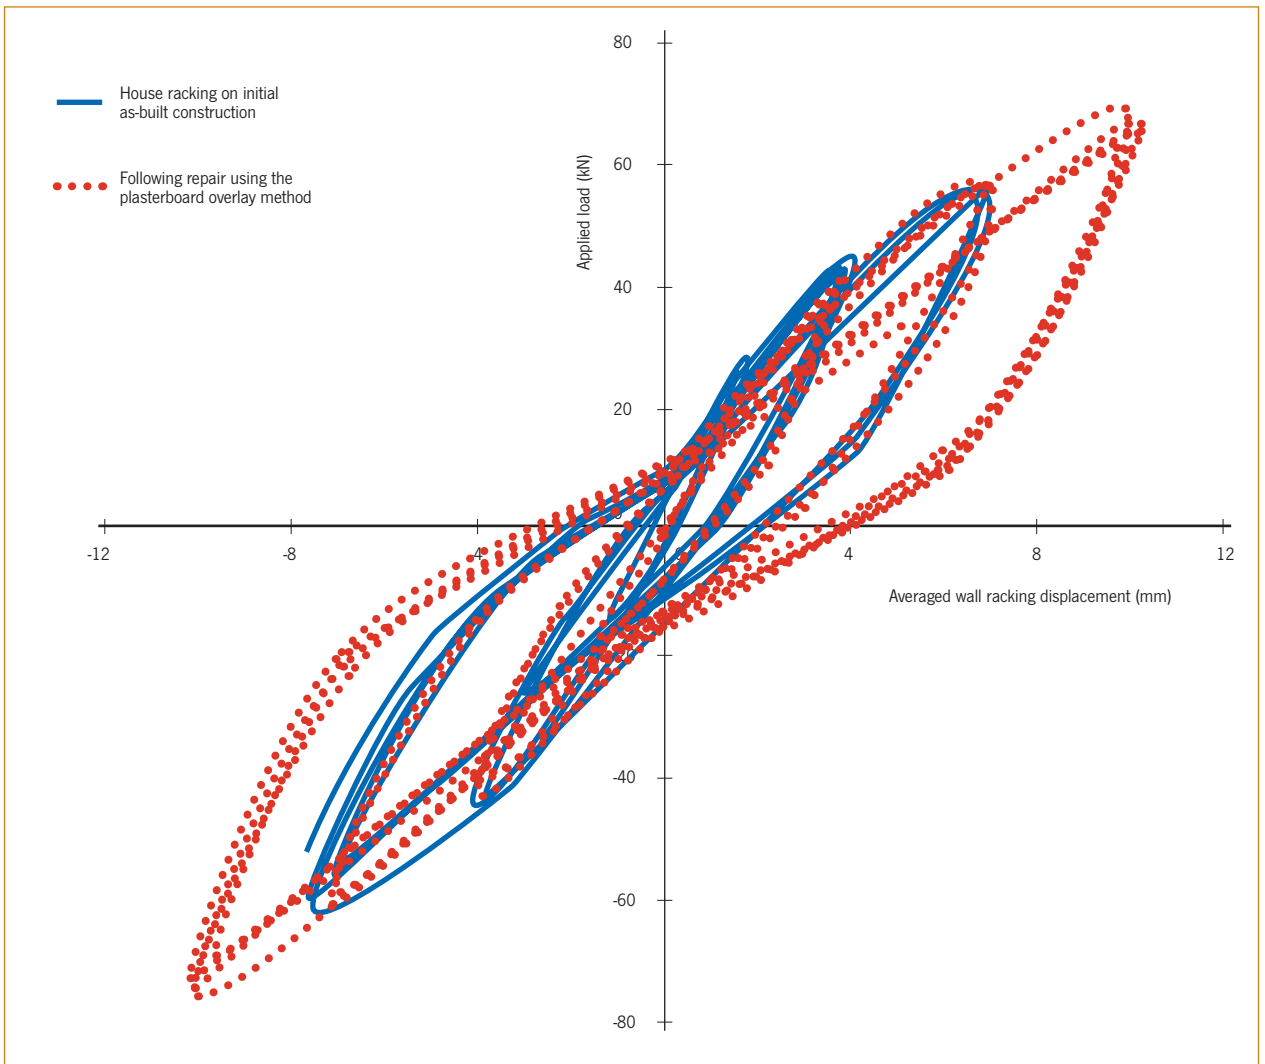
Figure 6. Comparison of applied load versus top plate displacement of the test building in its original condition and after the plasterboard overlay repair (Method 3)

3.3.2 A typical test comparison between performance before and after a repair is shown in Figure 6. Here, the applied force versus building racking displacement at serviceability is compared for the building in its initial condition and after it had been racked to 31 mm (the approximate ultimate limit

state displacement) and then repaired using the sheet overlay technique. The plot shows that this particular repair effectively reinstated the building to its initial (undamaged) properties. While the initial cycling continued up to 31 mm, only the displacement cycles up to 8 mm are shown for clarity of the comparison. Similar plots after other repair methods showed some reduction in building stiffness.
