ISSUE 551 **BULLETIN**

LEARNINGS FROM THE CANTERBURY EARTHQUAKES

August 2012

■ This bulletin gives an overview of the learnings that came from examination of damaged buildings.

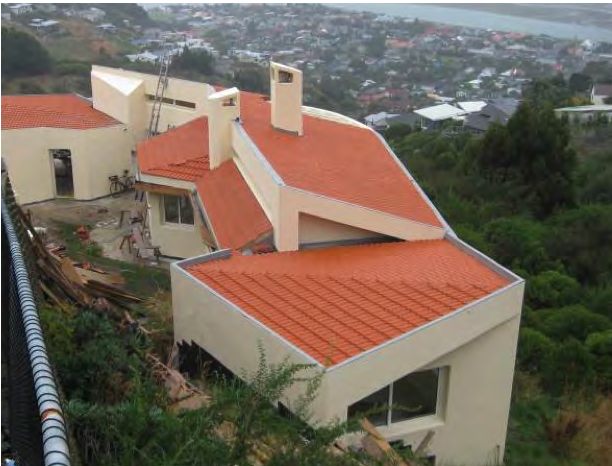
Plan irregularity increases the risk of damage.

6.1.3 BRANZ examined a number of hillside houses that had large open internal spaces and panoramic windows along one wall designed for a view. These houses often suffered because the front of the house (with the windows) was much less stiff than the rear.

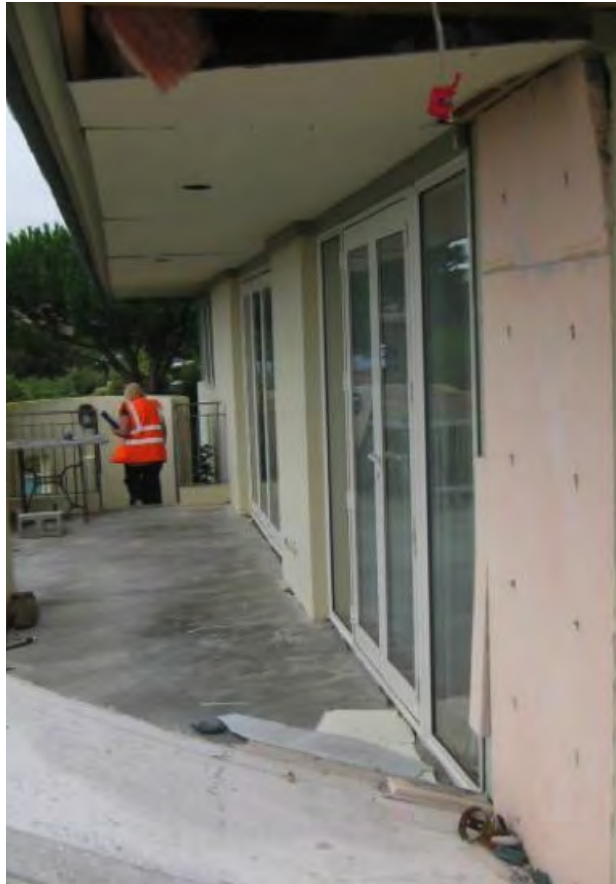
The connections failed on this precast concrete panel.

6.2.6 BRANZ saw some connection problems in houses built with precast concrete panels.
