ISSUE 627 **BULLETIN**

## THE IMPACT OF GEOTHERMAL ENVIRONMENTS ON METALS AND WOOD

August 2018

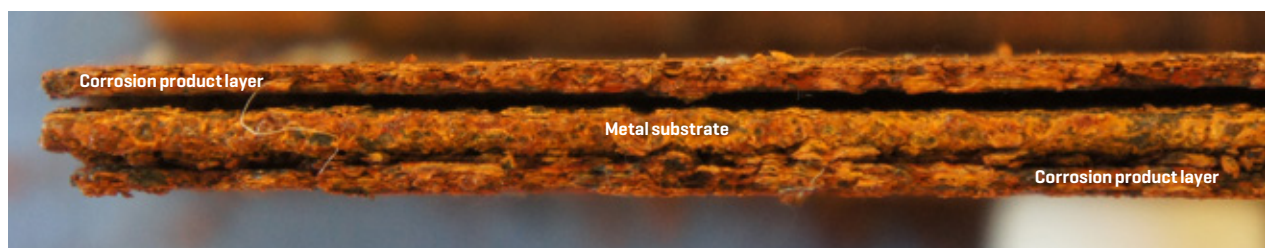
**2.0.4** At the wastewater treatment plant site, a thick corrosion product layer that could easily break off formed on the mild steel (Figure 3). The sample increased from 3 mm to around 5–6 mm thick after a 1-year exposure.

Figure 3. Corrosion products on the mild steel sample exposed at the wastewater treatment plant site for 1 year.

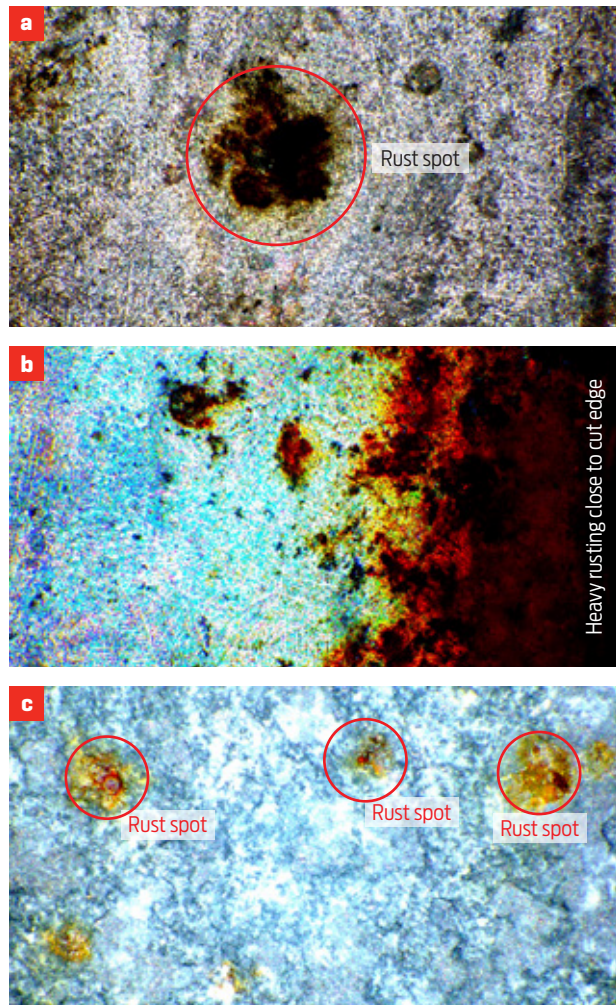
**4.0.4** After a 2-year exposure in a geothermal environment, sample surfaces did not show heavy rusting – just a few small, random rust spots [Figure 5a]. This indicates that the alloy coating has been consumed locally and some parts of the steel substrate have then been exposed to the environment.

**4.0.5** Heavy rusting was seen close to unprotected cut edges [Figure 5b]. This indicates that the exposed steel was not protected by the cathodic protection effect normally lent by a zinc coating.

**4.0.6** Spot rusting and grey/white patches were occasionally seen on samples exposed to the severe marine environment (Figure 5c). Rusting was limited to very small areas close to the bottom cut edge. Damage seen in some areas on the top surface of the marine-exposed sample was the result of mechanical impact from wind-blown sand or salt.

Figure 5. Surface of Al-Zn alloy coating after a 2-year exposure at [a] approximately 5 m from a fumarole [Scion campus] [b] the wastewater treatment plant approximately 200 m south of Sulphur Bay and [c] Oteranga Bay [severe marine].

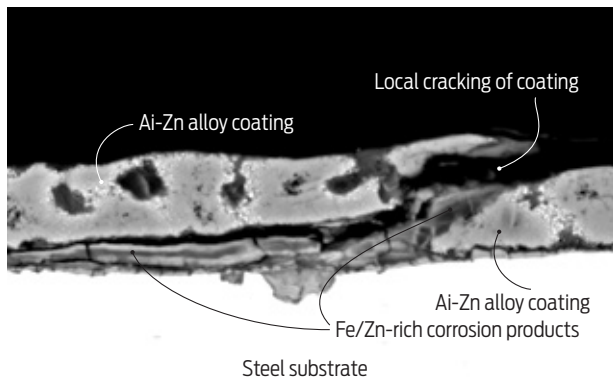
**4.0.10** This process may happen more quickly than in marine environments. Iron-rich corrosion products can form at the coating-steel substrate interface (Figure 6). The huge stresses generated by the volume expansion produce more physical defects in the coating such as bubbles and/or cracks (Figure 7). During extended exposure, severe, localised attack to the steel substrate leads to larger volume expansion, more damaged areas and finally coating failure with the formation of iron-rich rust on surface areas.

Figure 6. Cross-sectional view of a Al-Zn alloy coating after a 2-year exposure to a strong geothermal environment.

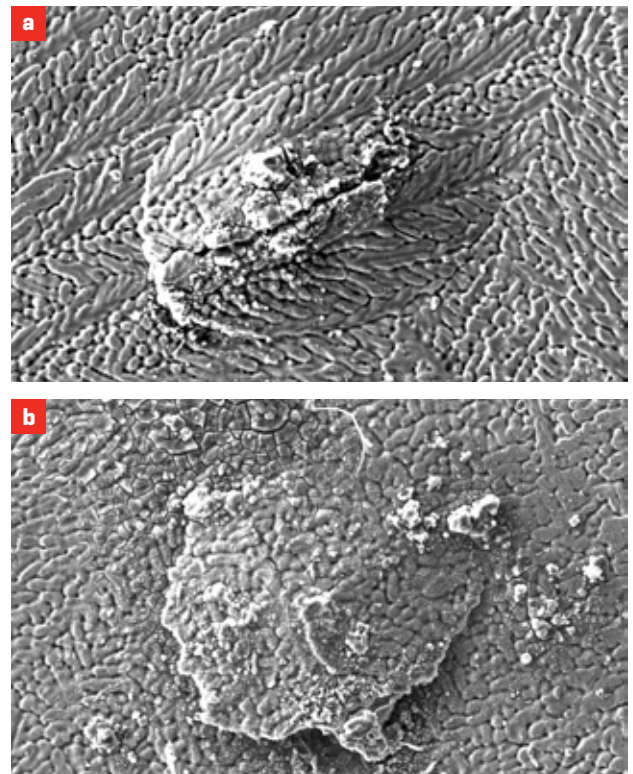
Figure 7. Failures seen on Al-Zn alloy coatings exposed to a strong geothermal environment: (a) bubbling/cracking, (b) lifting up.

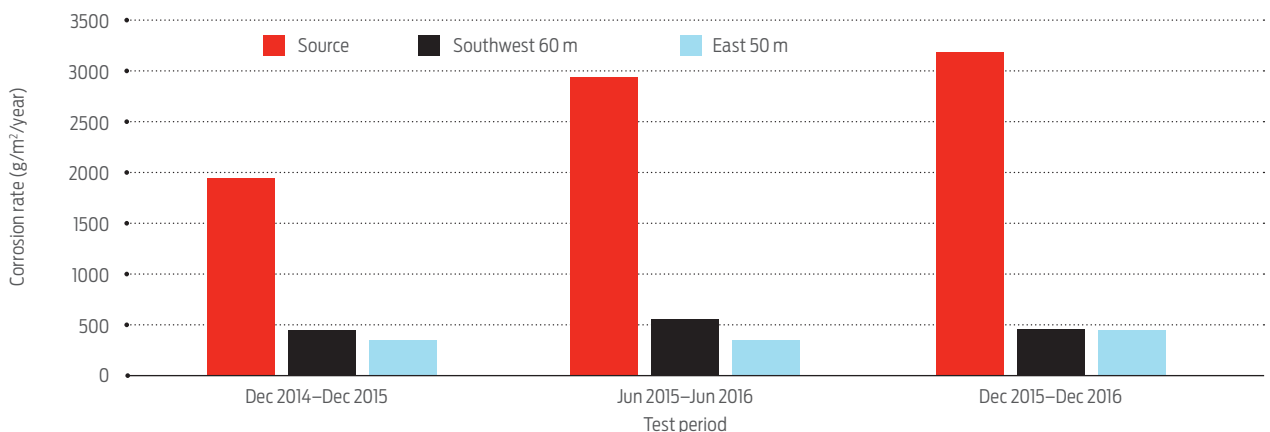
**5.0.3** A separation of 50–60 m from the geothermal source was shown to significantly decrease the corrosion rate of all three metals tested, by up to 10 times in some cases (Figure 8 shows the results for mild steel). This is likely related to lower airborne concentrations of sulphur-containing gases – H<sub>2</sub>S concentrations 50–60 m from the fumarole could be 5–10 times lower than that at the fumarole itself.

Figure 8. First-year corrosion rate of mild steel exposed at three locations around a fumarole in the Scion campus.

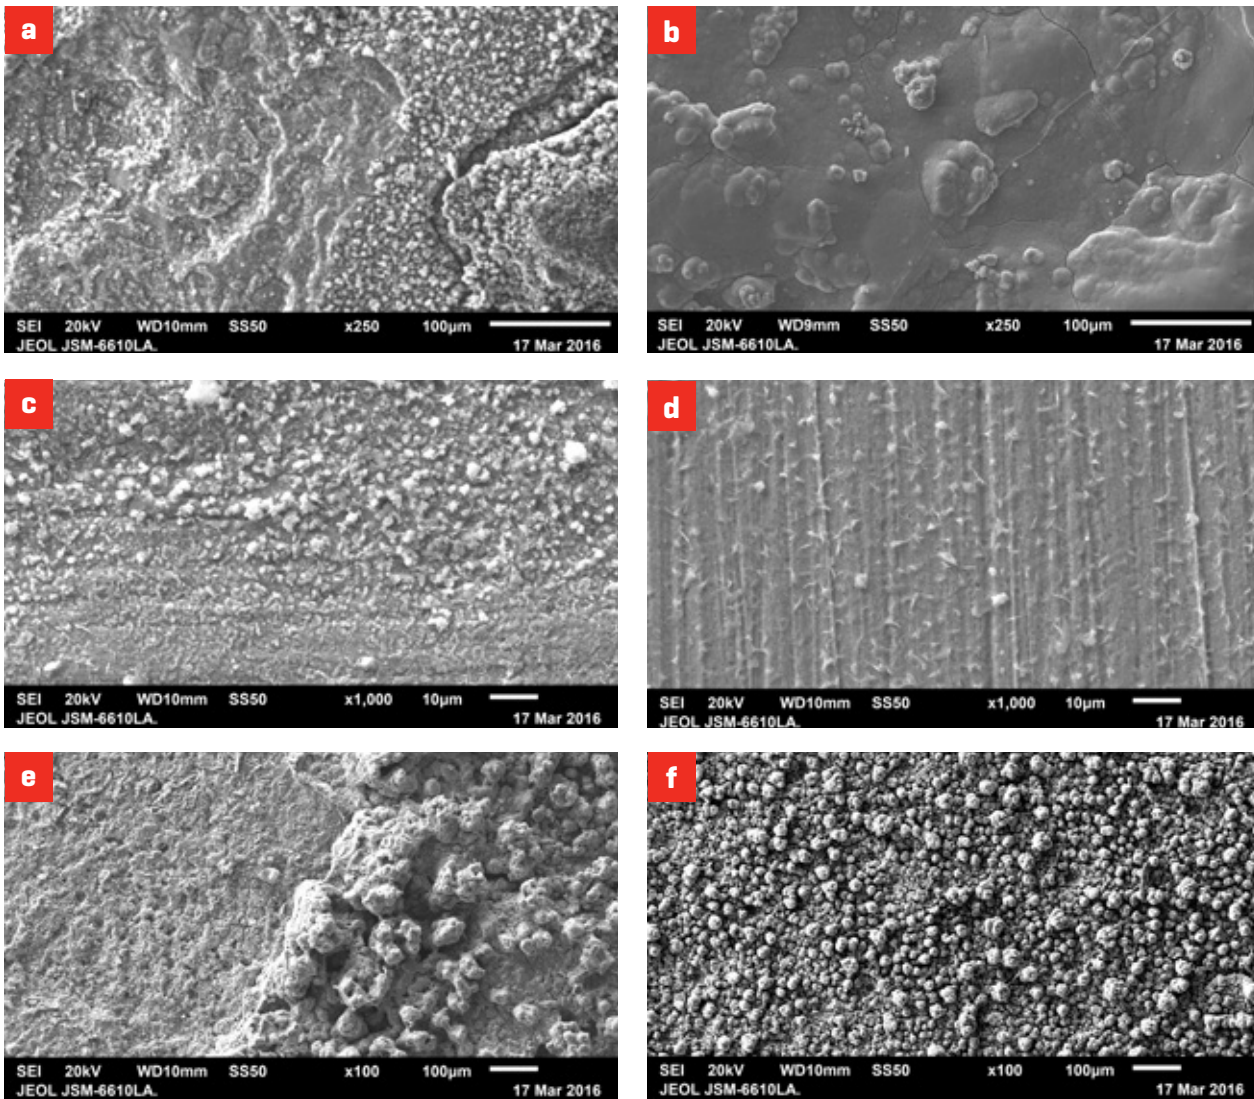
**5.0.5** Mild steel samples 5 m from the fumarole suffered severe corrosive attack (Figure 9a) with cracking and spalling. By contrast, corrosion product layers on mild steel samples exposed 50–60 m away showed no

significant detachment or spallation, although there were some cracks (Figure 9b). Corrosion product layers with better protective capabilities had formed.

**5.0.6** The corrosion layer on the zinc sample 50–60 m from the fumarole (Figure 9d) was much thinner than that on the zinc sample 5 m from the source (Figure 9c).

**5.0.7** Corrosion products on copper samples close to the fumarole detached and spalled with nodules/clusters formed (Figure 9e). Spallation and/or detachment were not seen on the copper samples 50–60 m away (Figure 9f).

Figure 9. Surface of metal samples exposed for 1 year: [a] mild steel at 5 m from a fumarole, [b] mild steel at 50 m, [c] zinc at 5 m, [d] zinc at 50 m, [e] copper at 5 m, [f] copper at 50 m.

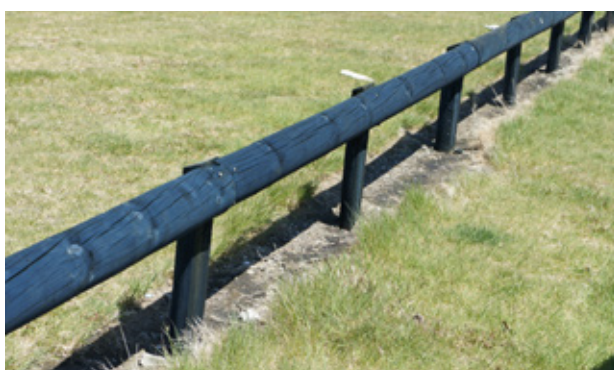
**6.0.1** Discolouration of wood, particularly wood treated with copper-containing preservatives, is common in geothermal environments (Figure 10). Although the change is mainly cosmetic, consistent exposure can result in large, deep cracks.

Figure 10. Wood discolouration in an area with strong geothermal influences.

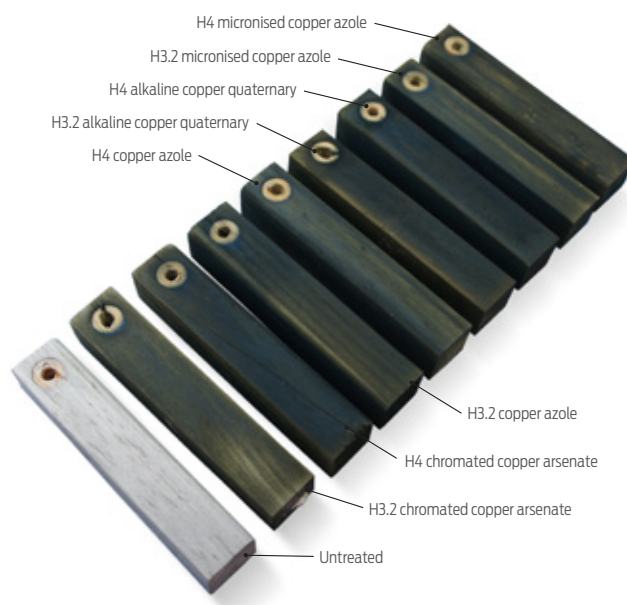
**6.0.4** After 1 year, all treated wood samples turned blue [Figure 11]. An examination of cross-sections showed a colour change up to 1 mm deep [Figure 12].

**6.0.5** The discolouration may be connected to the preservation chemicals containing copper ions, since the untreated wood showed no discolouration. [The field tests found that copper metal samples also changed colour after exposure to sulphur-containing geothermal emission.]

Figure 11. Discolouration of untreated and treated wood blocks from a site approximately 5 m from a fumarole in the Scion campus.

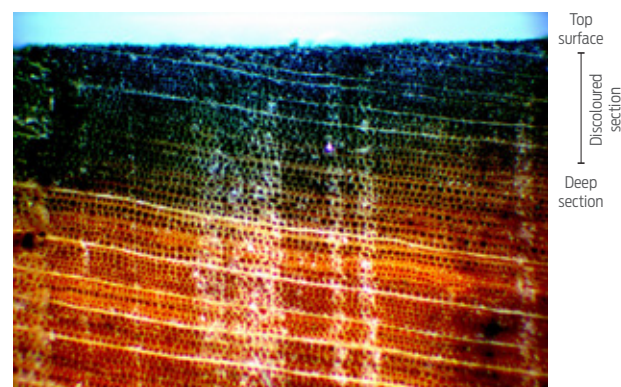
Figure 12. Optical microscopic view [32 $\times$ ] of the cross-section of an H4 micronised copper azole-treated wood block.
