BRANZ STUDY REPORT

A SURVEY OF MOISTURE DAMAGE IN SOUTHERN NEW ZEALAND BUILDINGS

H.A. Trethowen and
G. Middlemass

BRANZ Study Report SR 7

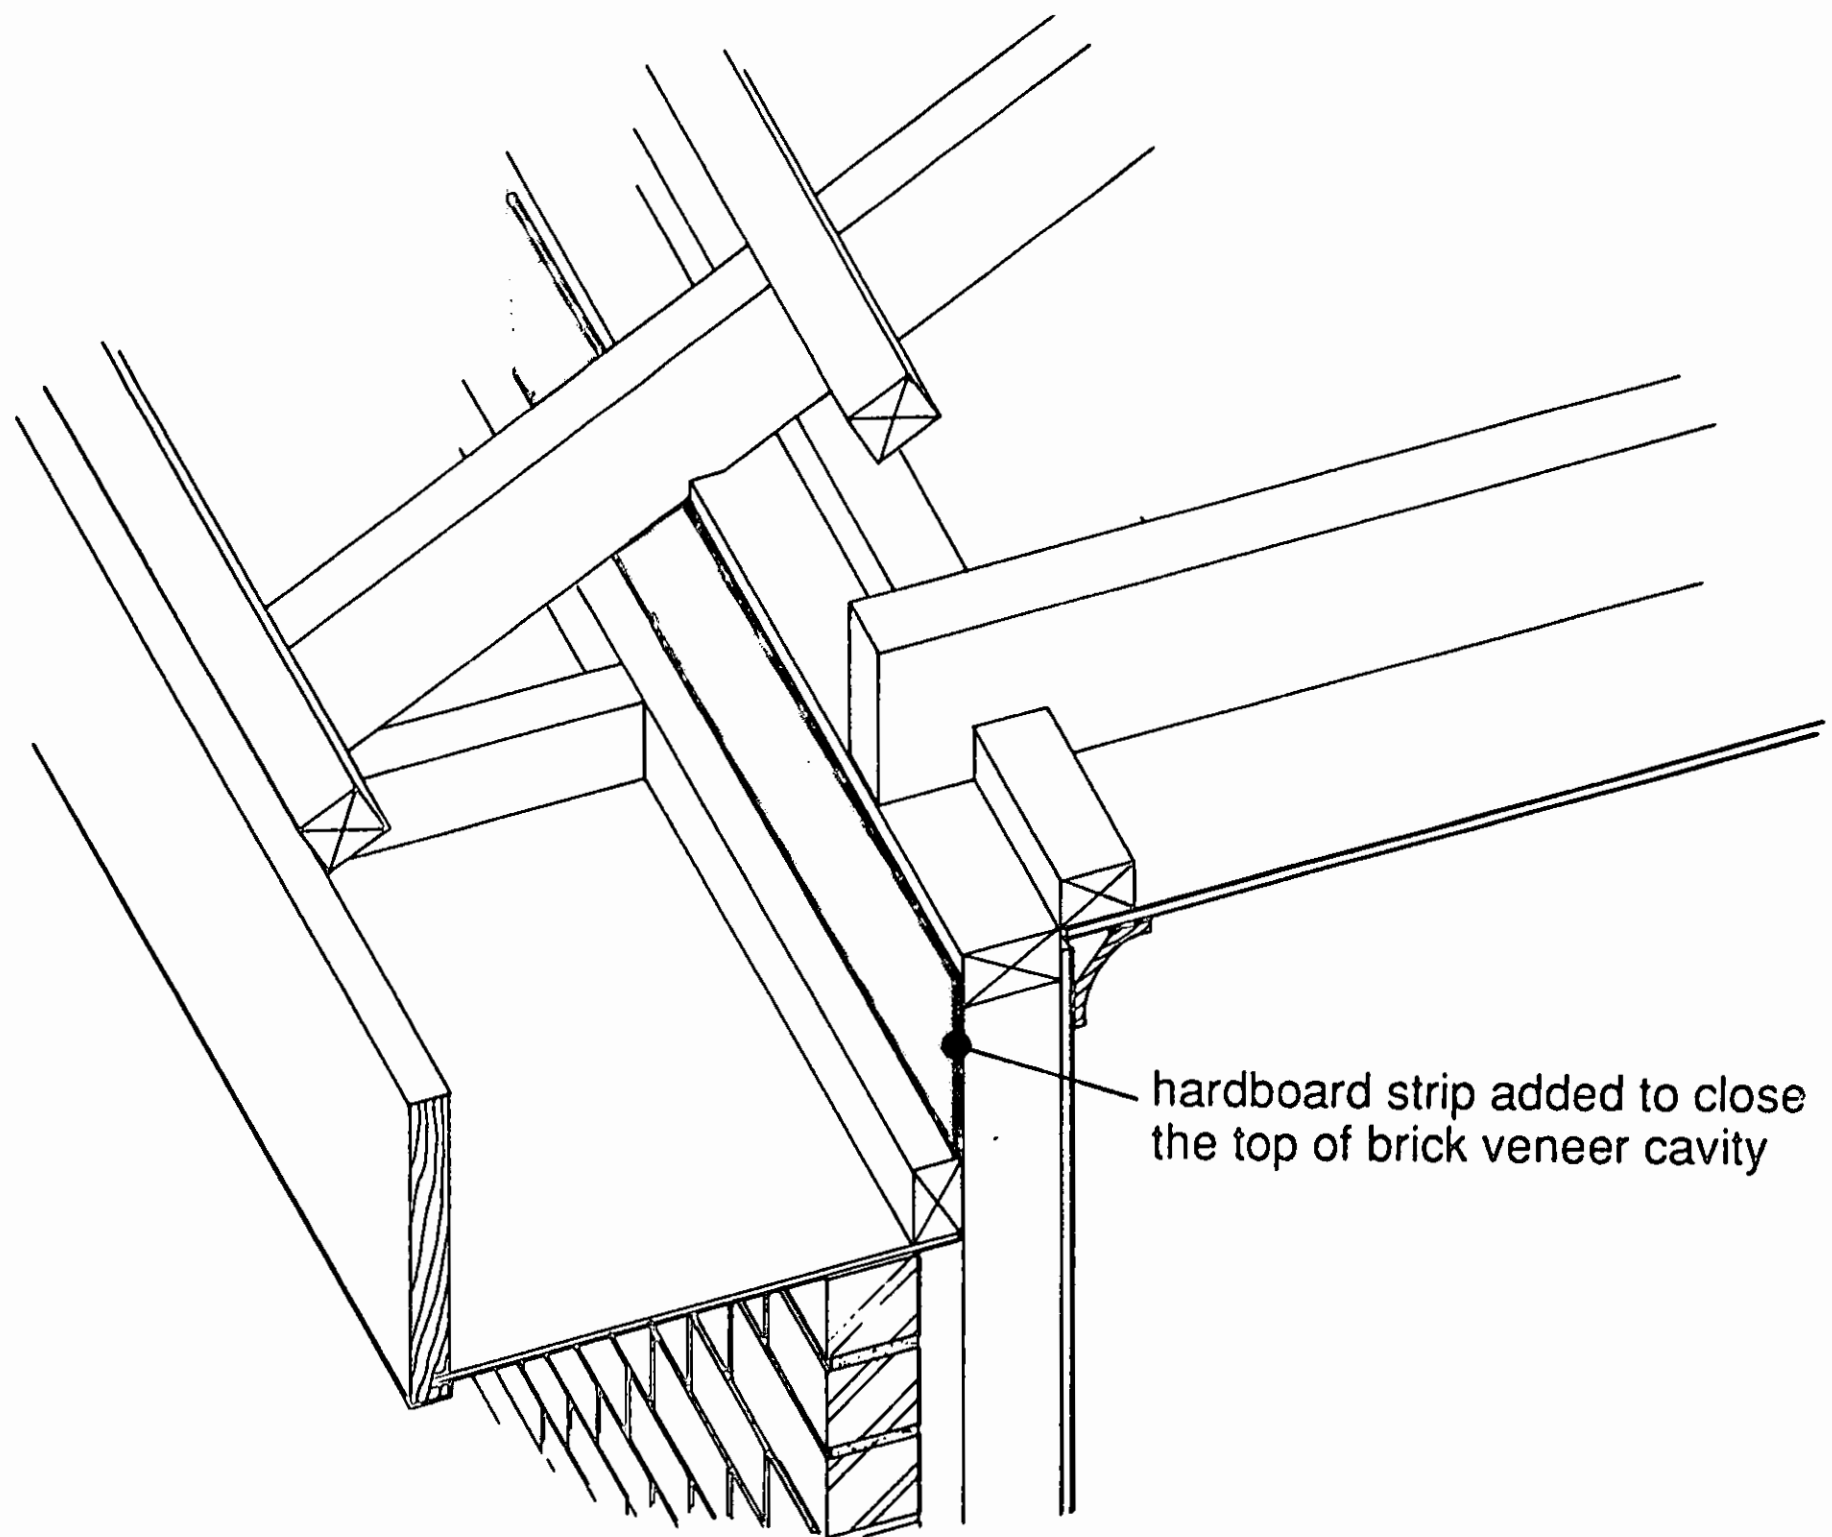
Figure 5 : Method of blocking eaves.

- a. to block the veneer cavity at eaves level
- b. to block the veneer cavity at floor level
- c. to cover the ground below the floor with polyethylene film.

The methods of carrying out these modifications were selected with a view to their possible commercial application later. Cavity blocking at eaves level was done by lifting part of the roof, and nailing hardboard strips over the top of the frame, in line with the building paper. Gables were more difficult to treat, but hardboard closers were used here also, applied from within the roof space. Cavity blocking at floor level was carried out with polyurethane foam spray, or with bitumen impregnated foam strips. Covering of the ground with polyethylene film was preceded by some smoothing and raking, and the sheets were lapped and taped to each other and to the foundations and piles. These measures were necessary to achieve a tidy finish, and are considered to have been of more importance for that purpose than for technical success.

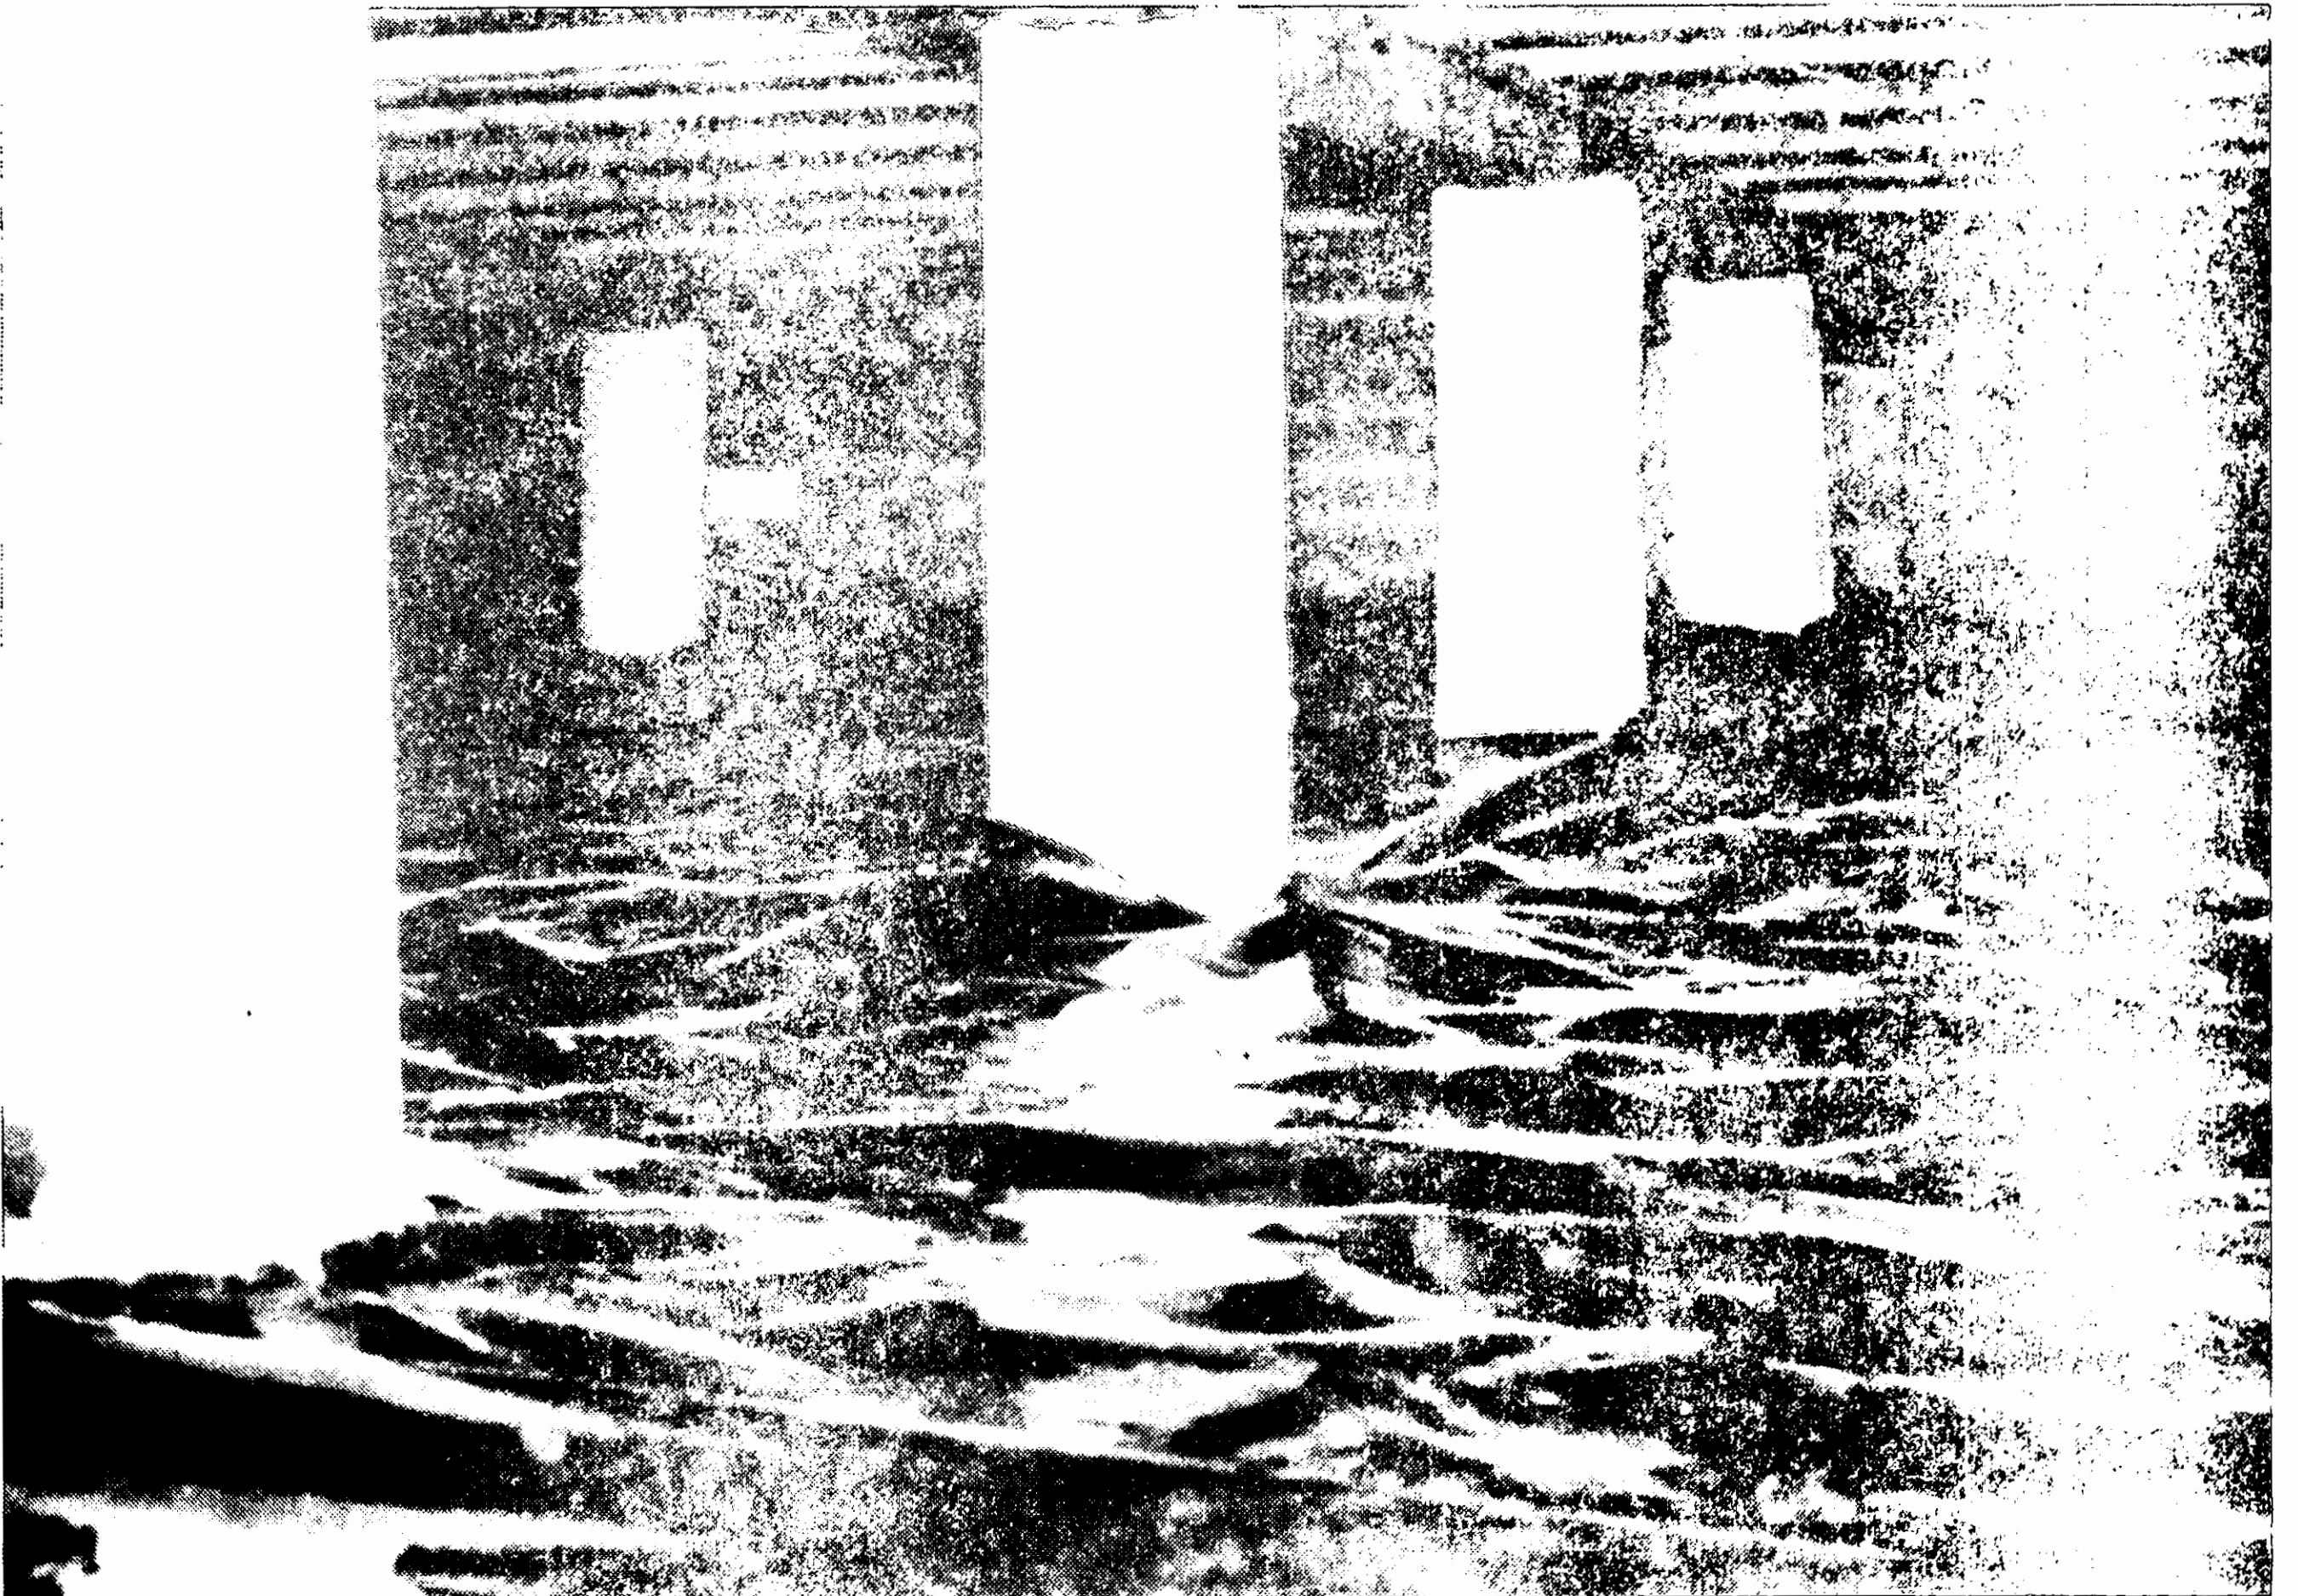
Figure 6 : Method of covering ground.

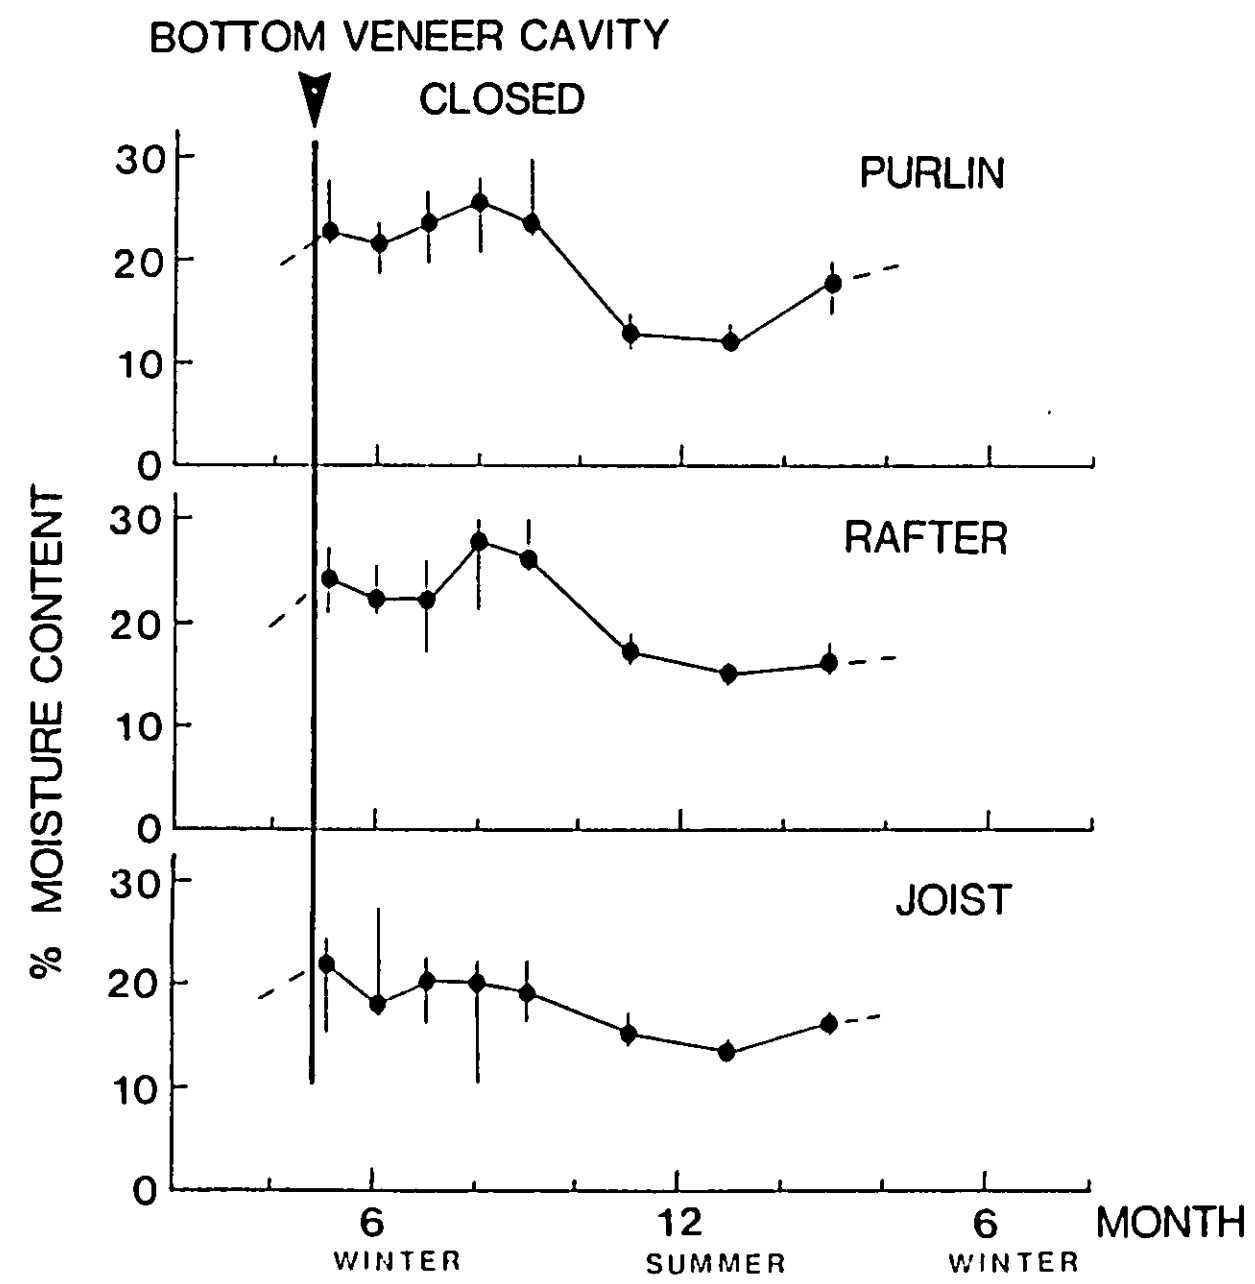
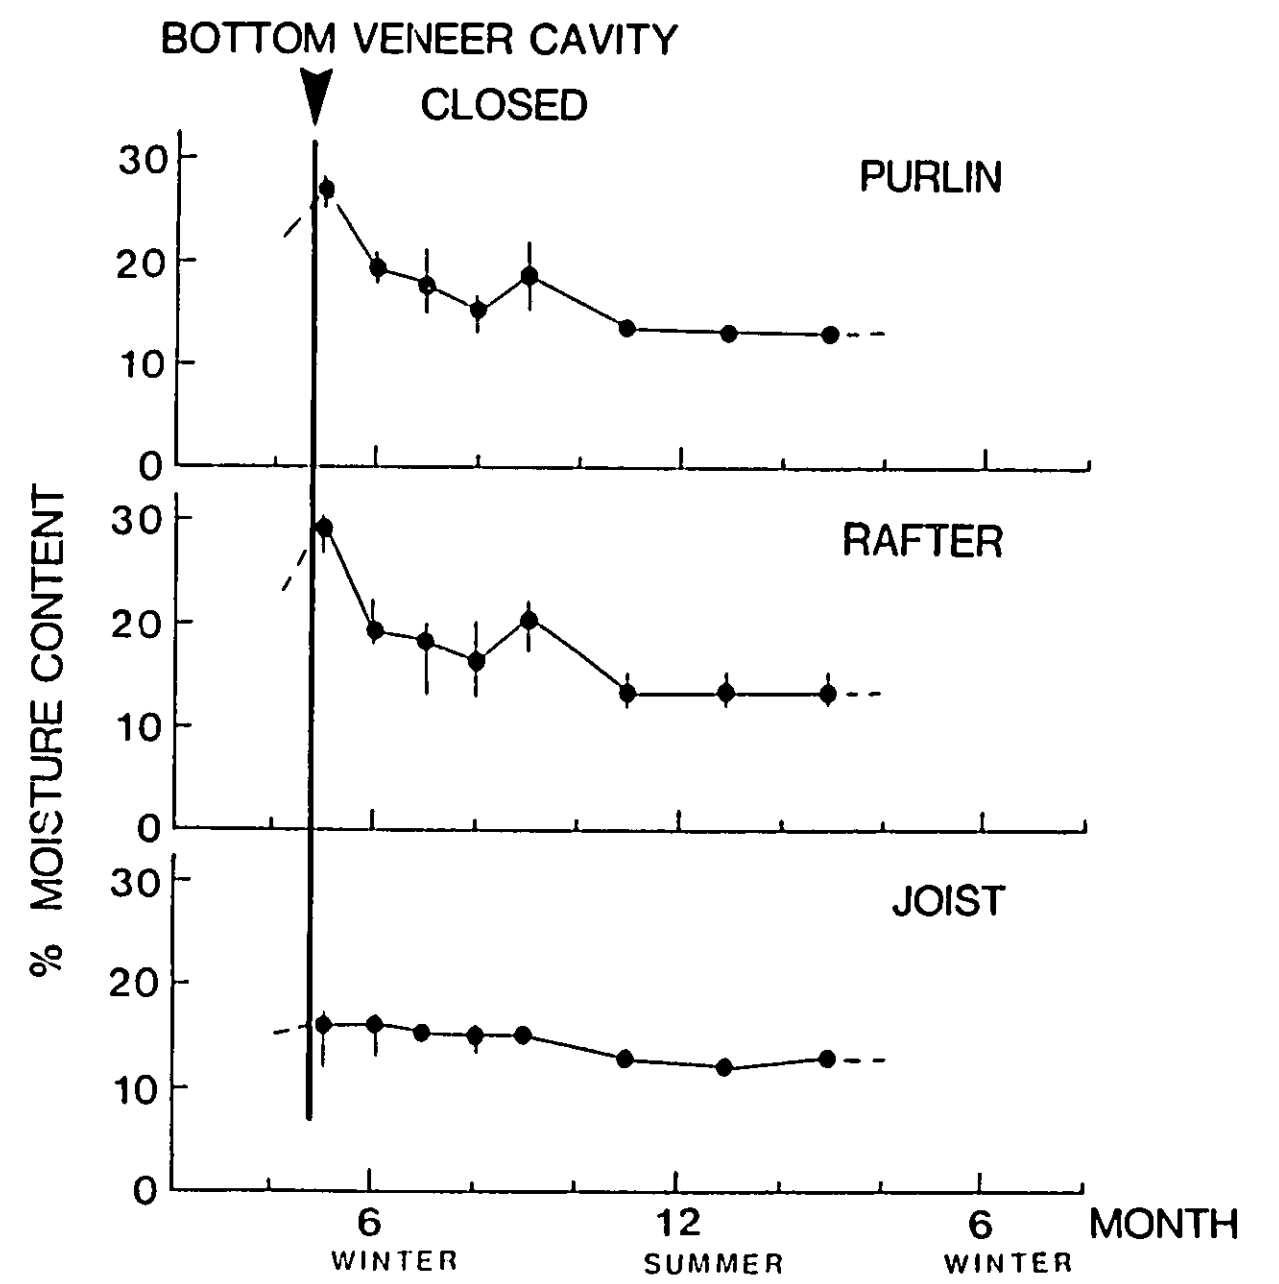
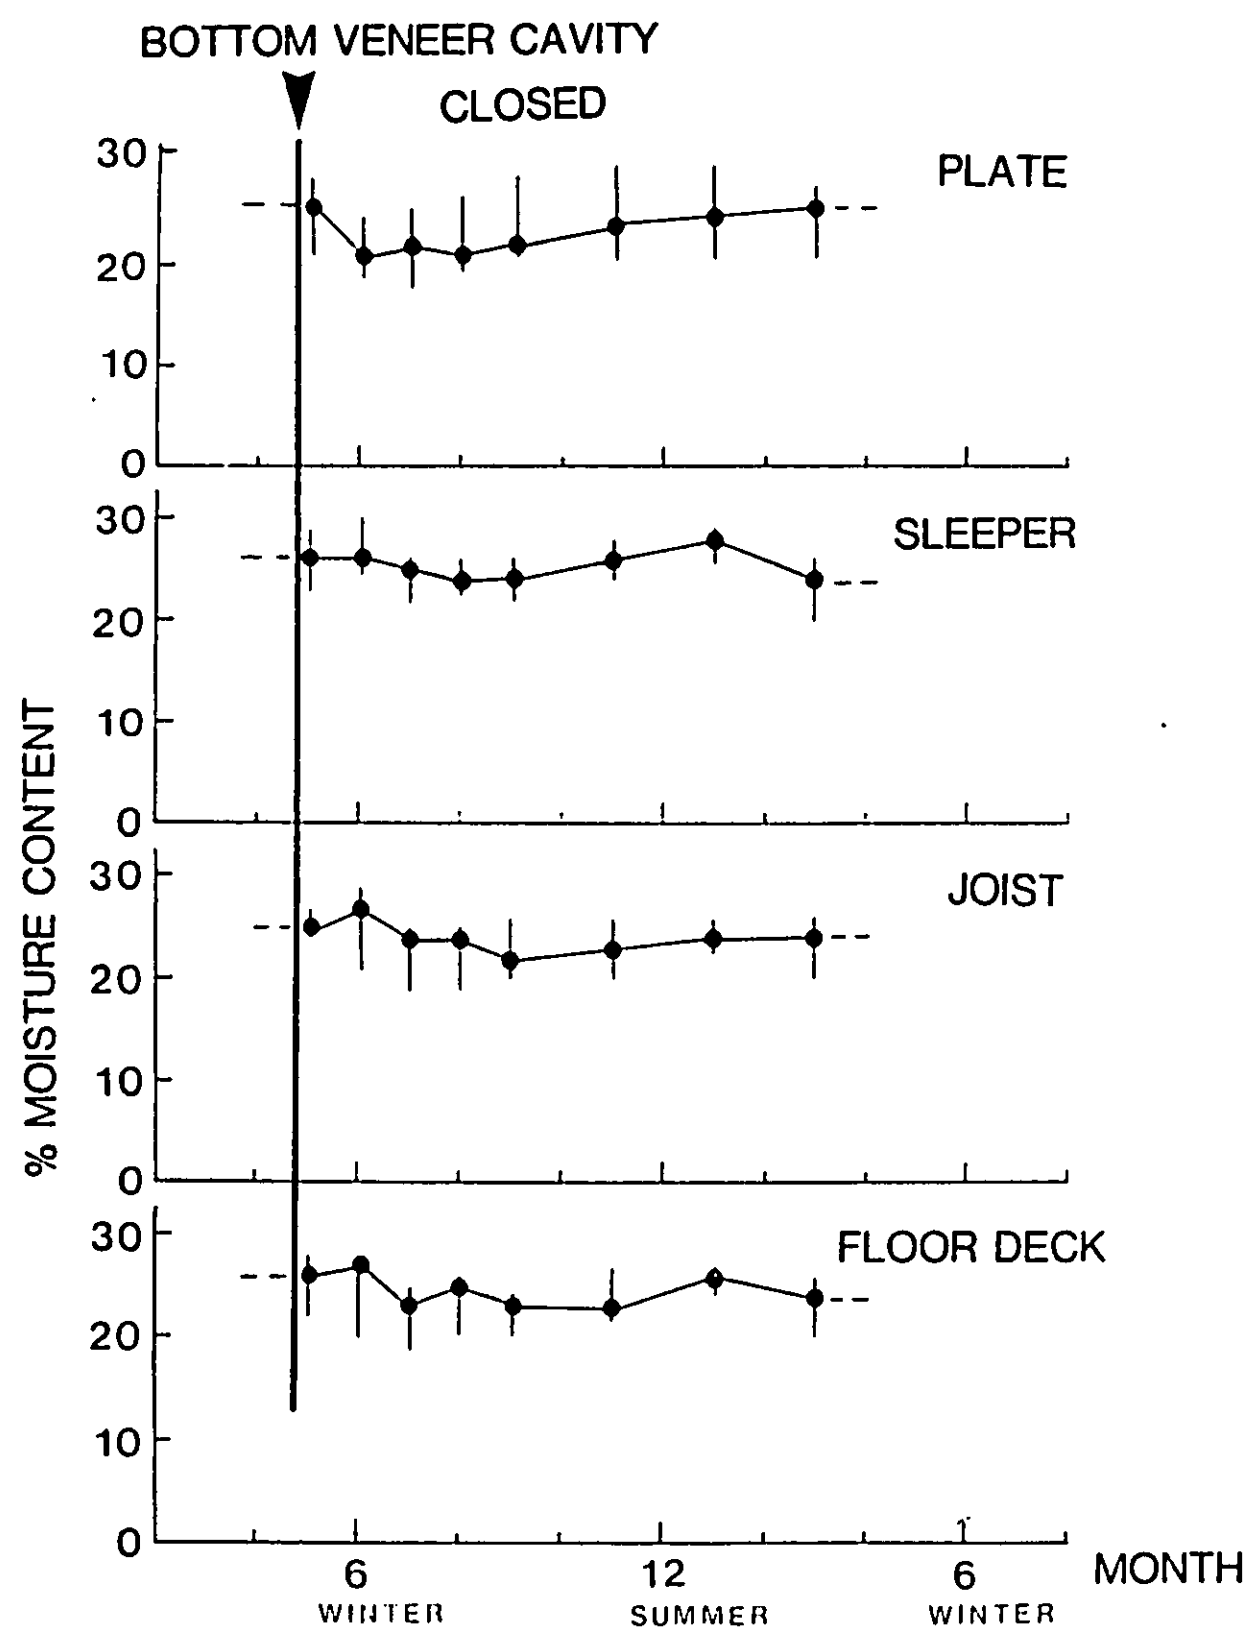
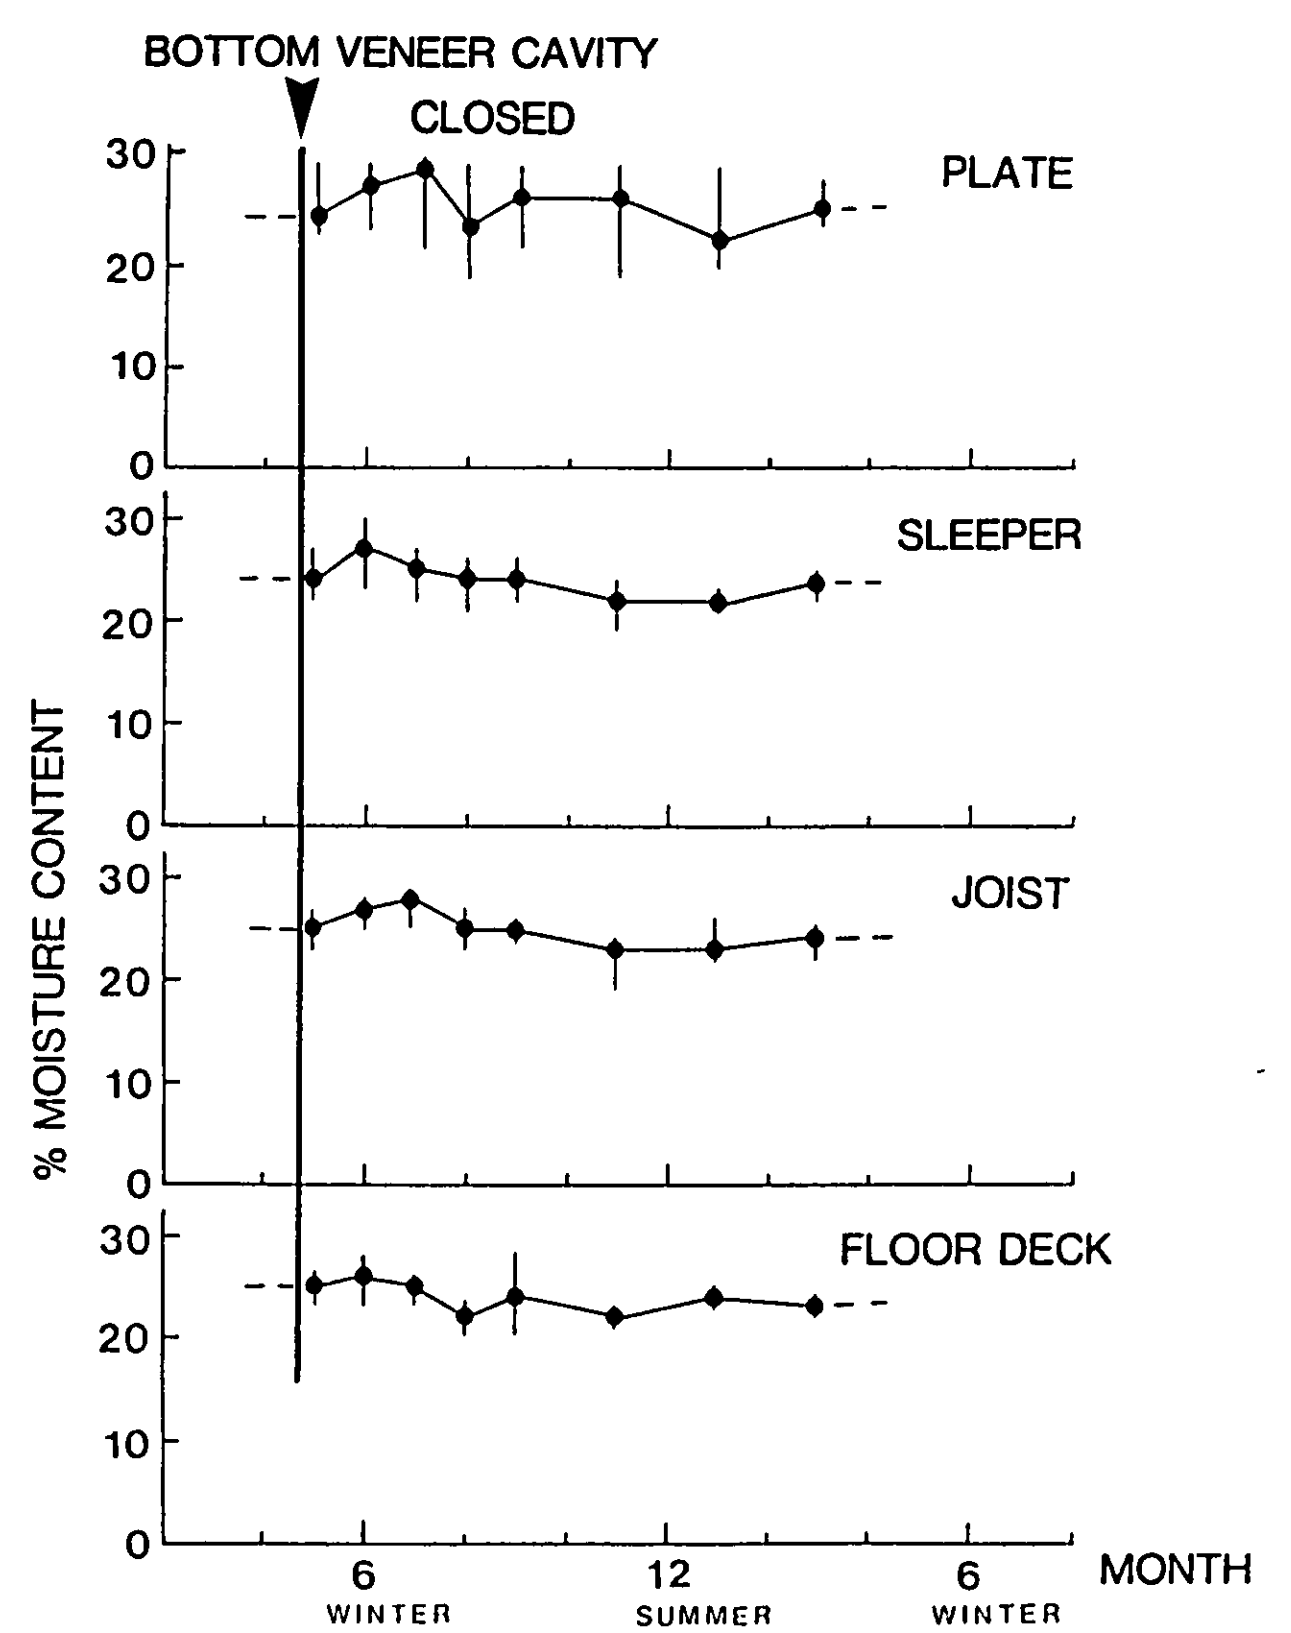
Fig 8 (c) : Individual m.c. observations in 10 houses.

The responses differed quite markedly, with the roof space of house 5 remaining at relatively high moisture contents throughout the winter, and that of house 6 drying out as rapidly and as positively as in houses 1-4. Both roof spaces were dry during the summer.

Both floor spaces remained at high moisture content through the entire programme, summer as well as winter. Moisture content

scarcely dropped below 20% at any time, and in a number of places remained over 25% for lengthy periods.

These two houses, one with gable and one with hipped roof, were both treated by closing the veneer cavity near floor level.

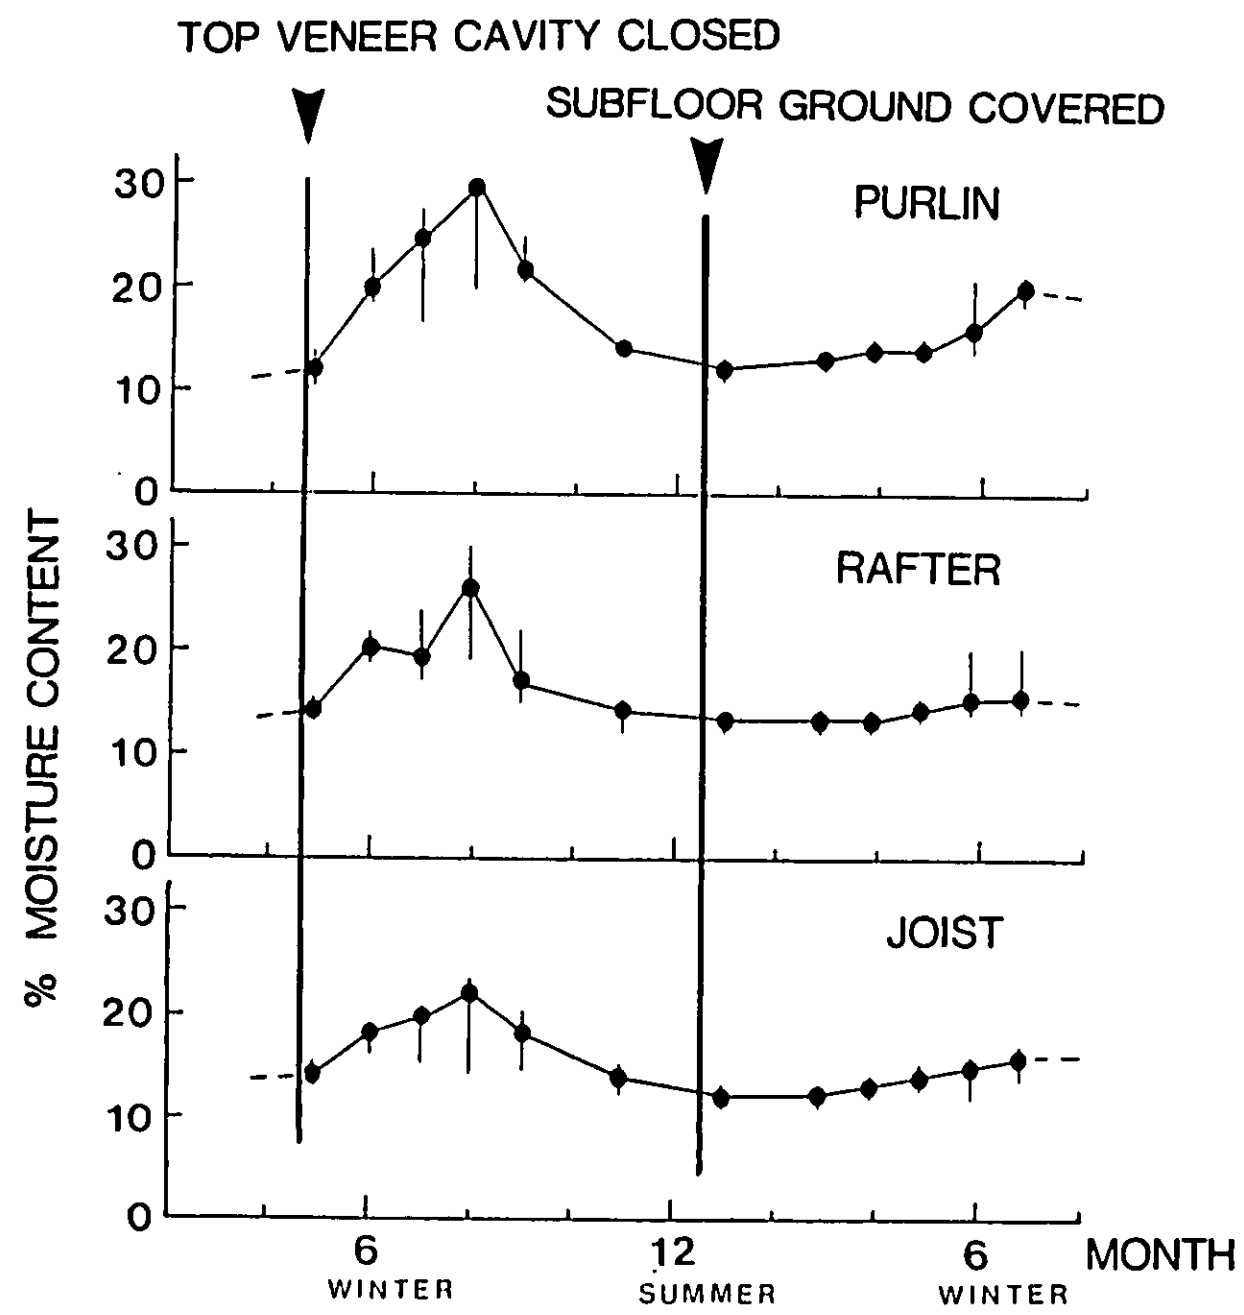
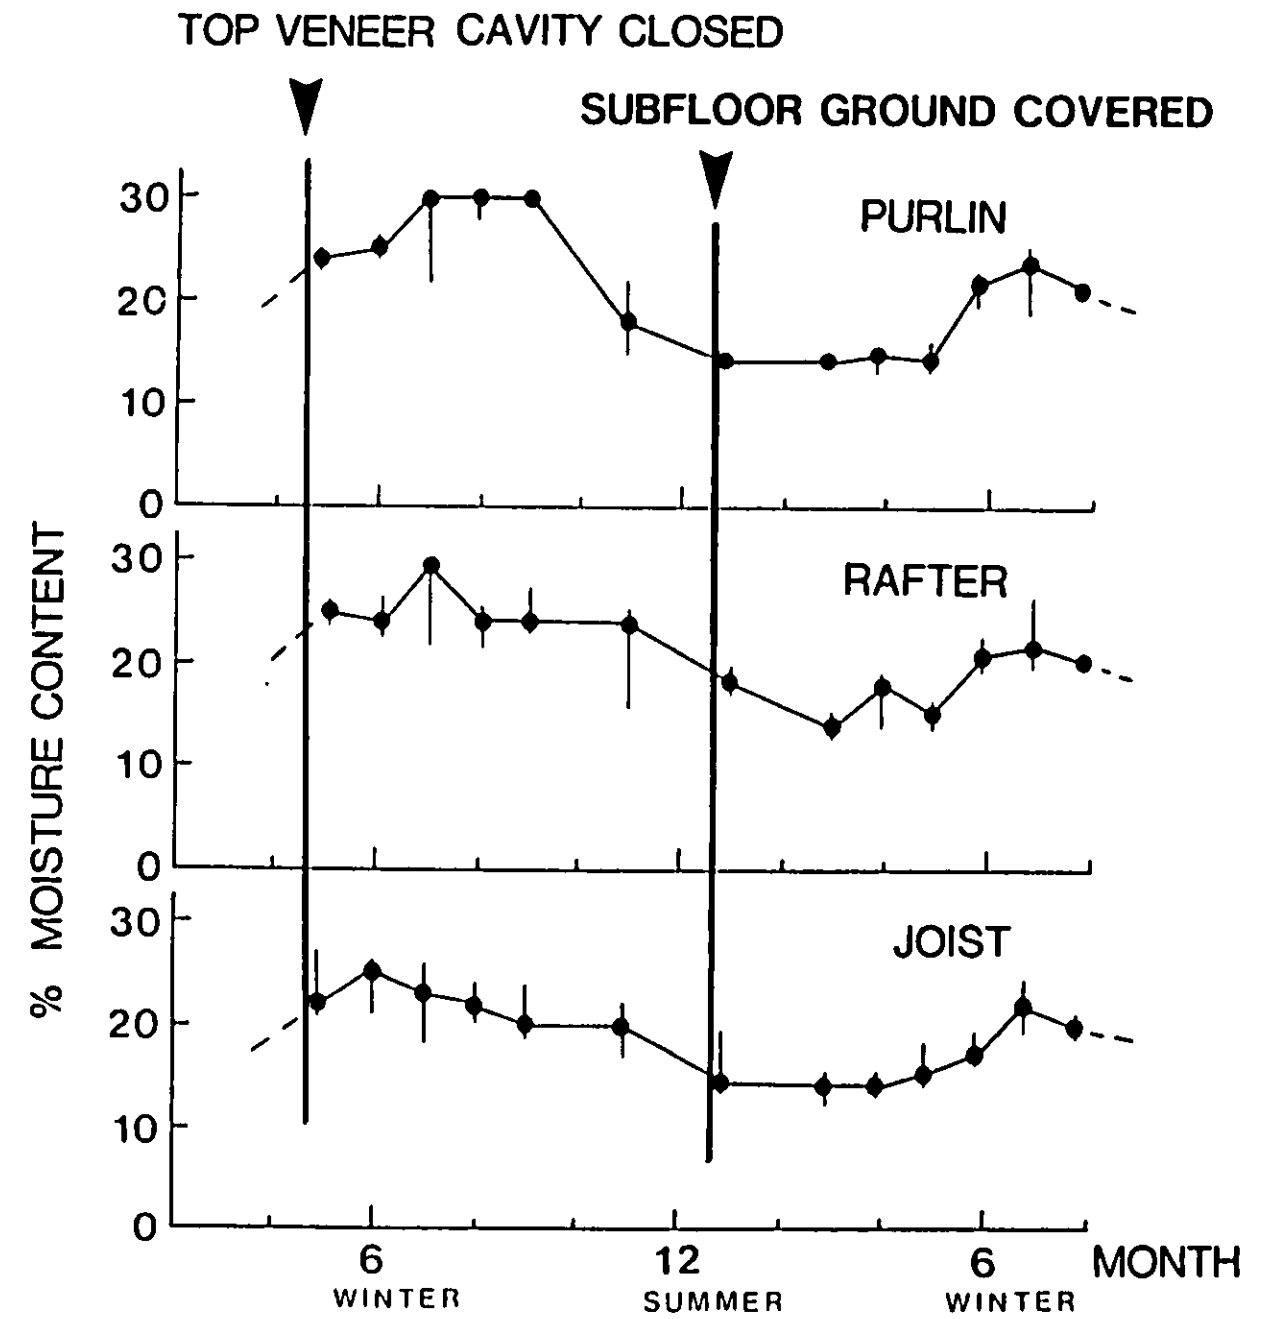
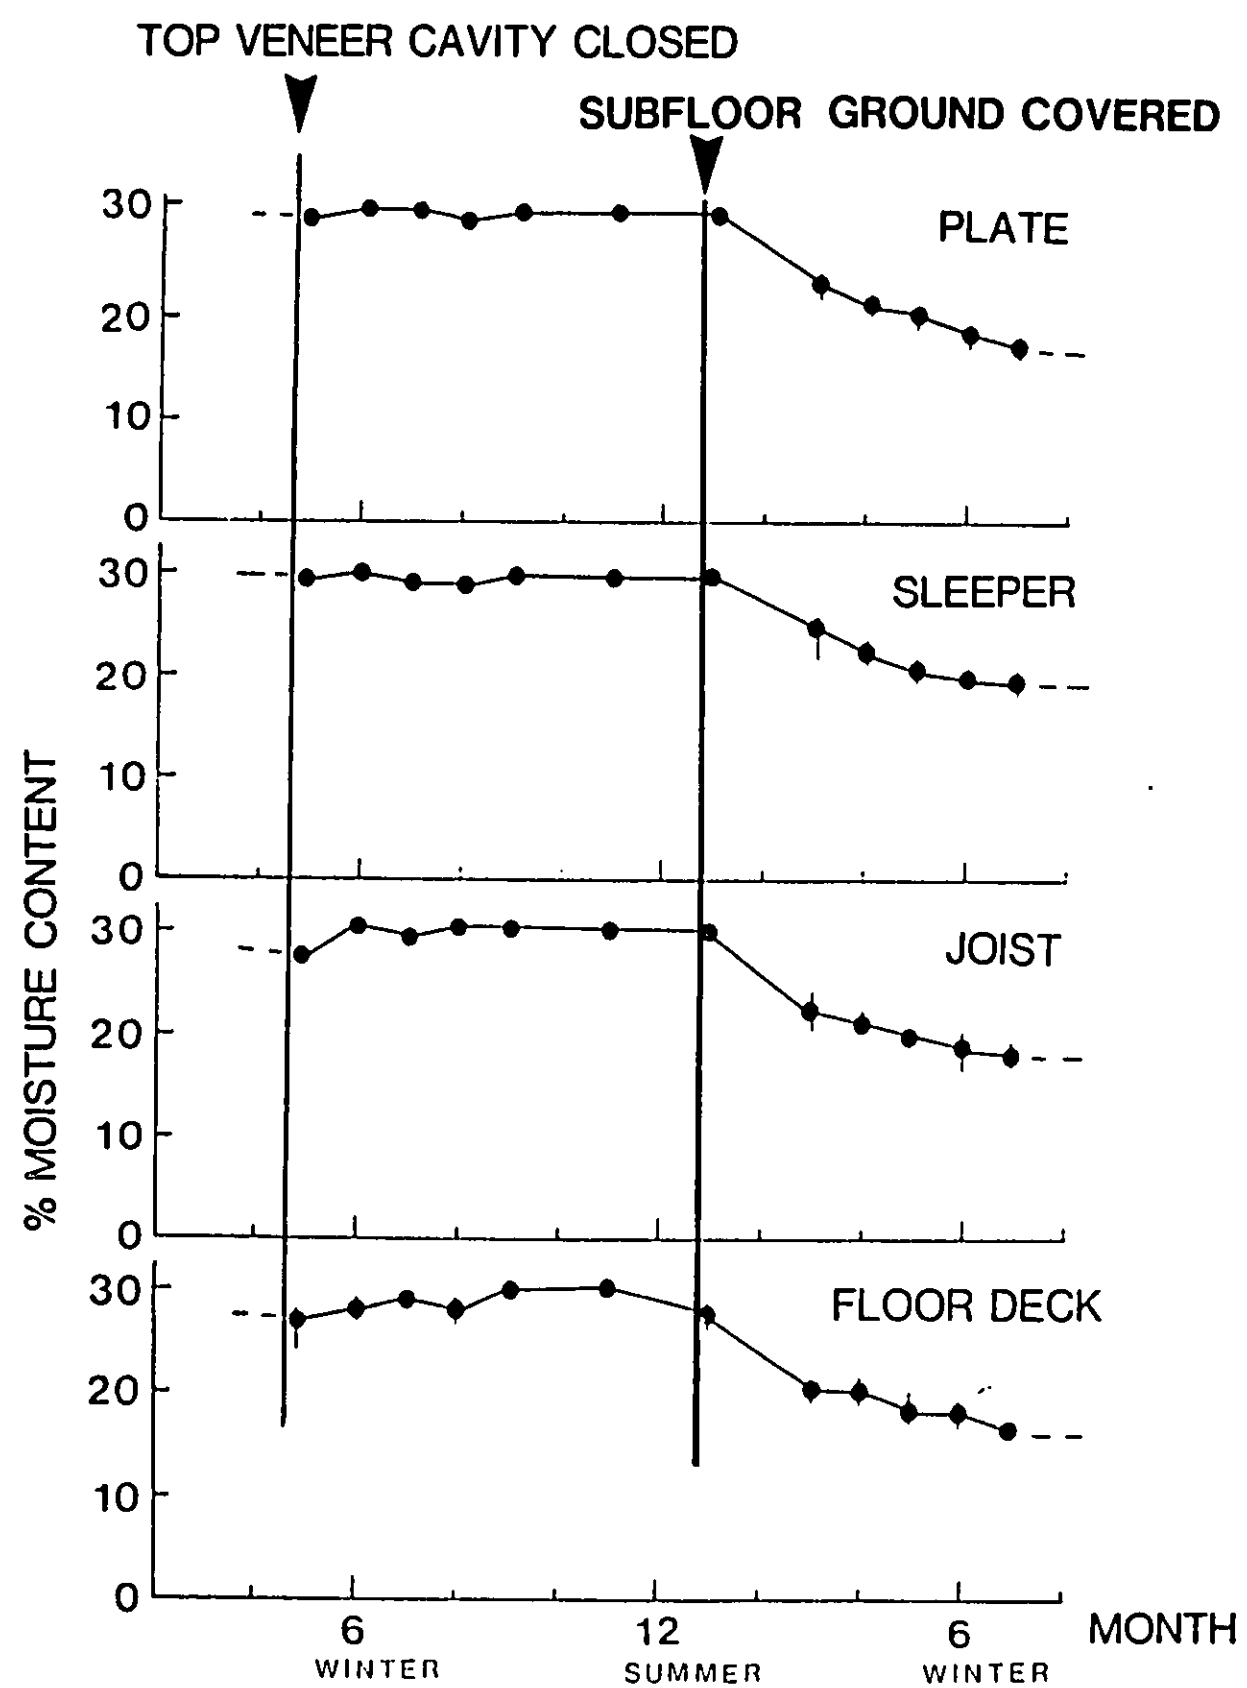
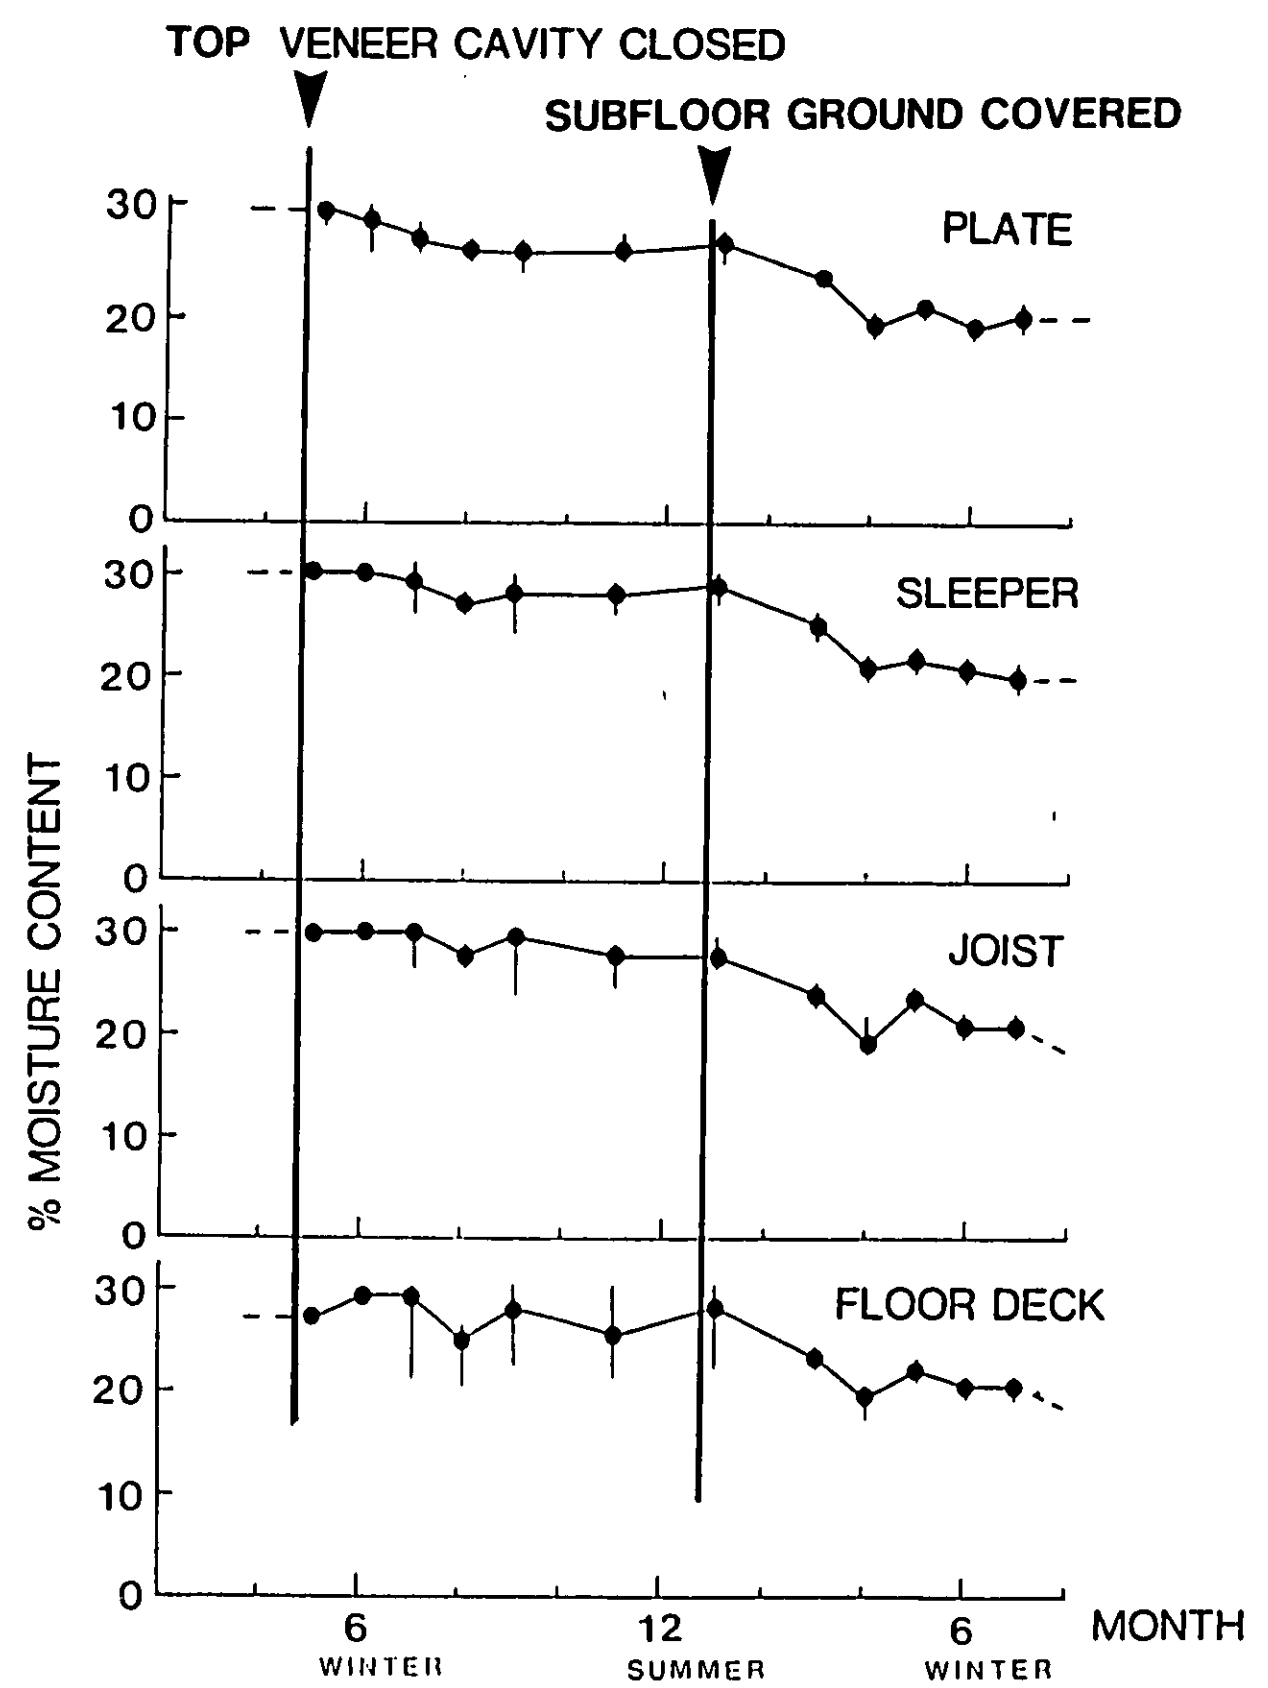
Fig 8 (d) : Individual m.c. observations in 10 houses.

These two houses were treated by blocking the veneer cavity at eaves level, and neither appeared to gain any value from the treatment. Moisture behaviour through the winter was typical of the many untreated houses in the district.

In both houses, roof space moisture contents rose to very high levels in winter and remained at those levels for most of the winter. The wettest timbers were those closest to the roof: purlins, rafters, joists - in that order. There were common sightings of extensive visibly wet areas within the roof, with the inspector estimating that 50% of all purlin surfaces and 20% of rafter surfaces were wet or dripping. Roof underlay over most of the roof was reported visibly wet or dripping on several successive monthly visits. Both roof-spaces dried out to the same state as the other eight during summer.

In both subfloor spaces the timber remained at very high moisture content, at or close to 30% at all locations, summer and winter.

There was a prompt and permanent change in behaviour when the ground under these two houses was covered, during the summer. All subfloor timber m.c. began immediately to fall, by some 2% - 3% per month, to at least 10% below their previous level, where they remained. During the following winter, the roof space moisture content rose, but substantially less than in the previous winter. Visibly wet patches were seen once, in one house, and then only briefly. Otherwise, timber, ceiling insulation, and roof underlay were all reported as "warm and dry to touch", through the winter.
