STUDY REPORT

NO. 62 (1995)

NEW ZEALAND HOUSE CONDITION SURVEY 1994

I.C. Page
W.R. Sharman
A.F. Bennett

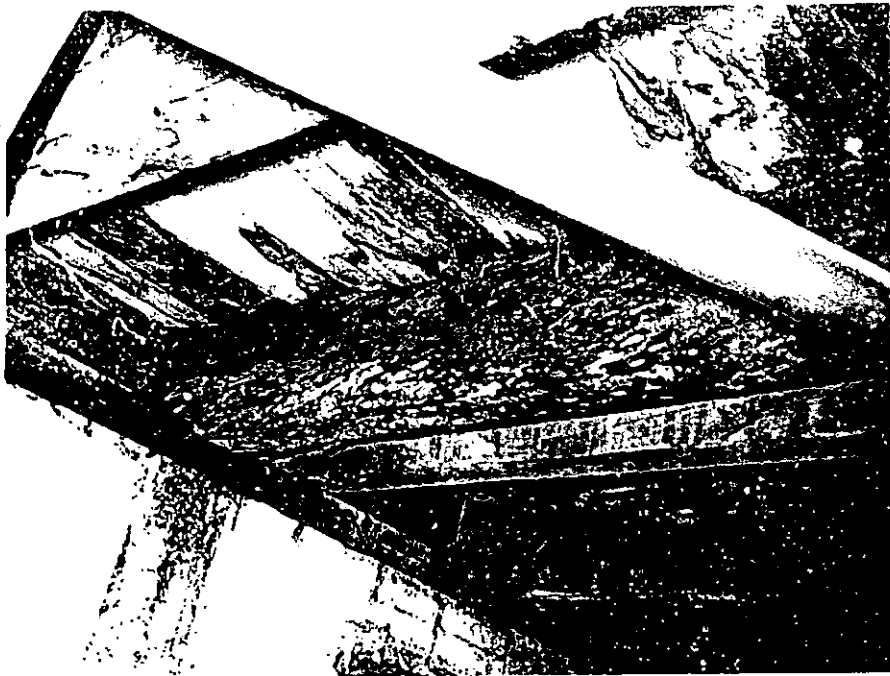
Mould growth on
floor joist due to
leaks from the
bathroom above.

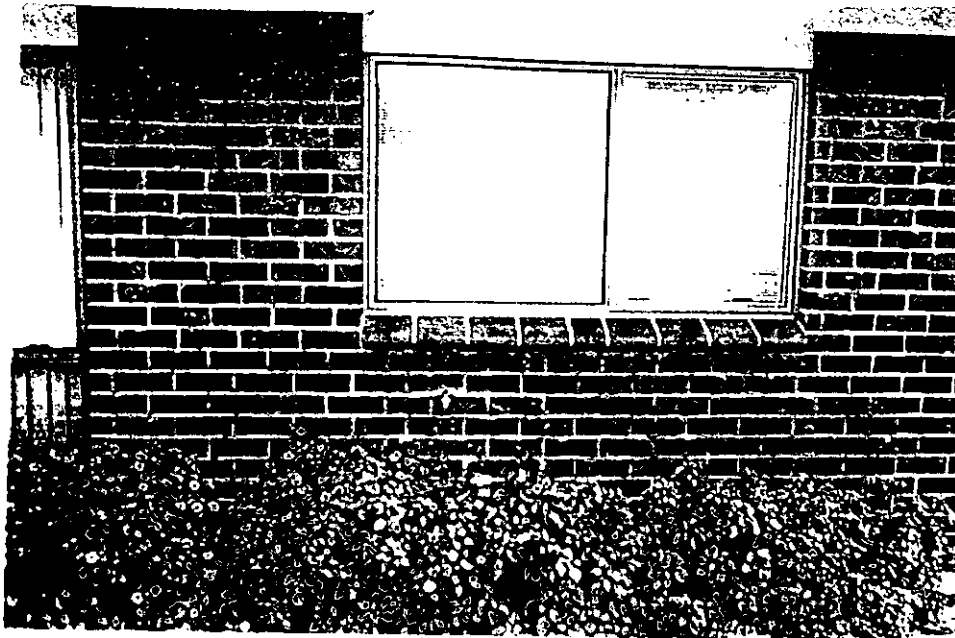
Severely inadequate or blocked vents. Includes insufficient vents in the original construction (C:E2), vents not spaced at the required centres (C:E2), vents blocked by subsequent additions such as paths, patios and new rooms (C:E2, P), vents blocked by vegetation, soil, and firewood (M).

Vegetation
blocking sub -
floor vents.

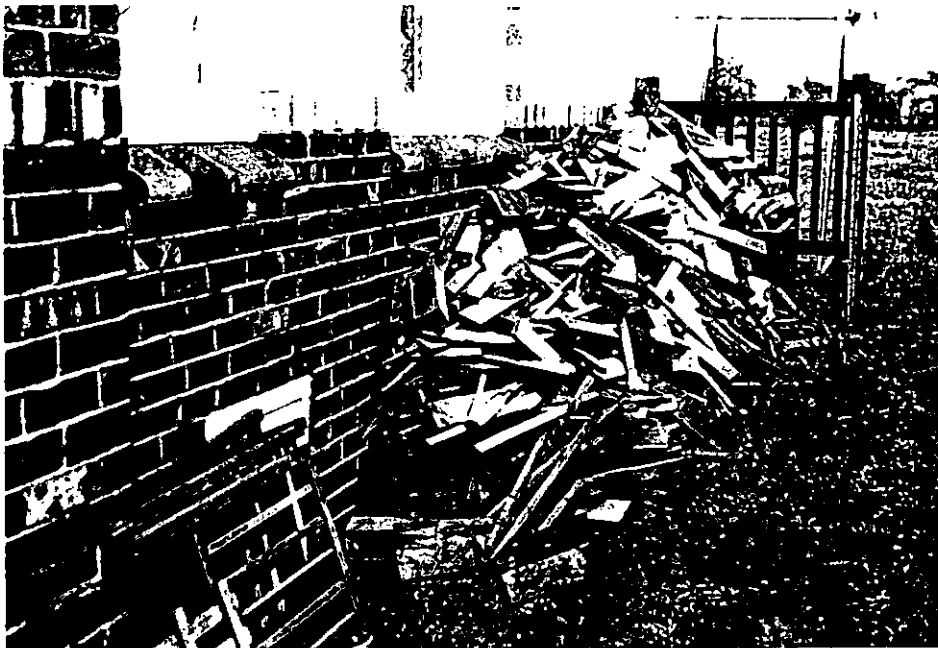
Firewood
blocking sub-
floor vents.

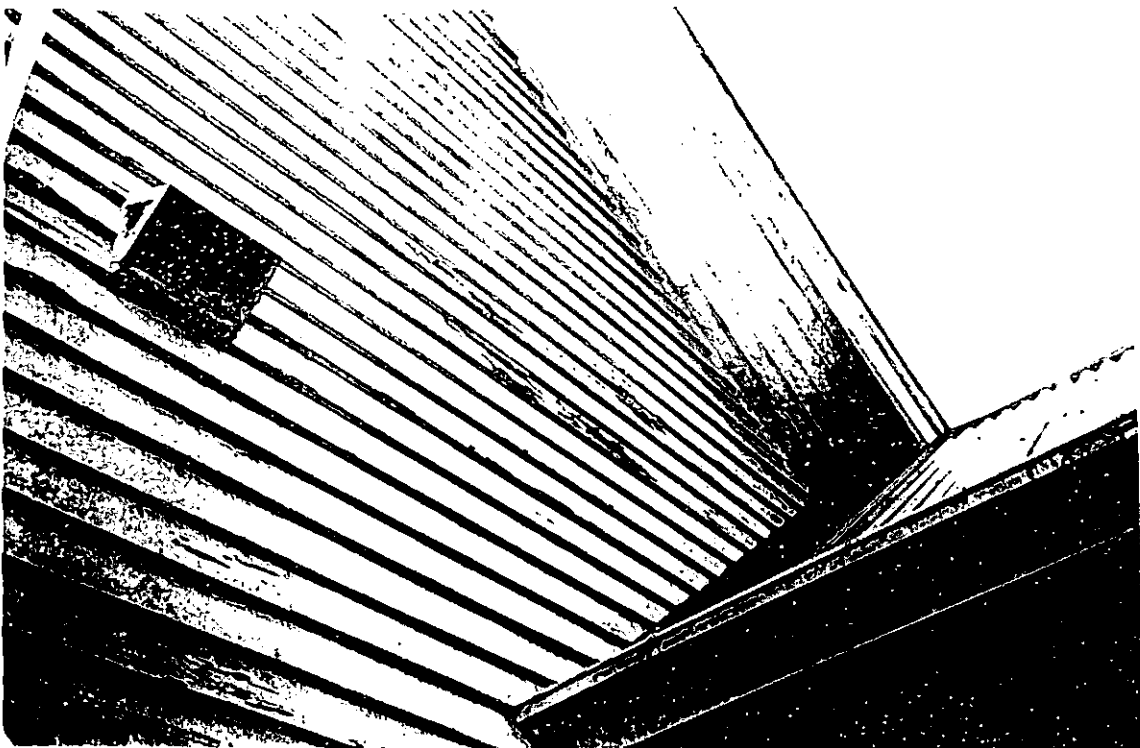
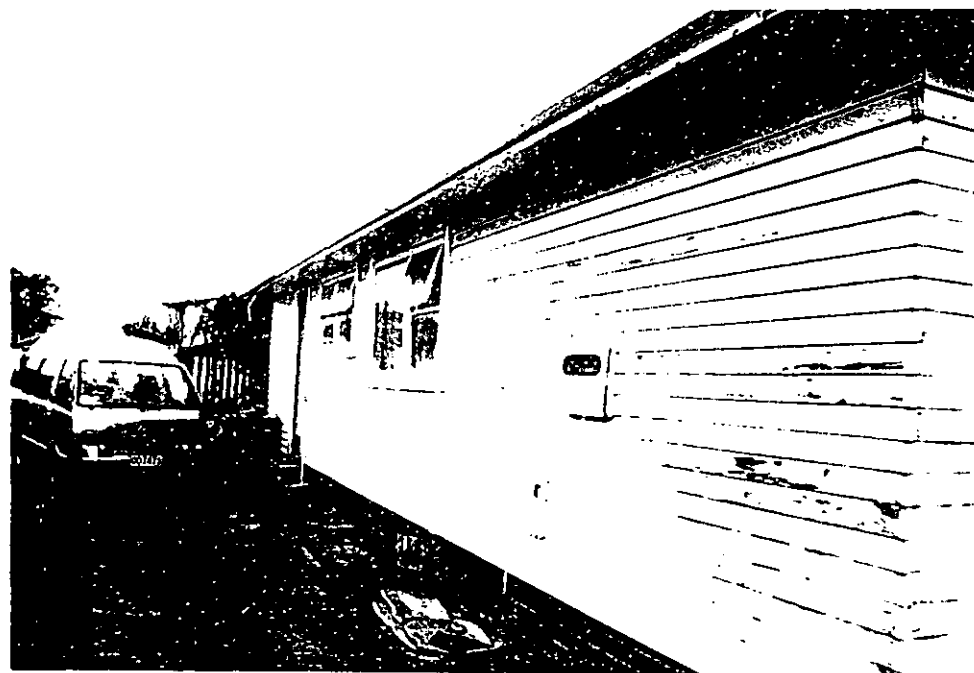
TOP &
MIDDLE.
Paint deterioration
to bare timber.

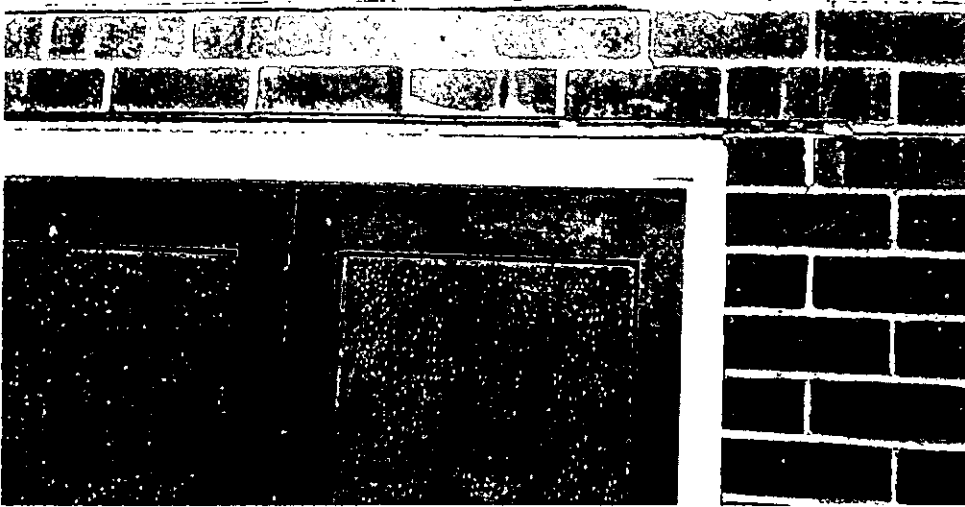
Brick lintel
cracks.

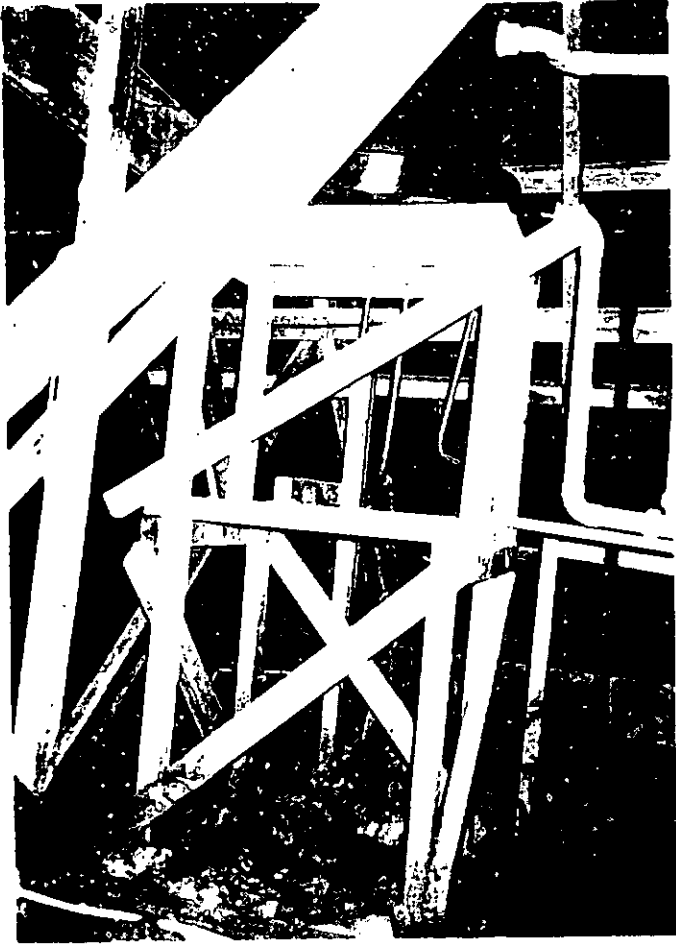
TOP LEFT.
Unsafe support to
the header tank.

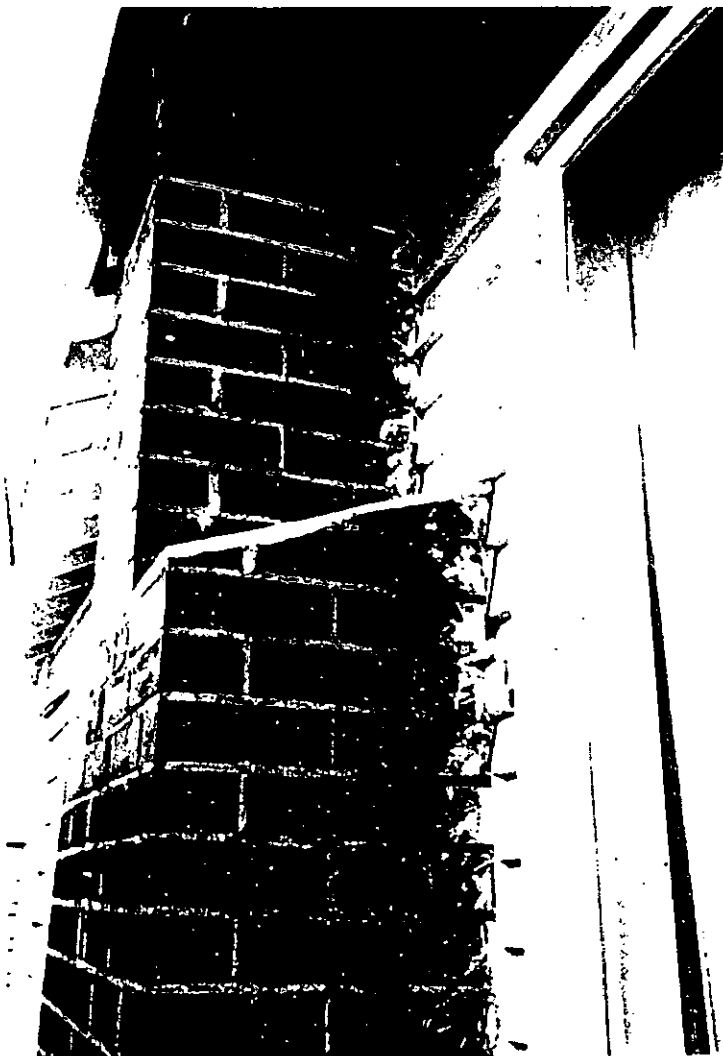
LEFT
Cracks in brick
chimney.

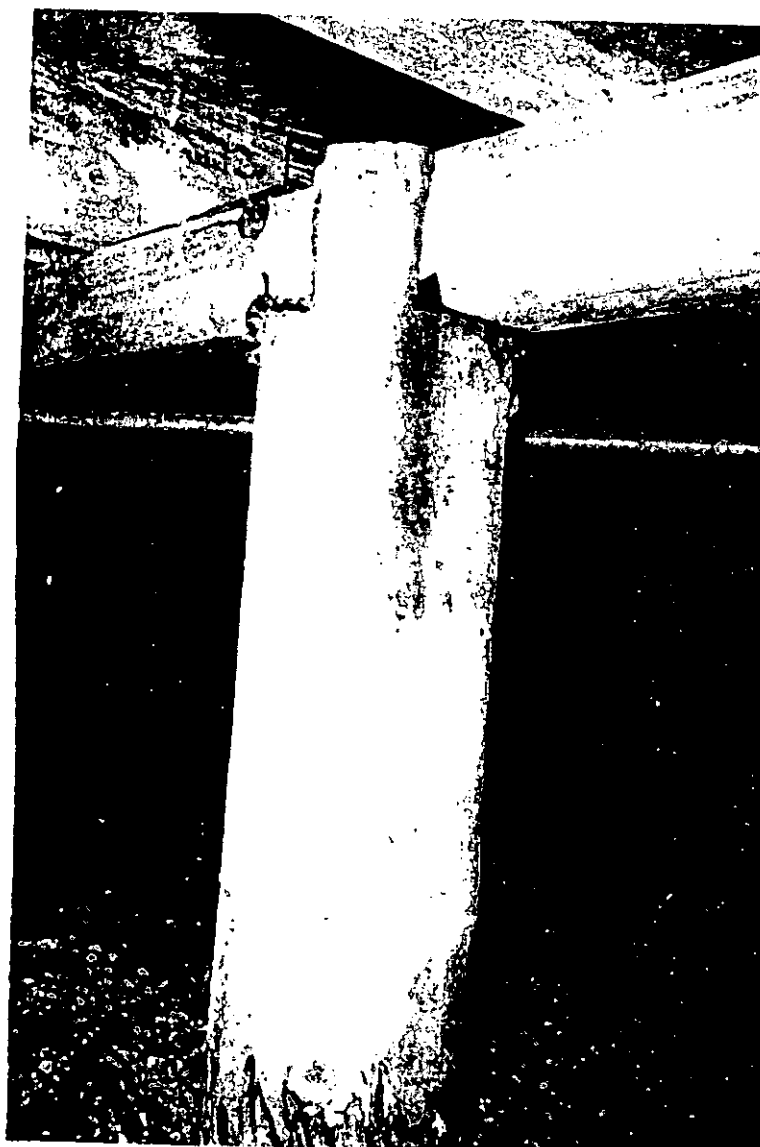
Insufficient pile
material at bolt
fixing to the
bearer.
