STUDY REPORT

No. 84 (1999)

The Effect of Coatings on Wood Composite Siding Performance

Adrian F. Bennett

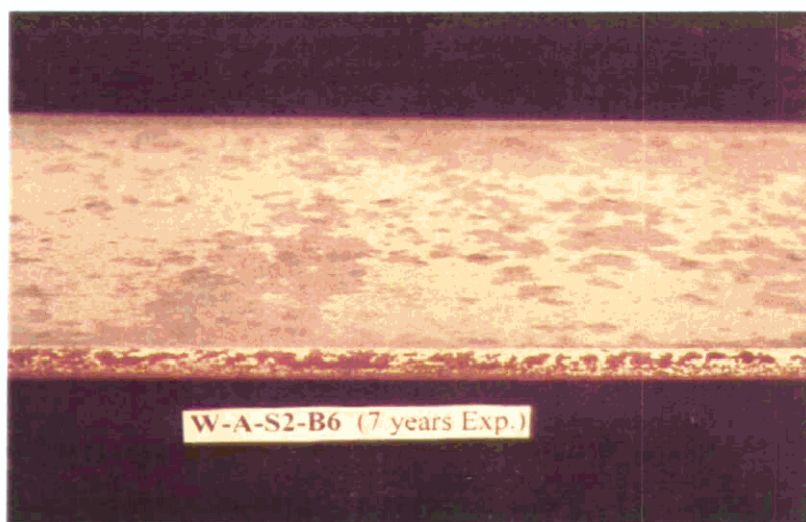
Photograph 1. HB1 Coating System A

The hardboard panels were generally in reasonable condition after the seven years exposure, with no major board deterioration visible. Some paint loss occurred, with the primed-only panels losing approximately 50% of the primer from the exposed surfaces. The loss of primer had had little visible effect on the condition of HB1 (Photograph 1) but HB2 had developed cracking and softening of the lower edge (Photograph 2).

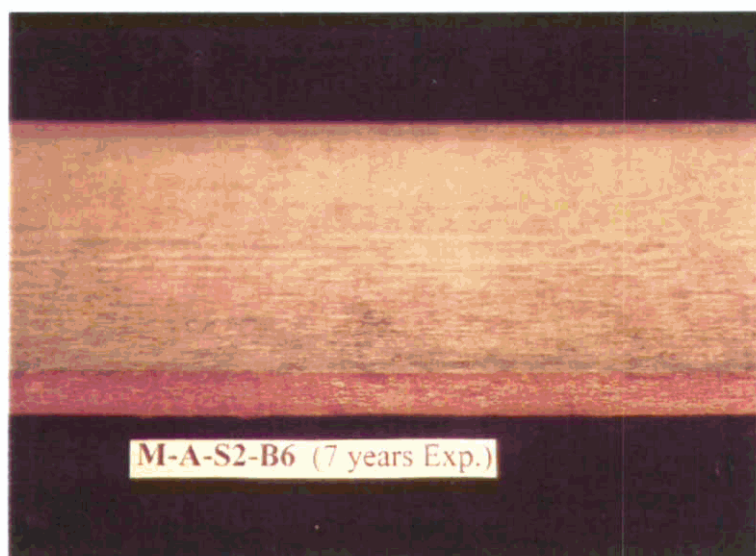
Photograph 2. HB2 Coating System A

The edges of the panels were removed during the preparation of MOR, MOE and IB test specimens, so the effects of minor swelling have not had a significant impact on the results. The exception was HB2 coated with only the factory primer. The degree of edge swelling on this panel was approaching 50% and softening was detectable. Significant decreases in IB (78%), MOR (52%) and MOE (33%) were recorded on this panel. HB2 coated with system F also exhibited edge cracking and recorded decreases in MOR, MOE and IB.

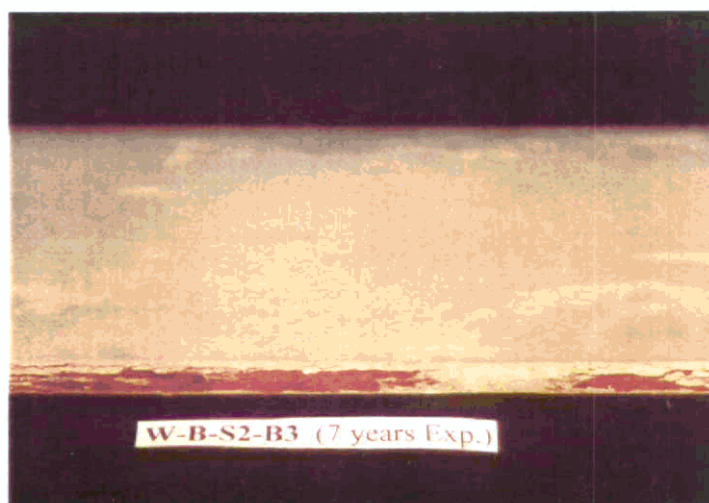
Photograph 3. HB1 Coating System B

Systems B and C (conventional acrylics) were in good overall condition, with minor chalking and some areas of cracking and blistering starting to become evident on the edges of the raised texture on the surface of HB2. HB1 B had developed edge cracking along approximately 30% of the bottom edge (Photograph 3).

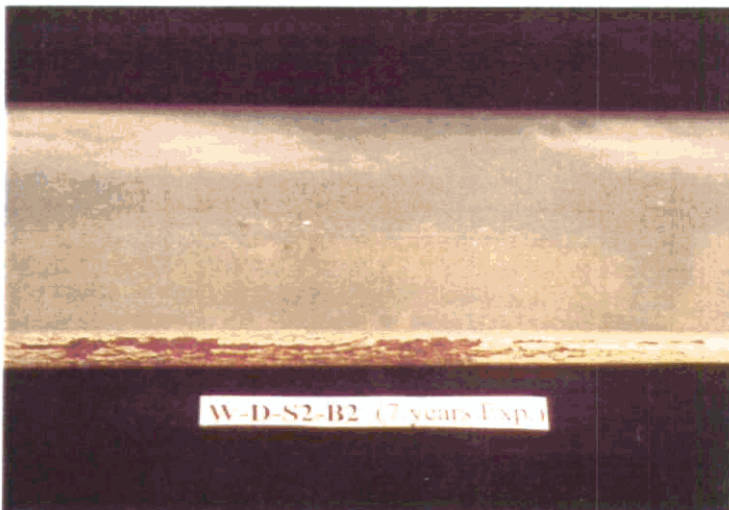
Photograph 4. HB1 Coating System D

The alkyd system D showed more deterioration than E with HB1 D showing edge cracking and loss of paint over 50% of its length (Photograph 4). HB2 D had only minor edge cracking visible but approximately 20% of the front surface had flaking topcoat (Photograph 5). HB1 E had only minor edge cracking visible (Photograph 6) and HB2 E had only minor localised edge swelling.

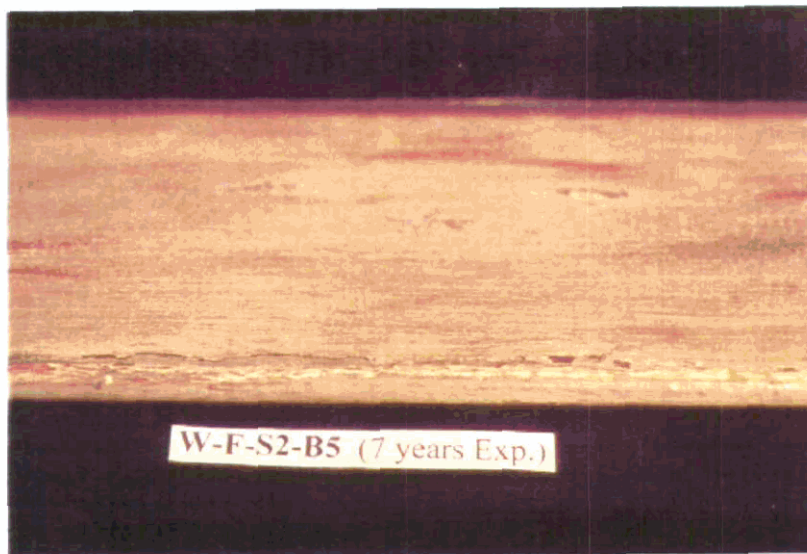
Photograph 7. HB1 Coating System F

Coating system F was an experimental three-coat high-build acrylic which did not weather as well as was expected. The top coat developed crazing within the first year of exposure and areas where the paint had flaked were visible after seven years (Photograph 7).
