# STUDY REPORT

No. 91 (2000)

**NEW ZEALAND HOUSE**

**CONDITION SURVEY**

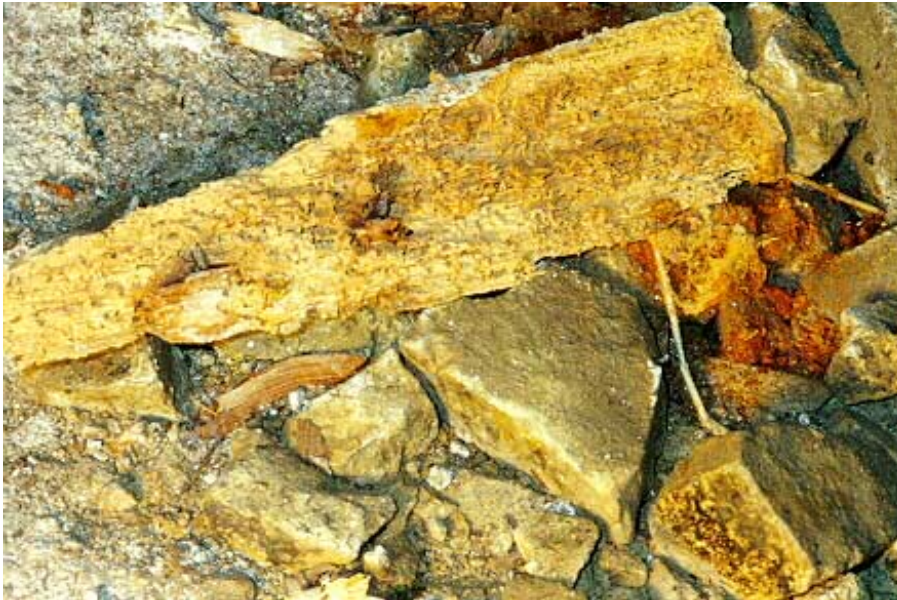
1 Above: Borer infestation in rubbish left in subfloor space. Also, high moisture levels in subfloor timbers from water seepage under house, and borer in floor joists.

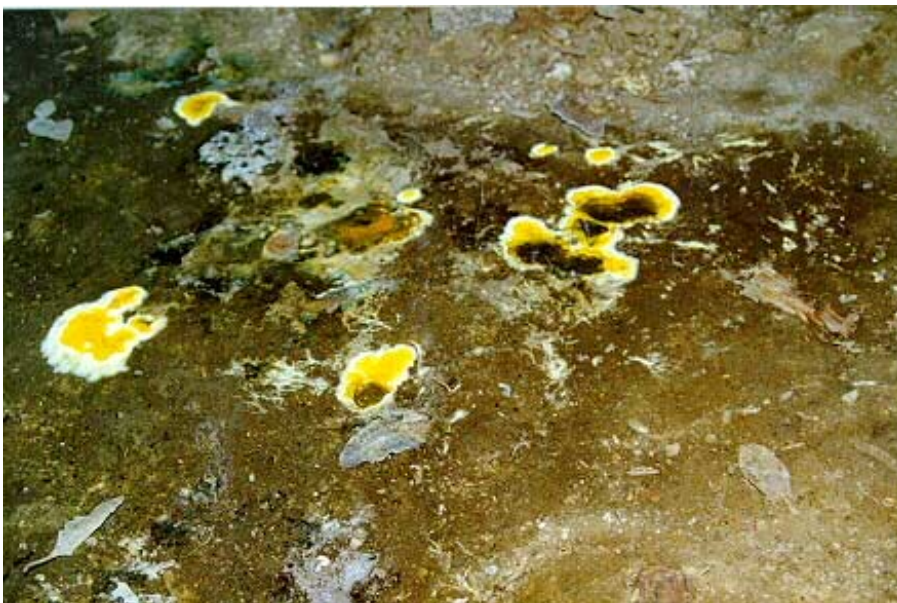
2 Above: 1960's house which felt damp inside. Fungal growth on soil under house indicating high moisture levels. House also had sub-standard subfloor ventilation, with some vents blocked off as shown in photograph 13.

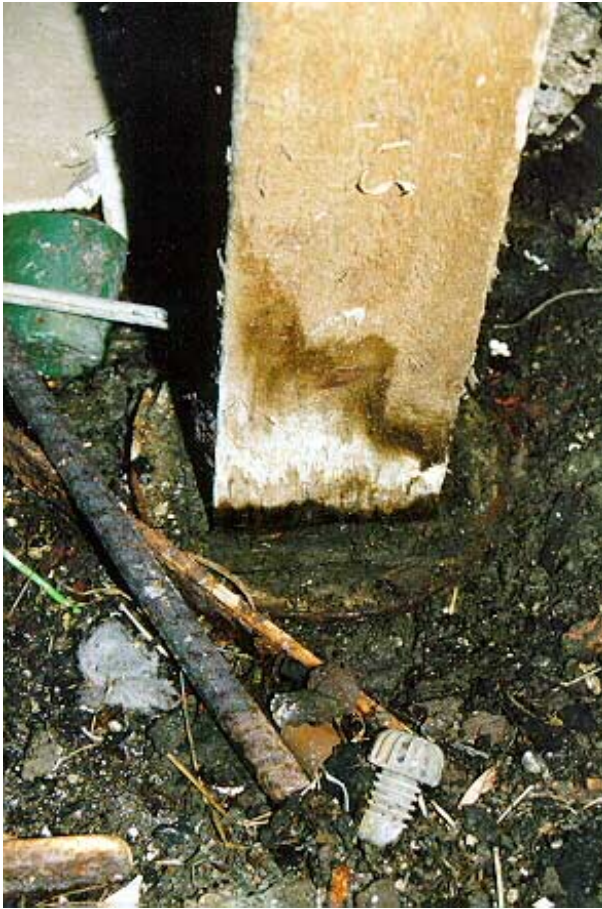
3 Left: Timber pile showing water stains. Concrete pile is level with surrounding soil.

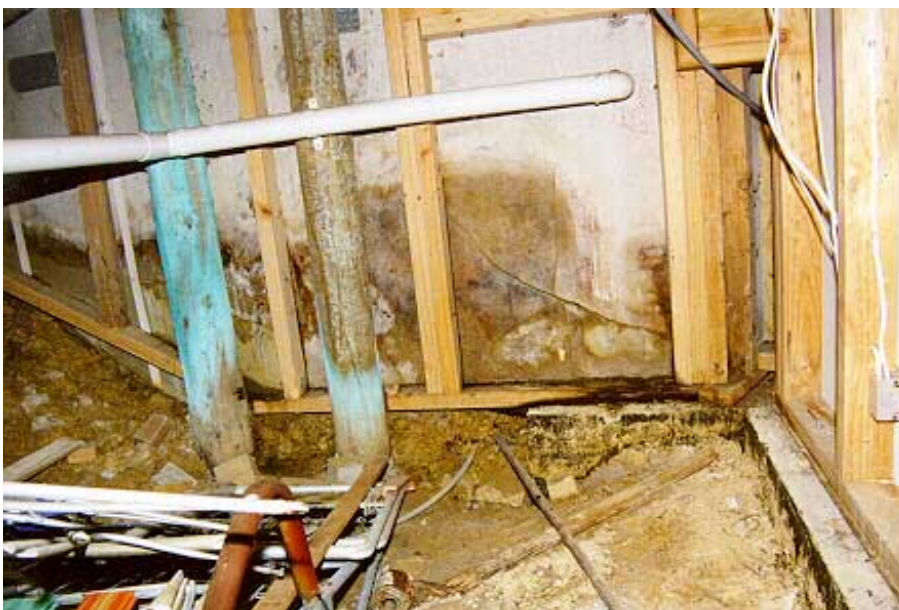
4 Below: Decay in bottom wall plate and moisture damage to back of basements linings. Large 1980's Auckland house. No subfloor ventilation and high moisture levels.

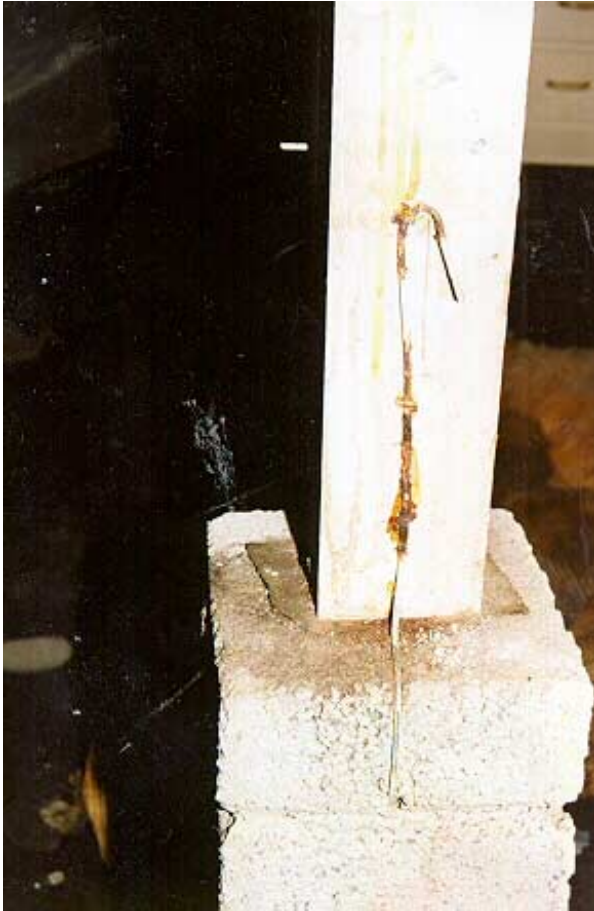
5 *Left: Corrosion of wire foundation ties in damp subfloor conditions. 1960's house with native timber framing. (high moisture levels, but not yet attacked by borer).*

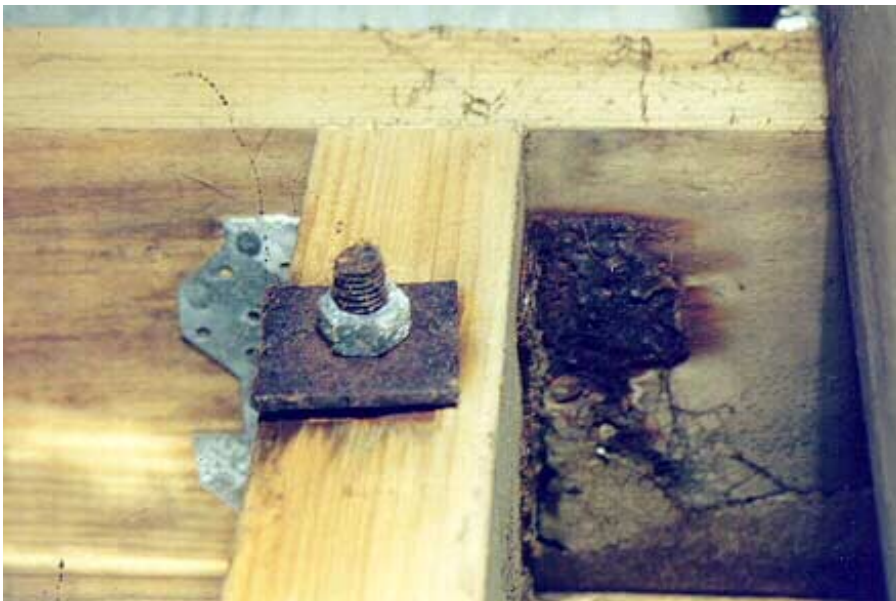
6 *Below: Severe corrosion in galvanised steel nail plates and bolts. 1980's house with sufficient subfloor ventilation but in severe marine environment.*

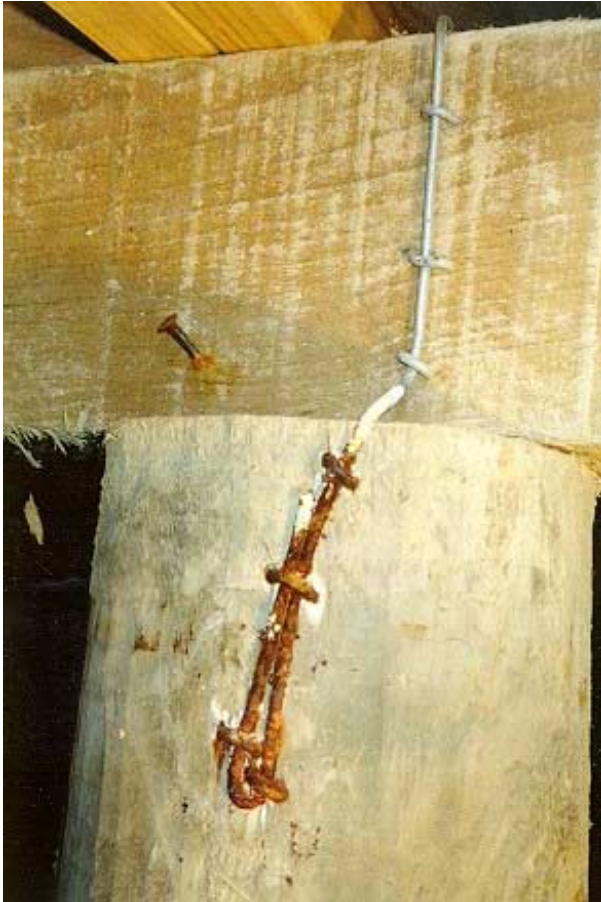
7 Left: Treated timber piles less than 10 years old, but galvanised wire and staples already corroding from damp subfloor conditions.

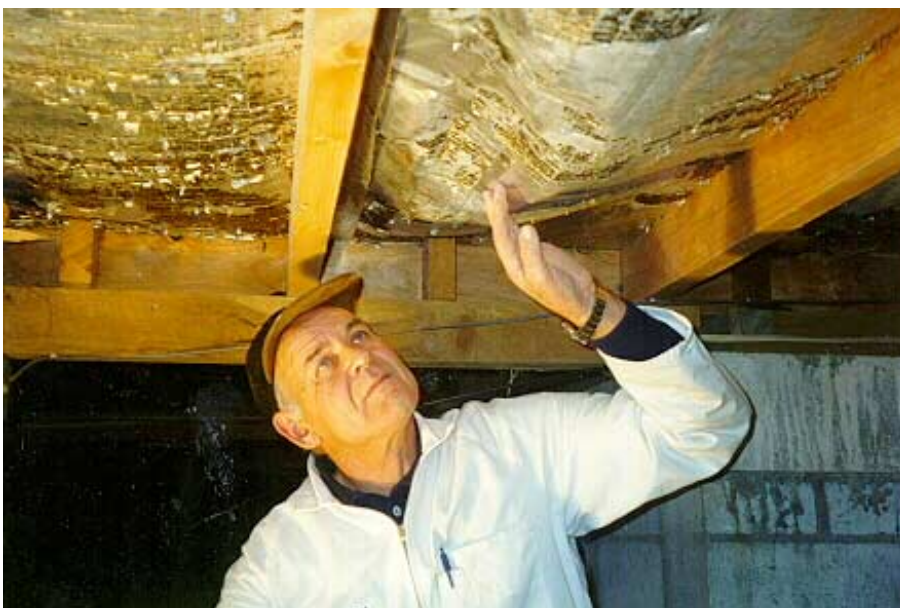
8 Below: Underfloor foil insulation degrading. 1980's house exposed to severe marine environment.

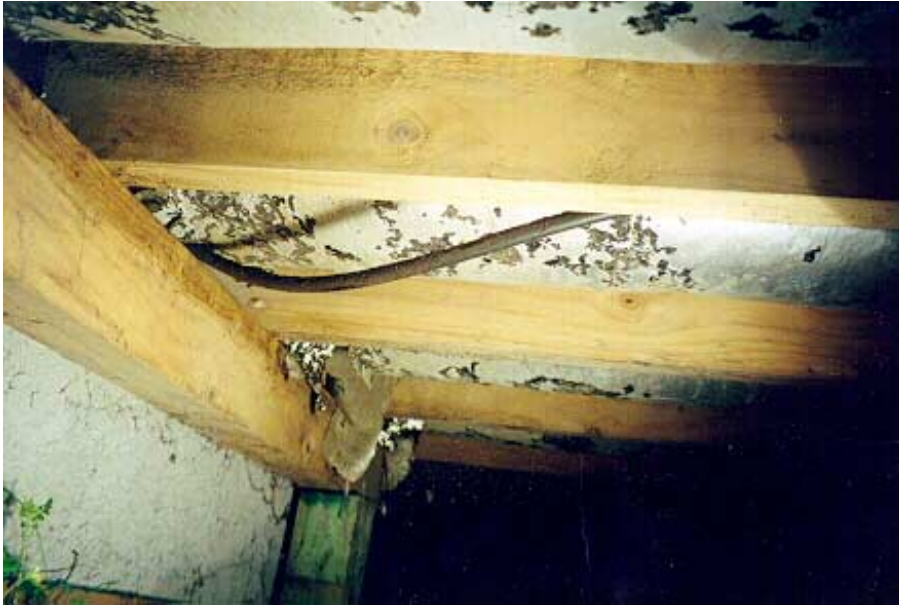
9 Above: Same house as shown in photograph 6. Breakdown of foil backing to particleboard flooring in house in severe marine environment (with sufficient subfloor ventilation).

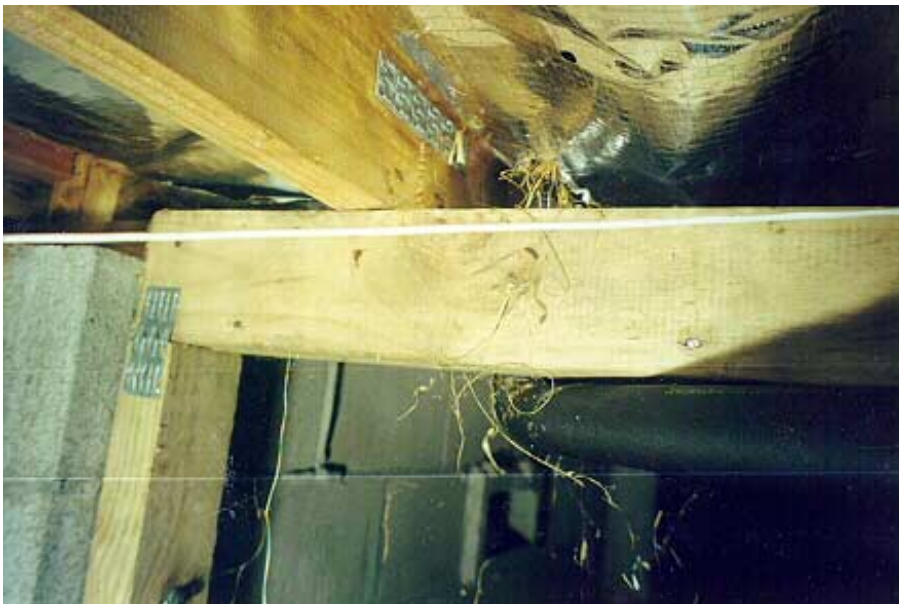
10 Above: Rats' nesting in drooped foil insulation (beneath hot water cylinder).

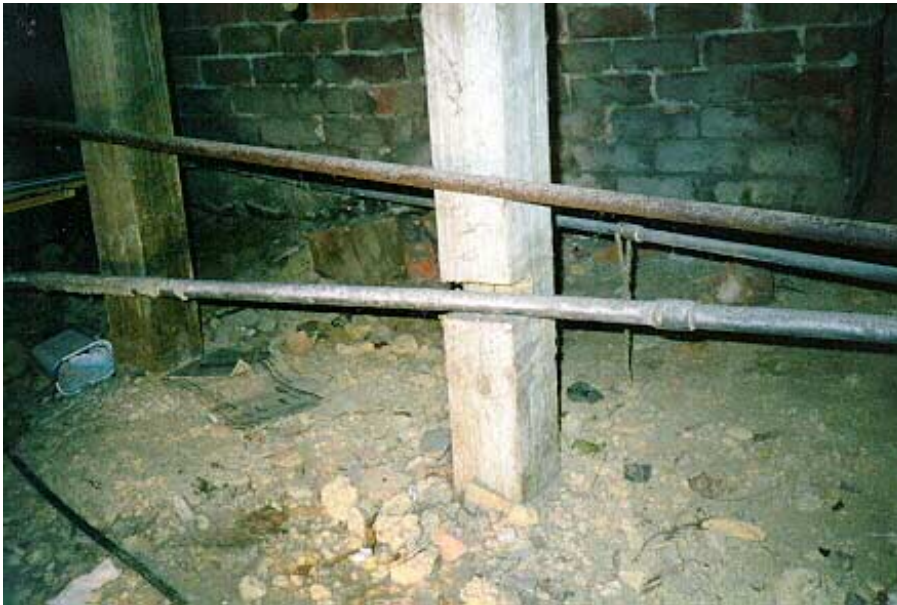
*11 Above: Old timber jack stud rebated for water pipe.*

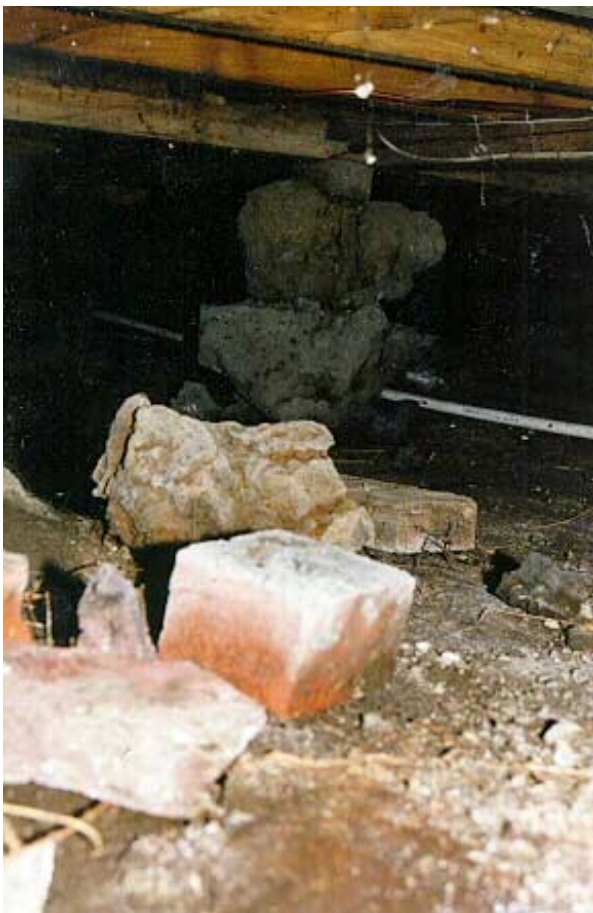
*12 Left: Seventy year old Auckland house with stacked rocks as supports to floor joists (along with a variety of other types).*

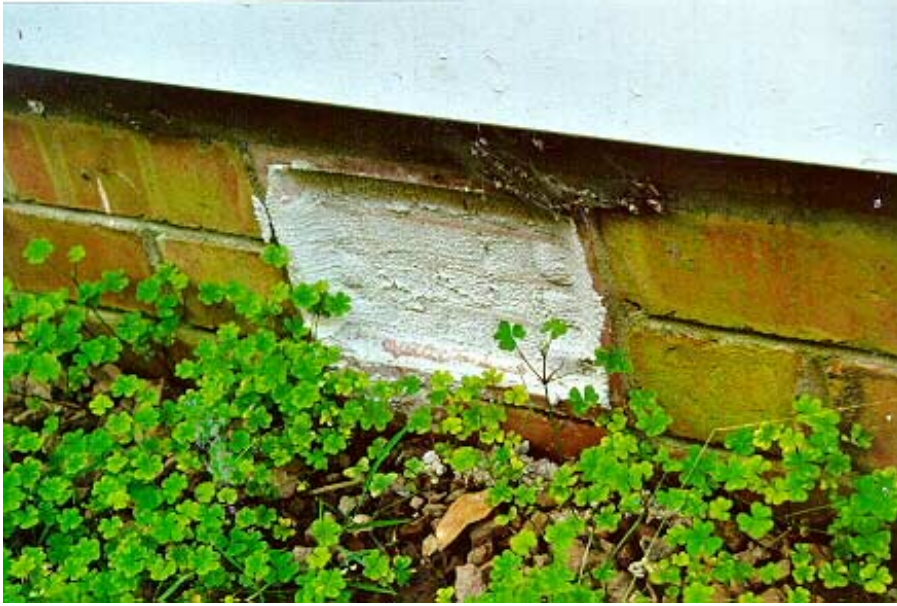
*13 Above: Same house as shown in photograph 2. Subfloor vents purposely blocked off, resulting in high moisture levels and rising damp inside the house.*

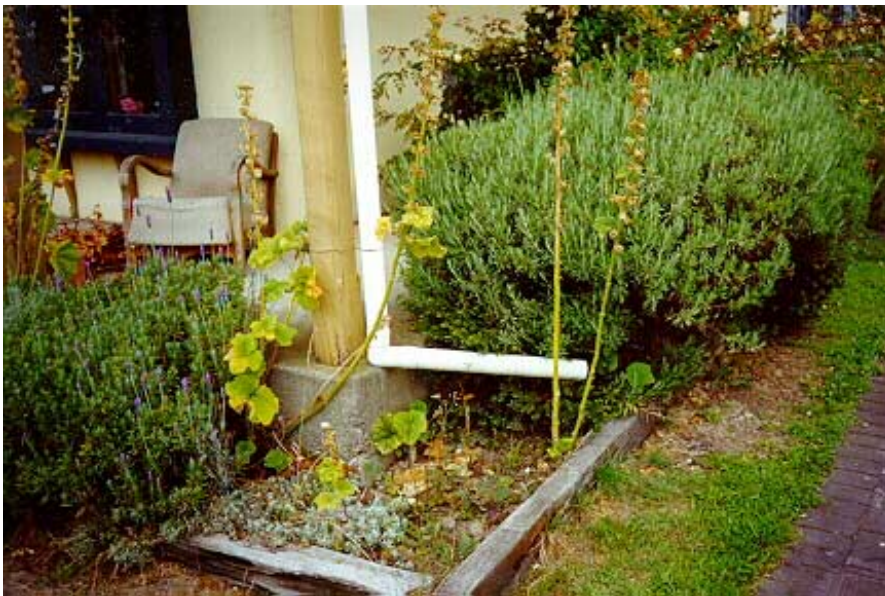
*14 Above: 1910's Christchurch house with inadequate cast iron foundation vents. Subfloor ventilation that is already deficient is aggravated by vents blocked with garden soil, grass clippings and vegetation.*

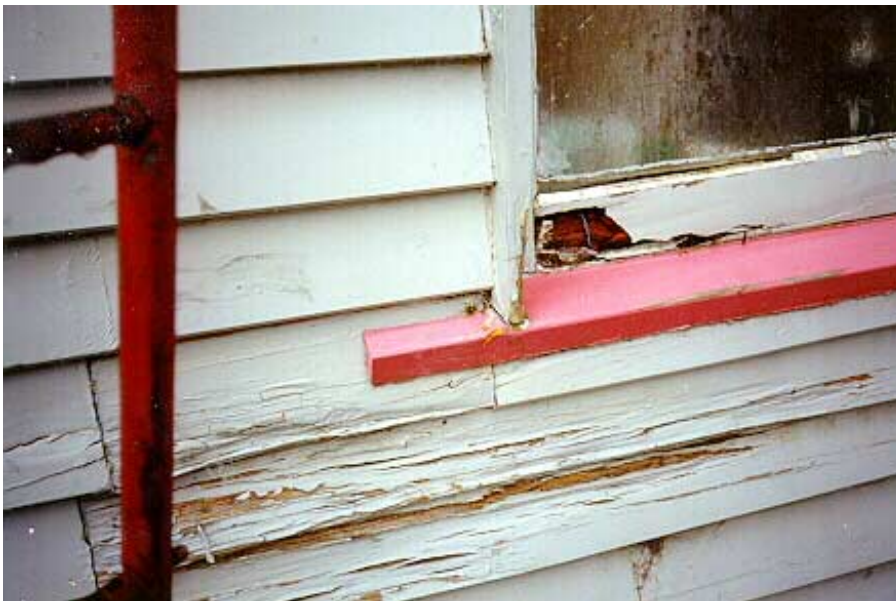
*16 Below: Severe decay in weatherboards and windows in 1900's Christchurch house.*

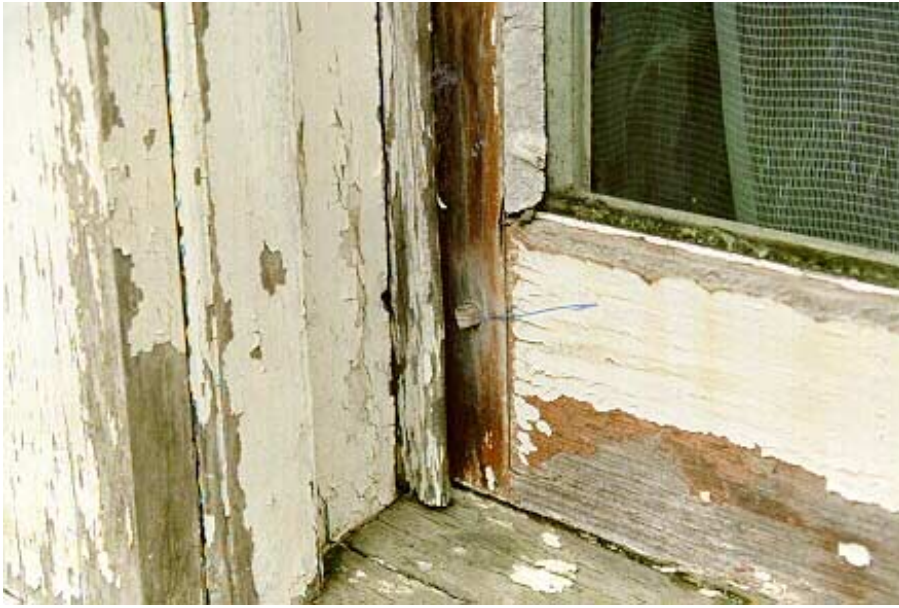
*17 Above: Severe deterioration of paintwork in 1900's Auckland house. Note popping of dowel at joint, missing putty and splitting of timber.*

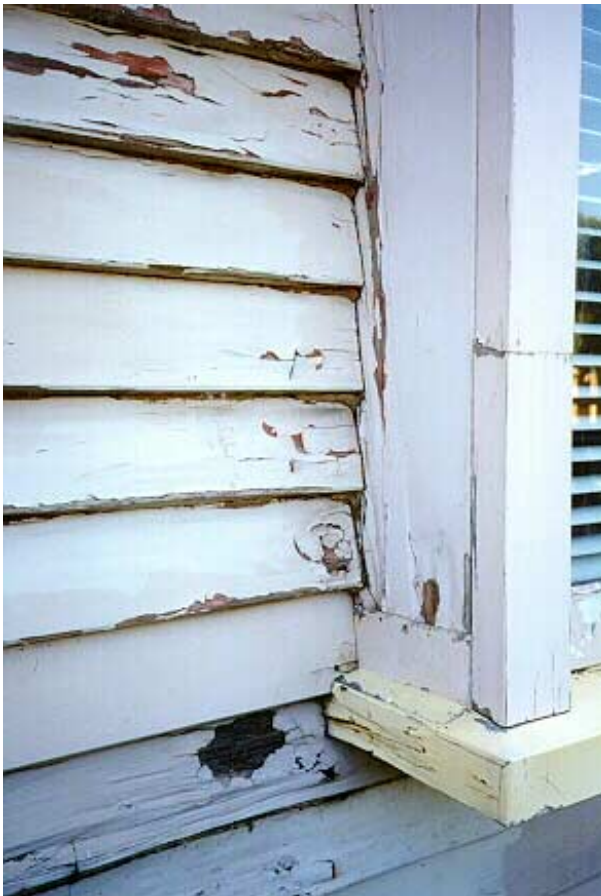
*18 Left: Severe decay in weatherboards and windows in 1920's Auckland house. (Refer photograph 47 for interior moisture damage to same house)*

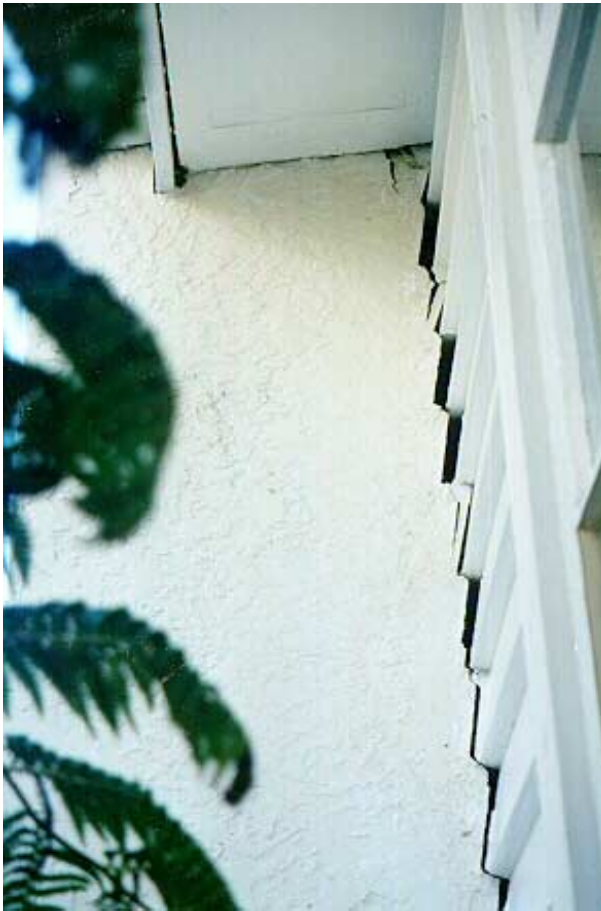
*19 Left: Crack showing movement of chimney away from timber wall.*

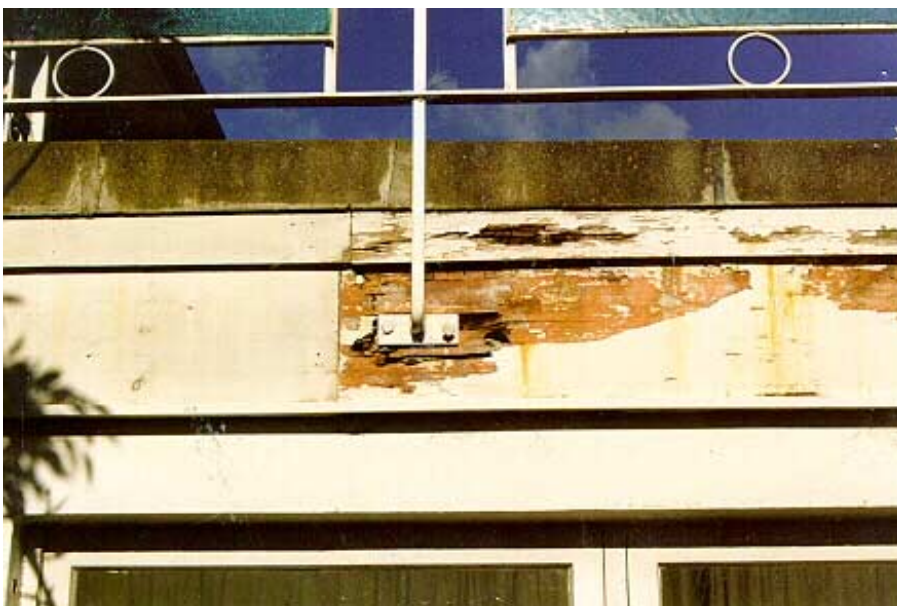
*20 Below: Severe decay endangering fixing of handrail support.*

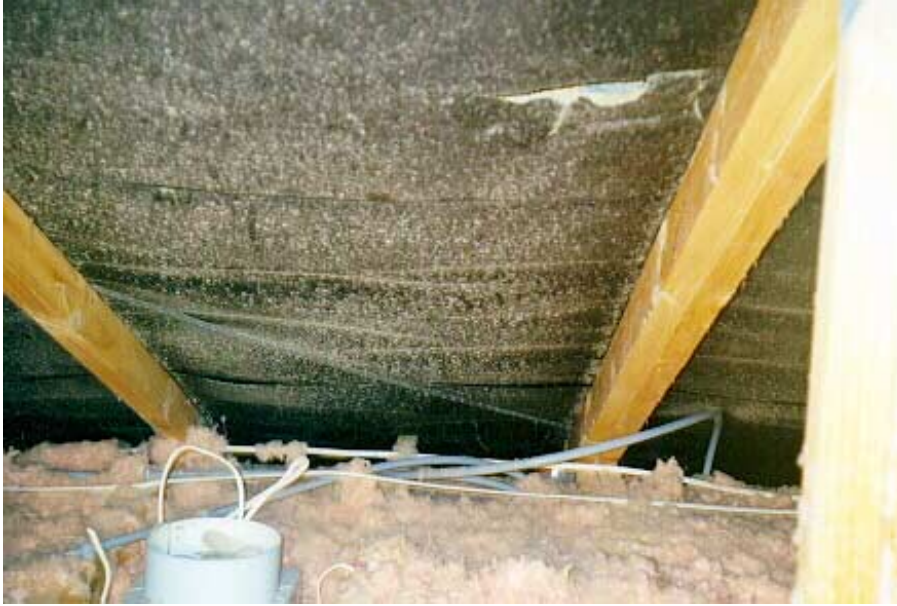
21 Above: Bathroom extractor fan discharging into roof space. Note damage to building paper above fan.

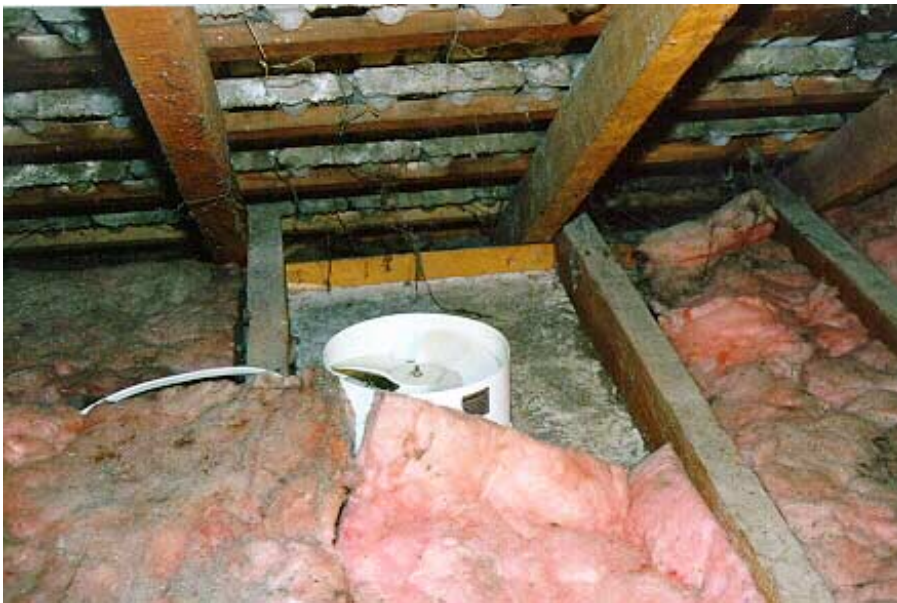
22 Above: Extractor fan discharging into roof space. Note insulation not replaced after installation.

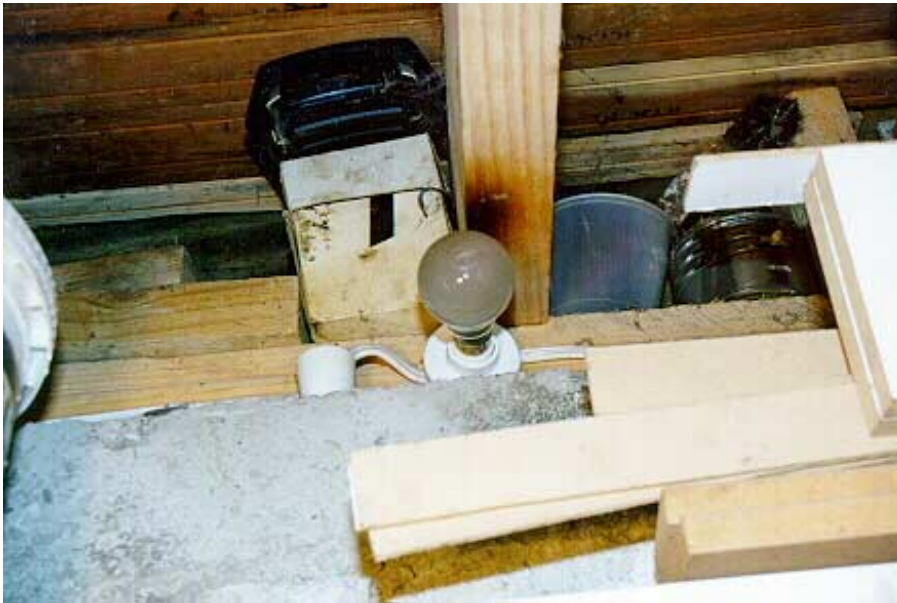
23 Above: Light fitting installed too close to timber causing a fire hazard. Note scorching of timber and paint materials stored alongside light.

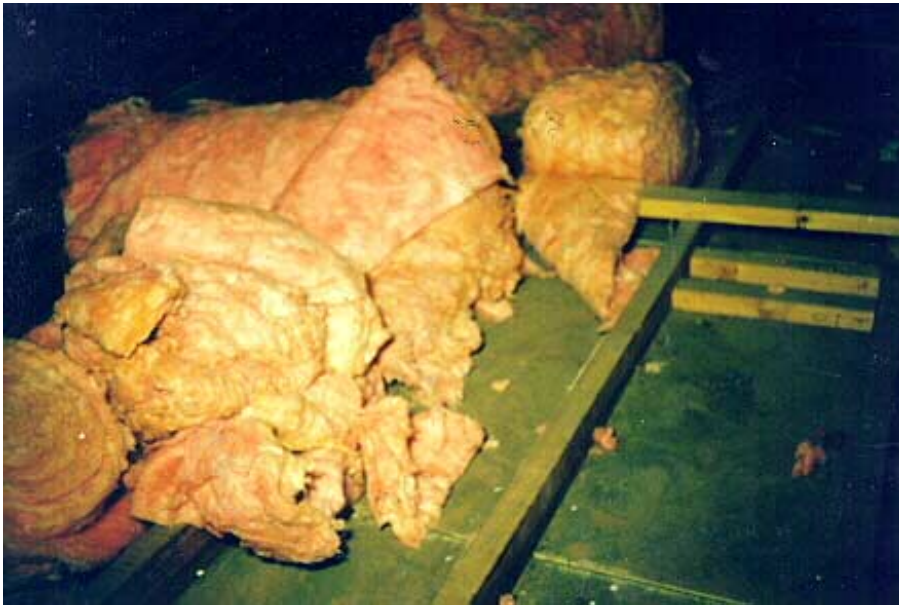
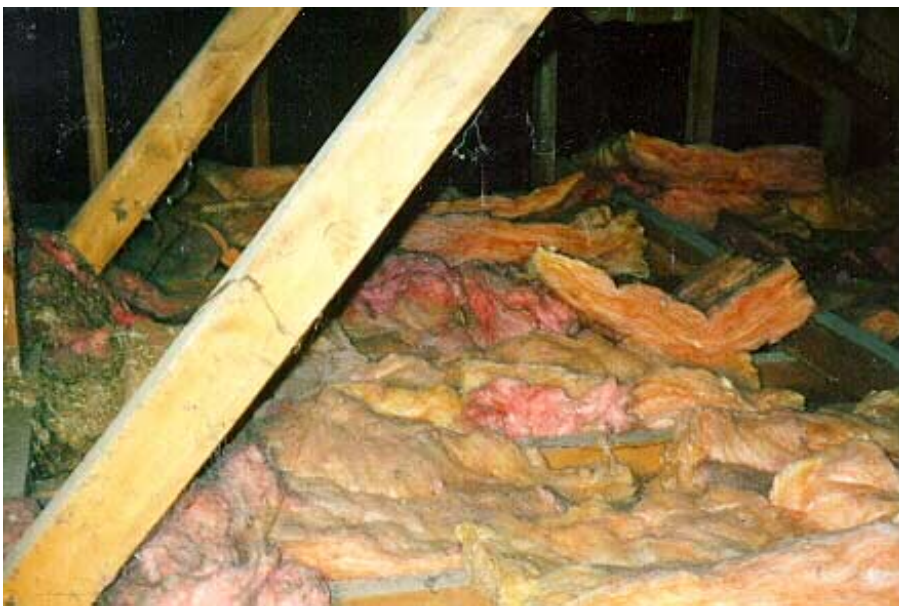
24 Above and below: Fibreglass insulation damaged or not put back after work done in ceiling space, allowing unnecessary heat losses.

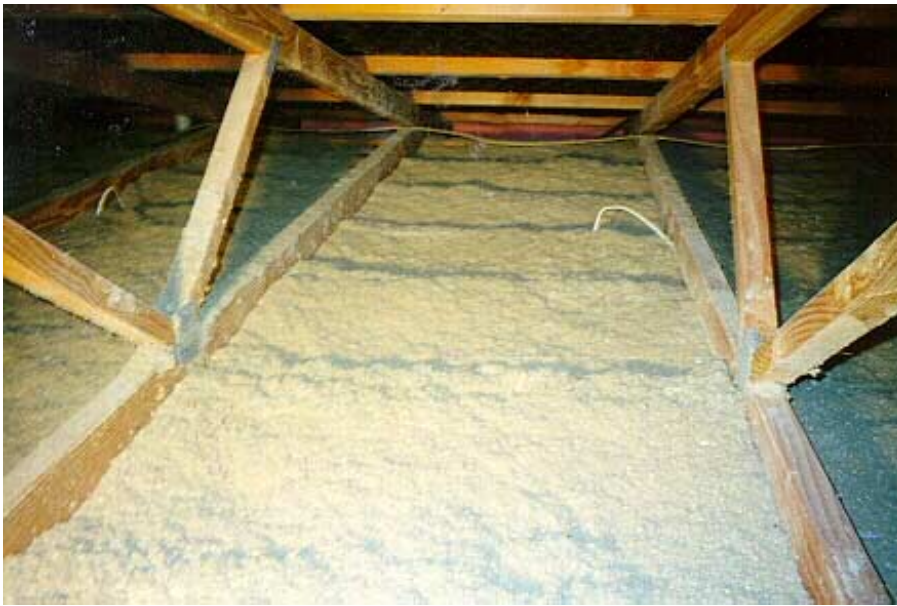
*25 Above: Loose fill macerated paper insulation settling with age and deteriorating in efficiency (average thickness is now less than 50mm)*

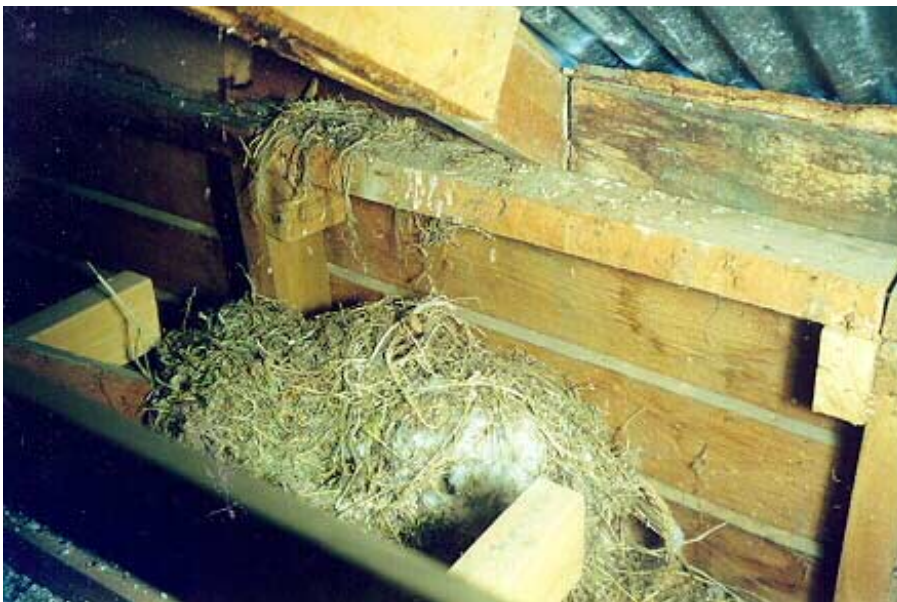
*26 Above: Rats' nest near eaves.*

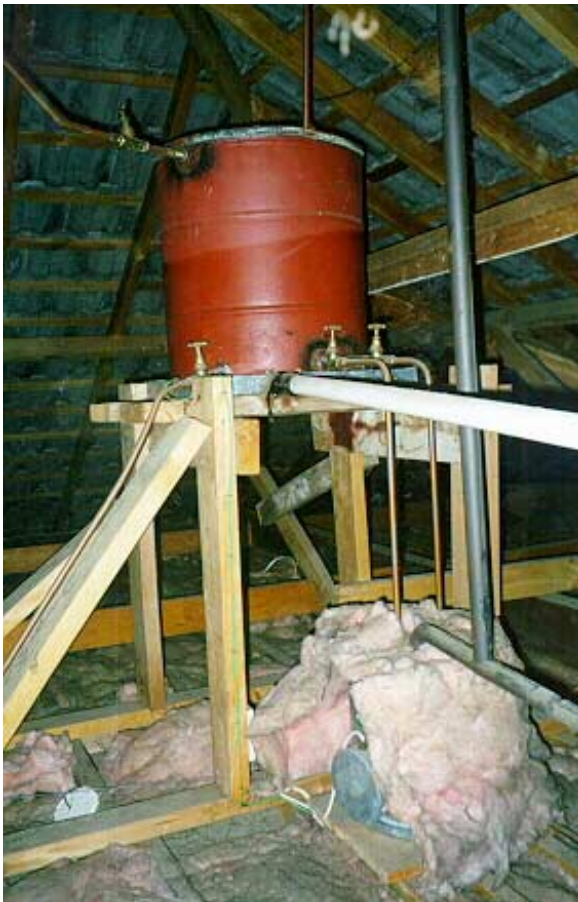
30 Above: Unrestrained header tank on high poorly constructed tank stand (note also the attempt to wrap the hot water cylinder).

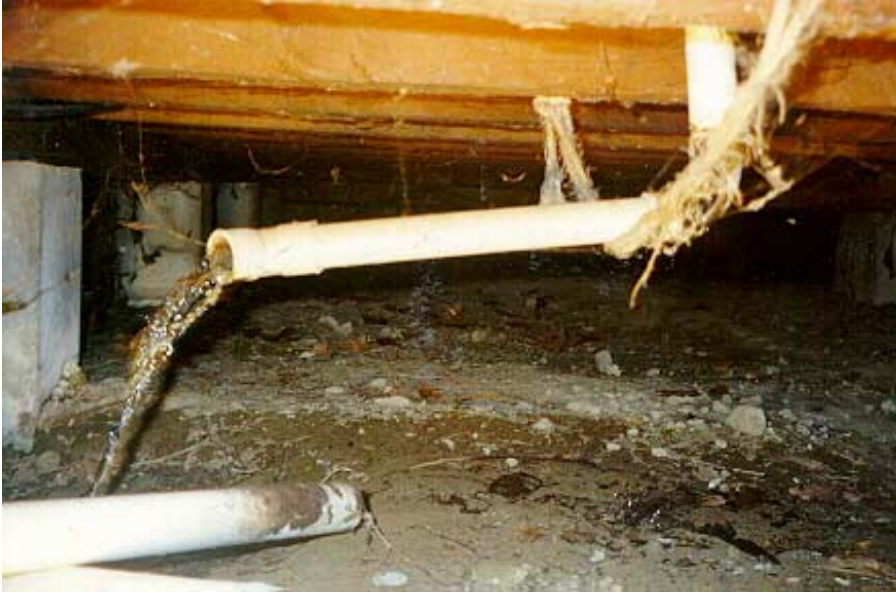
*31 Above: Joint failure in PVC waste pipe allowing undetected discharge of wastewater into subfloor space (note pipe support).*

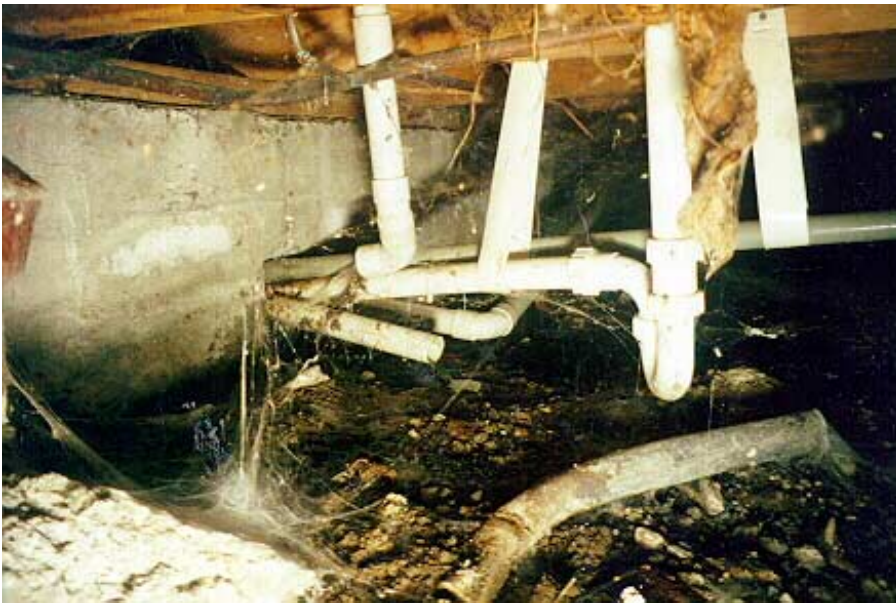
*32 Above: Joint failure in PVC waste pipe allowing undetected discharge of wastewater into subfloor space (note also state of hot water pipe lagging).*

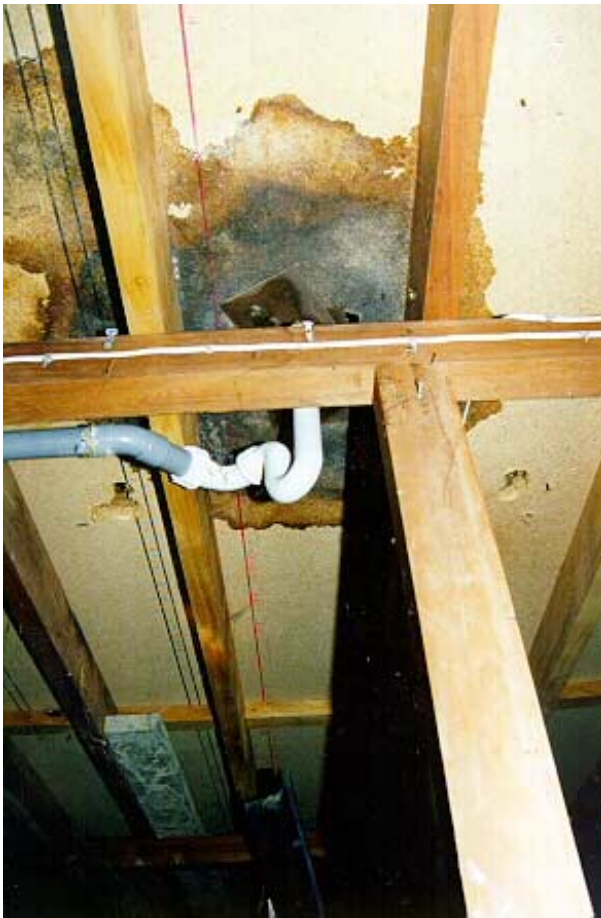
*33 Left: Water staining from leak under shower. Leak was detected and repaired before much damage was done to particle board flooring.*

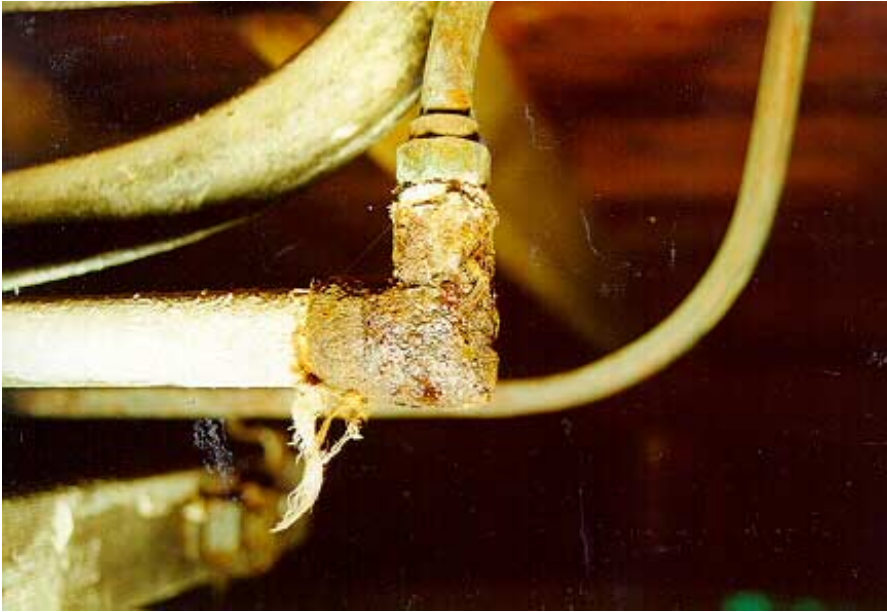
35 Above: Corrosion in joint of galvanised steel water pipe likely to cause a leak.

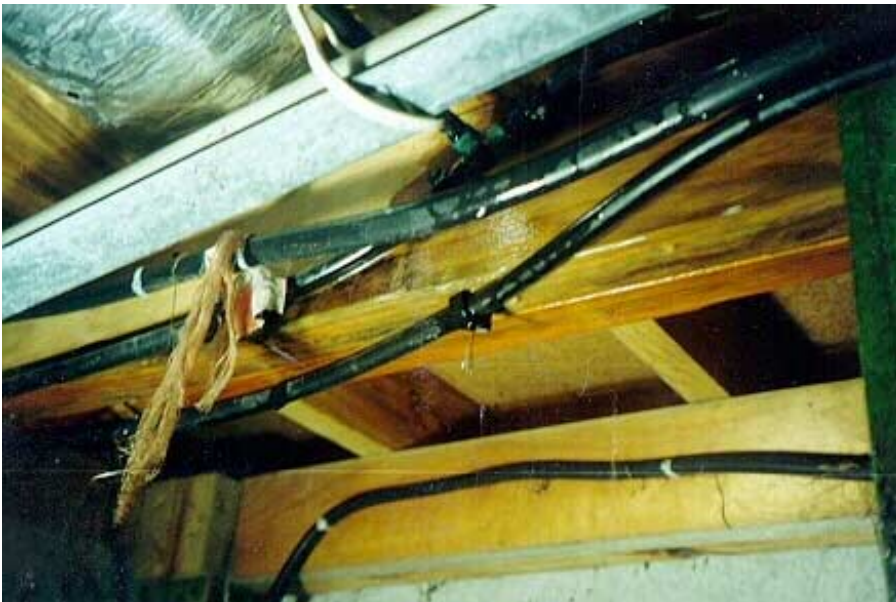
36 Above: Joint failure in polybutylene hot water supply pipework (note drips and wet timber).

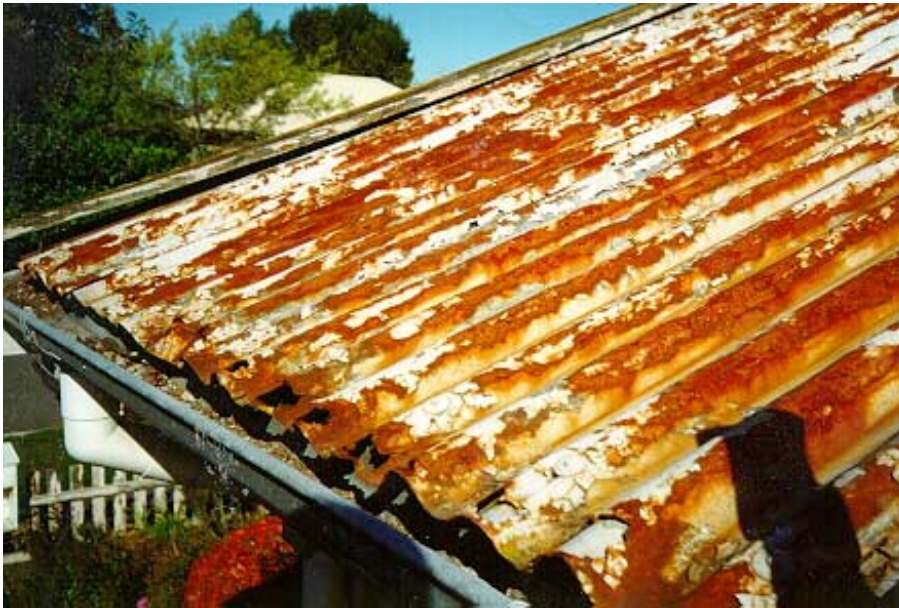
*37 Above: Severe corrosion to old galvanised steel roof in Auckland house (note: same house as shown in photograph 18).*

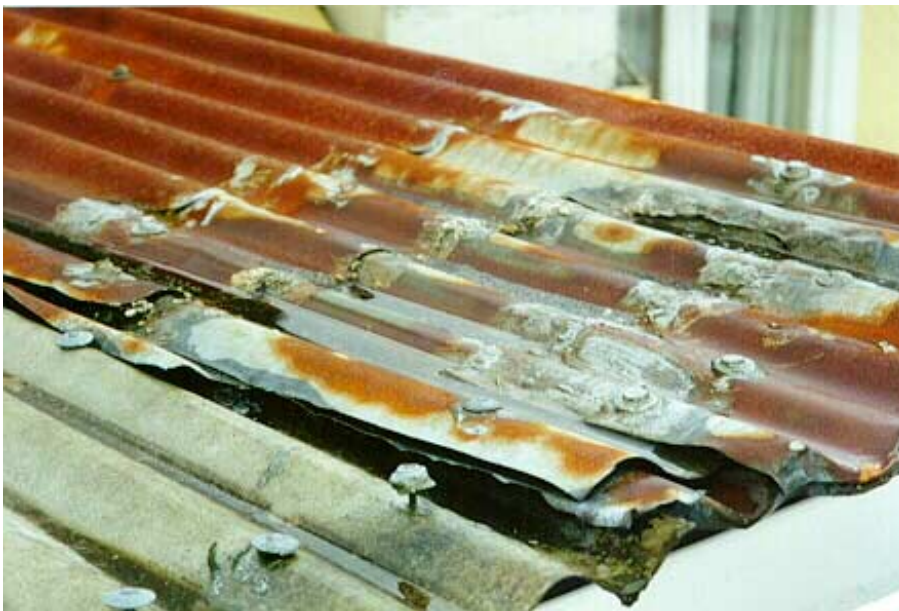
*38 Above: Severe corrosion to old galvanised steel roof in Wellington house (note: same house as shown in photograph 35).*

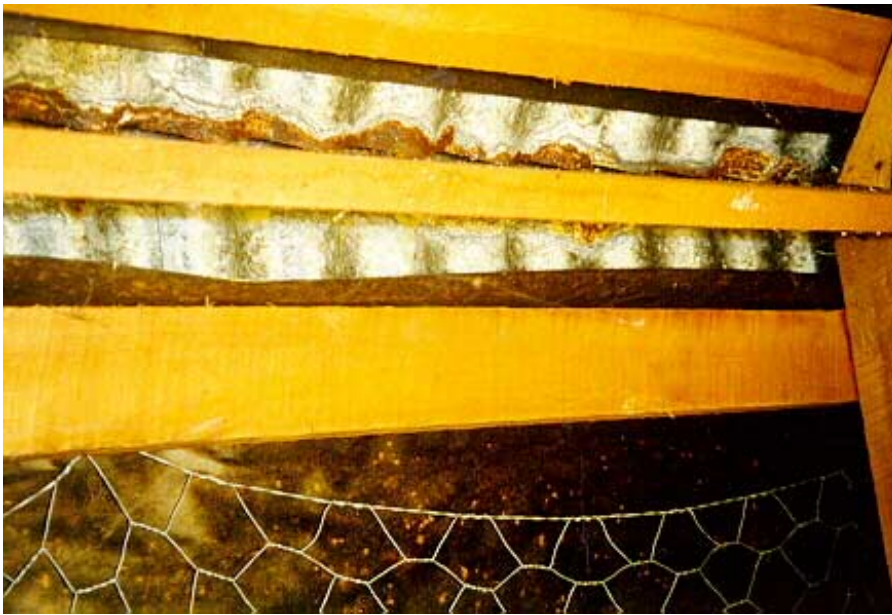
*39 Above: Faulty ridge flashing leading to corrosion.*

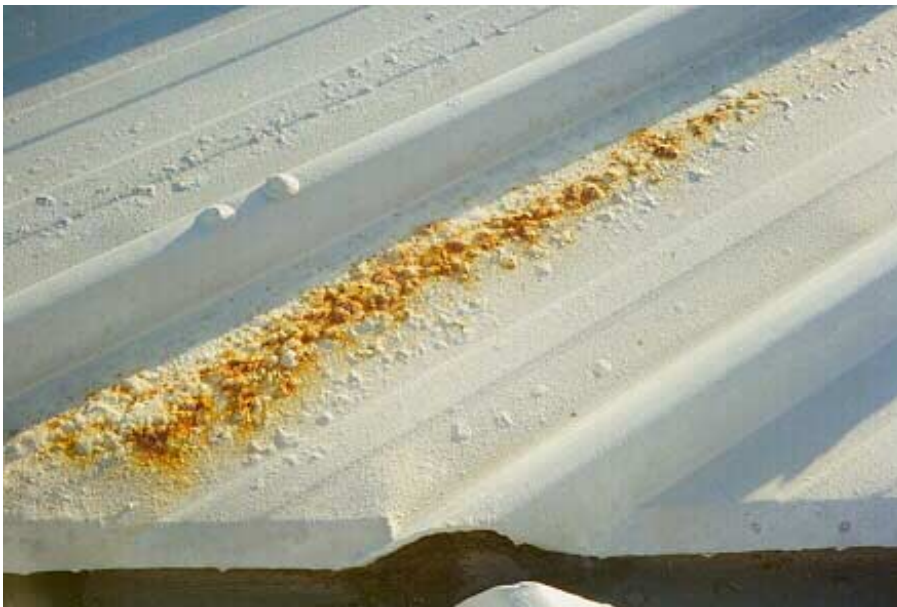
*40 Above: Severe corrosion to longrun galvanised steel roofing in 1980's Wellington house (exposed to severe marine environment).*

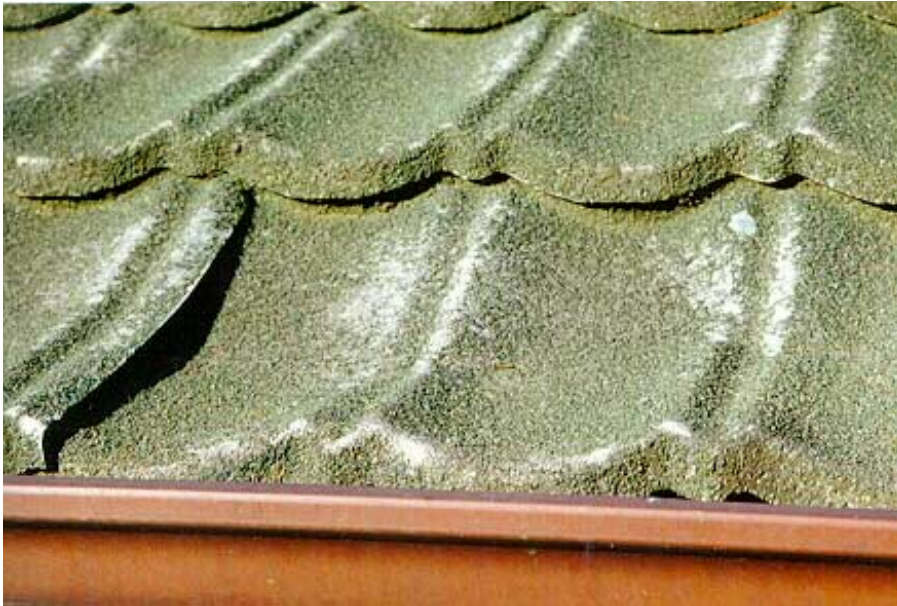
41 Above: Deterioration of chip coating (note also the dented tiles due to lack of protection when roof walked on).

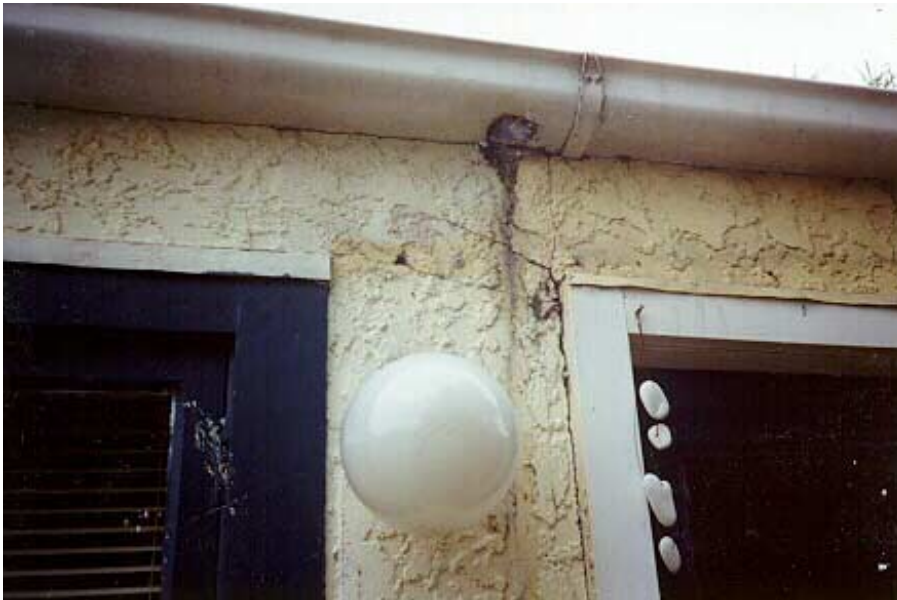
42 Above: Poor falls in galvanised steel guttering causing ponding and subsequent corrosion and holes (note also the cracks in the stucco cladding)

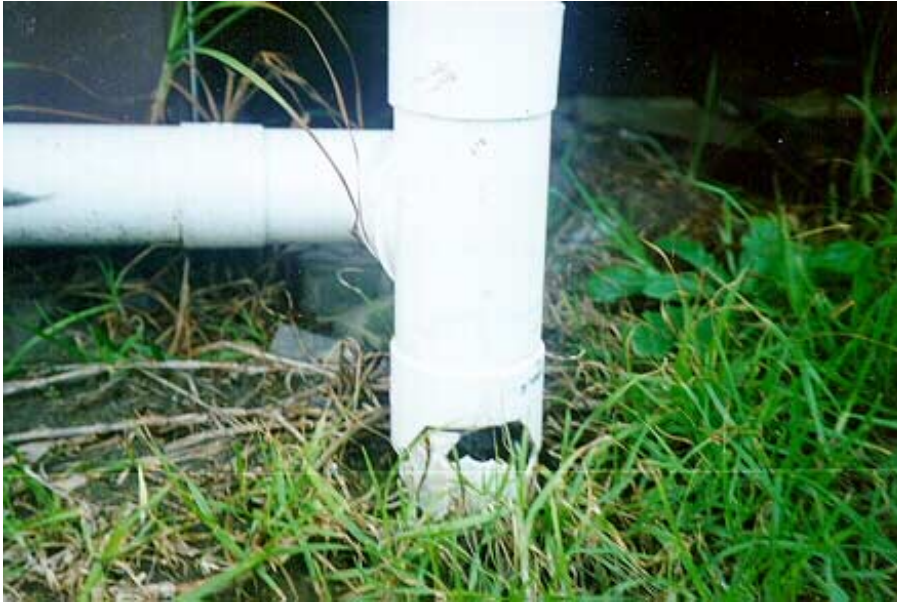
*43 Above: Damaged PVC downpipe allowing stormwater discharge onto soil and subsequent moisture problems in adjacent subfloor space.*

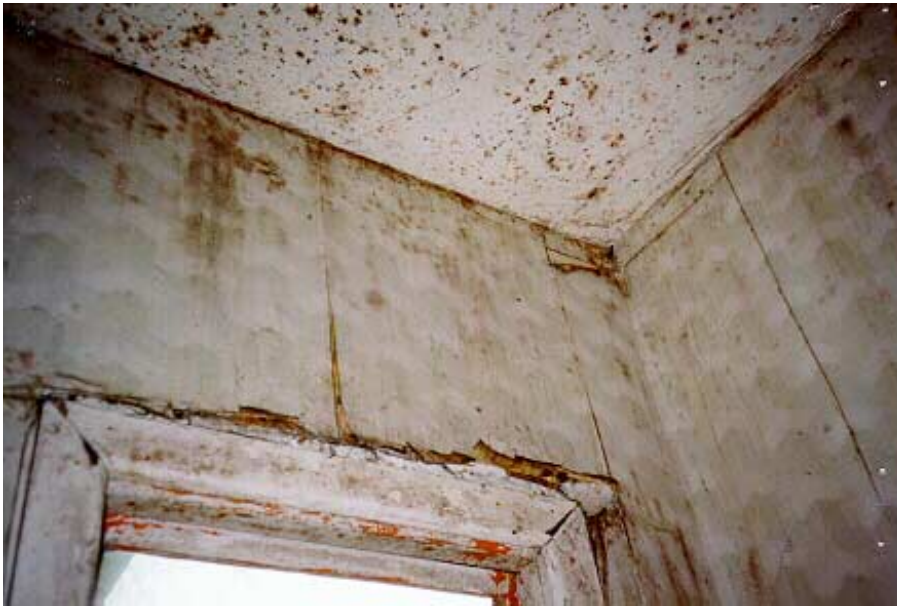
44 Above: Extreme levels of mould and mildew on lathe and plaster linings to bathroom of 1900's Christchurch house (same house as in photograph 16).
