# STUDY REPORT

No. 91 (2000)

**NEW ZEALAND HOUSE**

**CONDITION SURVEY**

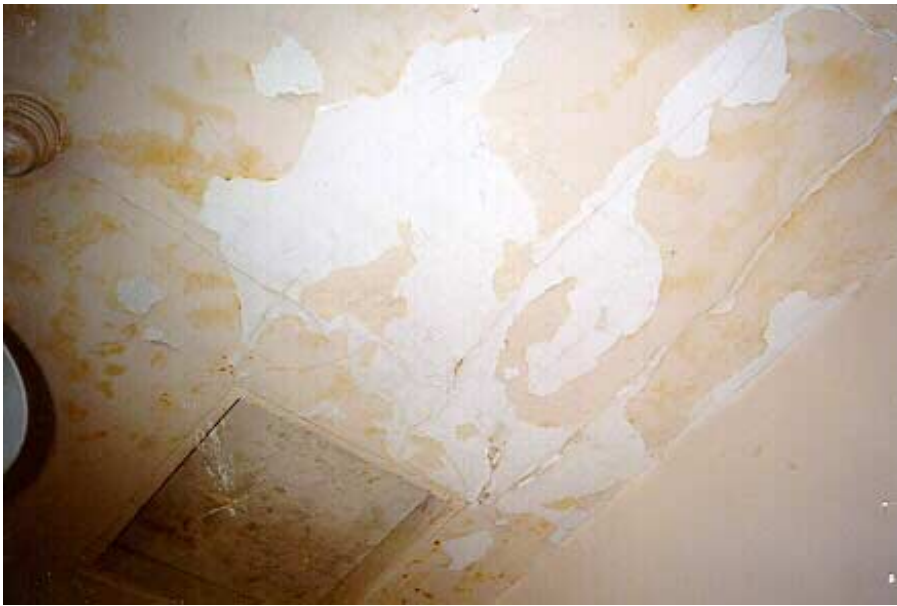
46 Above: Extreme levels of mould and mildew on lathe and plaster linings to 1920's Auckland house (same house as in photograph 18).

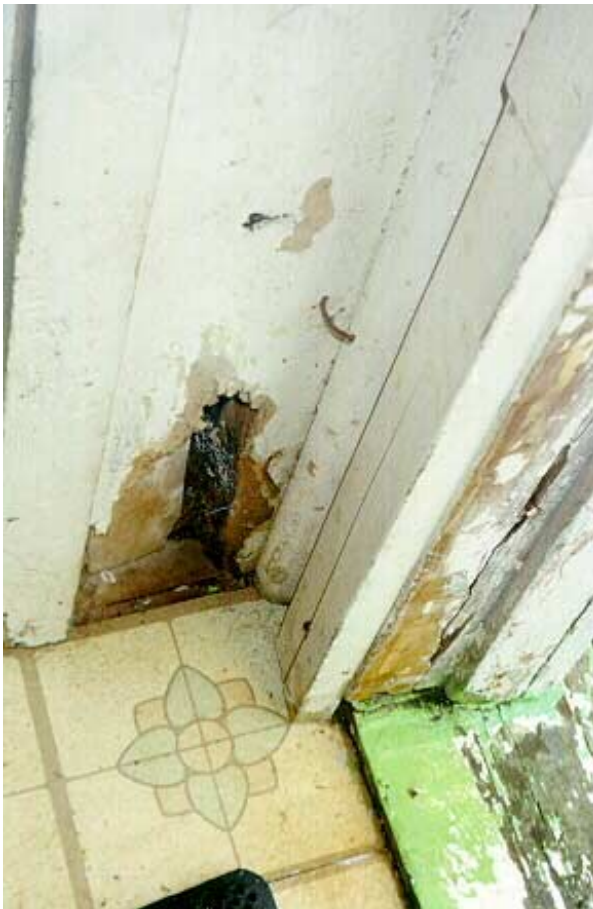
47 Left: Poor condition of exterior shell causing decay visible inside the 1940's Wellington house (same house as in photograph 39).
