# STUDY REPORT

No. 123 (2003)

## Repair and Reinstatement of Earthquake Damaged Houses – Derivation of Repair Techniques – Phase II

G.J. Beattie

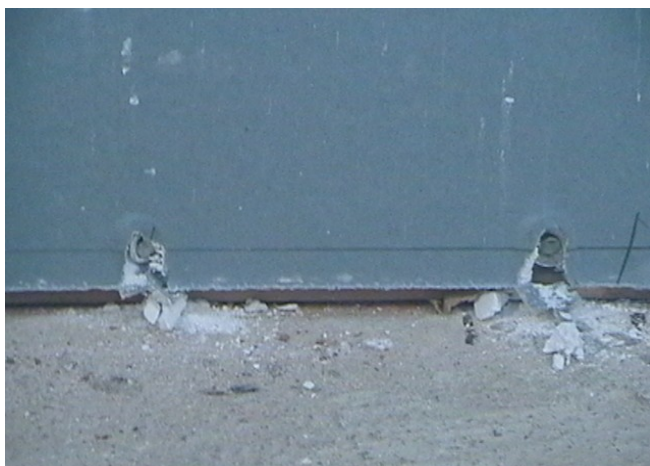
Damage occurred along the fixings of the plasterboard to the bottom plate of the framed wall. While the nail heads were in their original positions at the completion of the test, there was clear evidence that they had pushed the plaster core out of the bottom of the sheets (Figure 3). With skirting boards present in a real situation, the only possible evidence of this damage may have been some observable displacement of the plasterboard with respect to the skirting board. This would not be so obvious if the wall was wallpapered. The recorded uplift of the veneer at the door end of the specimen (where there was no return wall) was 14 mm. The bottom plate remained firmly attached to the foundation and the studs lifted from it, confirming the observed damage in the plasterboard.

**Figure 3: Evidence of nails pulling through the edge of the plasterboard sheets**

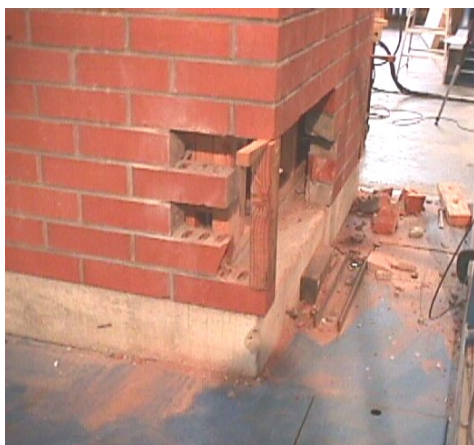
A recording of the north-south direction displacement record from the El Centro earthquake was introduced to the shake table. The controller for the shake table was set to 40% of the full El Centro signal. Inspection of the veneer after shaking revealed that a section of the veneer at the bottom corner of the wall intersection had permanently displaced outwards. This was coupled with a horizontal crack in the face-loaded veneer in a mortar joint one course of bricks above the bottom row of ties. On the in-plane loaded face, the crack extended up at an angle from the bottom corner to about mid-height of the veneer where it stopped. This crack followed the line of the mortar joints in a stepped fashion, with one exception where the brick fractured.

**Figure 4: Damaged corner removed and propped**

A bricklayer was asked to inspect the damage and advise on the sort of repair he would carry out in this situation. His advice was to remove the lower courses of bricks in the corner where the major damage had occurred and replace these. He commented that it would never be as strong as the original wall because there would not be the gravity load on the last mortar joint beneath the existing veneer. A repair was commissioned. Fine cracks in the mortar (< 0.5 mm) were left on the basis that free water would not penetrate these and any seepage would be drained as usual behind the veneer. Attempting to repair the cracks would have been more obvious than leaving them as they were. A sequence of photographs showing the repair process is given in Figure 4 to Figure 6.

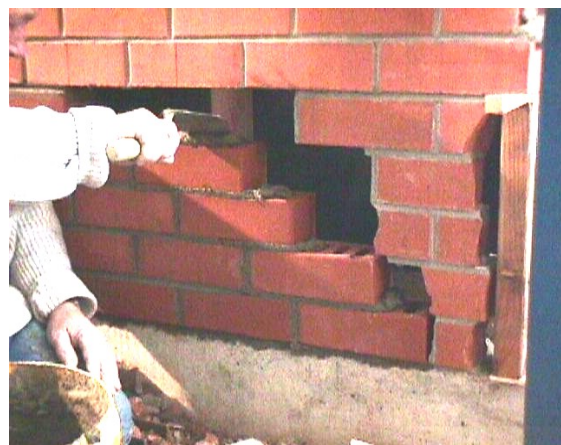
**Figure 5: Replacement bricks being installed**

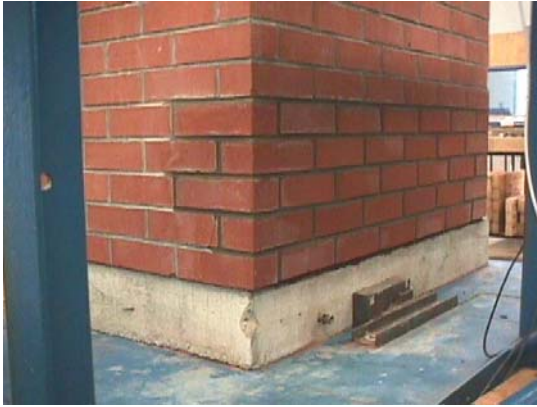
**Figure 6: Veneer repair completed (note mortar is darker because it is still fresh)**

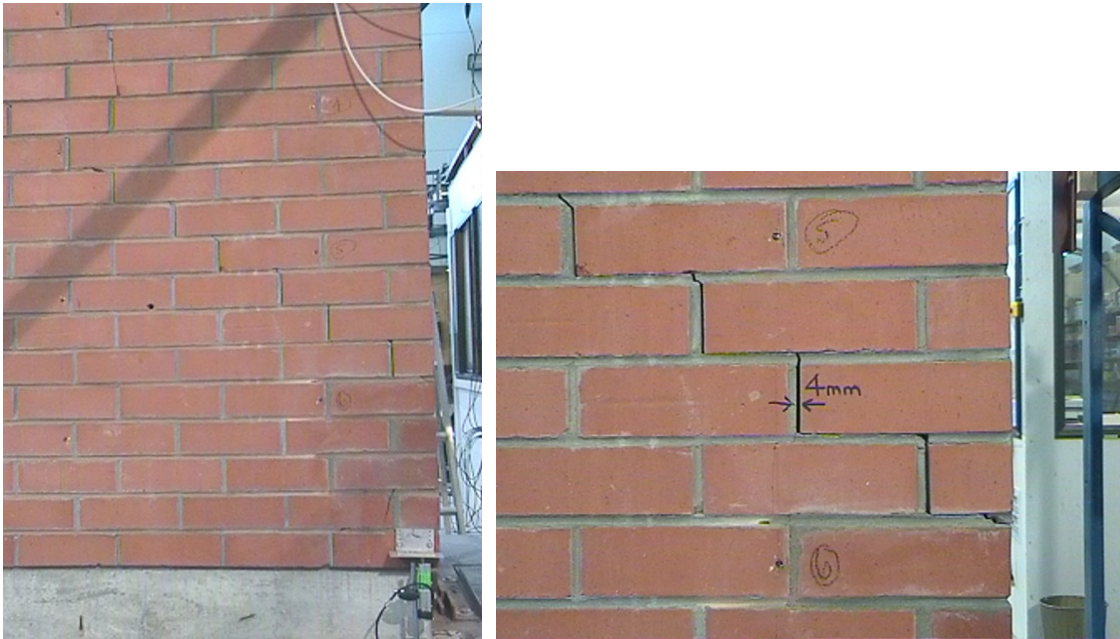
However, both the face-loaded section of veneer above the repaired area and the in-plane loaded veneer showed signs of permanent horizontal movement (Figure 7) to the extent that removal and re-building would be necessary. The spiral ties appeared to work well, but eventually began reaming out the installation holes in the bricks. None of the veneer collapsed, indicating that while the ties had lost some of their holding ability, they were still able to provide some resistance. The repaired area of the veneer was virtually undamaged, except for local cracking at the return in the wall (Figure 8).

**Figure 7: Views showing loss of alignment of the veneer face**

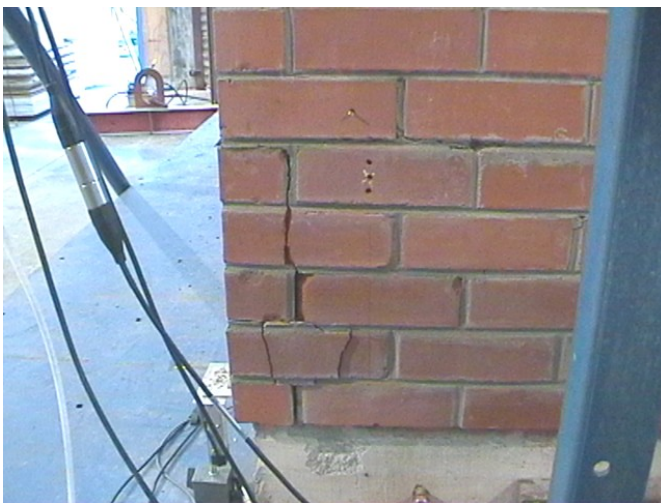
**Figure 8: View of damage to repaired veneer in the return corner**

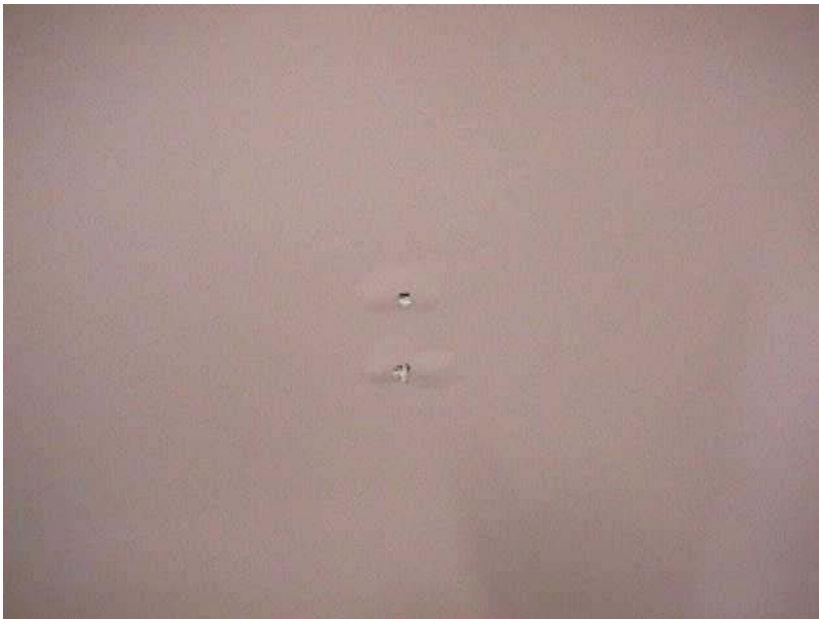
After cycling to  $\pm 14$  mm popping at nail heads was seen at six nails in the painted zones, but none in the wallpapered zones (Figure 10). Any similar damage that may have been present under the vinyl wallpaper was hidden and therefore would not be detectable by an assessor. There were faint cracks in the paint along the junctions between the timber scotia and the wall which would likely be covered by a new coat of paint. There was a small amount of crumbling and wrinkling of the plasterboard corner at the painted end near the bottom of the joint (Figure 11). A repair in this area would require cutting out of the taped joint and re-stopping with new tape. This could possibly only extend to just above the region of wrinkling, but it may be difficult to match a paint repair. Re-stopping and painting of the popped nail heads would be necessary and extra fixings should be added adjacent to the popped nails.

**Figure 10: Popped nail damage on painted plasterboard**

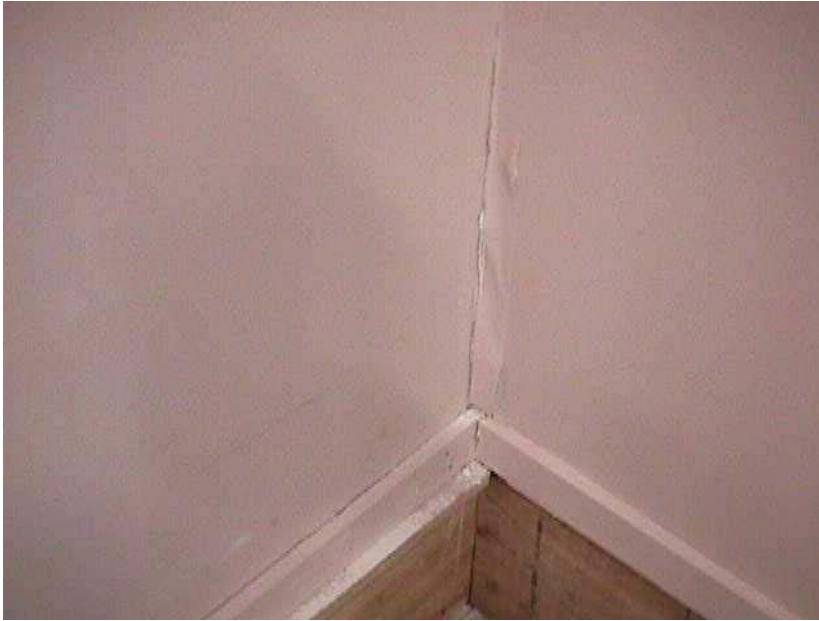
**Figure 11: Wrinkling and crumbling of the plasterboard at the painted corner**

The wall junctions in both the painted and the wallpapered sections were crumbling and wrinkling near the bottom corner. A similar repair, as specified above, of cutting out the stopped joint and installing new paper tape and stopping would be necessary. The daubs of glue fixing the plasterboard sheets to the intermediate studs had failed in the top and bottom thirds of the wall on many studs. The plasterboard rattled against the studs when tapped. A simple solution in this instance would be to nail or screw the board to the intermediate studs. These would require stopping and re-painting or re-papering.

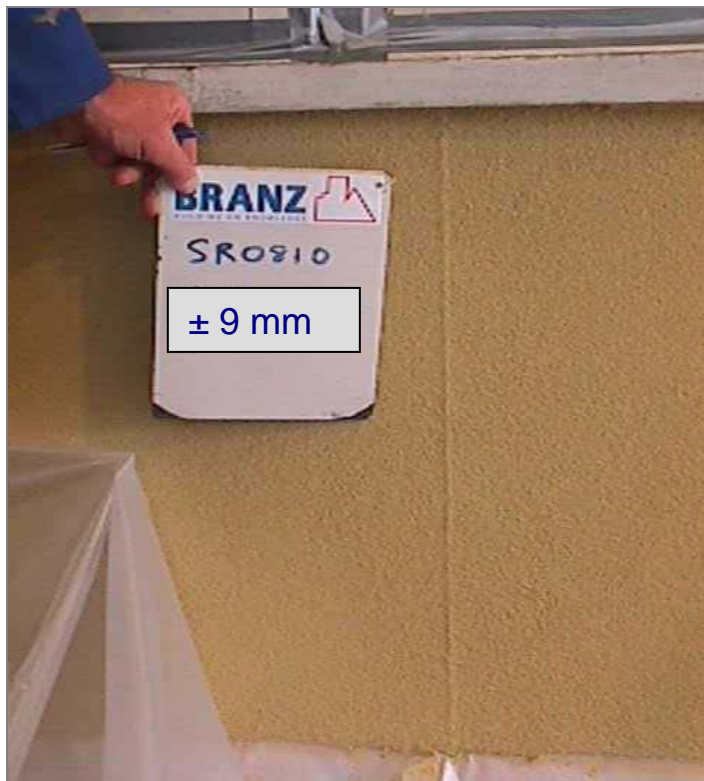
The vertical joint in the fibre-cement cladding centred directly below the timber window had bulged (Figure 28) and would require repair. While the joint appeared to remain watertight, it was very noticeable in the monolithic finish. A procedure suggested by the plaster coating applicator involved vee-ing out the joint and filling with a flexible sealant before refinishing the wall with a new plaster coating and paint. Attempts to refinish the area locally only would very likely be impossible to complete without the region being obviously different, mainly because of difficulty matching the paint colour. The bulge was left without repair so that the joint's performance under larger deflections could be observed.

**Figure 28: Bulge in fibre-cement cladding joint after  $\pm 9$  mm racking**

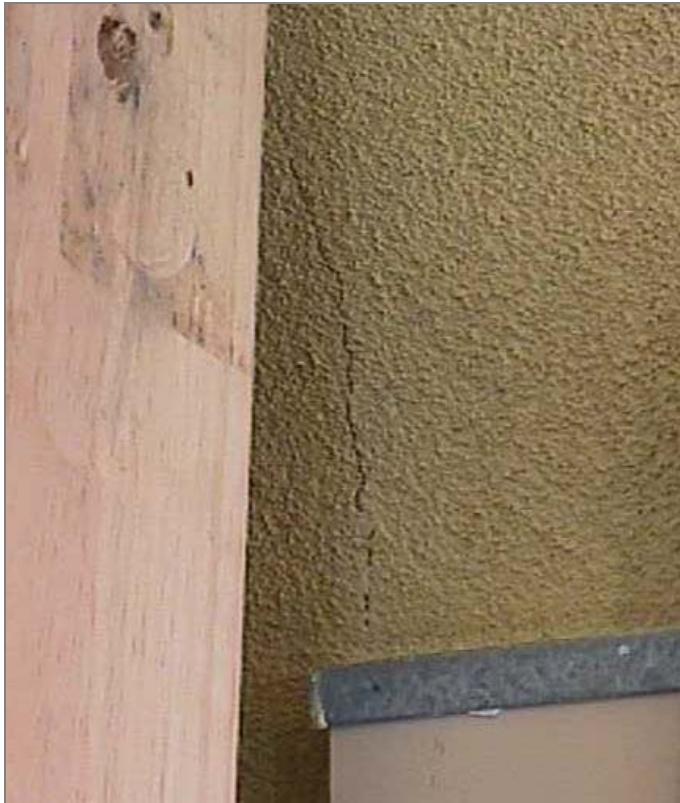
A 150 mm long diagonal crack had formed in the fibre-cement cladding from the top corner of the timber window, reaching 1 mm width at 9 mm wall deflection (Figure 29). This was obviously a failure of the substrate board. However, when the wall was returned to its zero deflection point this crack closed and was not visible to the eye alone. Assessors would need to carefully check for this damage. If the structure remained vertically aligned after the earthquake the crack may not show, but it could form a path for moisture entry in the future. A new coat of paint over the area would serve to re-seal the crack.

**Figure 29: 1 mm wide crack in fibre-cement cladding above window head**

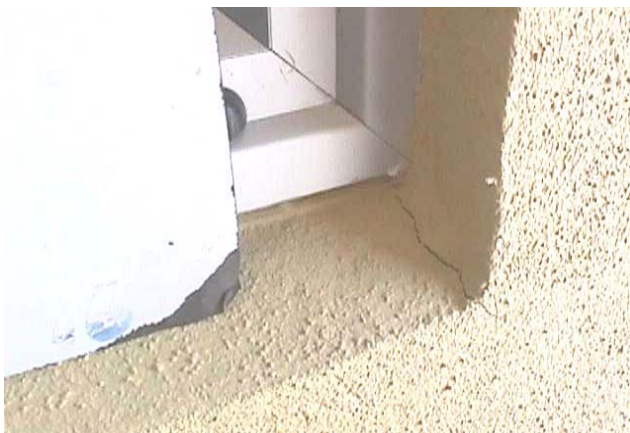
A diagonal crack had formed over the width of the sill only at each end of the window in the EIFS section (Figure 30), reaching 1 mm width at 9 mm wall deflection. However, when the wall was returned to zero deflection these cracks closed and were only just visible to the eye alone.

**Figure 30: Crack in the corner of the EIFS cladding at the corner of the window**

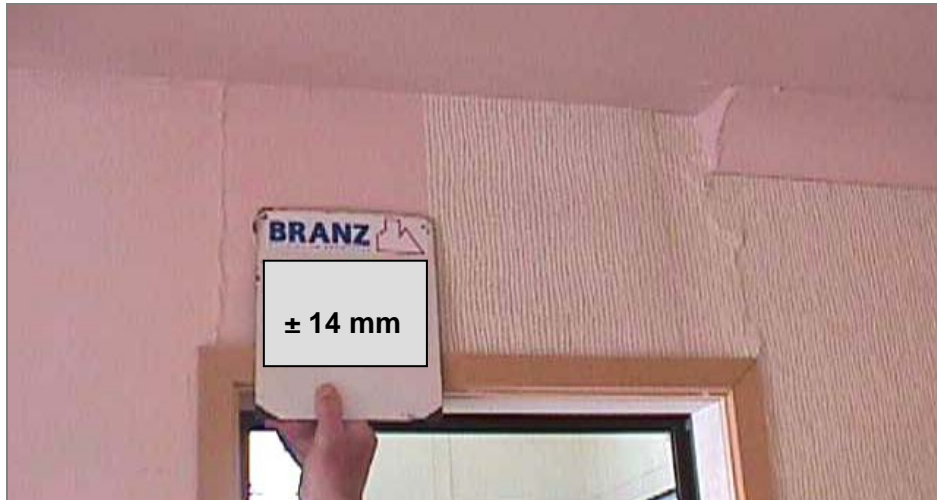
During these cycles greater damage had occurred at the vertical joints at the middle window (Figure 31). Cracks emanating from the left-hand side corner now extended to the skirting and scotia respectively, with adjacent sides of the cracks sitting proud by approximately 2 mm. The wallpaper had ripped further at the right-hand side corner of the window.

**Figure 31: Damage to the interior surfaces at the joints between sheets**

The appropriate repair procedure would be to gouge out the joints and re-tape and re-stop them, followed by refinishing the wall with wallpaper or paint, as appropriate.

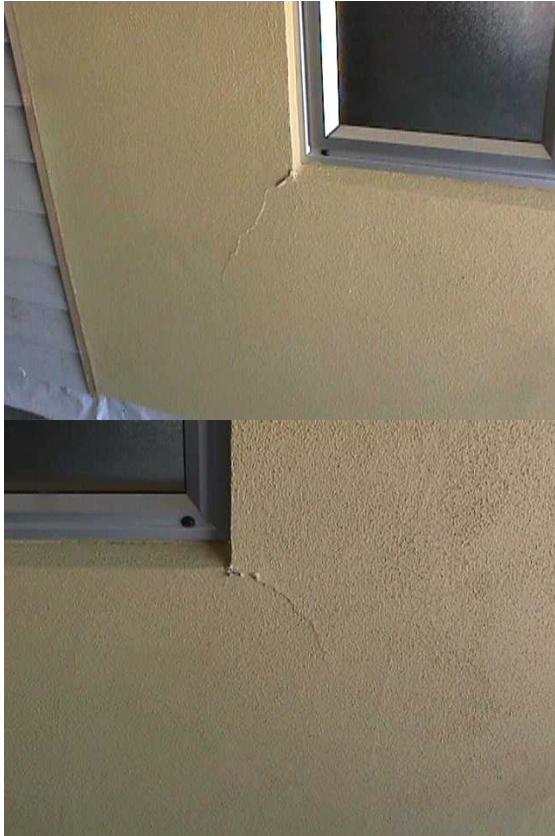
On the exterior face of the wall the cracks emanating from the bottom corners of the window in the EIFS cladding now extended 210 and 350 mm down the wall (Figure 32). Cracks from the top corners were 100 mm and 130 mm long respectively.

**Figure 32: Cracking damage in EIFS cladding after cycles to  $\pm 24$  mm**

The plaster coating applicator was engaged to carry out a repair on these joints. The three smaller cracks were vee'd out for the full coating depth and about 5 mm wide (Figure 33). The larger crack was scraped out to a taper finish over about 100 mm width. The fibre-glass mesh had fractured (possibly during the scraping out process). A new strip of fibre-glass was used over this scraped out area and it was filled with polymer-modified cement plaster. The polymer-modified cement plaster was trowelled over the other cracks and a few minutes later was feathered out with a sponge (Figure 34) which gave the same texture as the original texture coating – which had irregular grain size. Spray painting of the surface was undertaken after three days. One coat of spray paint was applied around the crack and shortly afterwards the entire wall was re-sprayed. Once dry, while the wall looked almost as new, it was still possible to identify where the cracks had been repaired. On some occasions it may be necessary to apply a new coat of texture coating over the entire wall before re-painting.

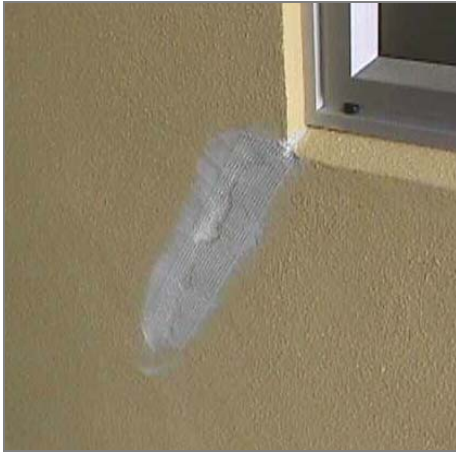
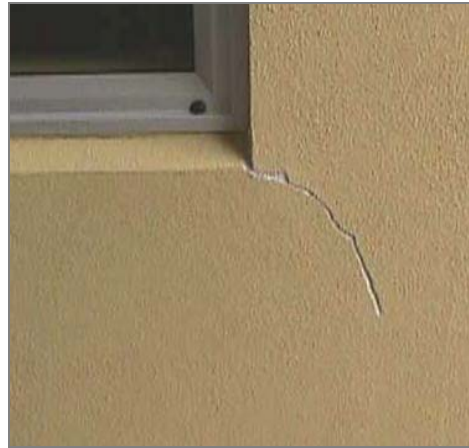
**Figure 33: Crack in EIFS cladding prepared for filling**

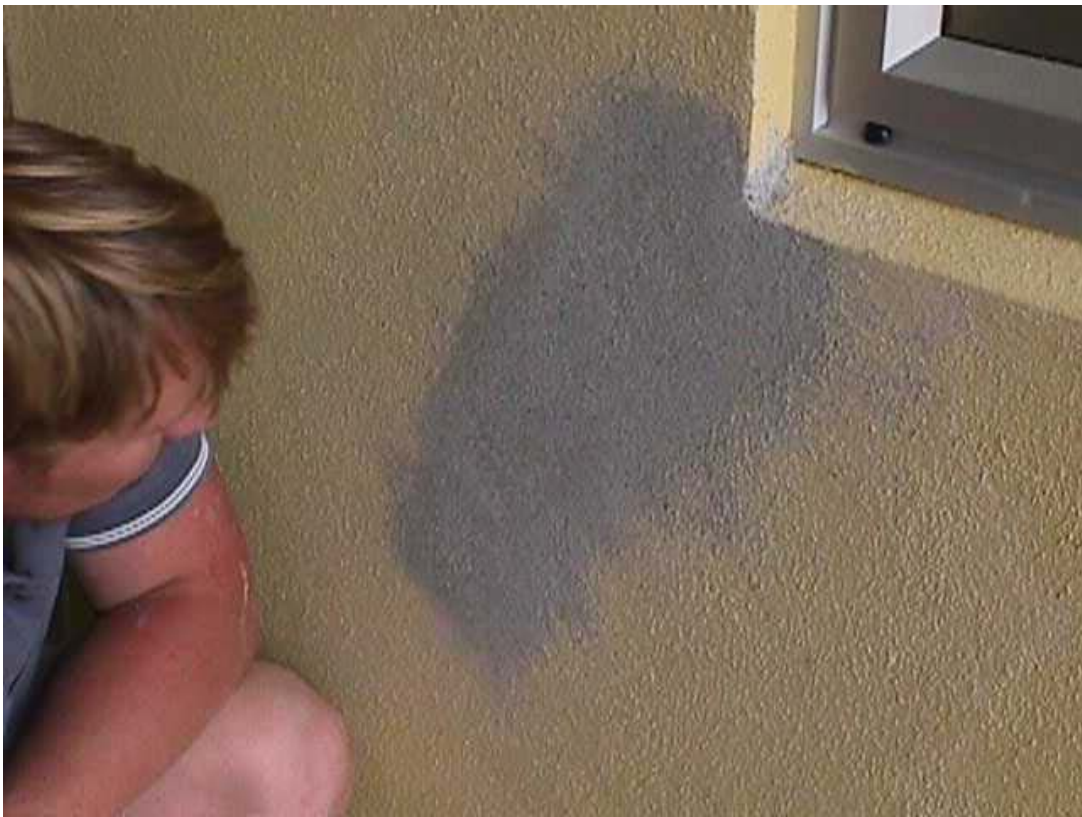
**Figure 34: Feathering with a sponge to match the coating**

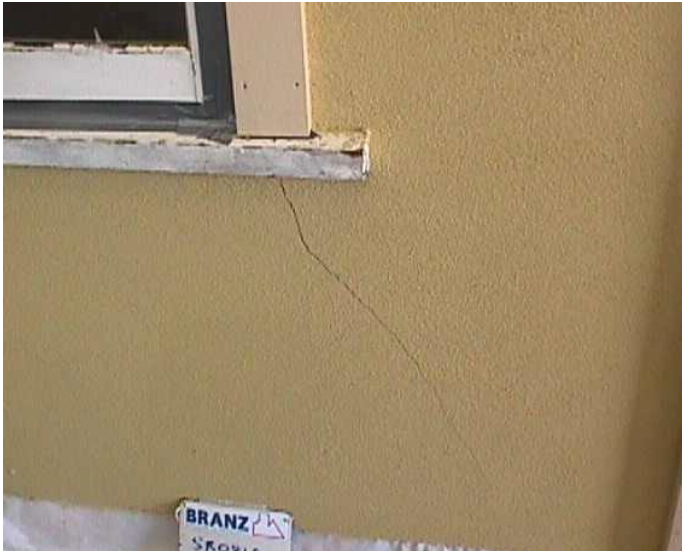
The bulge under the timber window in the fibre-cement cladding was still more pronounced. The cracks emanating from the bottom corners of the timber window now extended well down the wall and were several millimetres wide (Figure 35). Cracks from the top were 250 mm long.

**Figure 35: Diagonal cracks in the fibre-cement wall from the bottom corners of the window**

With large diagonal cracks, normal practice is to replace the sheet rather than trying to repair a diagonal crack as it will likely crack again at serviceability level loadings.

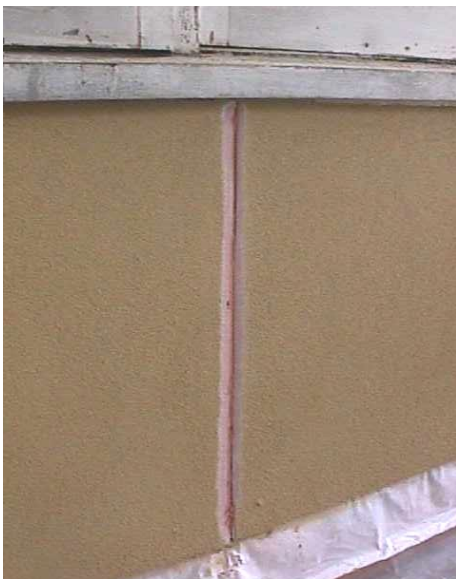
**Figure 36: Fibre-cement sheet joint prepared ready for filling**

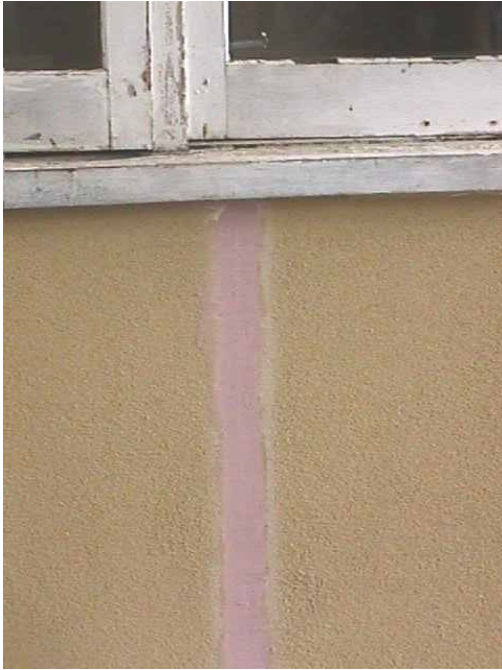
**Figure 37: Fibre-cement joint filled with flexible jointing material**

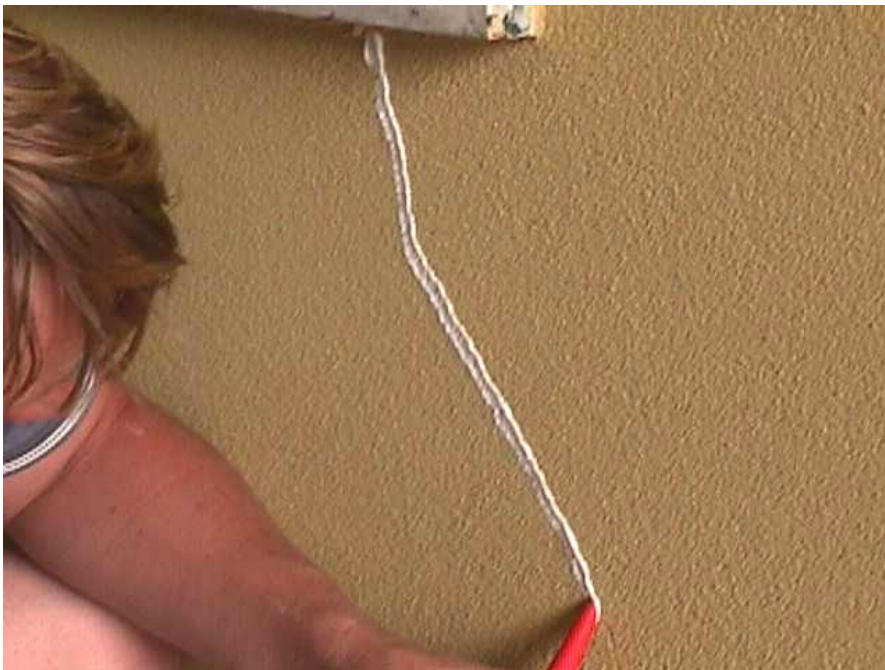
**Figure 38: Filling the diagonal crack in the fibre-cement cladding with sealant**
