# **STUDY REPORT**

**No. 158 (2006)**

## **Repair and Reinstatement of Earthquake Damaged Houses – Phase III**

**G J Beattie**

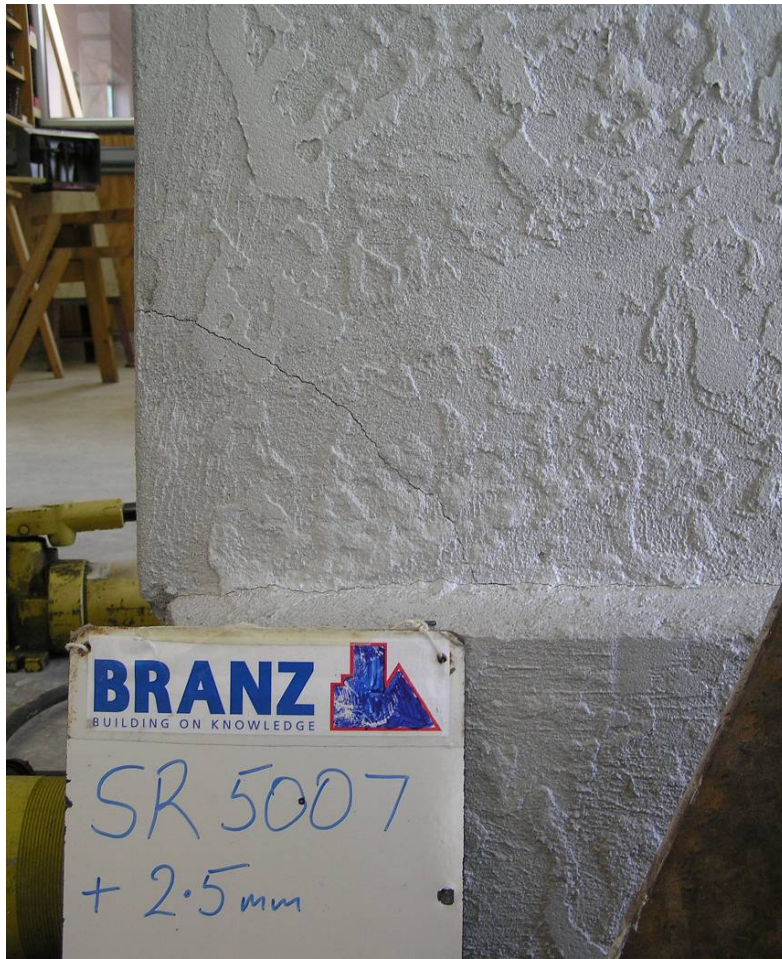
During the first cycle to +2.5 mm, a fine crack opened in the stucco at the bottom corner of the specimen and at the junction with the foundation (Figure 4). Similar cracks opened at the opposite end of the wall during the cycle to -2.5 mm. However, when the load was removed the cracks closed and could not be distinguished.

**Figure 4: Fine crack at the bottom of the wall and at the junction with the concrete foundation**

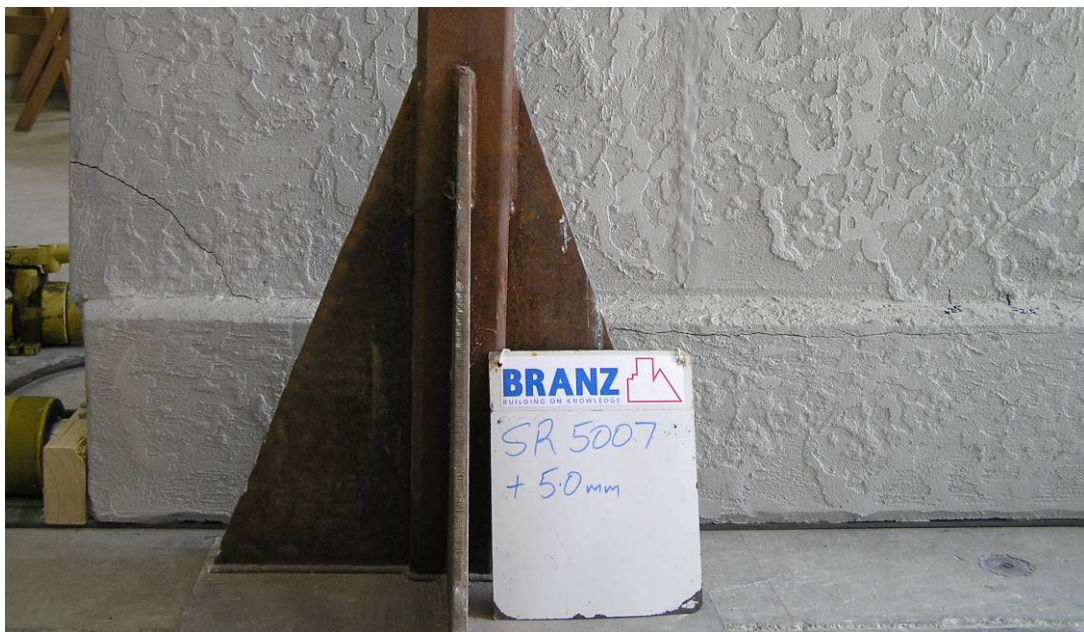
During the cycles to  $\pm 5$  mm, the crack at the foundation junction extended along the full length of the wall (Figure 5). Fine cracks also began to form at the lower corners of the window and at one top corner. Horizontal cracks also formed on both sides of the window at about three-quarters of the way up the side of the window.

**Figure 5: Cracks extending along the foundation junction during cycles to  $\pm 5$  mm**

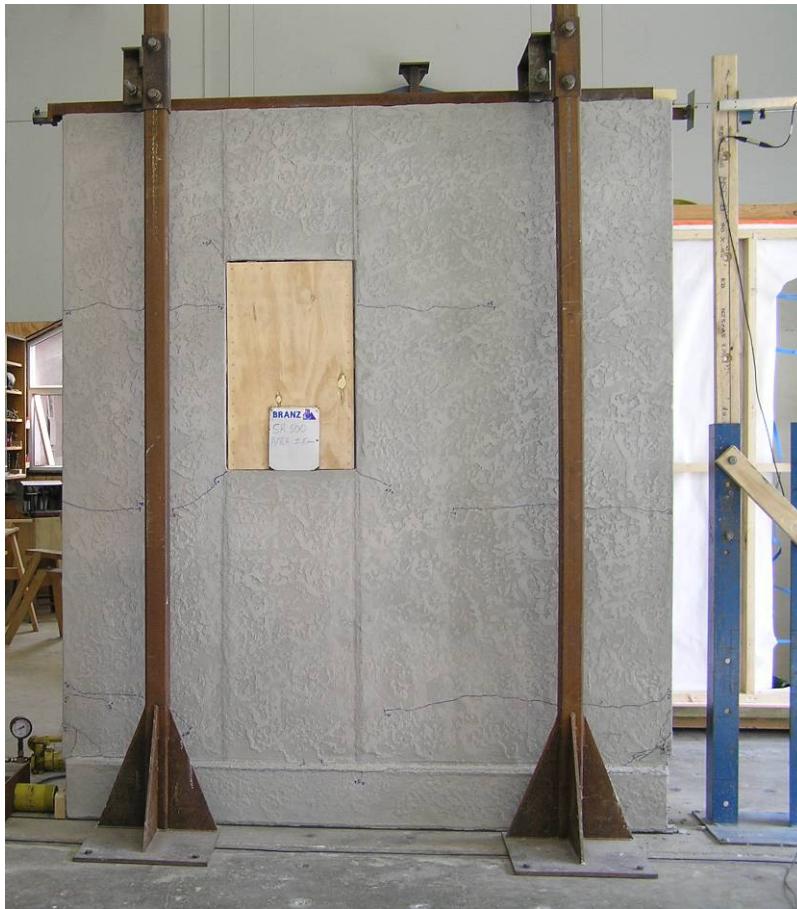
Light gauge metal straps were added to tie the end studs to the foundation and the wall was cycled again to  $\pm 2.5$  mm,  $\pm 5$  mm and  $\pm 10$  mm. This was followed by a further three cycles to  $\pm 20$  mm. After these three cycles some of the cracks were still visible, particularly along the line of the foundation junction (Figure 6).

**Figure 6: Crack patterns after cycling to  $\pm 10$  mm (note cracks have been marked with a felt-tip pen)**

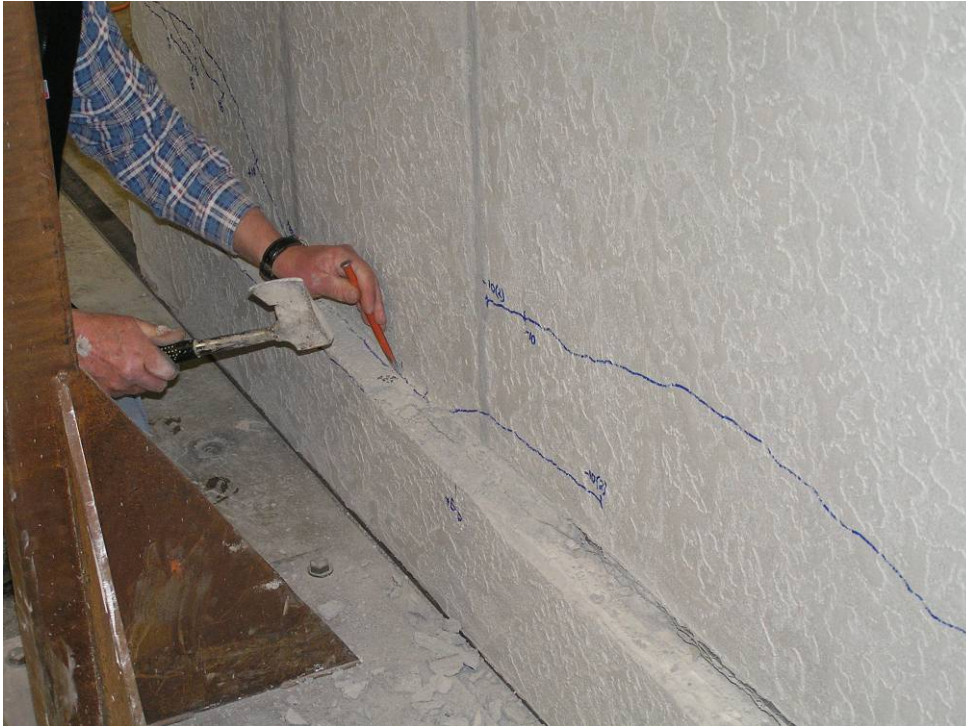
**Figure 7: Removal of loose plaster at the foundation junction**

Repairs were undertaken on the stucco joint at the foundation and at the ends and top corners of the wall. At the junction with the foundation, the loose plaster was chipped and raked out (Figure 7) and new plaster was applied (Figure 8). At the corners, new mesh was added where the old mesh had been damaged. No other repairs were undertaken on the finer cracks in the body of the wall. A good match was achieved between the old rough cast pattern and the new pattern (Figure 9). Some staining is visible in Figure 9 at the interface of the old and new plaster, but this would be easily covered by new paint.

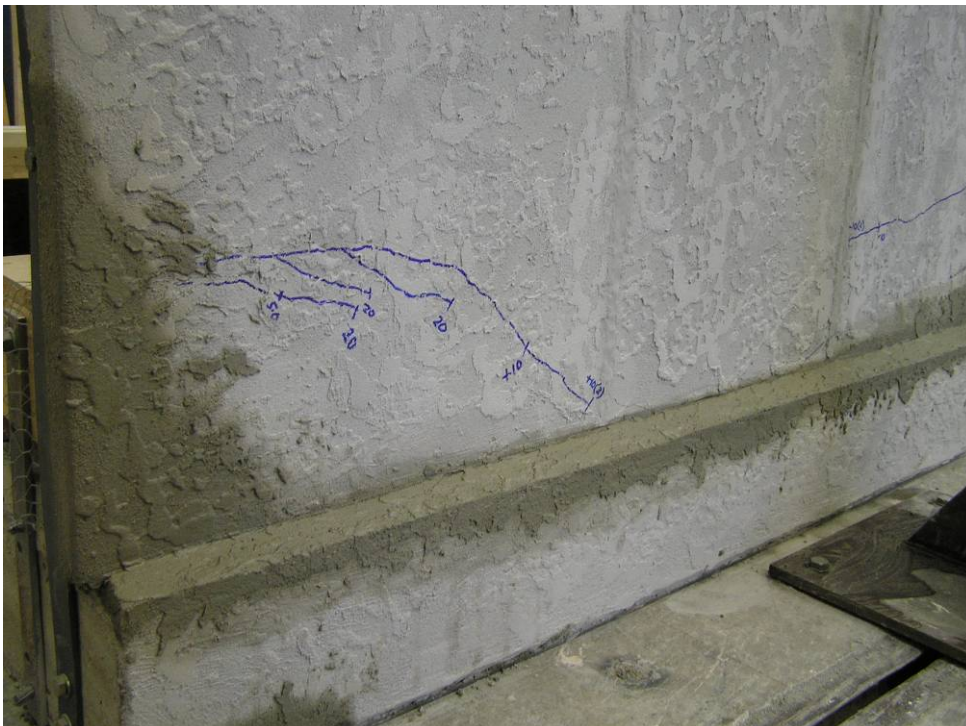
**Figure 8: Repaired stucco wall at foundation junction and at the wall ends**

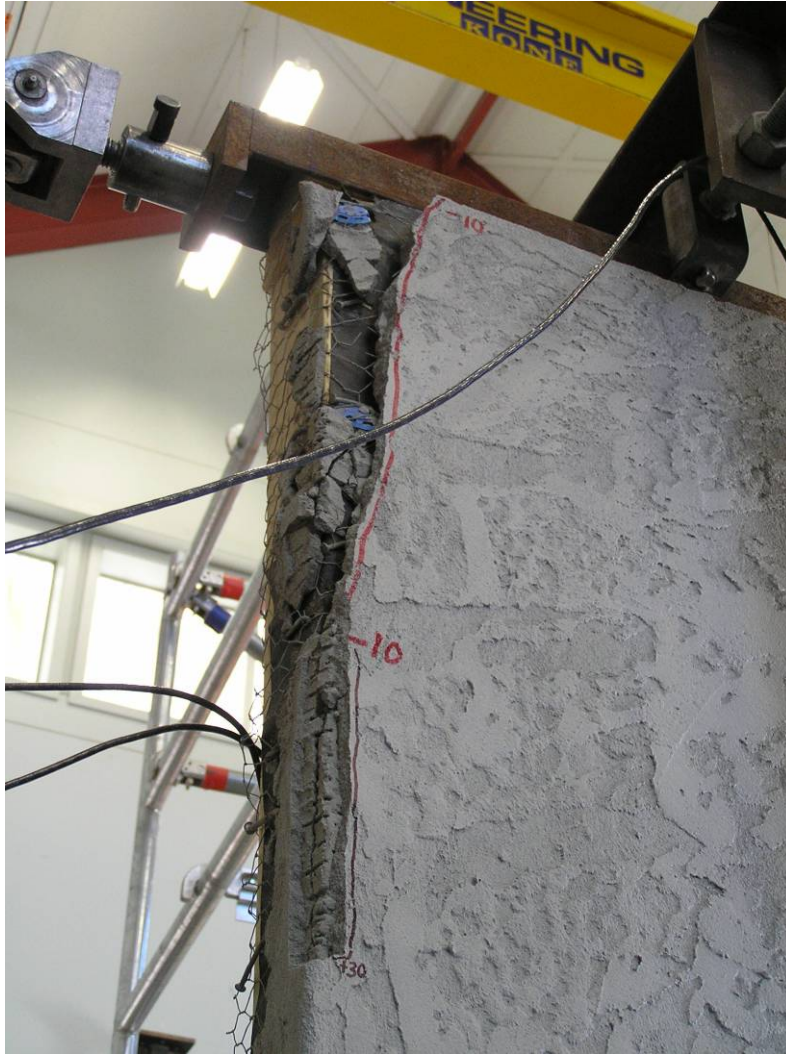
This cycling caused considerable damage to the top corners of the stucco and for approximately 1 m down the edge where the stucco wrapped around the corner (Figure 10). This became more evident as the lateral deflection increased from  $\pm 10$  mm to  $\pm 60$  mm. The studs, especially the end ones, bent considerably about their weak axis during this cycling, as the nails first eroded holes in the stucco and then detached from the stiff stucco panel. This movement caused wear holes in the building paper. The top plate progressively detached from the studs, especially at the end remote from the actuator. While the appearance of the panel from the outside was of a solidly fixed cladding, inspection from the back (inside) clearly showed that there was little connection of the upper part of the panel to the wall framing and that demolition or re-connection would be necessary. It would be important for the inspection teams following an earthquake to push against any stucco walls where damage at corners was significant, to ascertain whether the connection to the framing was still intact. Any discernable movement would indicate that the link was suspect.

**Figure 10: Damage at the top corners of the panel**

A further round of repairs was undertaken at this point. The repairs involved re-building the top end sections of the stucco panel, re-fixing the panel to the framing with new nails, and repairing cracks near the base of the panel that had opened to approximately 1 mm. Fine cracks were also painted over to determine the effectiveness of this repair.

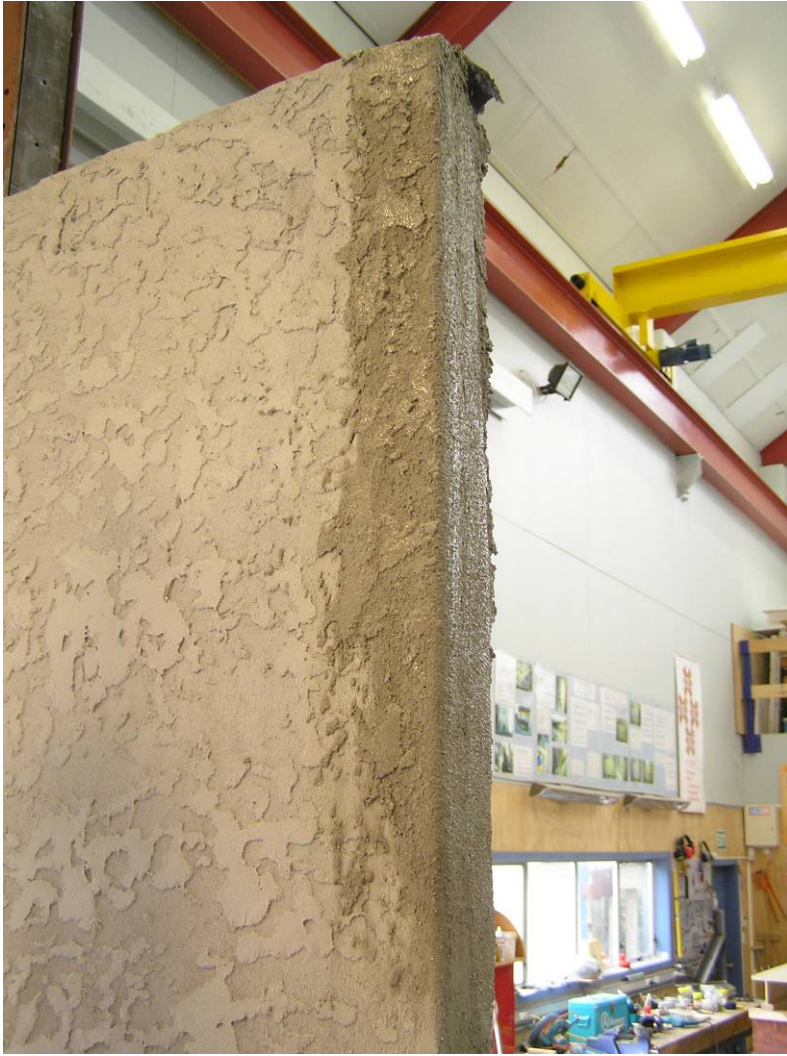
**Figure 11: Top corners of the stucco wall after repair**

Re-building the top end sections followed a similar process to the earlier described repair of the wall foundation junction (Figure 11).

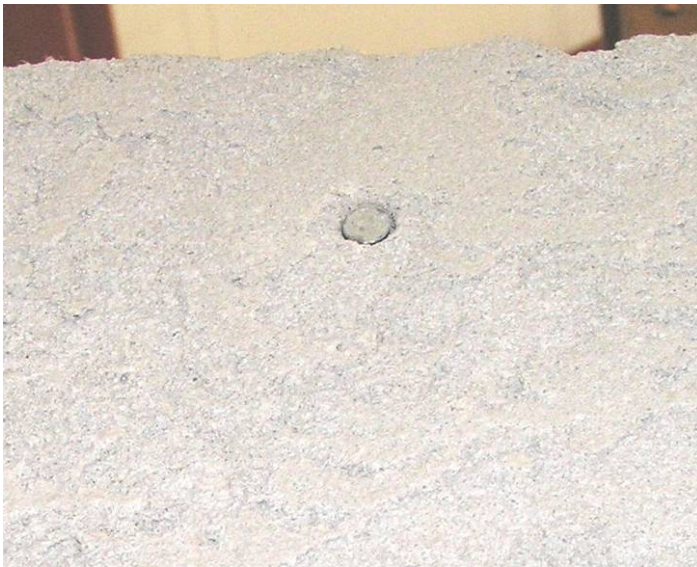
**Figure 12: New nail added to re-attach the stucco panel to the framing (to be plastered)**

New nails were added along the top edge of the panel (Figure 12) and then these were plastered over.

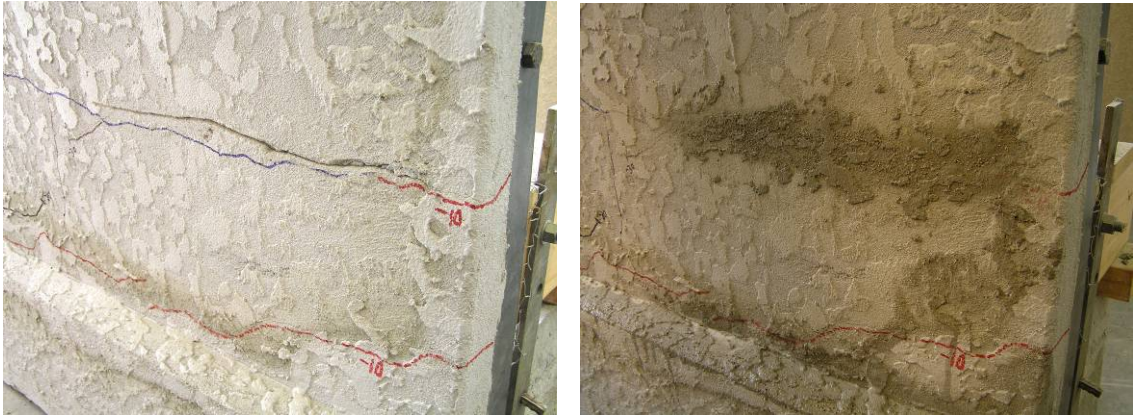
**Figure 13: 1 mm wide crack prepared and then ‘bagged’ over**

Loose material was removed from cracks that were approximately 1 mm wide and these were scraped out using a pointed steel probe. The resulting slot was wetted, and then as the surface dried to a damp state, it was then 'bagged' over (Figure 13). This process involves smearing some new plaster over the crack and working it into the crack with a cloth. The resulting repair fills the crack and also spreads a thin layer over the adjacent surface.

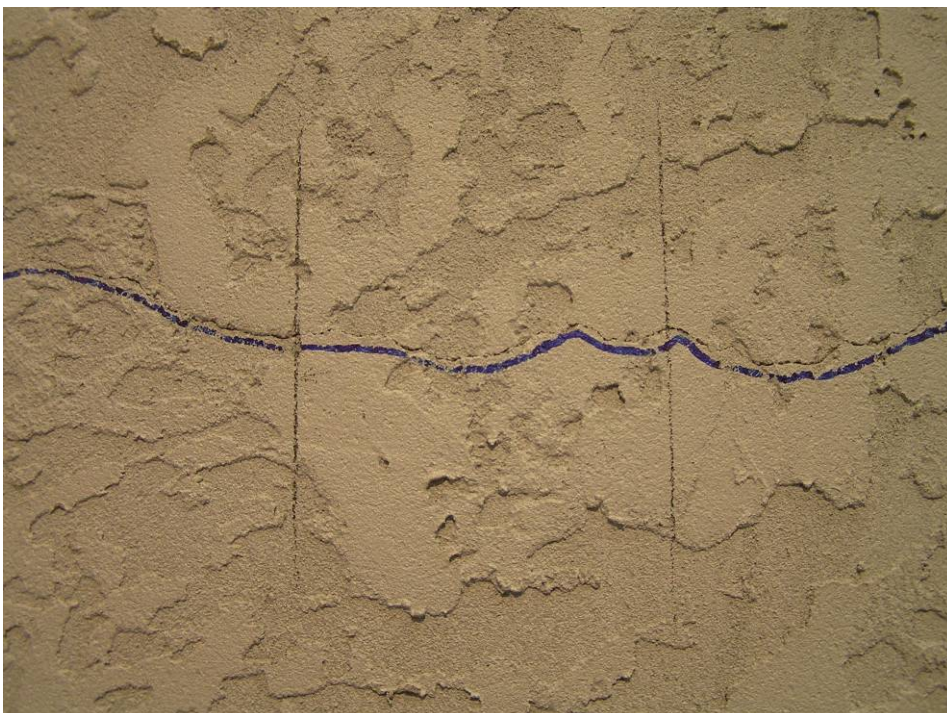
**Figure 14: Fine crack to be repaired by painting**

Fine cracks, less than 0.5 mm wide, may be adequately repaired by painting over with a flexible acrylic paint. The sequence of photographs in Figure 14 show an example crack before the application of paint, after the application of an acrylic primer undercoat (white), and after the application of a top coat of acrylic paint (grey).

Advice on usual paint repairs was obtained from the plasterers employed to build the stucco wall. They advised that they would paint over such cracks with Dulux Weathershield X10 (because it has a tough flexible finish) or Resene X-200 (because it has excellent crack-filling properties).

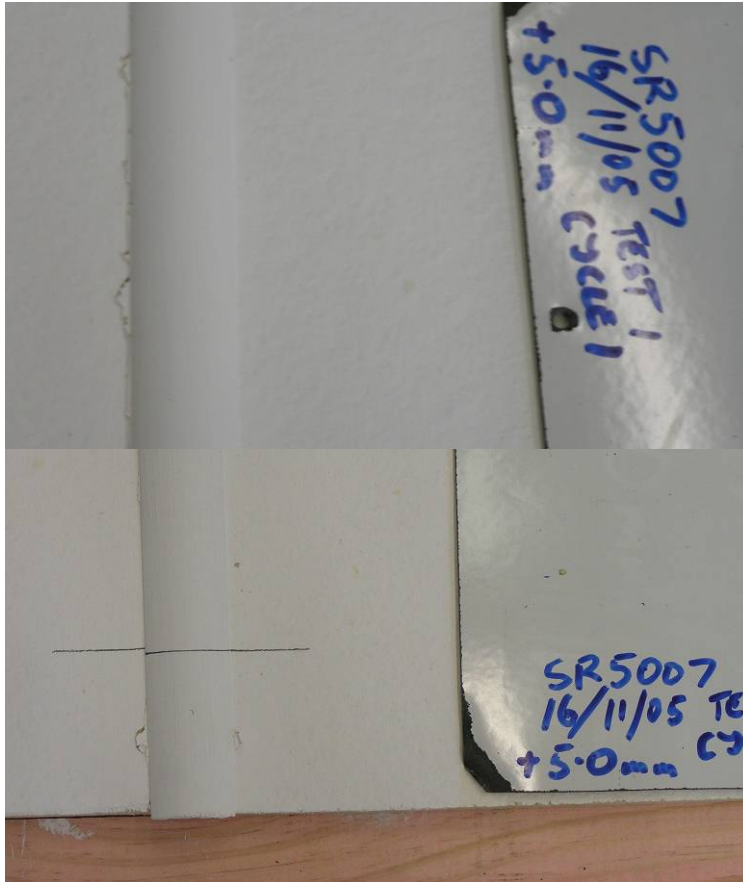
During cycling to  $\pm 5$  mm, movement between the beading and the softboard was noted at the half round beading between the sheets. The movement was approximately 2 mm and was

sufficient to break the paint (Figure 20). There was also sufficient movement of the softboard to cause the nail heads to 'pop' at the fixed end of the specimen (Figure 21) and under the half round bead (Figure 20).

**Figure 20: Movement of softboard sheet with respect to the beading**

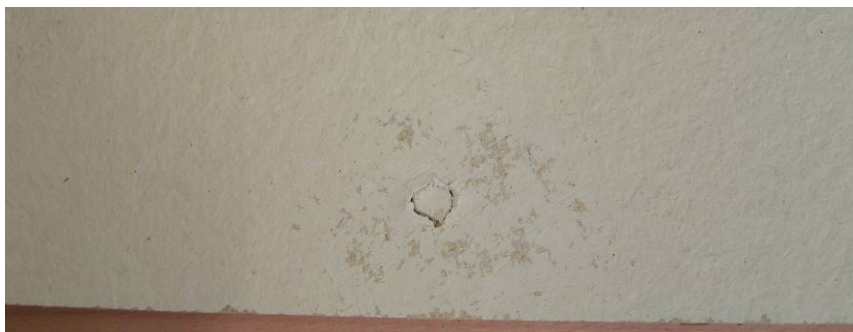
**Figure 21: Nail head beginning to show through gypsum plaster**

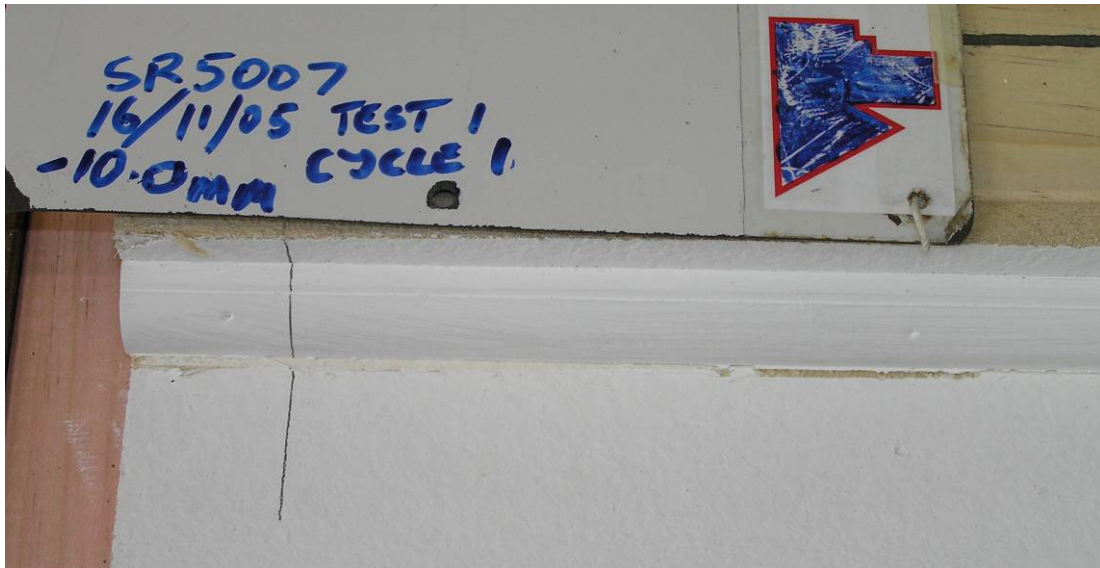
After cycling to  $\pm 10$  mm, some looseness of the softboard was evident at the loaded end of the specimen, caused by the nails scoring small slots in the softboard. The individual sheets had begun to rotate in-plane and movement between the sheets and the quads was obvious (Figure 22).

**Figure 22: Withdrawal of the softboard sheet from under the quad section**

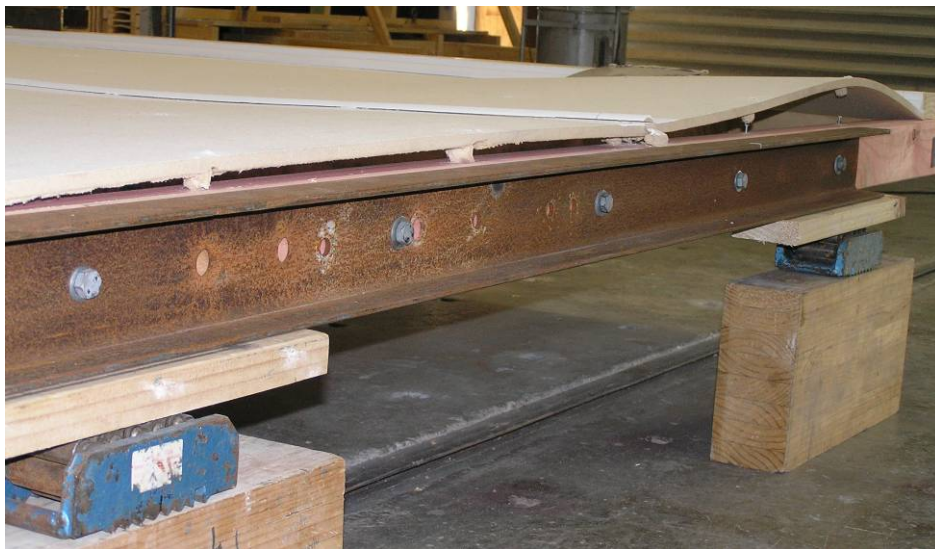
After three cycles to  $\pm 20$  mm, the racking was sufficient for the clouts securing the sheets to have worked large slots in the sheets (which would be expected to partially fall from the ceiling if not retained by the beading). It is expected that after such damage, the sheets would need to be re-fixed to the ceiling framing. Cycling to  $\pm 40$  mm caused the sheets to buckle along the loaded edge (Figure 23), and when the specimen was returned to zero displacement the half round beading had been lifted by approximately 10 mm. The clouts had pulled through the edges of the sheets and the corner nails had broken off sections of the sheets (Figure 24).

**Figure 23: Buckling of the sheet edges at 40 mm displacement**

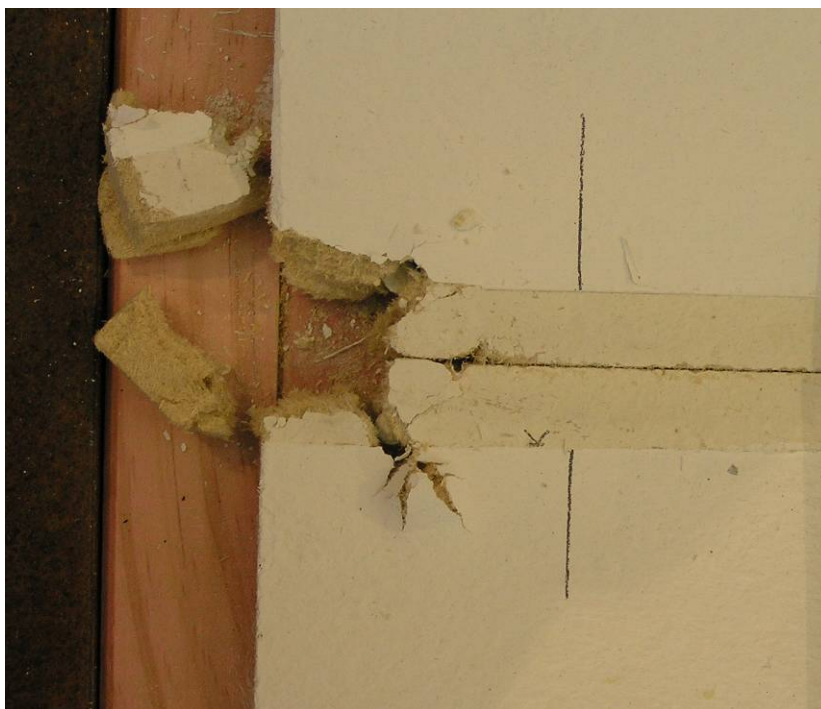
**Figure 24: Breakout of the sheet corners**

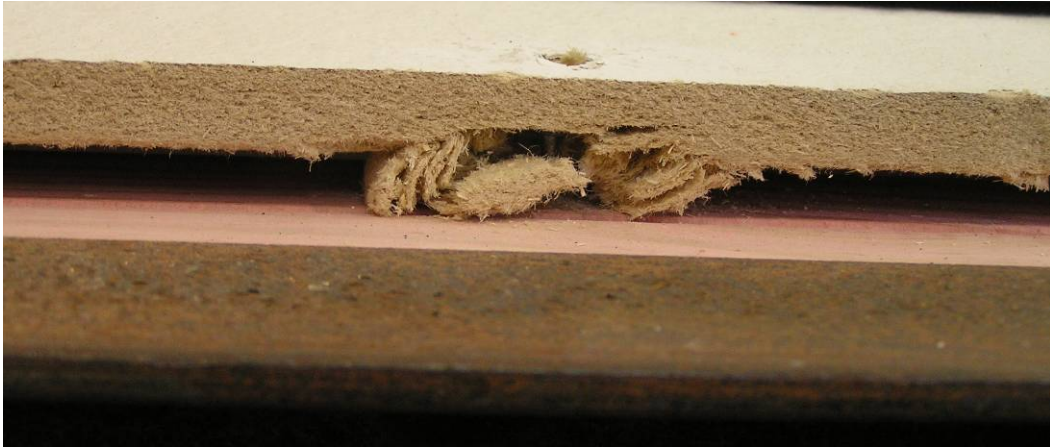
**Figure 25: Damage to underside of softboard caused by movement with respect to nails**

The half round beading was able to be removed intact. Most panel pins pulled through the timber beading and were hammered below the surface of the softboard. The bulges in the softboard caused by the working of the nails (Figure 25) were pushed back in place by hand and new clouts were driven approximately 25 mm from the original ones. A gap of up to 2 mm between the softboard and the ceiling joist remained after nailing due to displaced material left around the old nail hole when the nail pulled through. Displaced material around the nail holes above the surface of the softboard was either pushed or lightly hammered below the surface. The damaged areas and the heads of the new nails were then plastered in two operations: first to fill the larger holes; and then with a finishing coat to complete the repair. The plaster was then lightly sanded, where necessary, and two coats of primer undercoat were applied by brush. The surface looked presentable, but the plastered areas felt smoother than the softboard surface. If the paint had been applied by roller the surface texture would probably have been more uniform.

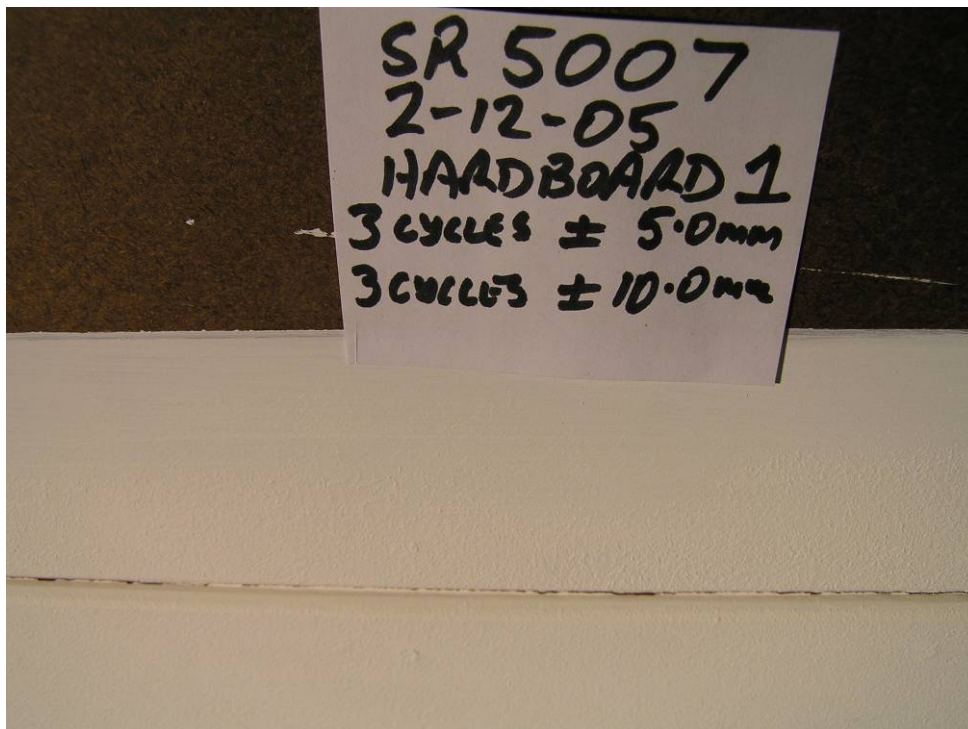
After three cycles to  $\pm 10.0$  mm, the crack in the paint at the join between the two sheets of hardboard was more noticeable (Figure 27). Some vertical movement of the sheets with respect to the framing was evident because the surface of the hardboard could be pushed up. This indicated that the panel pins had pulled out of the framing slightly. The paint covering some panel pin heads near the join in the sheets appeared to have been slightly disturbed.

**Figure 27: Crack observed in paint between sheets at champhered joint**

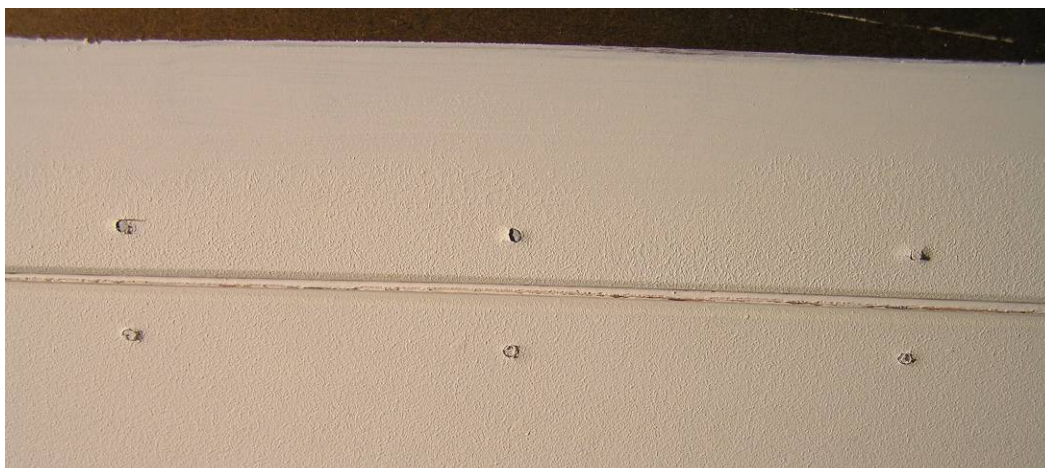
During the three cycles to  $\pm 20$  mm, the sheets began to pull out from beneath the quad sections at the specimen edges and the longitudinal misalignment at the joint between the sheets extended to 5 mm. The heads of the panel pins securing the sheets to the framing were clearly visible (Figure 28). At the junction between the sheets, the hardboard could be lifted approximately 0.5 mm to contact the framing because it had dropped away from the framing during the cycling. Nowhere was the hardboard fully detached from the framing.

**Figure 28: Panel pin heads becoming clearly visible during cycling to  $\pm 20$  mm**

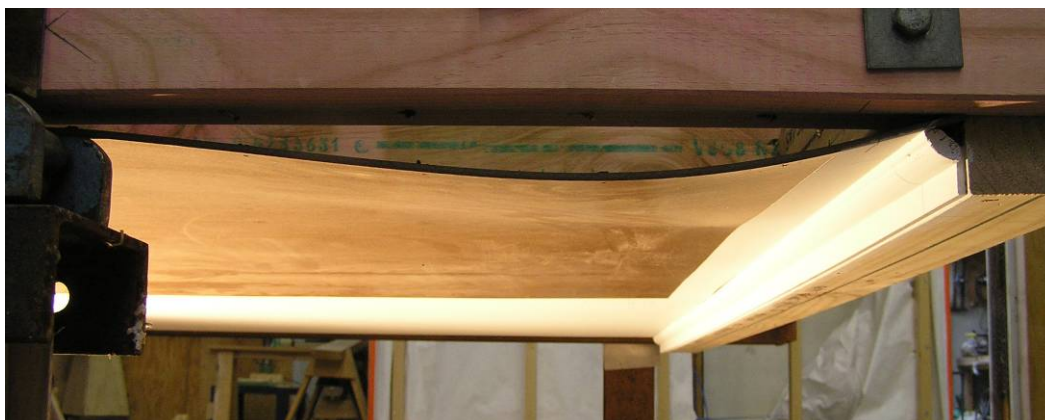
During the second half of the first cycle to  $\pm 40$  mm, the hardboard fully detached from the framing along the eastern (loaded) edge of the specimen (Figure 29). When the displacement returned to 0 mm, both the quad sections had been pushed out by the buckling sheets. The heads of the panel pins at the joint between the sheets were approximately 2 mm proud of the surface, and the half round beading had lifted approximately 1 mm. Where it covered panel pin heads, some damage had been sustained by the half round (Figure 30). The panel pins away from the edges of the sheets showed little sign of disturbance, and the sheets were not damaged except immediately around panel pin heads.

**Figure 29: Hardboard detached from the framing during the  $\pm 40$  mm cycle**

Repairs were undertaken which involved removal of the quad beads and the half round bead. Where the sheets needed to be re-attached to the framing, a block of 100 x 50 mm timber was used to 'hammer' the sheet back against the frame. This process prevented the sheet from local damage that would have been caused using a traditional hammer. Exposed panel pin heads were punched home and the hardboard was re-fixed with extra panel pins placed between the old pins. The surface was sanded where protrusions had been created by the moving panel pins and the holes were filled with gypsum plaster before repainting. A section of the repaired ceiling is shown in Figure 31. New sections of beading were installed.

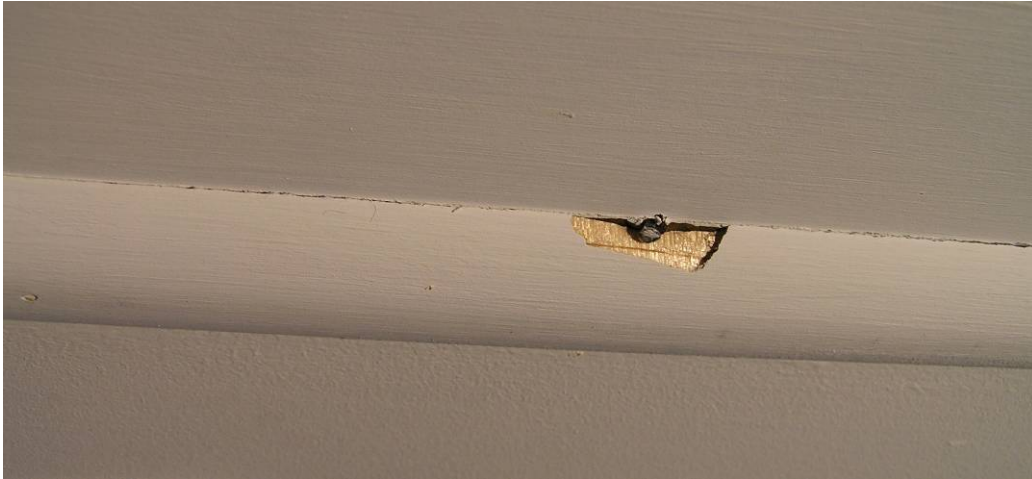
**Figure 30: Damage to half round bead caused by panel pin head**

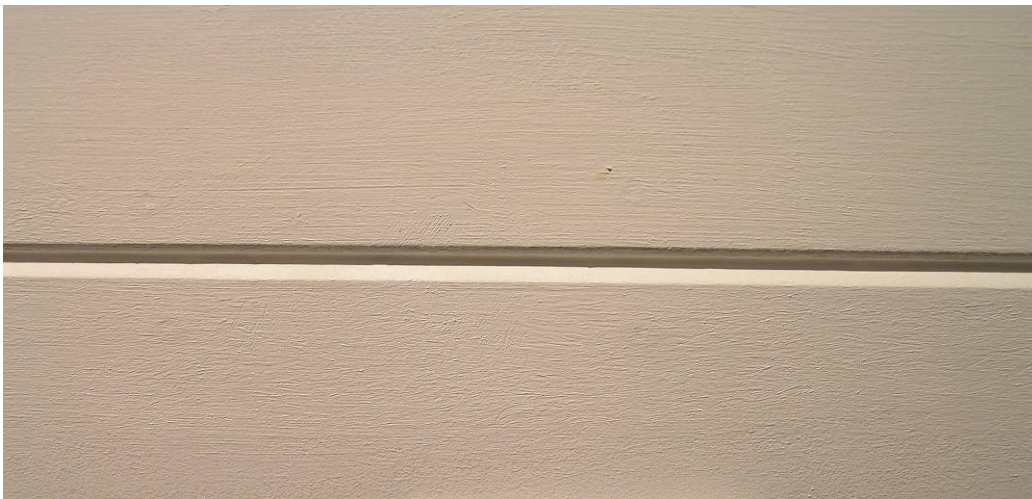
**Figure 31: Repaired champhered joint**

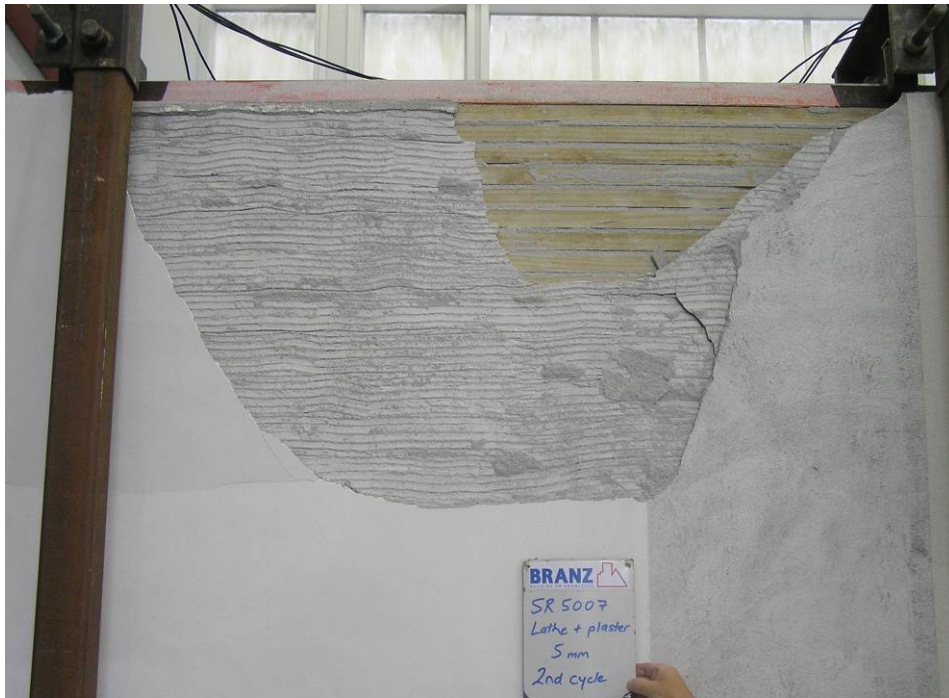
**Figure 36: Large sections of plaster lost from the upper third of the wall during cycling to  $\pm 5$  mm**

It could be argued that the plaster had not reached the strength that would be expected of it in normal service, and therefore the failure was premature. However, in subsequent discussions with the building contractor working at Lady Ferguson House in Thorndon, it was discovered that he had found it too difficult to work with the old lath and plaster walls and had elected to remove both the plaster and the lath and apply new gypsum plasterboard over 20 mm thick packing fixed on the face of the studs, thus matching the original thickness of the wall lining. This meant that door frames required no alteration to accommodate the new linings. To retain elaborate cornices, the plasterboard was butted up to the underside edge of the cornice. New skirting boards were fitted over the gypsum plasterboard.

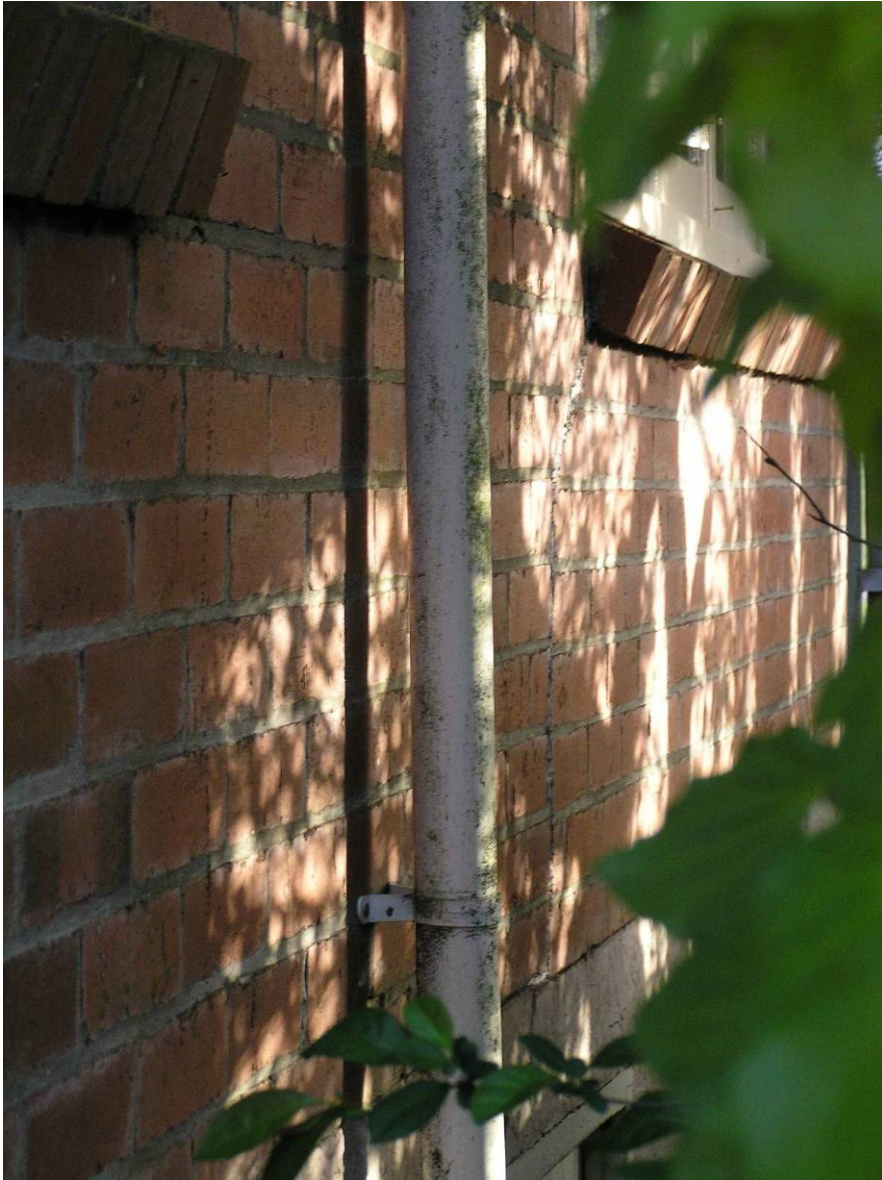
This case suggested that further settlement may have occurred since the injection work, but this must be tempered by the statement by the owner that he had elected to stop the injection when it may have been possible to lift the foundation further.

**Figure 37: View of wall showing the misalignment of the mortar joints and the crack**

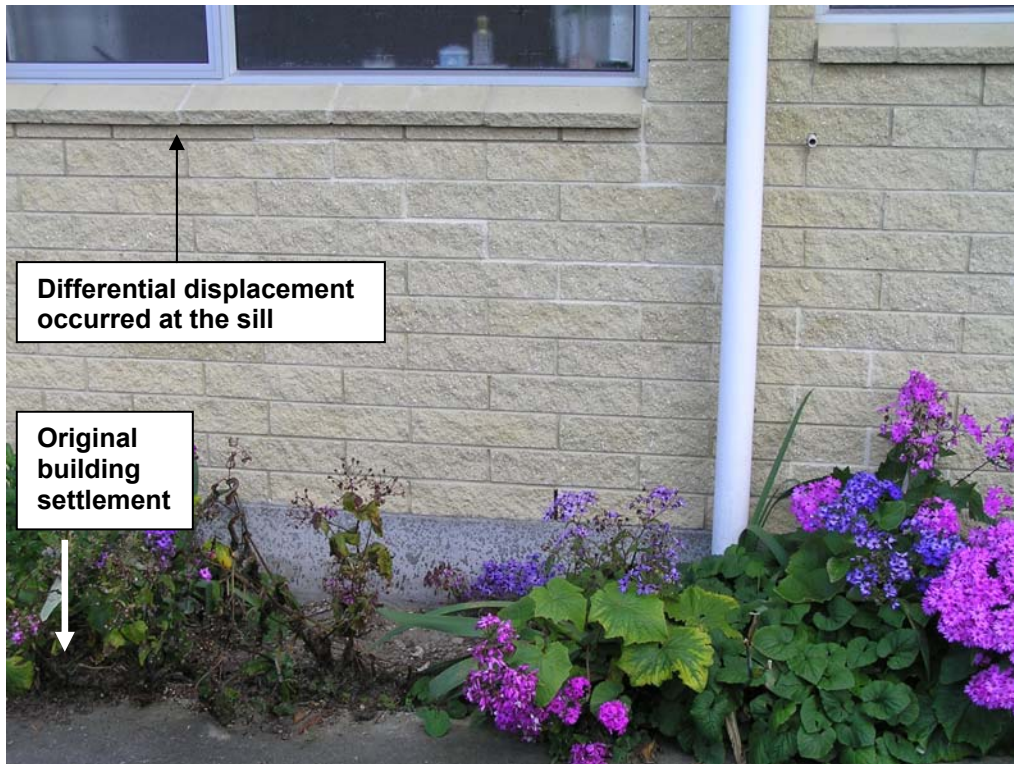
in the foundation was no more than a typical shrinkage crack ( $<0.5$  mm) and could have been easily repaired by rubbing in a cement paste. At this property, the floor adjacent to the sunken footing was lifted off the underlying hardfill during the injection process beneath the footing. However, the suspended span that was created was considered to be sufficiently small for mesh reinforced concrete that further injection beneath the slab for support was unnecessary.

**Figure 39: Overall view of the repaired veneer where the foundation had settled**

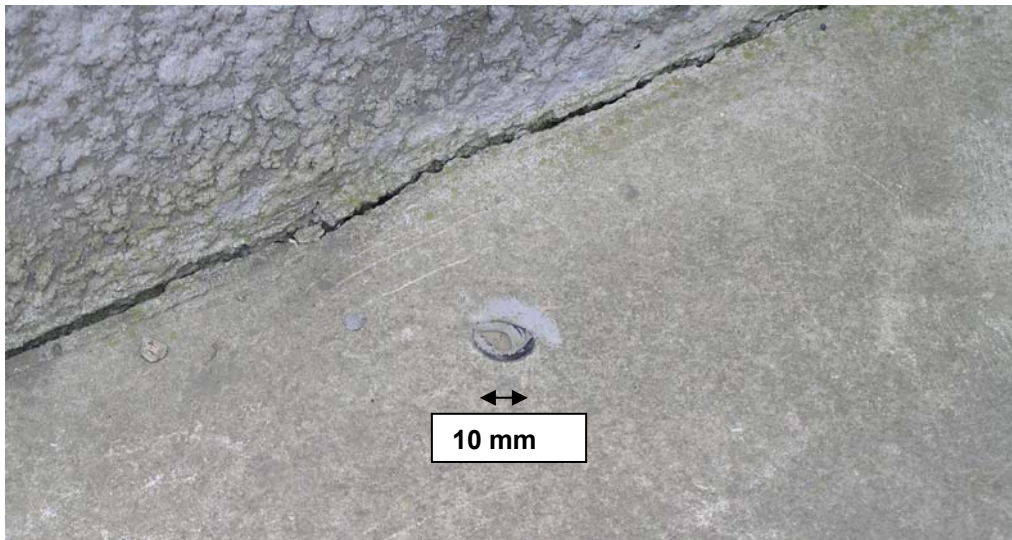
The only evidence of any injection work beneath the yard slab was the small holes left after the injection process that had been grouted (Figure 40). The owner of the property indicated that there had been no more water ponding problems since the levelling work was undertaken.

**Figure 40: Evidence of the injection process beneath the yard slab**
