STUDY REPORT

No. 191 (2008)

Seismic performance of brick veneer houses

Phase 3. Shake table tests on a concrete brick veneer room

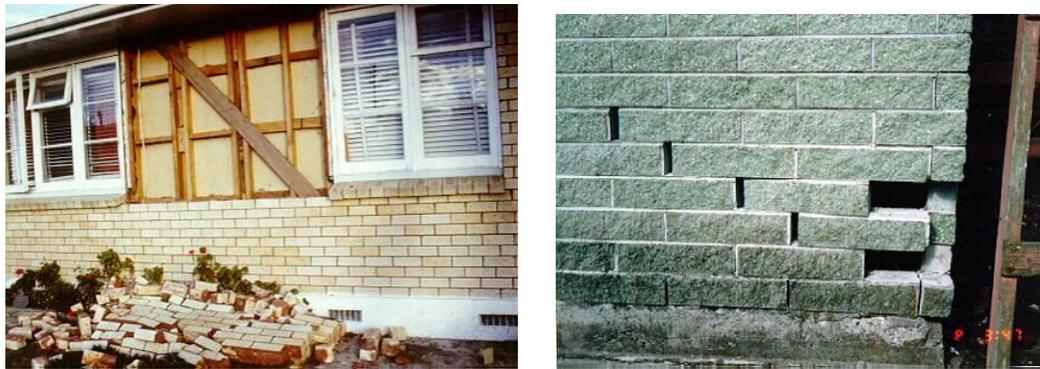
Figure 1. Examples of veneer damaged in the 1987 Edgecumbe earthquake

Historically brick veneer has performed poorly in earthquakes. Cracking, particularly at building corners, window/door corners and partial collapse of the veneer have been common (Figure 1). However, recent improvements in the way brick veneer cladding is constructed is expected to result in improved performance and this study is intended to quantify this.

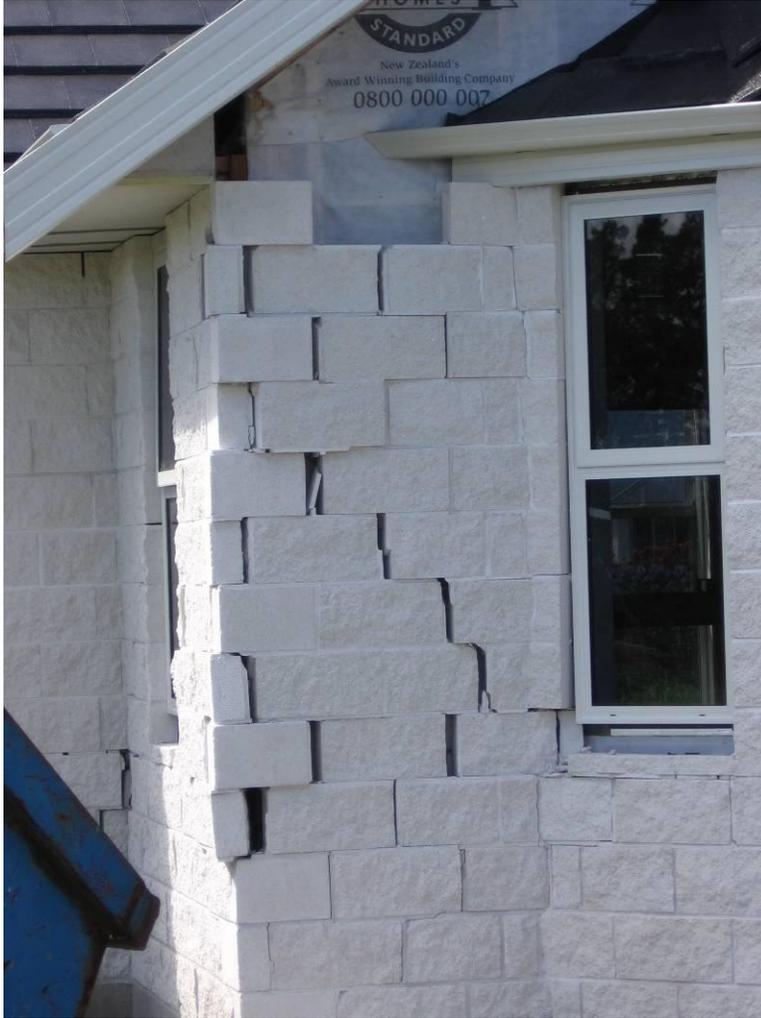
Figure 2. View of the damaged veneer on a Gisborne house

During the course of this research programme, a magnitude 6.8 earthquake struck the city of Gisborne, in Hawkes Bay. While little damage to brick veneer was reported, one particular property which was under construction exhibited significant damage in the veneer cladding (Figure 2). The veneer was 95 mm thick split concrete brick in this instance. It appeared that the bond between the bricks had failed sufficiently that individual bricks were ready to fall from the veneer.

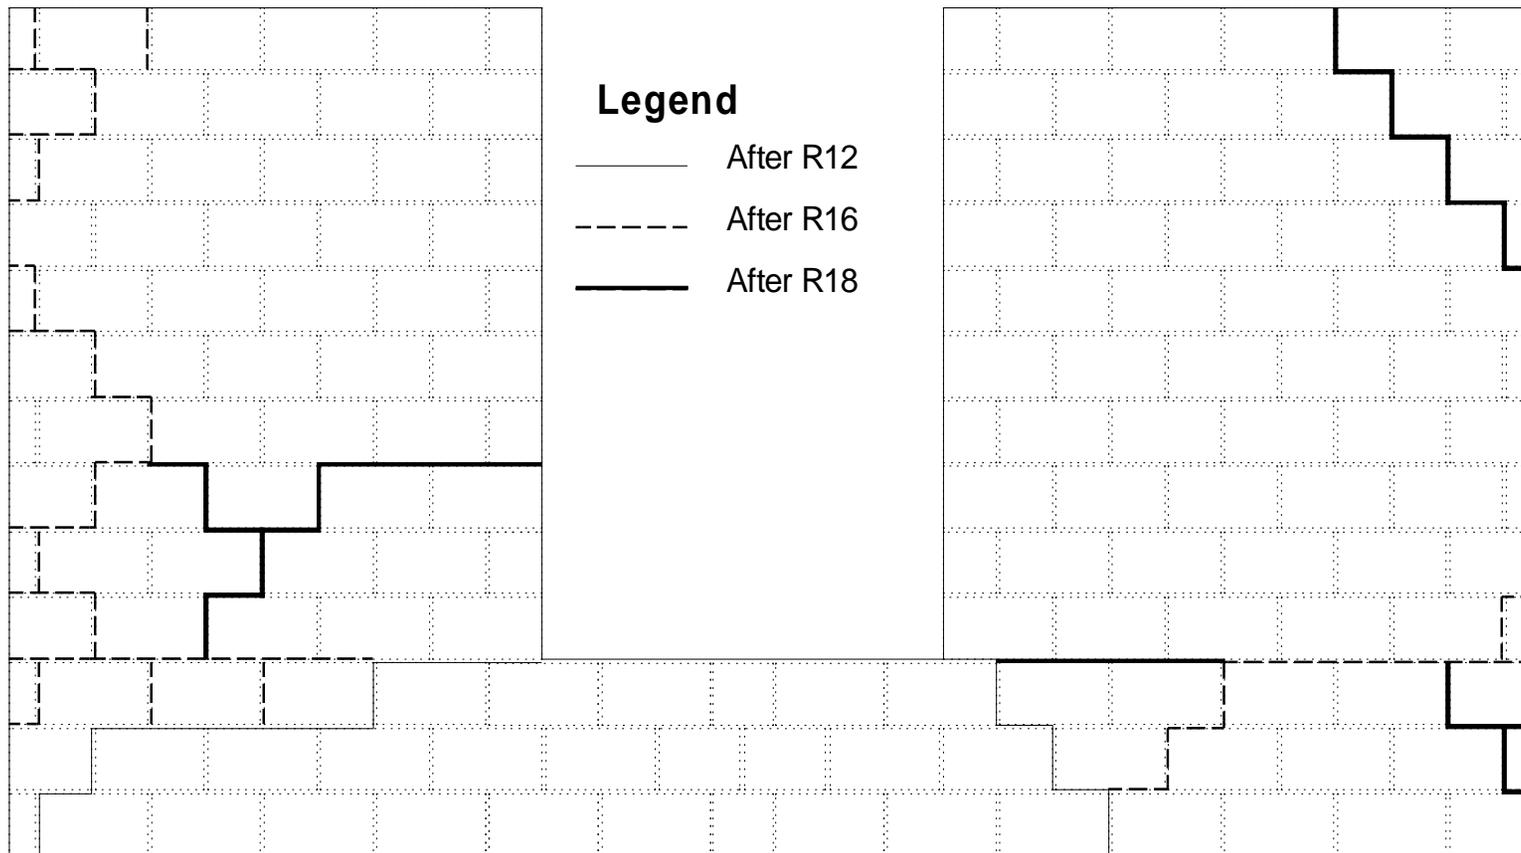
Figure 13. Cracking in Side 1

No veneer cracks were observed in Tests R1 to R11 (where the motion of the LTF ceiling relative to the shake table was less than ± 5 mm). However, some reduction in room stiffness/natural frequency did occur as discussed in Section 7.1. Very fine mortar cracks were noted after Test R12 (as shown in Figure 13 and Figure 14) where the ceiling motion relative to the table was ± 5.3 mm.

In Test R14, which was run at 4 Hz, the recorded LTF ceiling deflections were ± 9.1 mm and rocking in all four “L-shaped veneer corner elements” was clearly visible. The relative deflection of the ceiling with respect to the shake table increased to ± 20.5 mm in Test R15 at 3 Hz. The damage to the lining fixings was noted to be severe after this test. In Test R16, at 2 Hz, the recorded LTF ceiling deflections were ± 46 mm. This movement was almost entirely accommodated by rocking of the veneer panels above the base cracks.

At this stage, although fine cracks were observed as shown in Figure 13 and Figure 14, the veneer panels appeared to act as single units, there was no slippage along mortar joints and cracks closed at the end of these tests. The only visible damage after the tests was fine mortar cracks which could be repaired by re-pointing.

The observed veneer cracking at the end of Tests R12, R16 and R18 is shown in Figure 13 for Side 1 and Figure 14 for Side 2. Photographs are given in Figure 13 to Figure 21. A few concrete bricks completely dislodged and fell to the floor. These are shown hashed.

All four L-shaped corner veneer elements and the single isolated pier (Panel F) rocked about alternate ends of the cracks shown during the applied backward and forward motion. Unlike the shaking tests on the clay brick veneer (Thurston and Beattie 2008b), increased rocking resulted in panels sliding on horizontal mortar courses and a multitude of additional mortar cracks formed. In places, the veneer fragmented into separated bricks. The brick interlocking at corners was not as effective as in the clay brick construction and brick sliding and separation occurred mostly at panel corners or free ends. However, there was little evidence of the room end wall brick veneer having significant movement in the out-of-plane direction relative to the LTF.

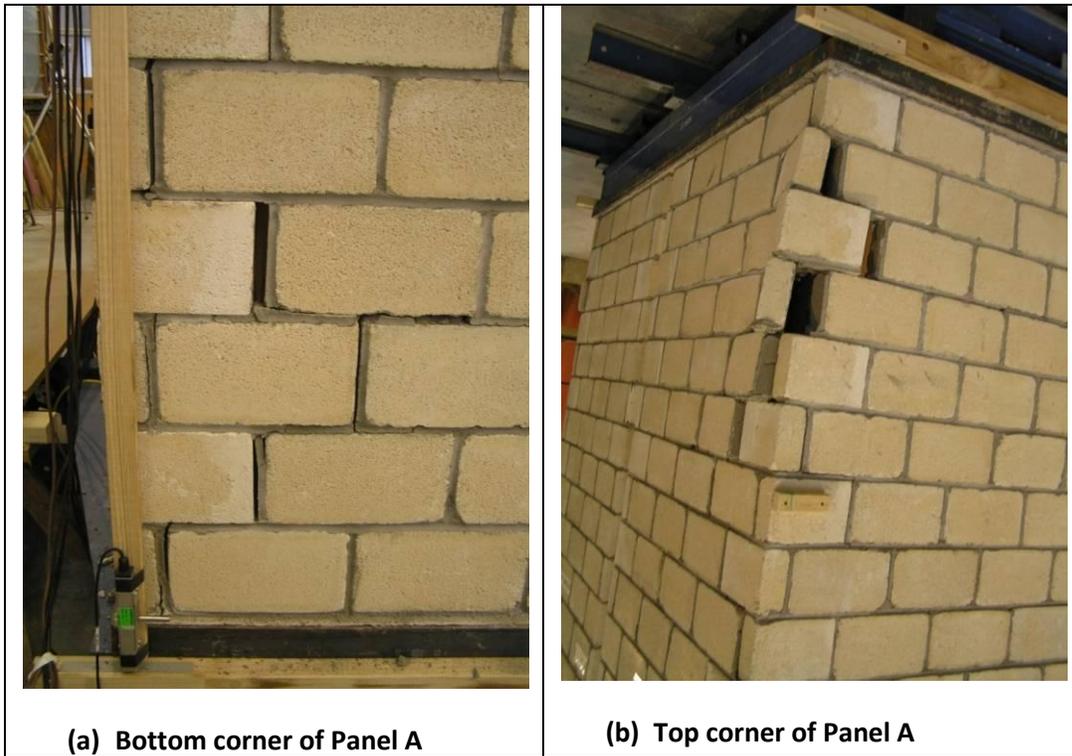
Figure 15. Panel A after Test R19

Tests R19, R20 and R21 were simply repeats of Test R18 for demonstration purposes. As there was no data recording, these tests are not included in Table 1. The veneer deteriorated significantly in these 30 seconds of testing, as discussed in Section 6.

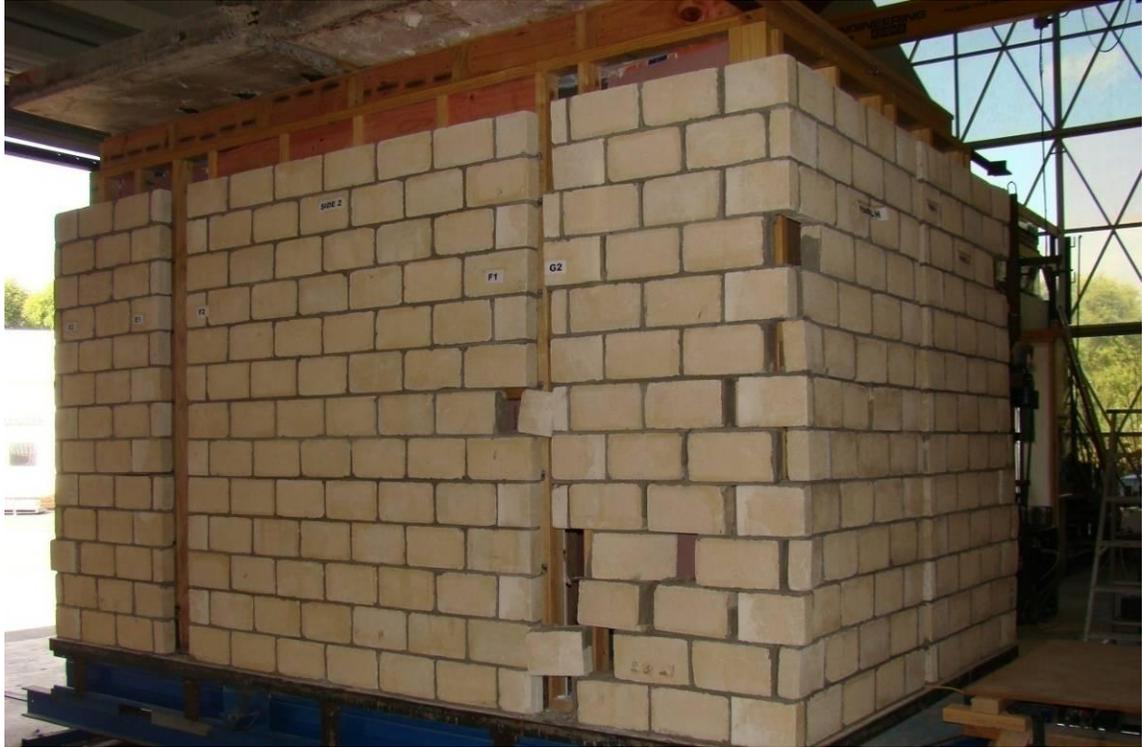
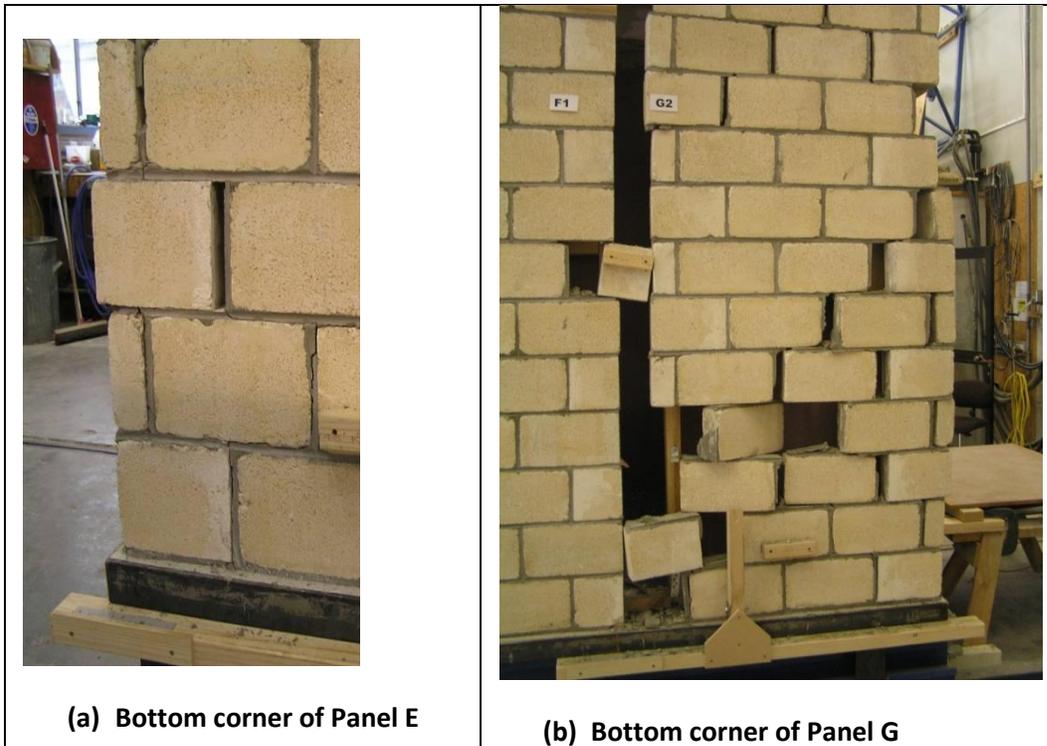
Figure 17. Side 2 after Test R19

Figure 18. Side 2 after Test R19

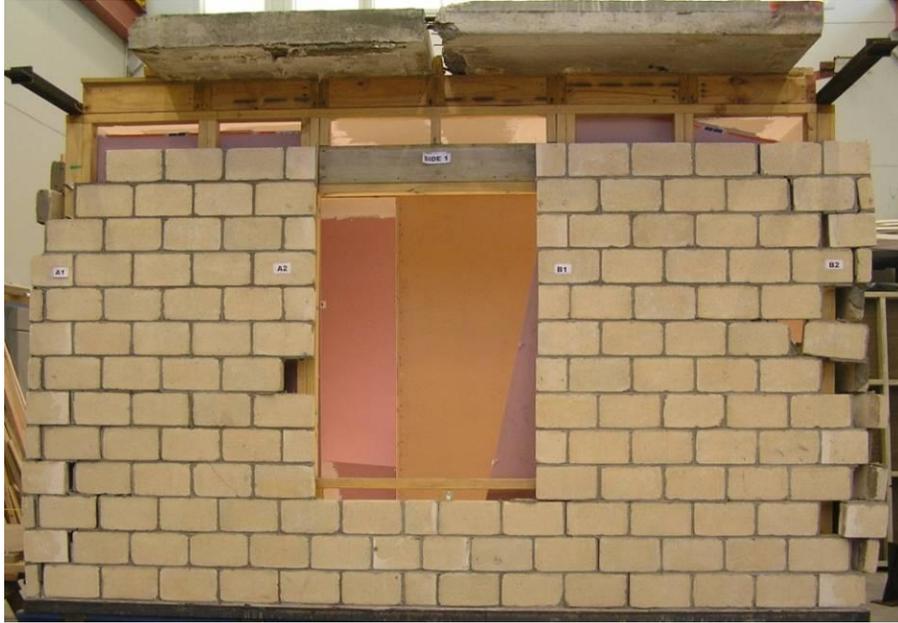
Figure 19. Side 1 after Test R21

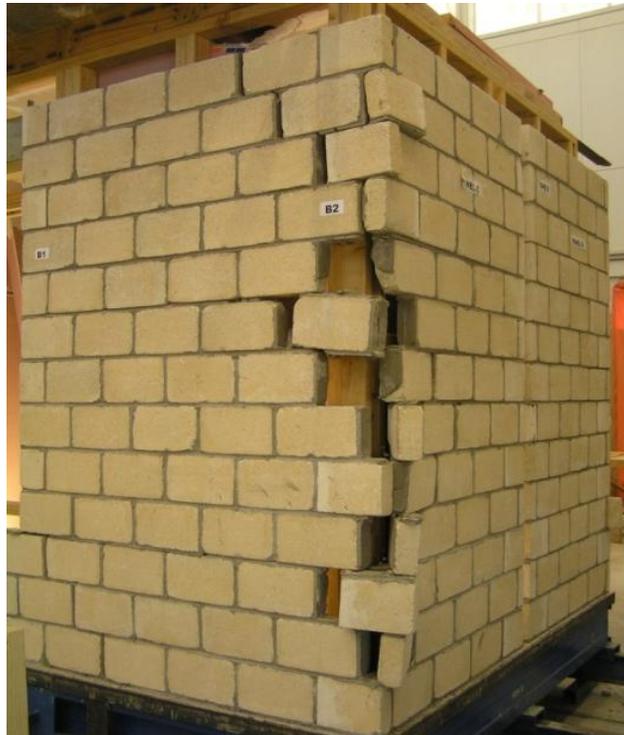
Figure 20. Corner of Panel B after Test R21

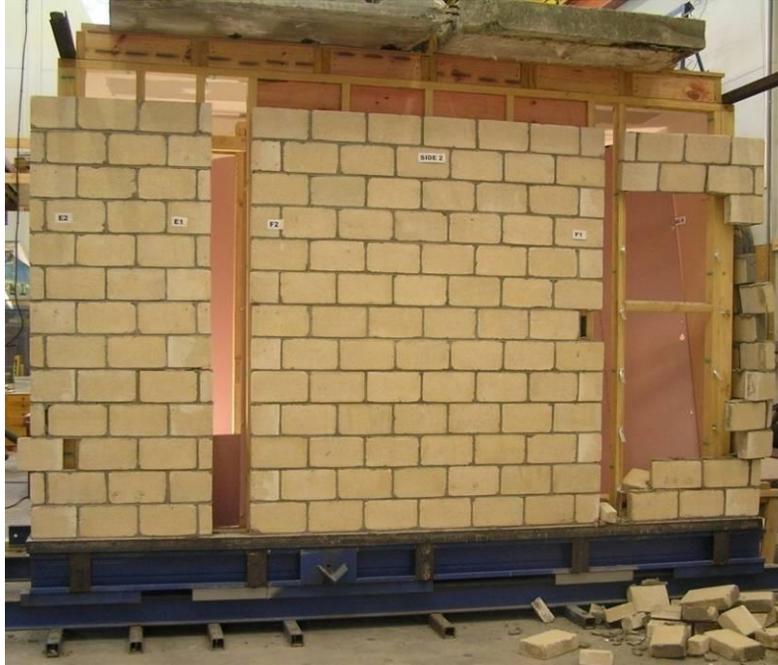
Figure 21. Side 2 after Test R21
