STUDY REPORT

SR0265 (2012)

Effect and Remediation of the Loss of Building Lateral Stiffness Caused by Earthquake Loading

SJ Thurston

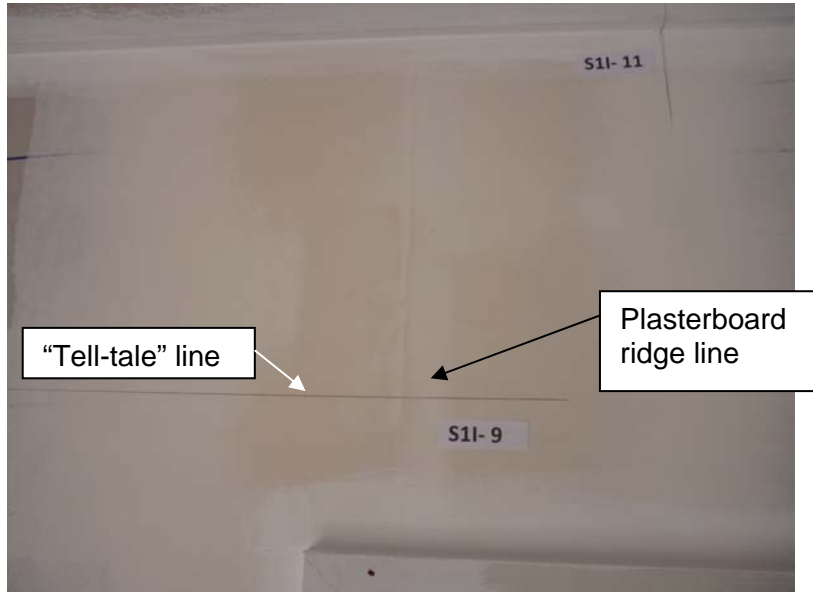
Photograph D1 taken at peak load in test P1D4. Typical plasterboard vertical ridge line which formed along plasterboard joints constructed at window corners (ridge lines flattened at zero displacement and were hard to detect).

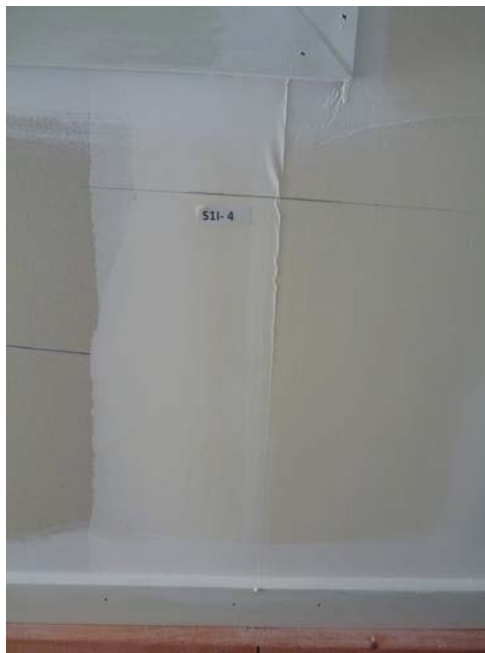
Photograph D2 taken after test P1D8. Typical plasterboard crack and ridge line which formed along most plasterboard joints constructed at opening corners

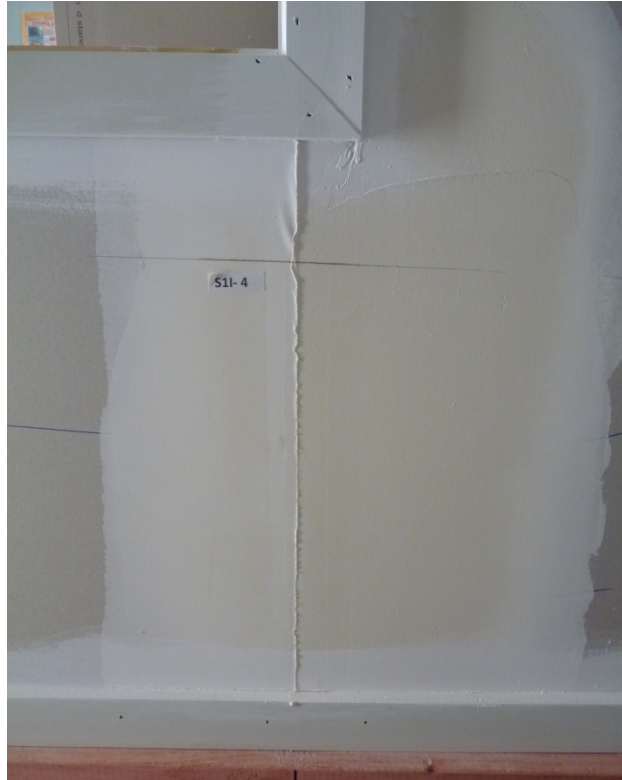
Photograph D3 taken after test P1D12. Typical plasterboard crack along plasterboard joints constructed at opening corners

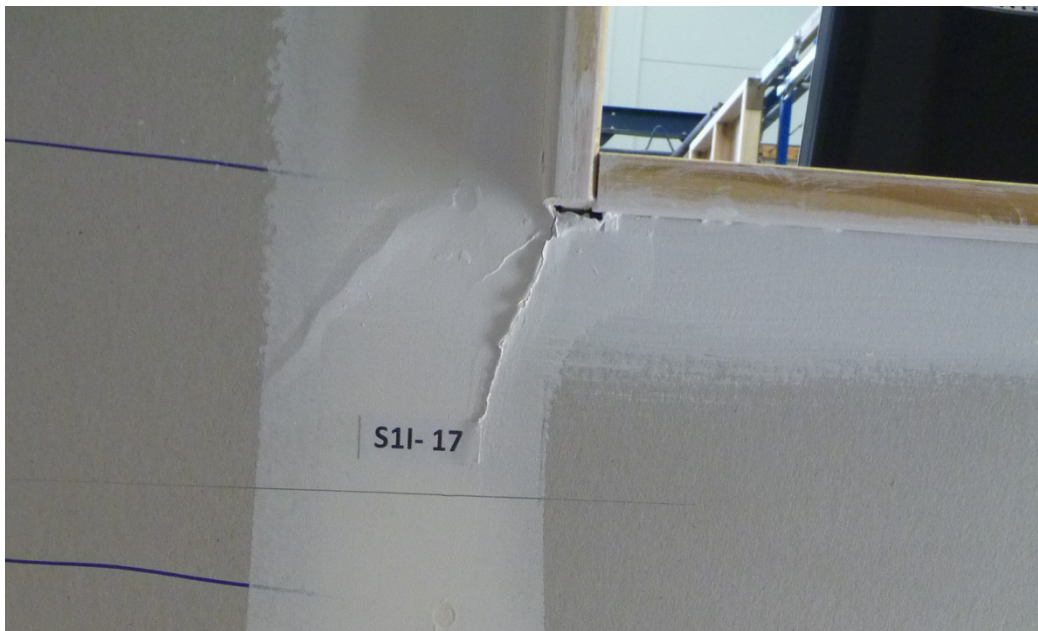
Photograph D4 taken after test P1D12. This is the largest of the diagonal cracks emanating from opening corners for construction complying with the J_NOT_Openings detail

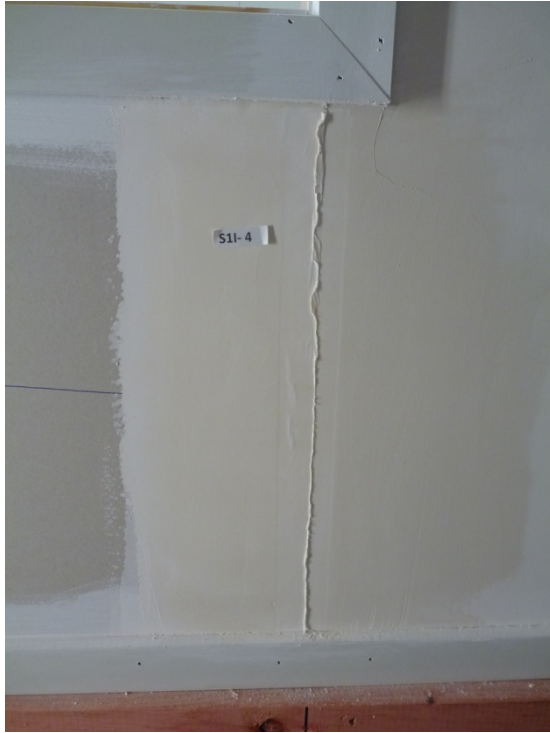
Photograph D13 taken after test P2D16. Vertical plasterboard cracks had increased in severity

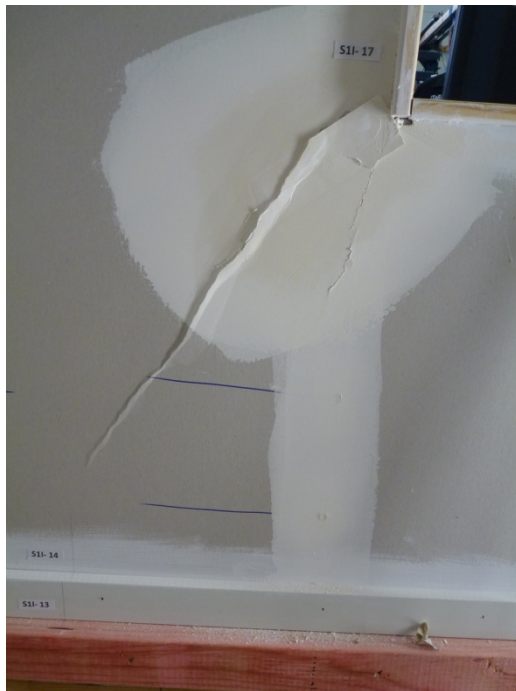
The testing in Phase 3 had only been taken to ± 10.7 mm and thus cracks were generally minor. However, the crack on sheet BP2 (location defined in Appendix B) was large (see Figure D.14) and thus the full sheet in panel BP2 which was cut around the window was completely replaced. Elsewhere, the following repair work was performed at the completion of the testing in Phase 3:

Photograph D14 taken after test P2D16. The largest of the diagonal cracks had now increased in length

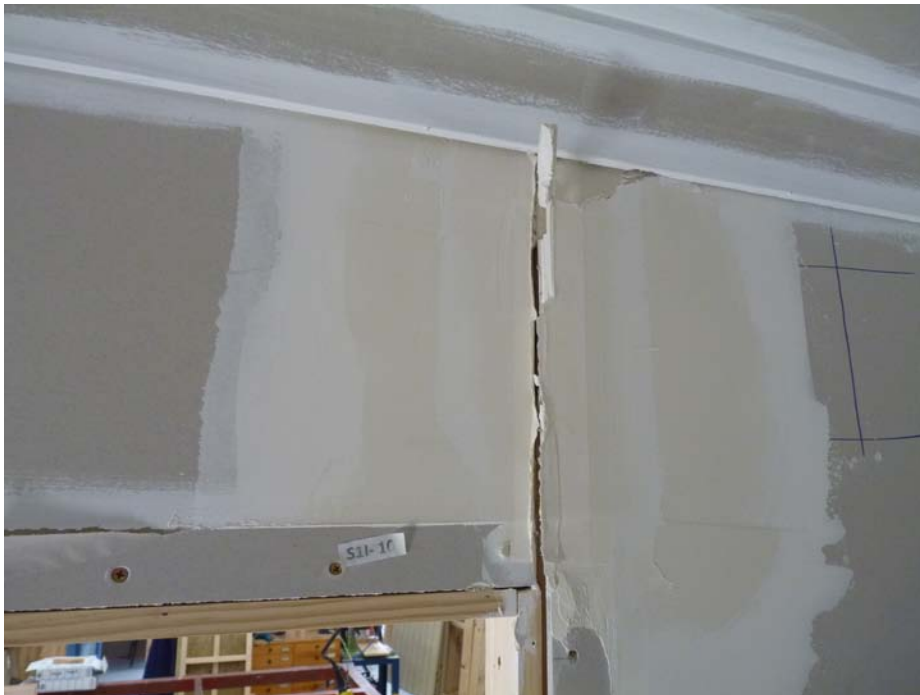
Photograph D20 taken after test P4D40. Vertical crack widths had increased in width and some sheets had become loose

1. The testing in Phase 4 had been taken to ± 31.4 mm and some sheets were partly detached and cracked with the plasterboard on either side of the cracks not aligned. To correct this damage, screws were removed until the board could be pushed to be flush with the studs and then the screws were replaced.

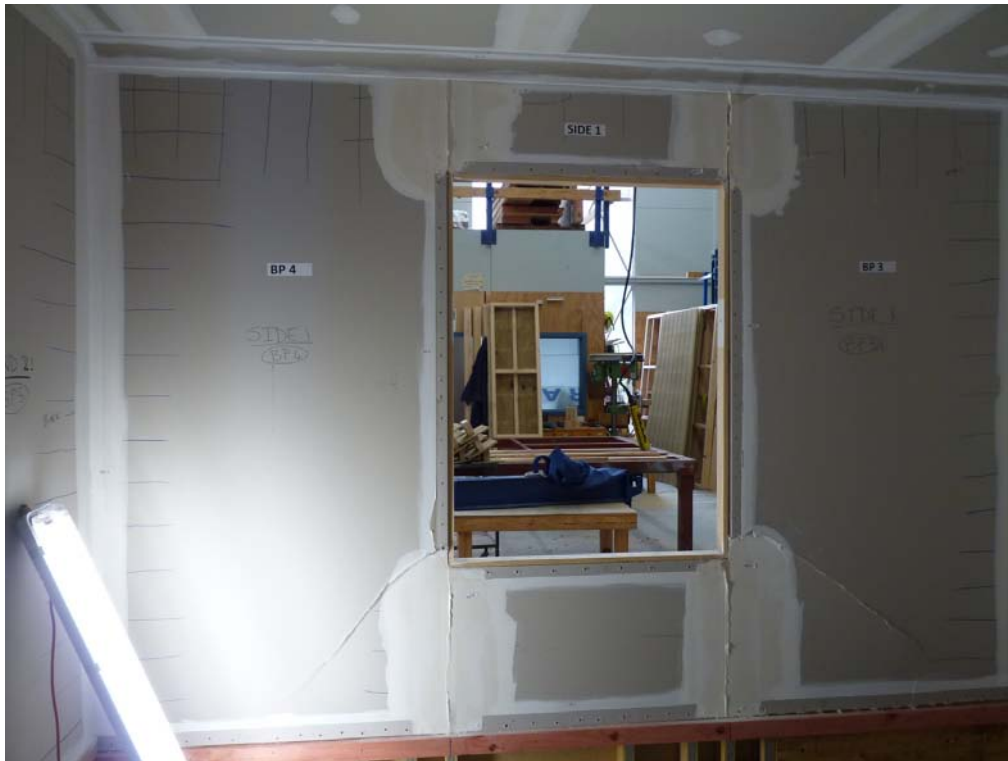
Photograph D21 taken after test P4D40. Note that diagonal cracks had formed at both the J_NOT_OPENINGS and J@Openings joints

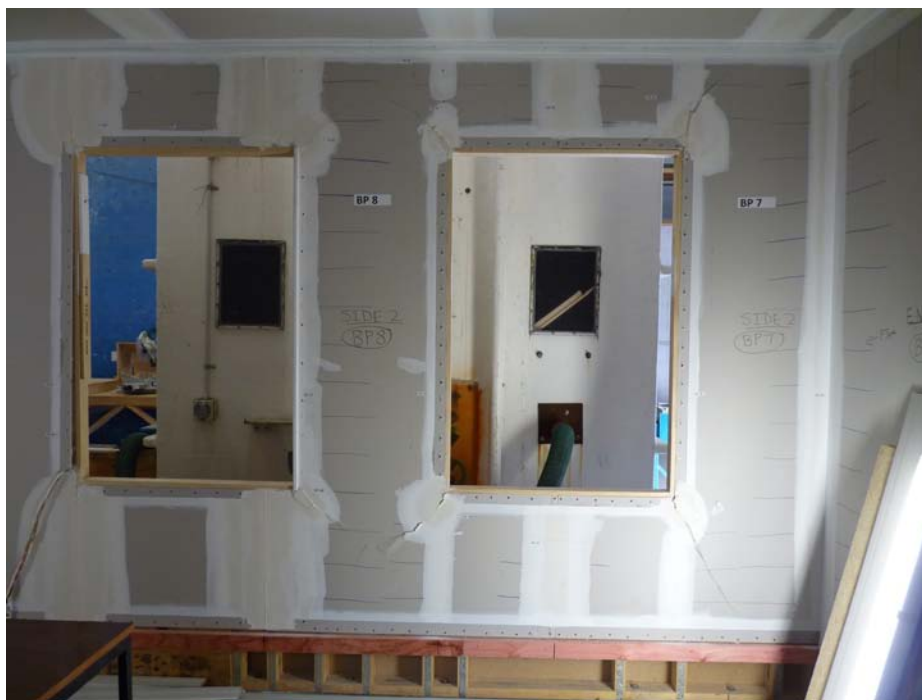
Photograph D22 taken after test P4D40 showing diagonal cracks from both the J_NOT_Openings and J@Openings joints

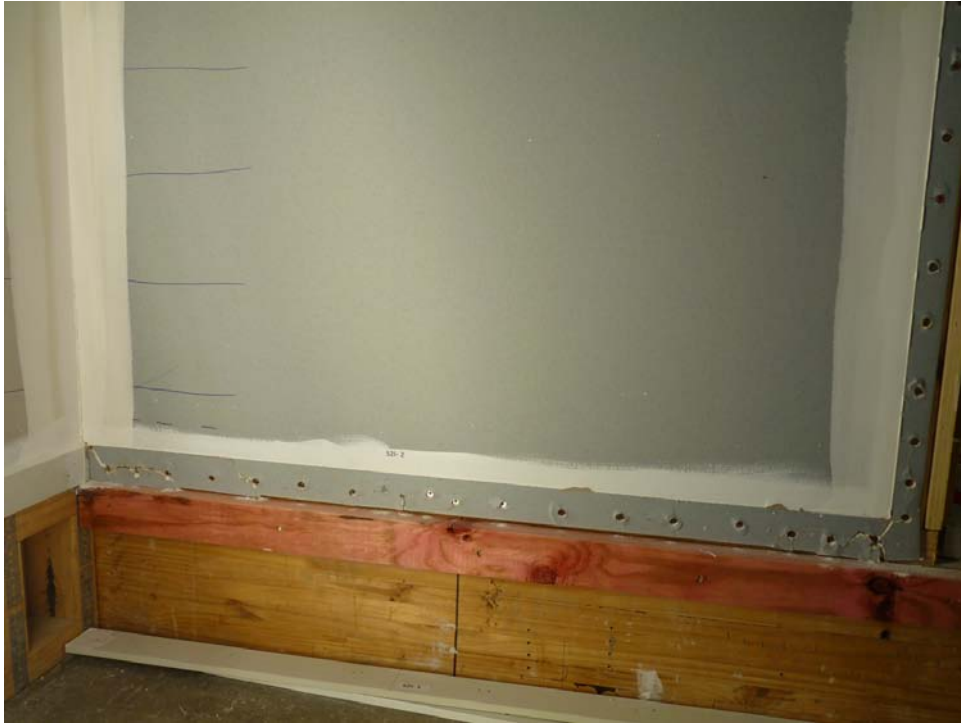
Photograph D23 taken after test P4D40. Plasterboard distress at screw locations

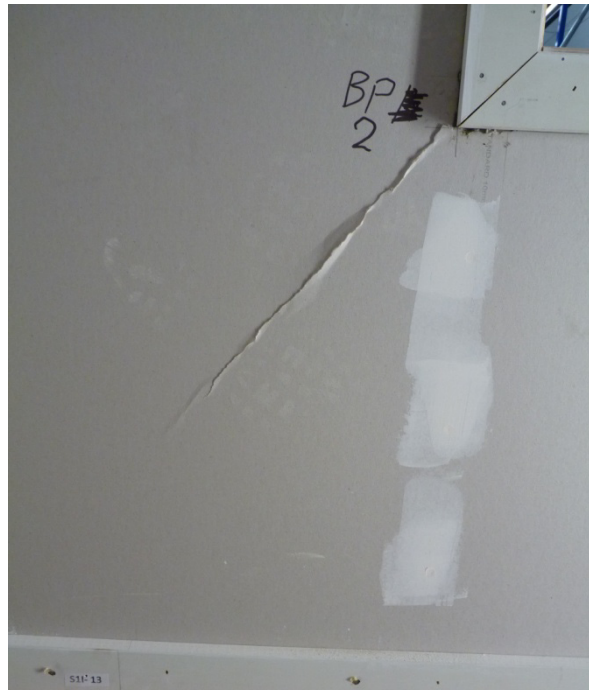
Photograph D24 taken after test P5D16. Crack length = 550 mm
