STUDY REPORT

SR 316 (2014)

New housing condition – A preliminary assessment

I C Page

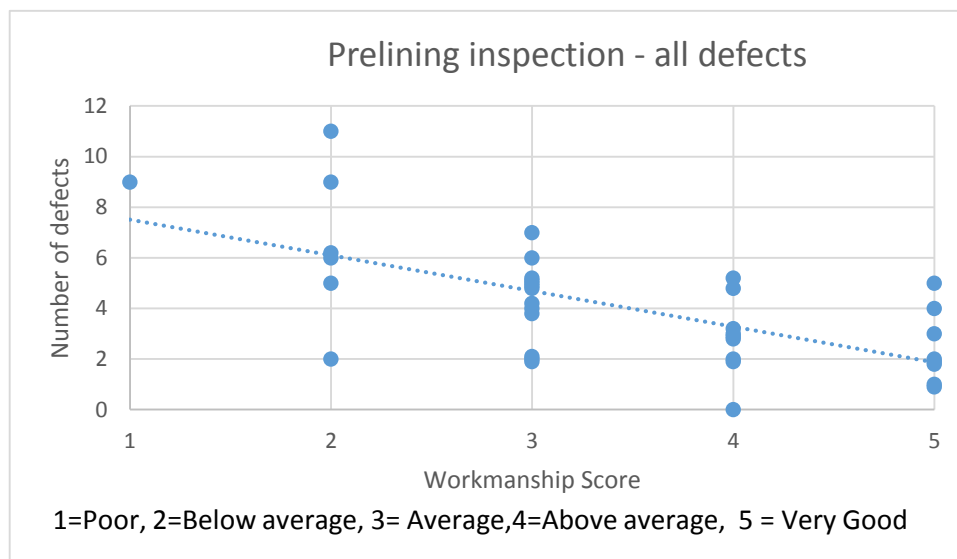
Figure 1 Pre-lining inspection defects v workmanship score

An overall assessment of workmanship was made on a five point scale ranging from very good to poor. Figure 1 shows a scatter chart of results for the 36 houses in the sample. The vertical axis is a count of the number of defects in a house, including code compliance defects and amenity or quality type defects. Generally houses with more defects were rated lower in overall workmanship, as is to be expected. The most common defects were incorrectly fixed window joinery, poorly fitting insulation, and straps and nogs sitting proud of the framing.

The inspectors were asked to give an overall rating for workmanship on a 1 to 5 scale with 1= poor, 2= below average, 3= average, 4= above average and 5= good. Figure 1 and Figure 2 show the number of defects against their workmanship score. The trend is downward from left to right, as expected but even with a good workmanship score there are still a significant number of defects in some houses. This suggests there may need to be refinement in scoring overall workmanship. Further investigations are needed in how the inspectors assess the workmanship score.

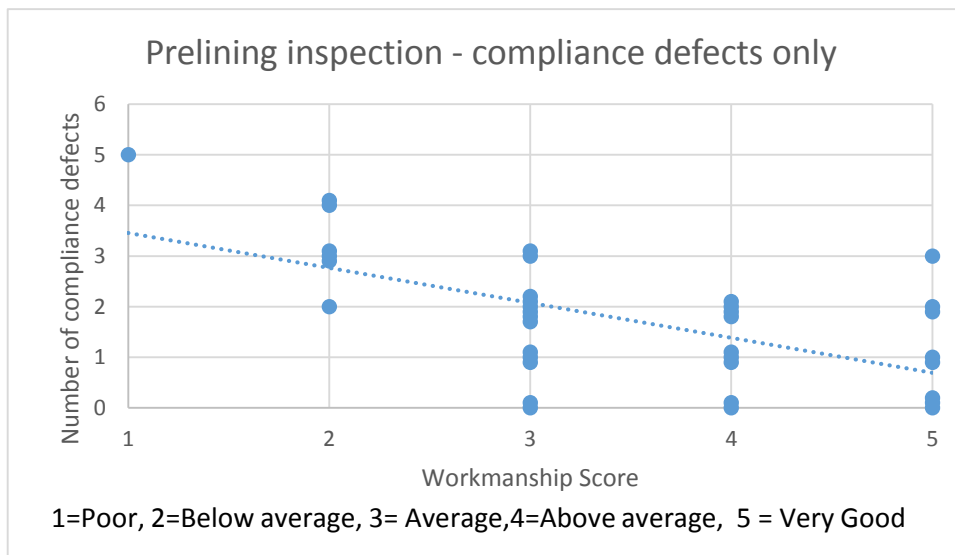
Figure 2 Pre-lining inspection defects – compliance defects only

Figure 2 shows the same data but for code compliance defects only. These defects relate to the frame and connectors and the defects counted were inadequate window fixing and air seals, large cut-outs in frames, inadequate holding down bolts, and penetrations not sealed to the wrap correctly. Other defects including misaligned studs and nogs, compressed/missing insulation, and particleboard flooring in wet areas were counted as “quality” type defects and not included in the compliance defects. The reason was the work has been done, but not to a completely satisfactory standard, affecting the performance or finish so it is counted as a quality defect rather than affecting code compliance.

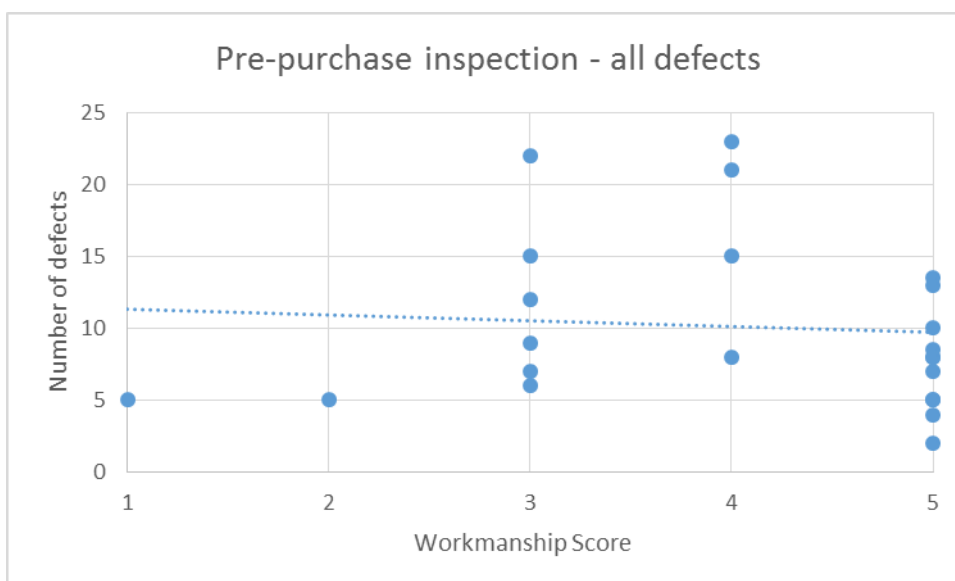
Figure 3 Pre-purchase inspection defects v workmanship score

Figure 3 shows a scatter chart of results for the houses inspected. The vertical axis is a count of the number of defects in a house, including code compliance defects and amenity or quality type defects. Generally houses with more defects were rated lower in overall workmanship although the link was not as strong as for the pre-lining inspections.

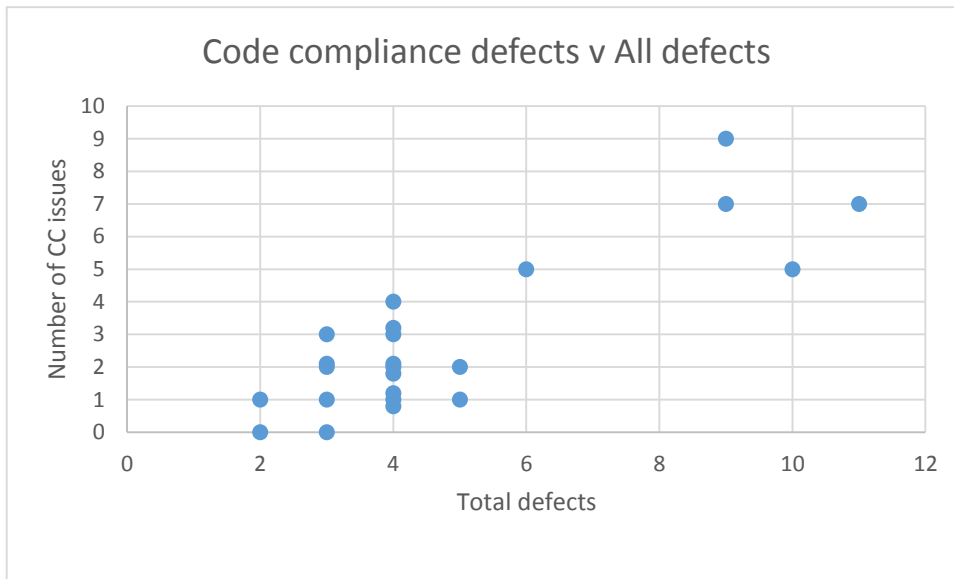
Figure 4 Pre-purchase inspection defects – Compliance v all defects

Figure 4 shows a scatter chart of code compliance defects on the vertical axis, against total defects on the horizontal axis. The two are strongly related, but houses with smaller numbers of compliance defects also tend to have smaller numbers of *additional* quality defects. For instance, houses with three total defects in total averaged 1.5 compliance defects and 1.5 quality defects. Houses with four total defects averaged around 2.1 compliance defects and 1.9 quality defects.

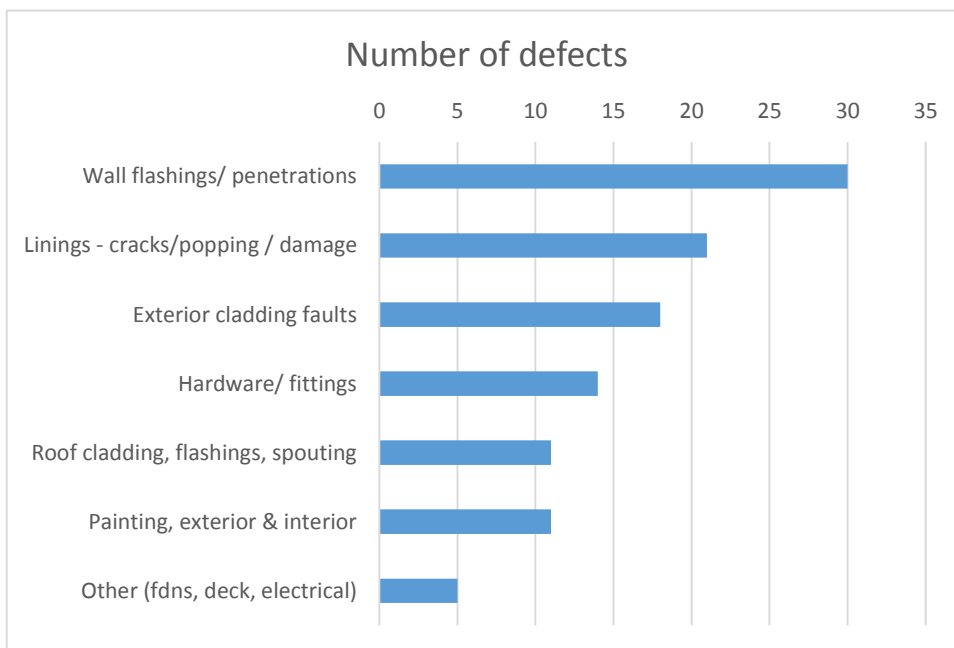
Figure 5 Pre-purchase inspection defects – Types of defects by number

Figure 5 shows the mix of main compliance and quality defects. The most common are wall flashings and penetration defects, cracked linings, and wall cladding defects (cracks/damage, loose bricks/ mortar, inadequate ground clearance to cladding). The defects counted as code compliance issues are wall flashings/ penetrations, exterior cladding cracks and loose bricks, and damaged roof cladding and flashing defects. The other defects in Figure 5 are considered to be quality type defects.
