STUDY REPORT

No. 112 (2002)

New Zealand Small Commercial Property Condition Survey (Pilot)

BRANZ Study Report SR 112 (2002) Rachel Hargreaves

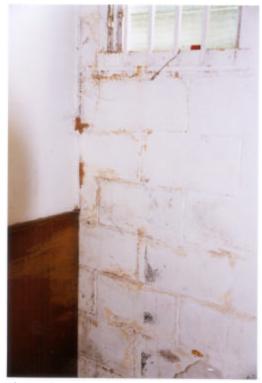
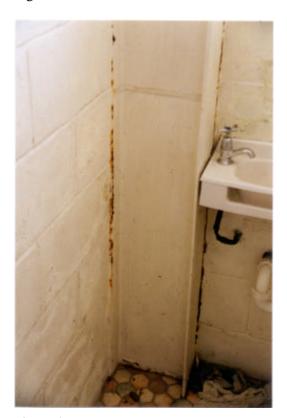
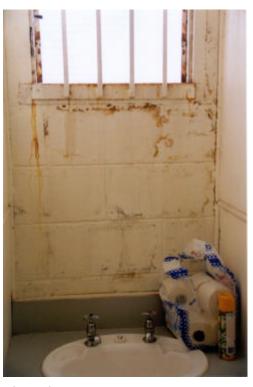
<u>Figures 1, 2 and 3: Coating/lining blemishes</u>

Moisture ingress has caused rusting of the steel work and formation of efflorescence behind the interior paint work.

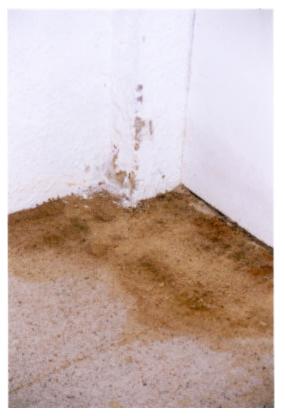
Figure 4

Figure 4: Water Stains

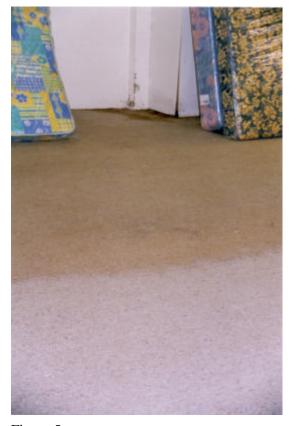
Figure 5

Figure 5: Water Stains

This photo shows the extent of carpet damage caused by the leak as shown in Figure 4.

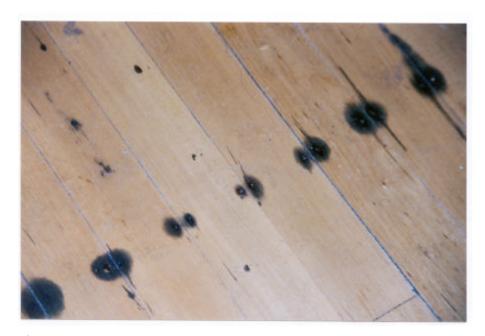
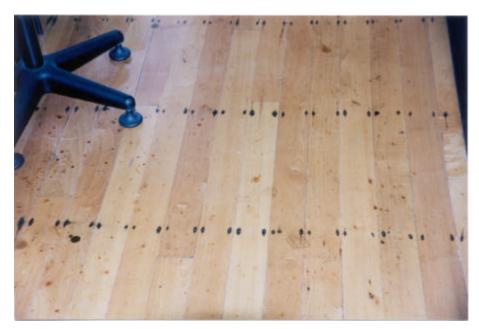
Figures 6 and 7: Fixing deterioration

This property had inadequate subfloor ventilation. The subfloor timbers were wet causing deterioration in the fixings.

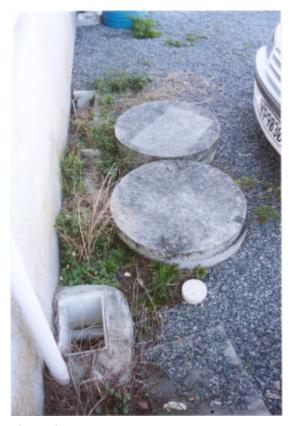
Figure 8

<u>Figure 8: Inadequate closure and missing grates</u>

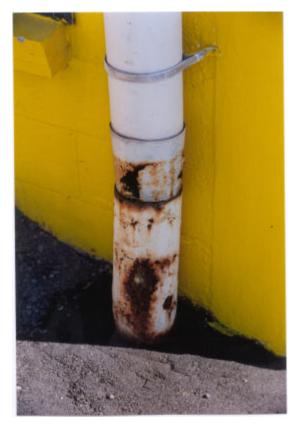
Figure 9

Figure 9: Corrosion of metal

This down pipe shows significant corrosion.

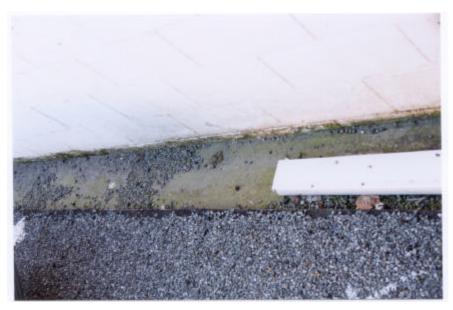
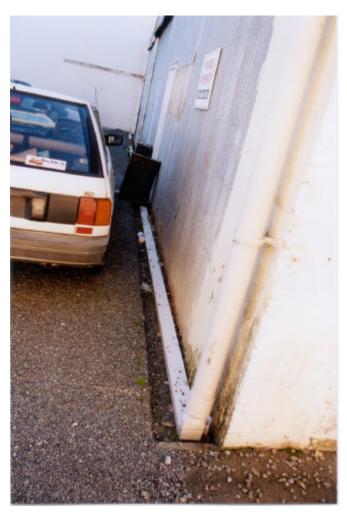
Figures 10 and 11: Missing drain

Stormwater discharge to car parking area; although there is a channel, there is no water outfall.

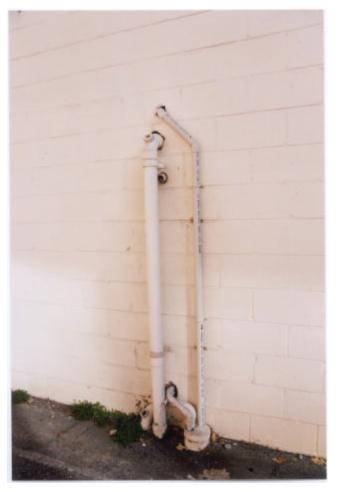
Figure 12

Figure 12: Missing cladding

Penetrations through claddings must be sealed off.

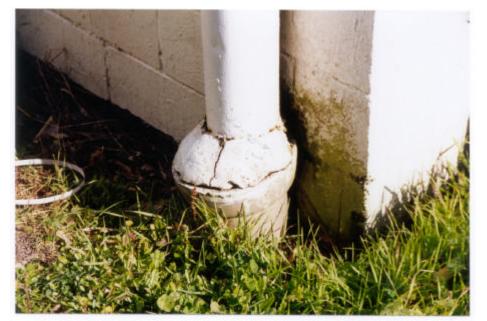
Figure 13

Figure 13: Leaks

Drains need to be maintained to avoid water discharge adjacent to foundations.

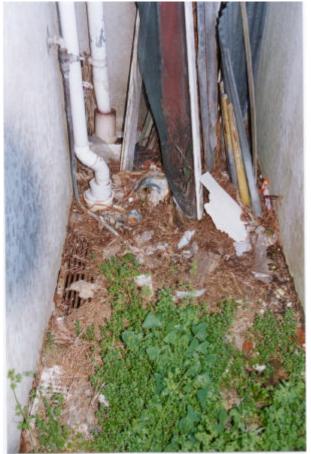
Figure 14

Figure 14: Rubbish accumulation A common maintenance problem is rubbish and vegetation accumulation

in drainage areas.

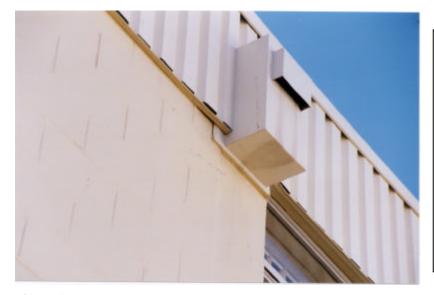
Figure 15

Figure 15: Internal gutter overflow

Although this rain head has an overflow it must be inspected regularly there are ensure no obstructions. This rain head overflows on a regular basis, as indicated by the water staining.

NB: It could be due to inadequate design.

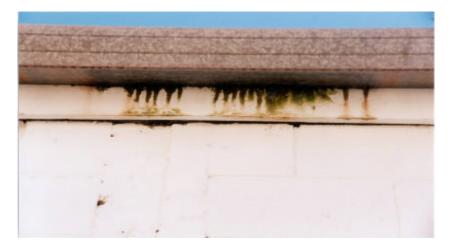
Figure 16

Figure 16: Corrosion and mould growth

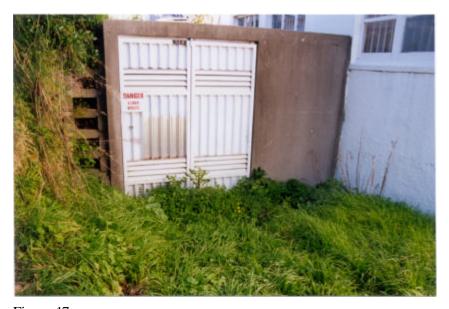
Figure 17

This transformer room is below ground level and is at risk of flooding.

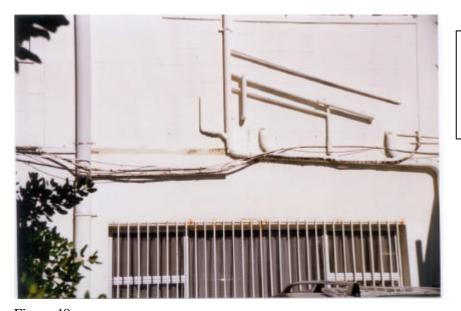
Figure 18

Figure 18: Insecure cabling

Exterior services need durable fixings and regular inspection.

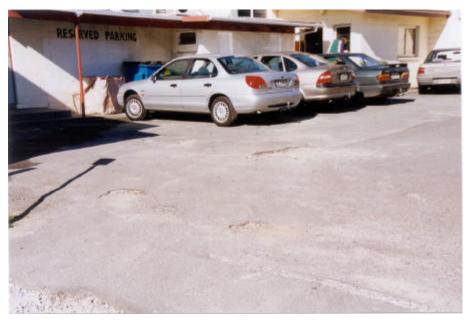
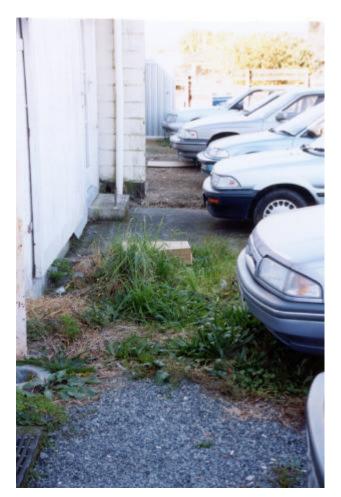
Figures 19 and 20: Uneven surfaces

These photos show neglected surfaces in parking areas.

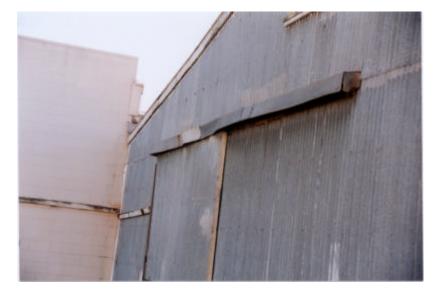
Figure 21

Figure 21: Damaged exterior cladding

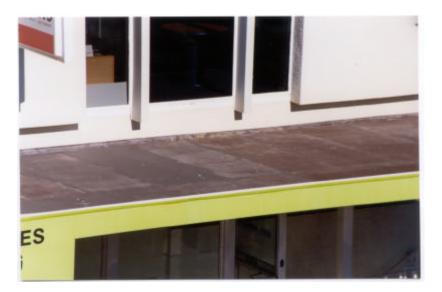
Figure 23

Figure 23: Cladding deterioration

Early signs of membrane deterioration.

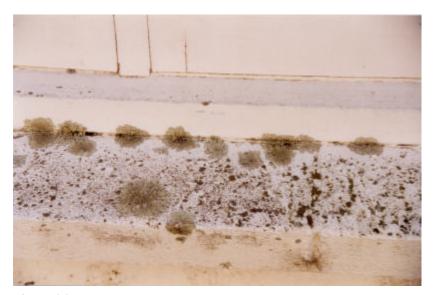
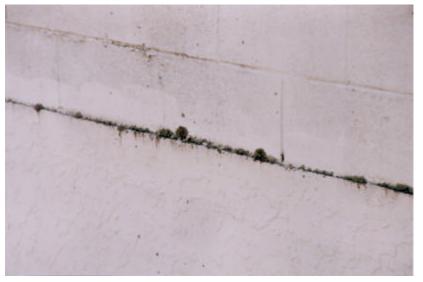
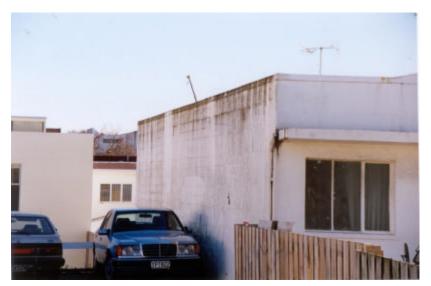
Figures 24, 25 and 26: Mould

Lichen and moss developing on external surfaces. It needs to be removed periodically to minimise the risk of damage to the host material.

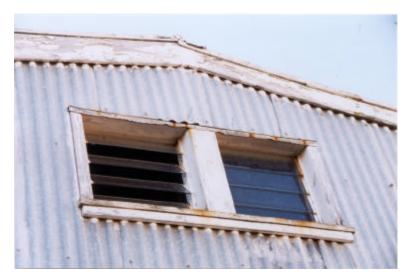
Figure 27

Figure 27: Window damage
