STUDY REPORT

No. 142 (2005)

NEW ZEALAND 2005 HOUSE CONDITION SURVEY

Susan J. Clark, Mark Jones
&
Ian C. Page

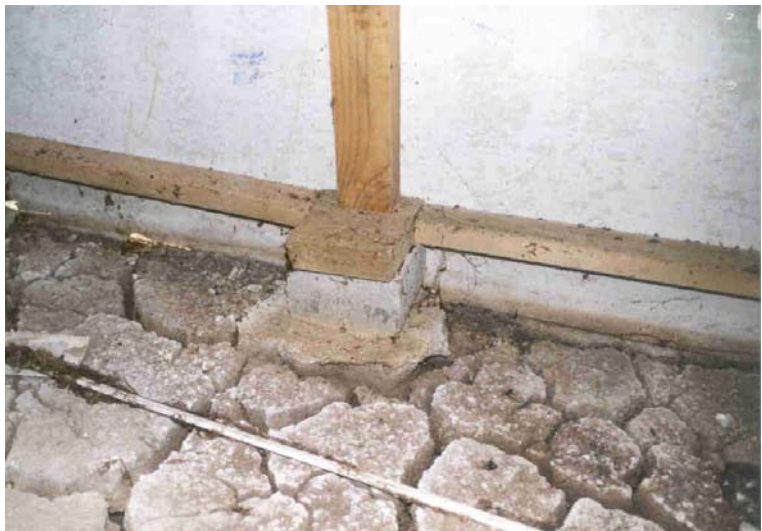
- 1970s Auckland house
- Concrete piles, timber jackstuds
- Inspected after long dry period
- Severe cracking of ground
- Indication of prolonged periods of high moisture levels, followed by drying
- Sub-floor ventilation less than 25% of required level

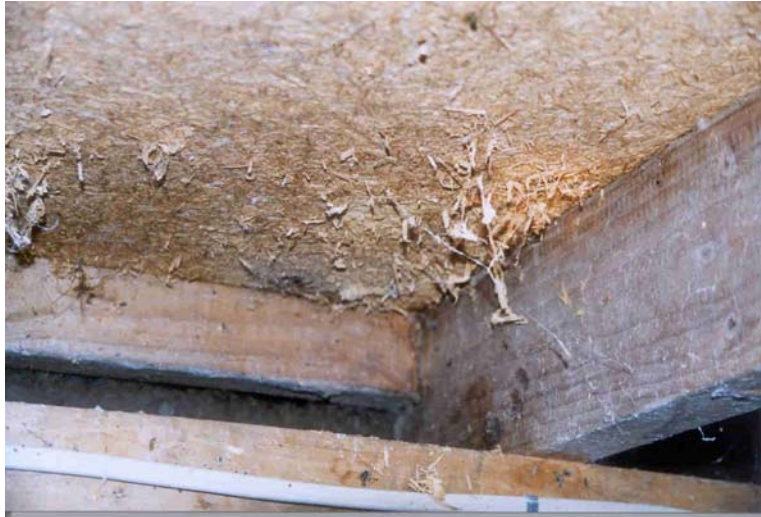
- 1970s Auckland house
- Particle board flooring moisture damage
- Sub-floor framing radiata pine with some water staining but no decay
- Damage related to past leak from floor above (now repaired)

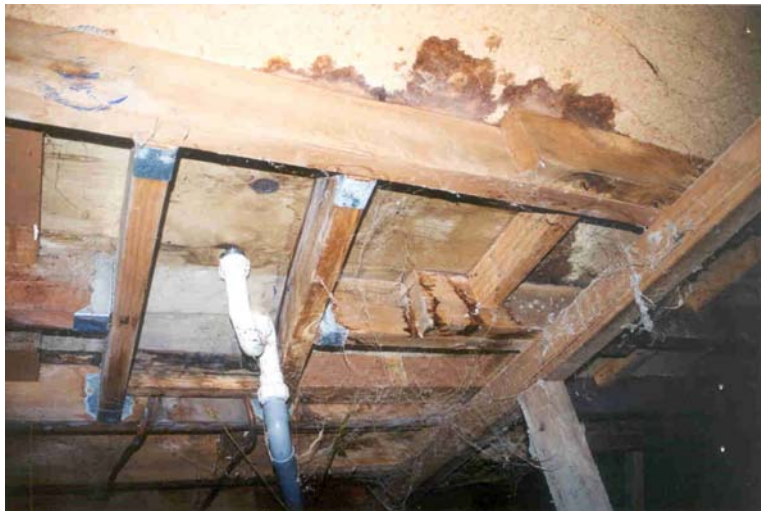
- 1970s Auckland house
- Concrete piles and radiata pine sub-floor framing
- Flooring particle board and plywood
- Extensive water staining but no sign of decay
- Past leaks from shower above – now fixed
- Adequate sub-floor ventilation provided

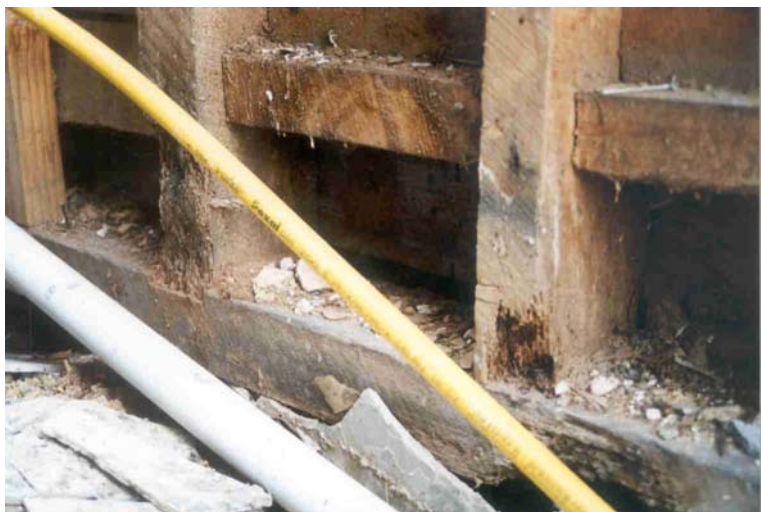
- Large two-storey 1900s Wellington house
- Repiled with concrete piles
- Sub-floor framing mainly rimu
- Water ponding under house
- Decay in lower exterior wall framing and borer in matai flooring
- No clearance to exterior weatherboard cladding
- Sub-floor ventilation only 10% of required level

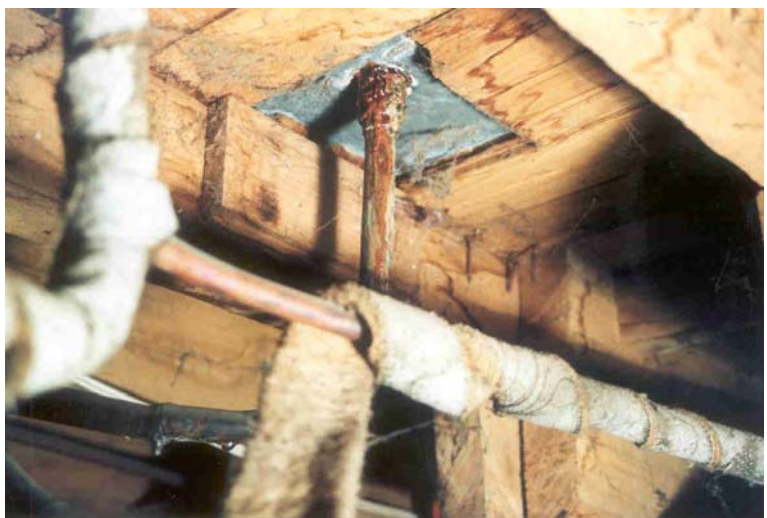
Photo 16: leaking pipe joint

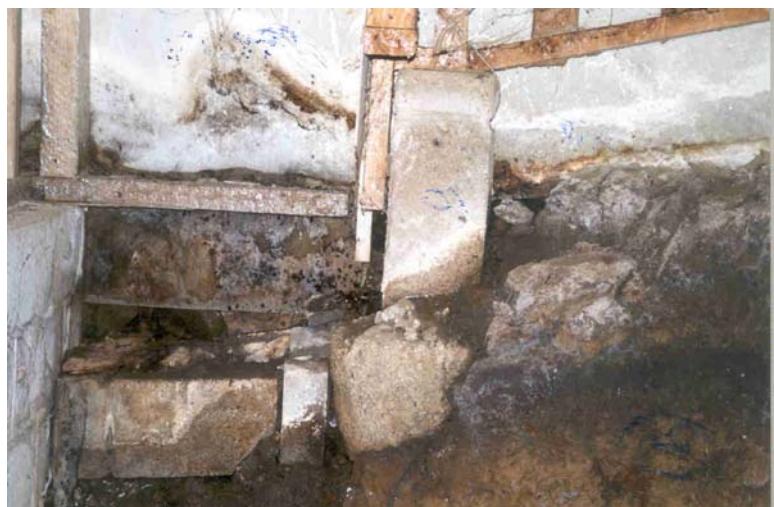
Photo 19: undermined piles

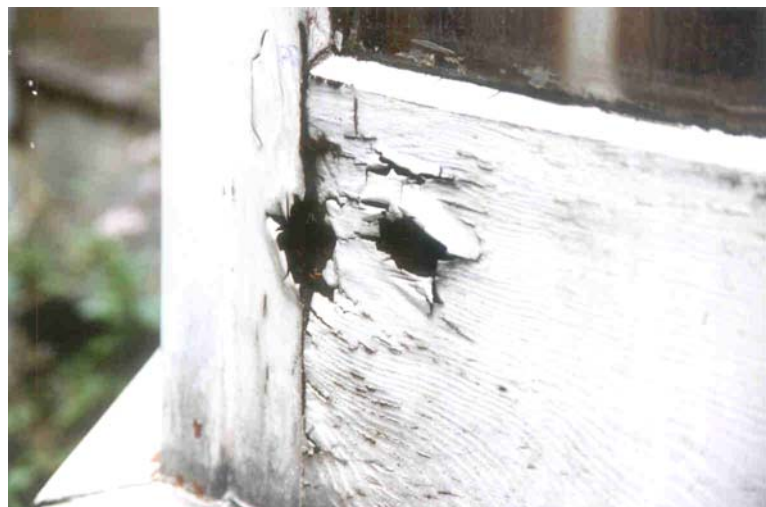
Photo 32: deteriorating timber

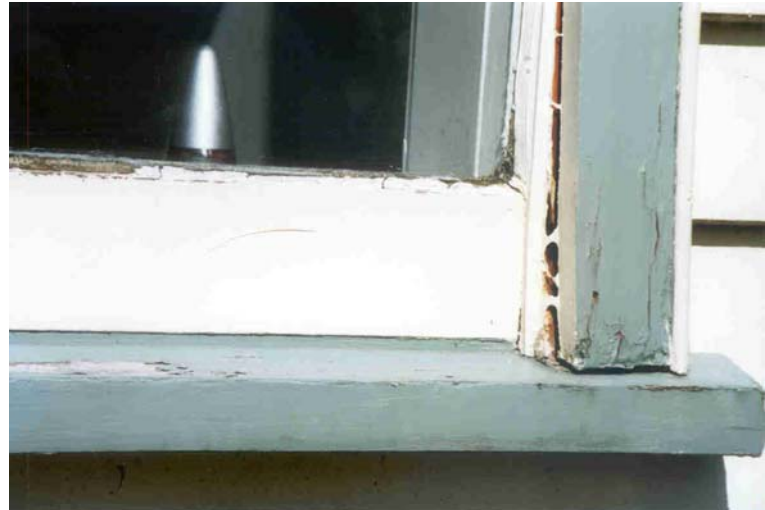
Photo 33: hardware corrosion

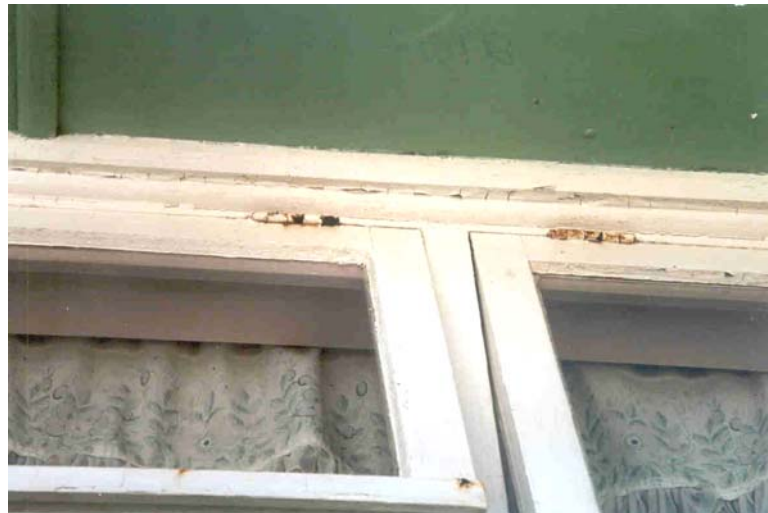
Photo 34: paint deterioration

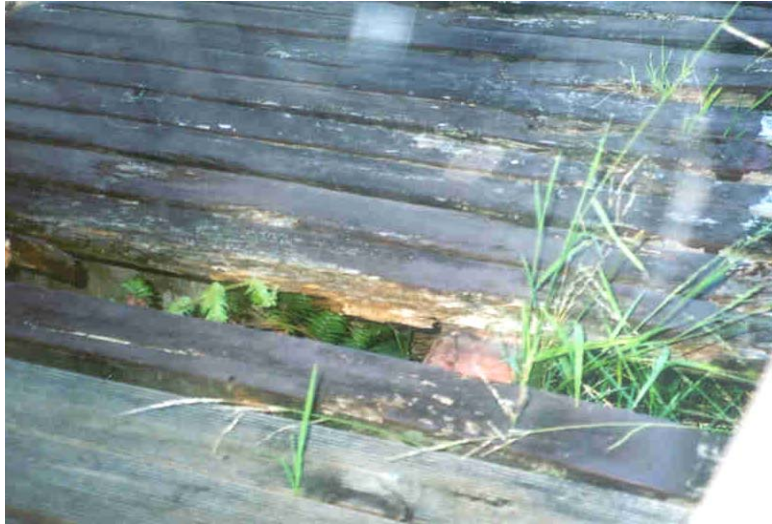
Photo 39: timber post-decay

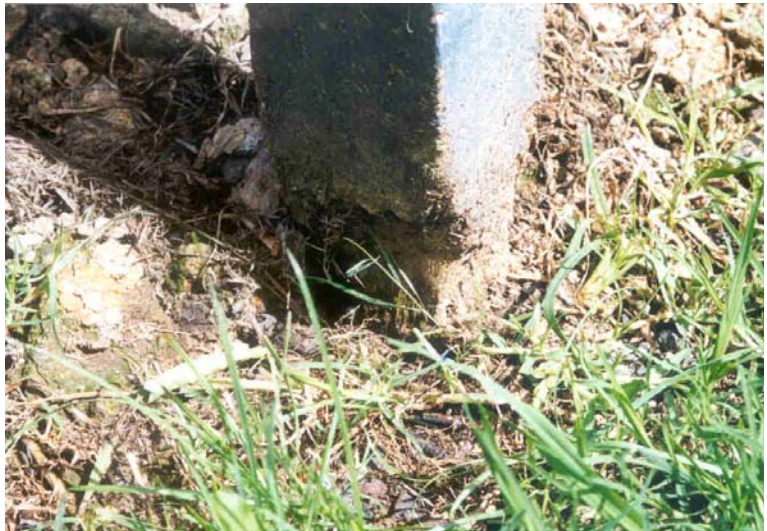
Photo 40: bracket corrosion

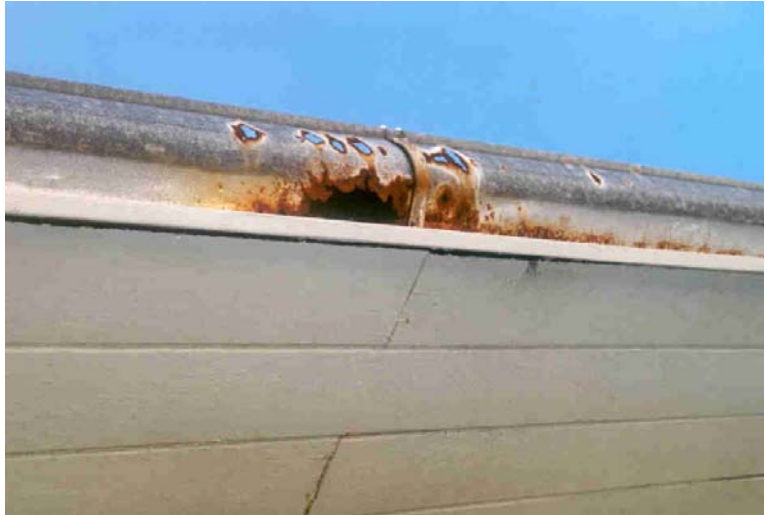
Photo 54: leaking gutters

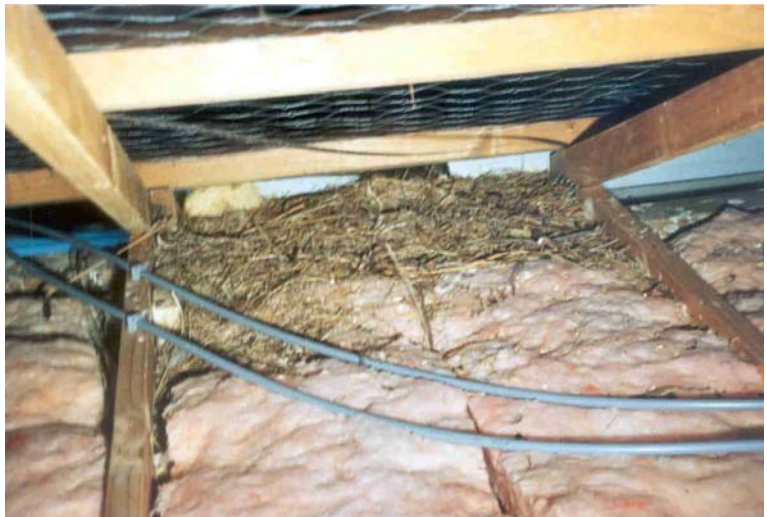
Photo 58: roof space pests
