SR 213 (2010)

Two-Year Field Exposure Corrosion Results

BRANZ Study Report SR 213

Abstract

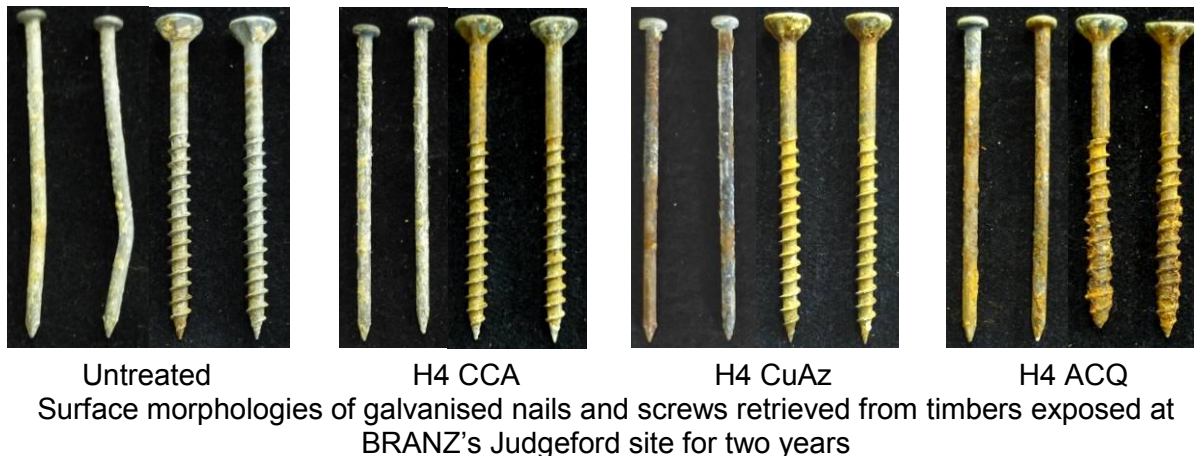
These morphological observations were also supported by mass loss measurements. Galvanised nails and screws in CuAz and ACQ treated timbers were losing their coatings at a higher rate than those in untreated and CCA treated timbers. In particular, timbers treated with H4 ACQ had a very high aggressivity towards the galvanised fasteners. The mass loss rate in H4 ACQ treated timber was anywhere

from two to four times higher than that in CCA and CuAz treated timbers. This is much the same as observations in the previous study (SR153: The Corrosion of Metallic Fastener Materials in Untreated, CCA-, CuAz- and ACQ-based Timbers and DC1396: Preservative Leaching and Metal Corrosion in CCA, ACQ, and CuAz Treated Timbers).

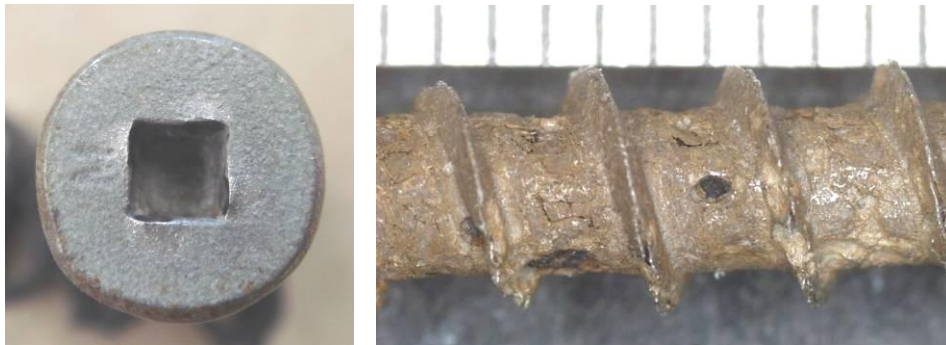
In comparison with hot-dip galvanised nails, rust was more pronounced on the galvanised screws driven into the same timbers. Thread areas appeared to be more vulnerable. Due to the presence of heavy rust, it was difficult to retrieve screws from the timbers. Some of the screws were broken. After the removal of corrosion products, it was found that on some screws, the threads were severely damaged in some areas, even to the extent of partial loss of thread. This might suggest that stresses associated with the driving-in process have damaged the zinc coating, introducing more physical defects into this area.

It must be noted that the conditions experienced by the head and the body section of a nail/screw can be quite different during service. In many cases, the head was still in good condition after two years' field exposure, while the body section suffered serious corrosive attack. This is a direct result of the difference in the aggressivity of the atmosphere and the micro-environment inside the timber. This difference in performance makes it very difficult to obtain any warning of the premature failure of metallic fasteners unless they are extracted from the timber structure concerned.

Morphologies of head and thread of a galvanised screw retrieved from H4 ACQ treated timber exposed at BRANZ's Judgeford site for two years

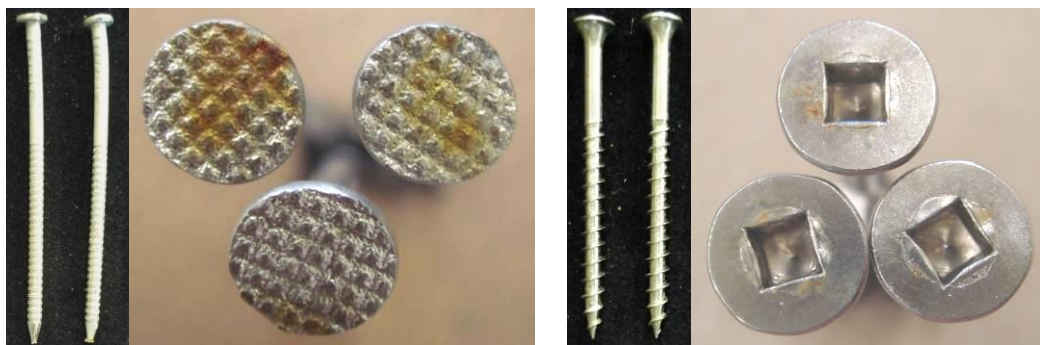
Unsurprisingly, stainless steel nails and screws performed very well in all combinations of preservative type and hazard class. No obvious signs of corrosion were found on the shaft/shank of the nails and screws. Very limited rust formation was occasionally found on the top surface of the nail head. It is believed that this is a result of local passivation breakdown induced by the hammering-in process and/or ferrous contamination from the hammer head.

Stainless steel nails and screws retrieved from H4 ACQ treated timbers exposed at BRANZ's Judgeford site for two years

carried out at the Judgeford site, BRANZ still recommends austenitic stainless steel (e.g. AISI 304 and 316) to ensure long-term durability in treated timbers (H3 and above) which will remain wet for a significant portion of their service life.
