STUDY REPORT

SR 232 (2010)

Using Infrared Thermal Imaging to Audit Retrofitted Wall Insulation in Houses

Ian Cox-Smith

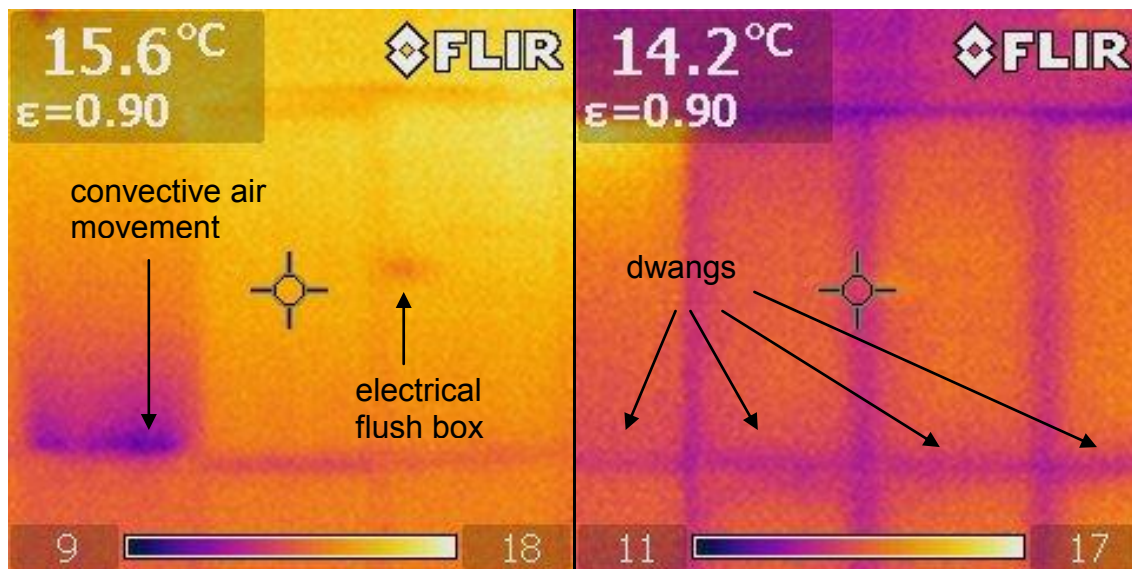
Figure 2: Thermal images of laboratory-based test walls using 250 x 250 pixel camera equipped with a standard lens.

Figure 2 shows two images from a laboratory test wall with deliberate defects and outward heat flow. The image on the left represents a larger overall temperature difference between interior and exterior than that for the image on the right.

The frame cavity on the left side of the left-hand image shows evidence of convective air movement around a gap at the bottom edge of the insulation. The insulation is thinner than the depth of the wall cavity, and there are gaps against both faces of the insulation. The frame cavity on the right side of the left hand image shows evidence of an electrical flush box size area of missing insulation.

In the image on the right, the small area of missing insulation has resulted in a warmer surface temperature than in the insulated area because of a transient increase in solar gain on the exterior of the wall.

Despite the dwangs towards the bottom of the images having different sized gaps between the insulation and the framing, the impact is not detectable because either there is insufficient temperature difference between interior and exterior or the camera has insufficient temperature difference resolution. An alternative reason could be that the field of view is too large to resolve temperature differences in the area of interest.

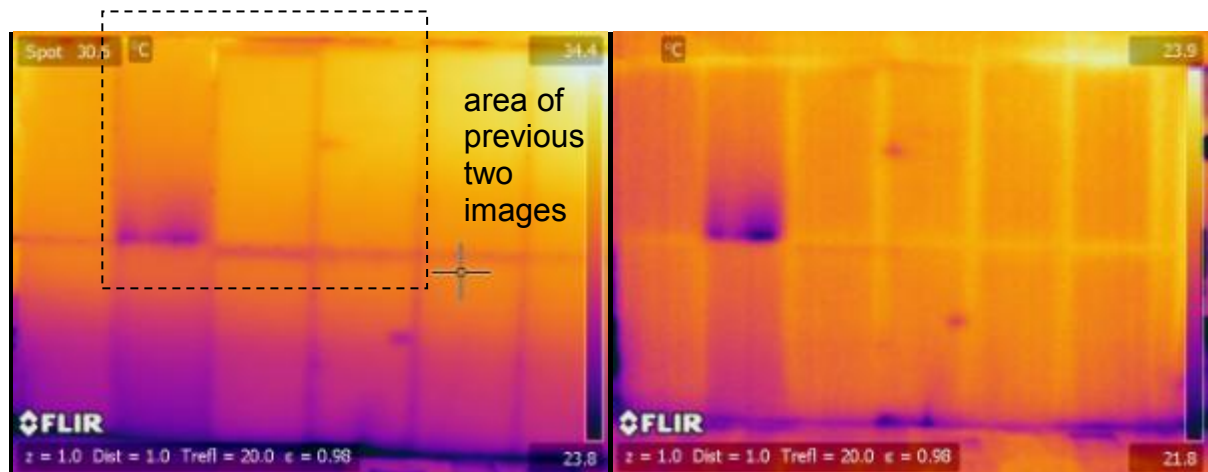
Figure 3: Thermal images of laboratory-based test walls using 640 x 480 pixel camera equipped with a wide-angle lens

Figure 3 shows the same laboratory test wall but with images taken with a 640 x 480 pixel camera and using a wide-angle lens. Because the full wall height is visible, it is possible to compare the upper wall cavities with the lower ones and to simultaneously observe surface temperatures in the vicinity of both the top and the bottom plates. It is also much easier to associate where the image was taken.

For the inward heat flow case (right-hand image), the surface temperature adjacent to the framing is warmer than the surface adjacent to the insulation. In both cases, the two electrical flush box-sized areas of missing insulation results in colder surface temperature than for the insulated areas. For the image on the right, this is because the image was taken in the late afternoon immediately after the disappearance of solar gain on the exterior surface of the wall. Thermal mass has kept the framing warm whereas the relatively low thermal mass cladding has immediately dropped in temperature. In the areas, where the insulation is missing, radiant heat flow from the exterior cladding has transferred heat rapidly to the interior lining.

Whilst the image on the right shows evidence of air leakage along the bottom plate, the appearance of the air leakage is similar to the area in the centre left of both images where there is convective bridging around the gap at the bottom of the insulation. The impact of air leakage at the bottom plate can be made visible for the image on the left by changing the temperature midpoint and span for the image.

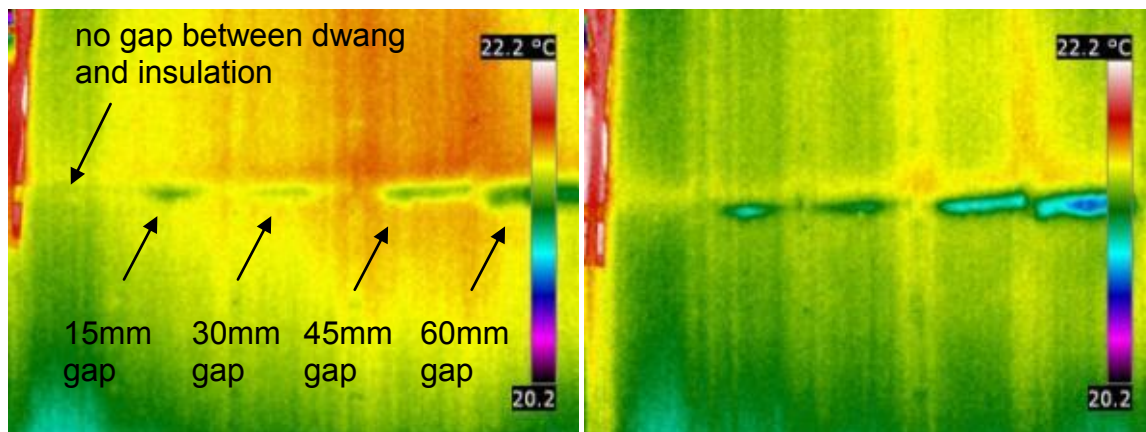
Figure 4: Test wall with two rows of five-frame cavities separated by a central row of dwangs.

Figure 4 shows a laboratory test wall with two rows of five-frame cavities separated by a central row of dwangs. From left to right, the gap between the insulation and the underside of the dwangs increases from nothing to 60 mm in steps of 15 mm. For the image on the left, the difference between the air temperatures on the two faces was only 5K, whereas the difference was increased to 10K for the right-hand image. In the left-hand image, the 15mm gap is only just detectable, as the surface temperature difference between the insulated areas and the areas with insulation missing is only 0.3K. For the right-hand image, the gaps are significantly more obvious because of the increase in surface temperature difference to 0.6K. These results are consistent with the predictions of surface temperature difference using 3D modelling of the test specimen.

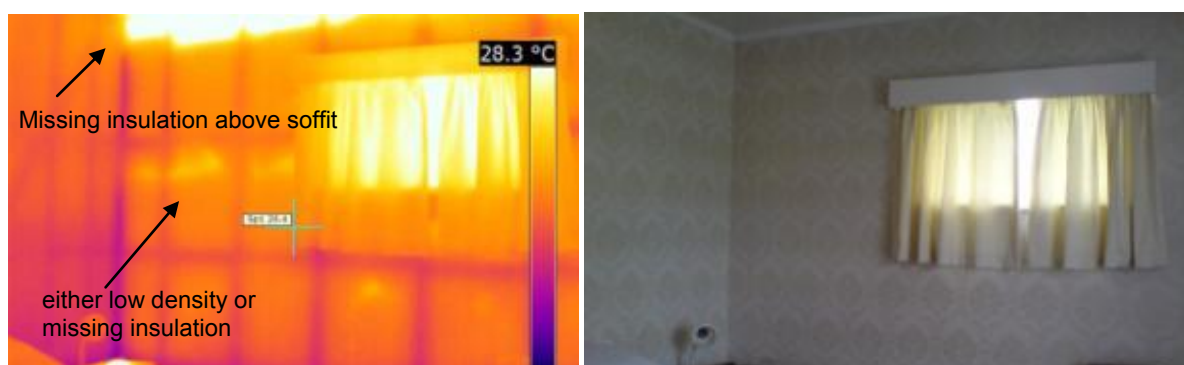
Figure 5: Wall with bright sunlight on exterior cladding

In Figure 5, the small bright areas towards the top of some of the frame cavities are a result of transient radiant heat transfer from solar gain on the exterior of the wall transferring heat through areas of either missing insulation or areas of insulation with significantly lower density. Because the image was taken during a period when there was a relatively small temperature difference between interior and exterior, the insulation defects were not visible without the benefit of solar gain.

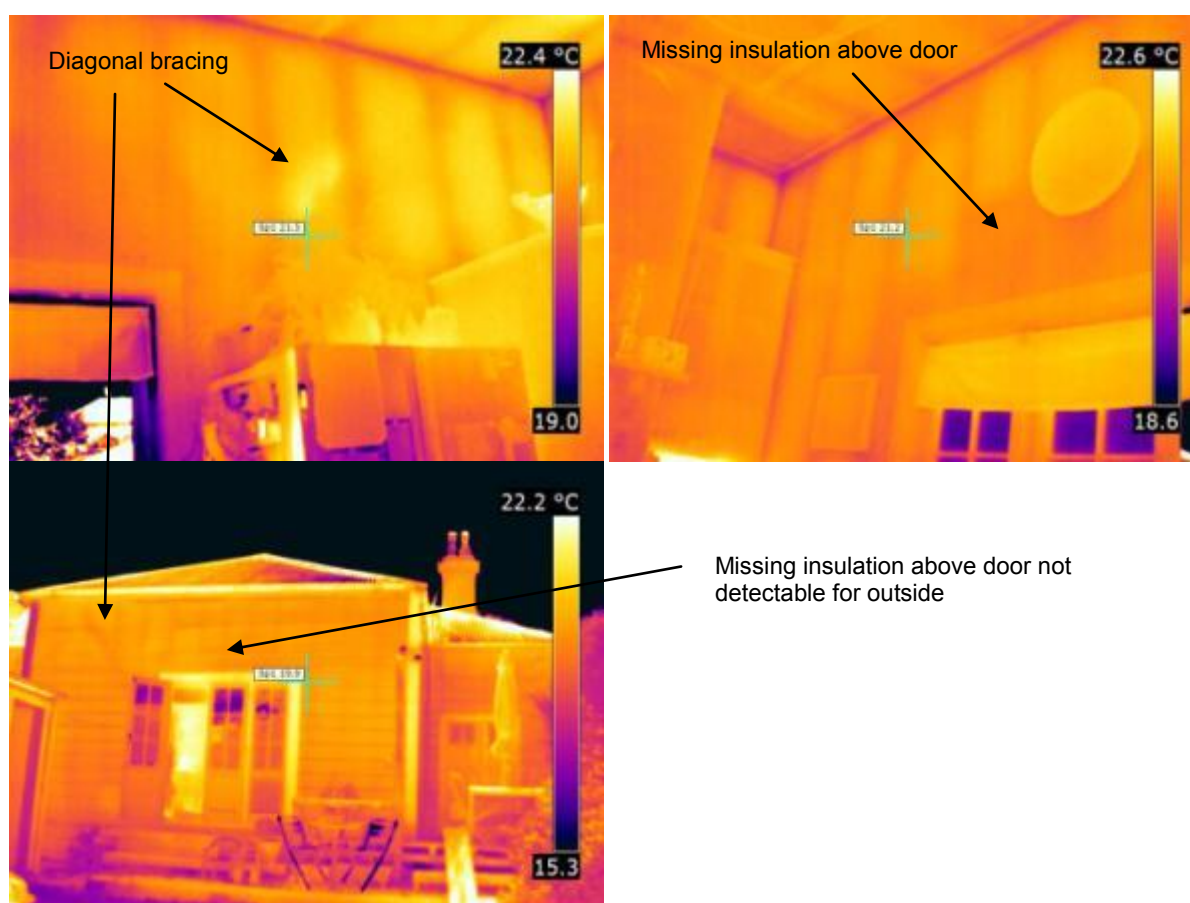
Figure 6: Bevel-backed weatherboard-clad wall imaged from both the interior and exterior of a house.

In Figure 6, whilst the diagonal bracing is only detectable in the image taken from the exterior, the missing insulation in the area immediately above the door is only detectable in the image taken from the interior. The diagonal bracing is highlighted in

the exterior image because it is both narrower than the depth of the wall cavity and located against the weatherboards rather than against the interior lining. In the top left-hand image, the bright area in the middle of the image represents a gap between the insulation and the diagonal bracing that has been highlighted because of solar gain on the exterior surface of the wall. Since diagonal bracing that is narrower than frame cavity is more likely to have been installed against the back of the cladding than against the back of the lining, it is more easily detected in thermal images taken from the exterior than those taken from the interior.

In principle, although diagonal bracing that is narrower than the frame cavity has a gap that allows retrofitted loose fill insulation to flow past, the presence of the bracing is sometimes difficult to detect (with thermal images, electronic stud finders, tapping on the surface or feeler wire) and not all material or installation methods will necessarily result in the insulation flowing through the gap.

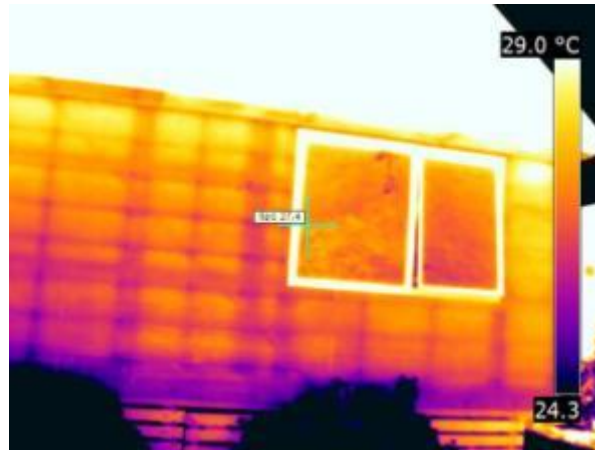
Figure 7: exterior of wall with shiplap weatherboards.

Figure 7 demonstrates how the physical shape of wall cladding – in this case, shiplap weatherboards – can make it more difficult to detect the thermal impact from any defects in frame cavity insulation.

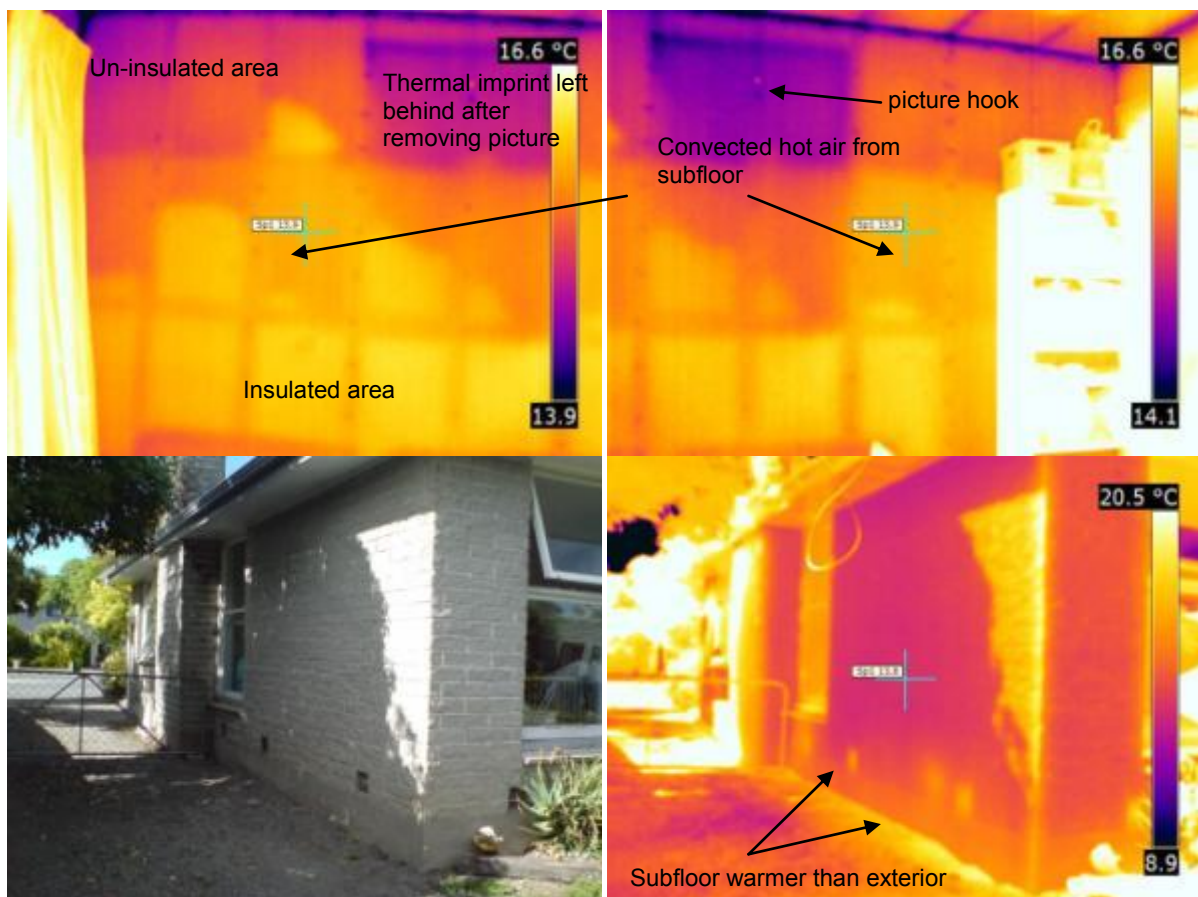
Figure 8: Both interior and exterior views of a wall with brick veneer cladding.

Figure 8 shows a situation where the thermal mass of the bricks has made the image taken from the exterior relatively featureless. The images taken from the interior highlight missing insulation but require careful analysis to fully understand the heat transfer processes occurring within the wall.

The brightest areas on the interior surface represent insulated areas, the slightly cooler areas are where hot air from the subfloor has penetrated into a few of the

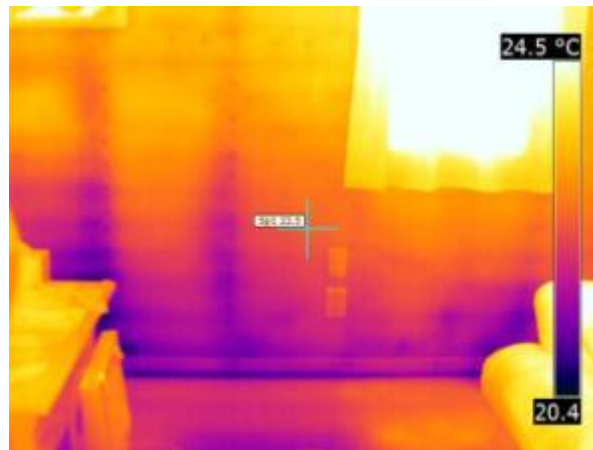
Figure 9: Wall lined with lathes and plaster.

Figure 9 illustrates how interior lining materials with either significant thermal mass or significant thermal resistance can make detection of framing and insulation defects more difficult because the difference in surface temperature is reduced.

This is also an issue where walls are lined with tongue-and-groove timber or double layers of plasterboard.

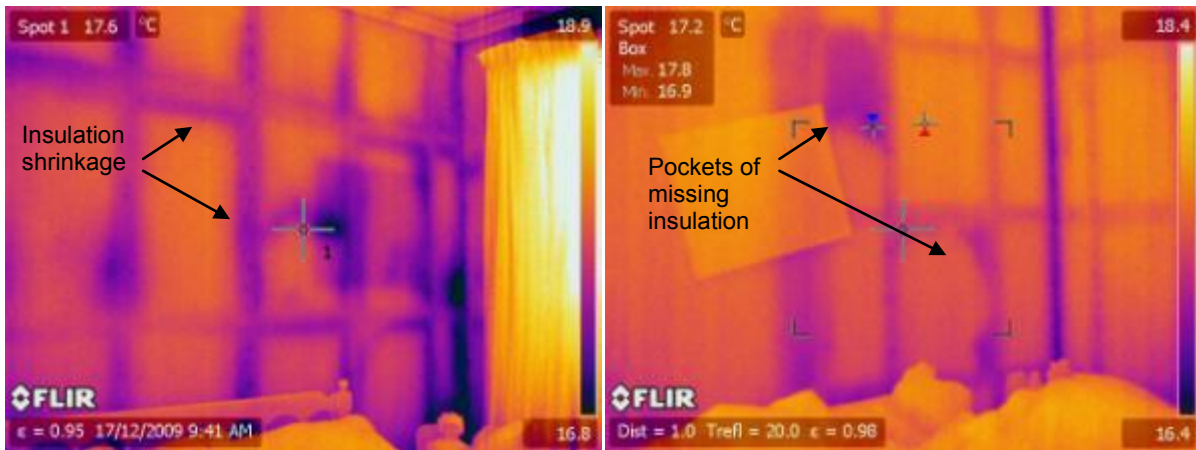
The image on the left of Figure 10 shows a wall insulated with a material that has shrunk with age, hence the relatively fuzzy thermal outline of the framing.

The image on the right is of a wall insulated with the same type of material but where shrinkage is not as severe, either because the material is less susceptible to shrinkage or it is at an age where the shrinkage is small enough that it not yet having a significant impact. In this case, the thermal signature of the framing is relatively sharply defined, and areas of partial insulation fill are still easy to spot.

This highlights the difficulty of detecting insulation shrinkage or settlement if it is occurring at a slow rate. The thermal impact of gaps between the top of the insulation and the underside of the dwangs is detectable in the left-hand images.

Figure 10: An example (left image) of insulation shrinkage creating gaps against framing and an example (right image) with little to no shrinkage but with missing pockets of insulation.

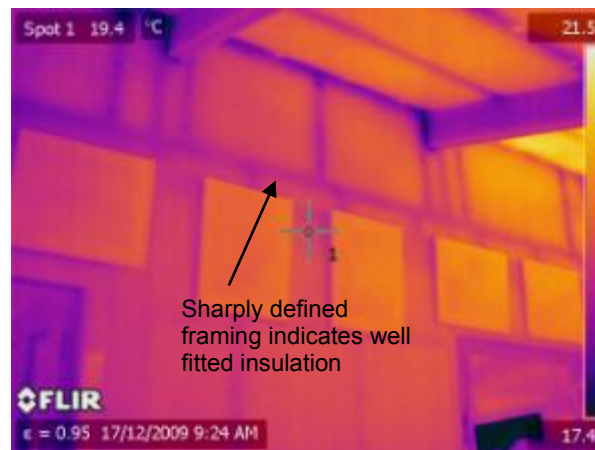
Figure 11: Wall and ceiling with well fitted bulk insulation.

In comparison, Figure 11 shows a wall and ceiling with well fitted bulk insulation with a relatively high thermal resistance. The wall and ceiling framing is sharply defined.

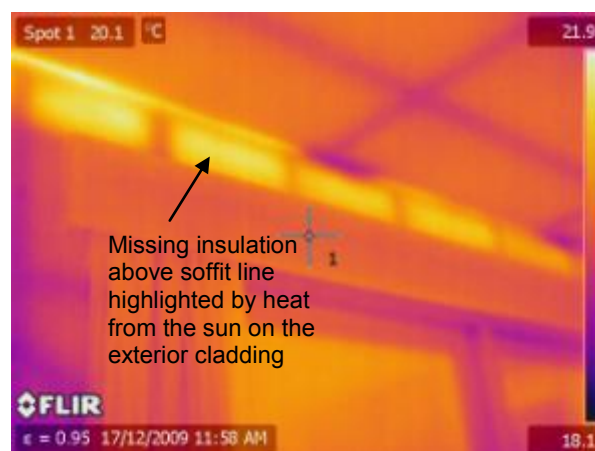
Figure 12: An example of the sometimes difficult to insulate area above soffit line.

Figure 12 shows a bright area above the curtain pelmet where there is no insulation because the soffit line is below the top of the wall. The thermal impact of missing insulation has been heightened by the radiant heat from transient solar gain on the roof. This is an area of a wall that is often either difficult to insulate or that is missed when retrofitting wall insulation.

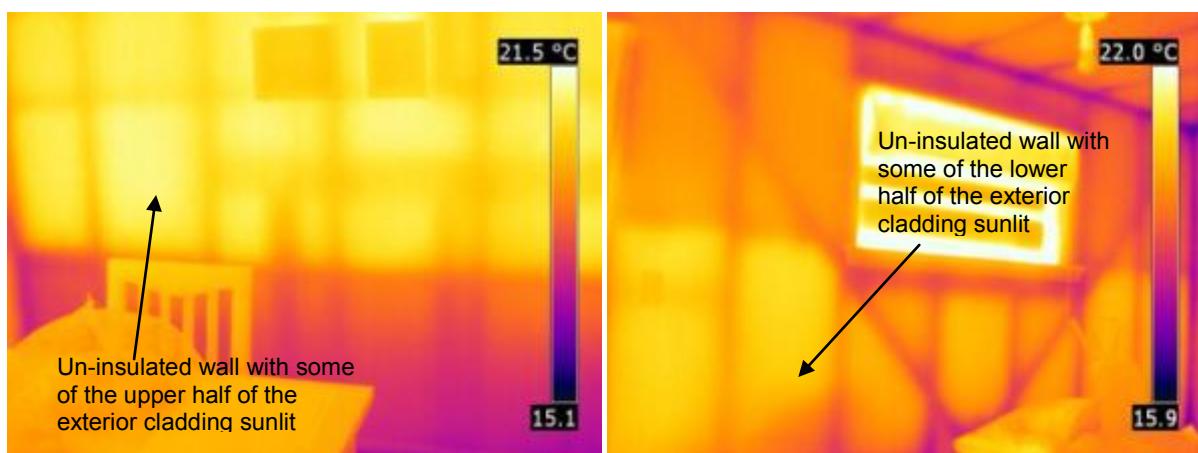
Figure 13 shows two uninsulated walls in the same house, taken on the same day, but with the exterior surfaces of the walls exposed to solar gain only on the upper part of the wall in the left-hand image and only on the lower part of the wall in the right-hand image.

Because of convective air mixing in the empty frame cavities, the row of dwangs through the midpoint of the walls causes the discrete temperature boundary on the surface. The natural buoyancy of warm air results in a larger overall vertical gradient in surface temperature in the left-hand image compared with the right-hand image.

Figure 13: Two uninsulated walls, the left one with sunlight incident on the top half of the wall and the right one with sunlight incident on the bottom half of the wall. Taken in same house on the same day.

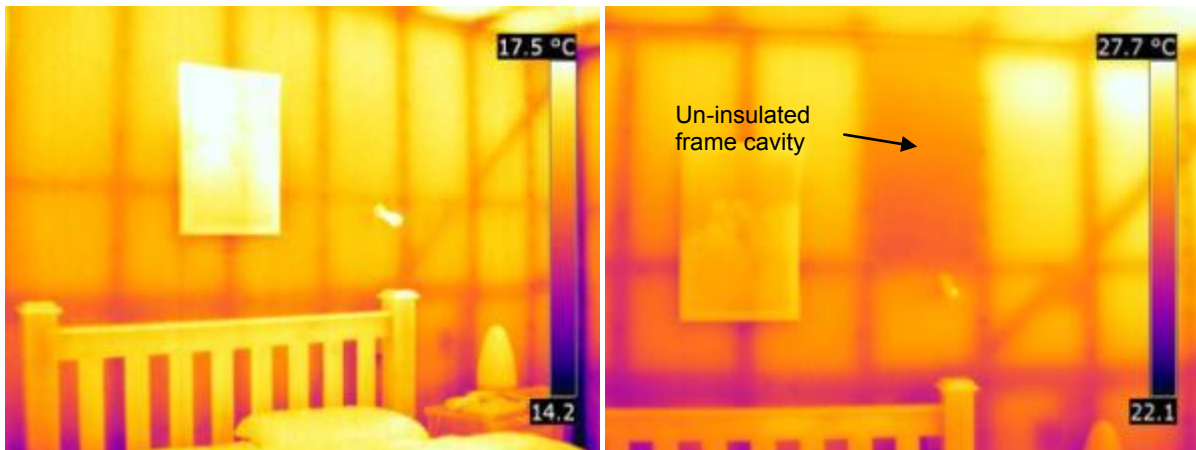
Figure 14: The same wall both before (left image) and after (right image) the retrofit of insulation.

Figure 14 shows two images are of the same area of a wall before and after the retrofit of a loose fill insulation material. The images were taken on different days, and there is a significant difference in both the mean and range in surface temperature. This highlights how difficult it can be sometimes to distinguish between the images from insulated and uninsulated walls. In this case, the cavity with missing insulation in the image on the right is a clear indicator that the wall has insulation. One of the triangular cavities formed by the diagonal bracing shows the effect of either incomplete fill or settlement of the insulation material.

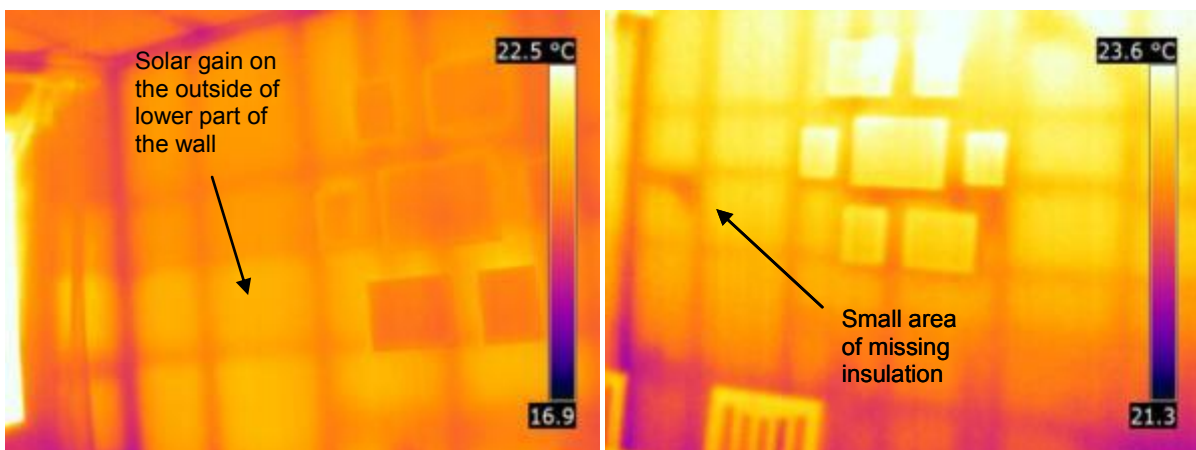
Figure 15: Same wall before insulation (Left) and after (Right)

Figure 15 is another example of before and after images for retrofit insulation. The absence of insulation in the left-hand image is indicated by the solar gain induced temperature change at mid-height on the wall. The presence of insulation in the right-hand image is indicated by the small defect in the insulation on the left-hand side of the image.

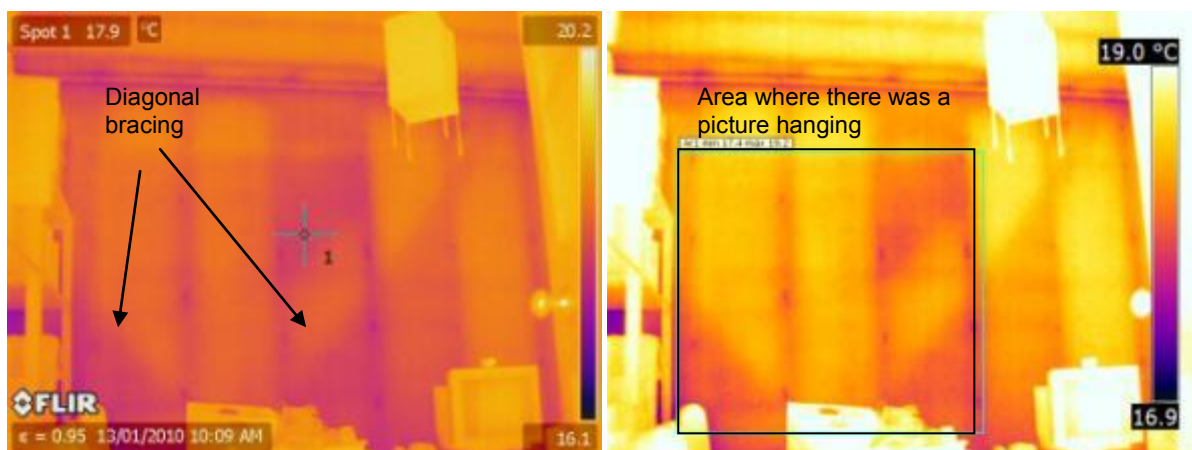
In Figure 16, the image on the left shows a wall that was retrofitted with a loose fill insulation material 3 years prior to the image being taken. The image on the right is the same as the one on the left but with the temperature span reduced (using software) from 4K to 2K to highlight the area (marked with a box) where there had been a large picture hanging just prior to the image being taken. The installer of the insulation has failed to detect the two diagonal braces (90 degrees to each other), so the insulation has not been installed below the bracing timber.

The residual thermal footprint from the picture frame has confused the thermal impact from the insulation defects to some extent, but the small area at the top of the wall above the middle cavity suggests that the cavity was only half filled above the

diagonal bracing. The area of that cavity that is below the diagonal bracing probably has no insulation.

Figure 16: Insulation not installed completely around diagonal brace

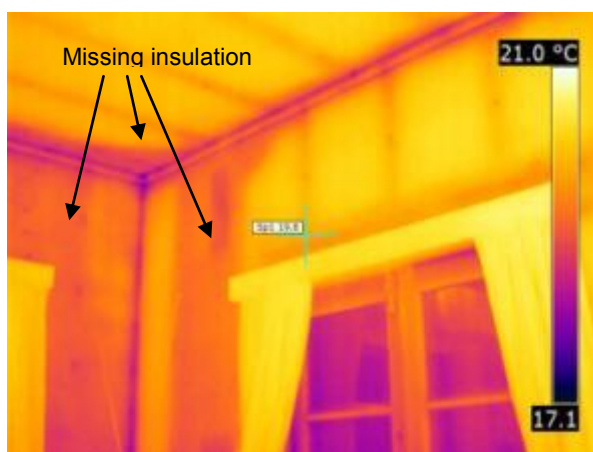
Figure 17: Area of insulated ceiling included in the image as a reference for the wall insulation

Figure 17 shows a wall from the same house as shown in Figure 16. Because there is only a small air temperature difference between exterior and interior, the thermal bridging from the framing is not particularly well defined. Since it is known that the ceiling insulation has a high R-value and has been well fitted, the inclusion of a section of ceiling in the image acts as reference point to enable an assessment that there are probably no significant gaps between the wall insulation and the framing.

The survey conditions are sufficient to determine that insulation has been missed out of some of the wall cavities, and one of the cavities above the window has a small corner of missing insulation.

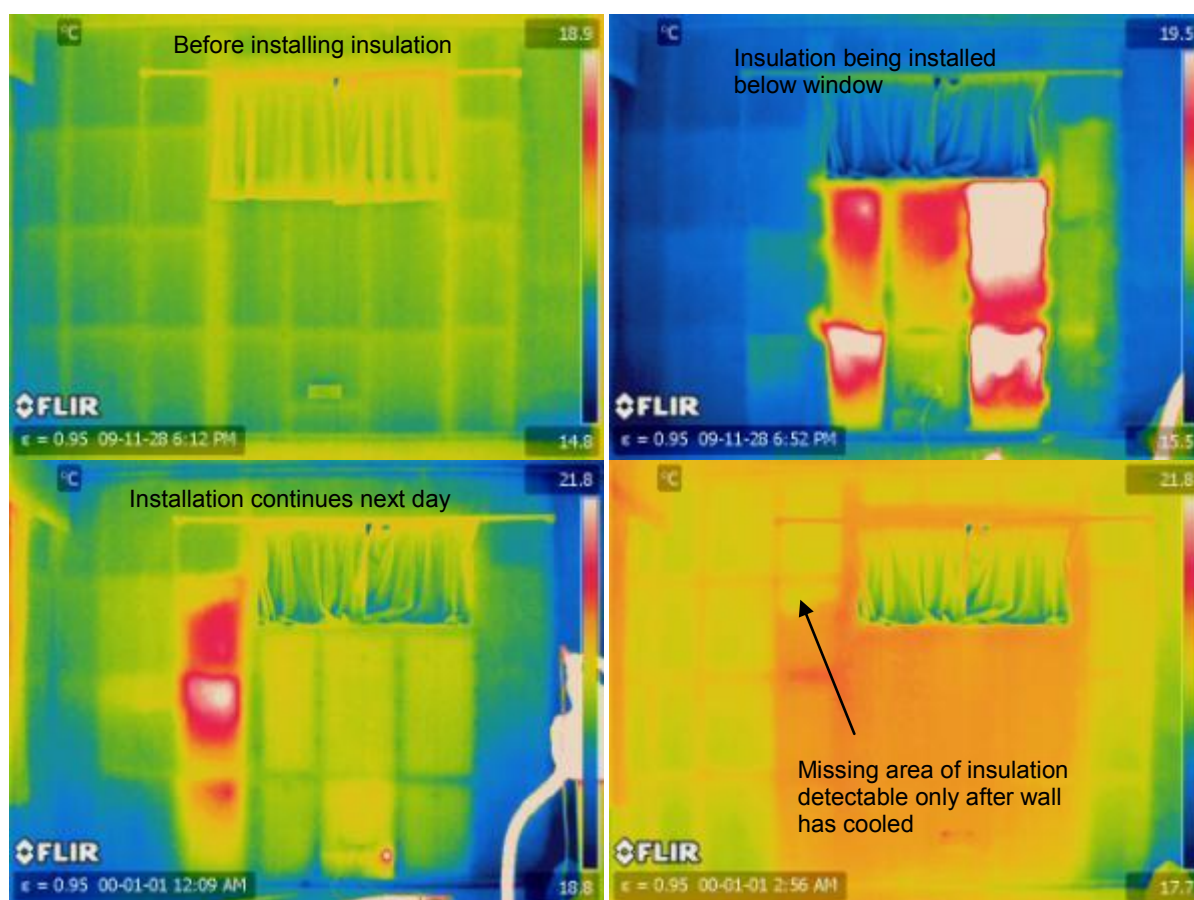
The images in Figure 18 show a wall retrofitted with a loose fill insulation material using holes drilled through the interior lining.

The top left image is the wall before installing any insulation. The top right image was taken immediately after installing insulation into the six frame cavities underneath the

window. The heat associated with the insulation blowing process has made it clear which frame cavities have been insulated, but the dramatic change in temperature has swamped any ability to use the thermal image to assess if each of cavities is completely full or to assess the quality of the insulation. Some of the heat has transferred into adjacent empty frame cavities and has more clearly defined where the framing is located. The bottom left image was taken the day after the first two and immediately after installing insulation into three further frame cavities to the left of the earlier ones. The frame cavities that were insulated the day before are now clearly visible, including the framing. The bottom right image was taken after the temperatures in the wall had come to equilibrium. It was only then, three days after the insulation was installed, that it was possible to detect that one of the frame cavities (to the left of the window) is only two-thirds full.

Figure 18: Impact of heat from the blower during installation of a blown insulation
