SR 240 (2011)

Preliminary BRANZ 2010 House Condition Survey Report – Second Edition

BRANZ Study Report SR 240

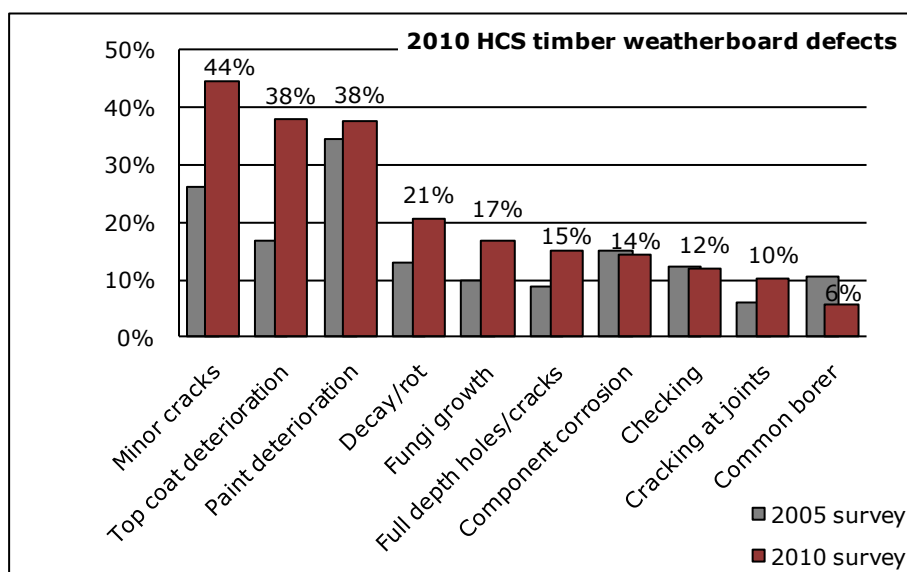
Figure 10: Defects in timber weatherboards

The most common defects with the highest frequency are paint deterioration (through more than just the top-coat) and top-coat deterioration. Minor cracks were the most frequently noted defect, although they tended to be of a lower frequency, as shown in Figure 11. Decay and rot was predominantly of a low frequency, as was fungi growth and the corrosion of components.

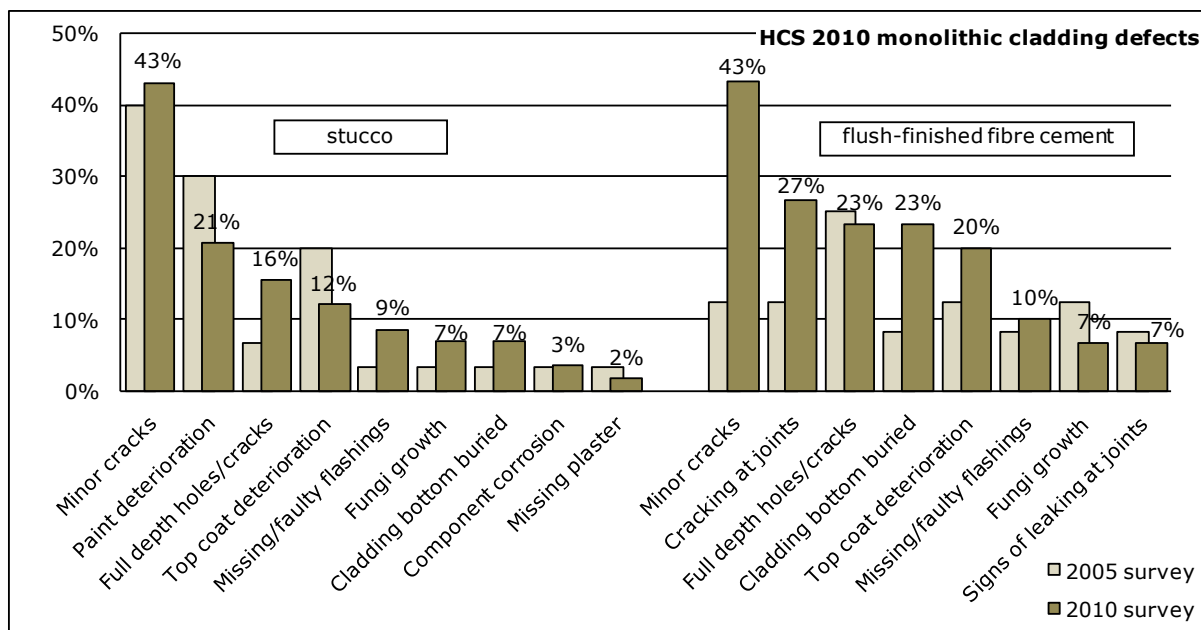
Figure 13: Defects in monolithic claddings

Figure 13 shows the defects found in the 2010 *House Condition Survey* sample. The results from the monolithic cladding defects should be treated with caution, as the *House Condition Survey* assesses the condition of monolithic cladding from the external appearance. This establishes that the true condition of the system requires destructive testing in order to check for issues on the rear face of the cladding. The surface appearance may conceal underlying issues.

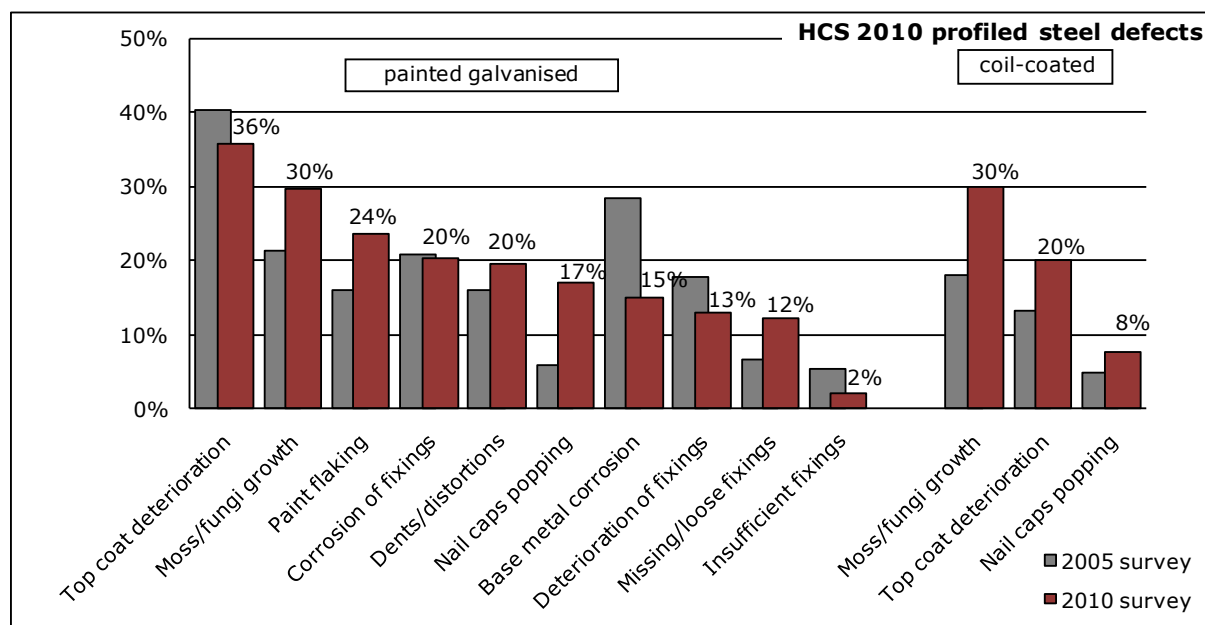
Figure 15: Defects in profiled steel roofing

As shown in Figure 8, profiled steel roofing (both galvanised and coil-coated) is the most common roof cladding, being present on over half of the houses in the sample. The most frequently observed defects are shown in Figure 15.

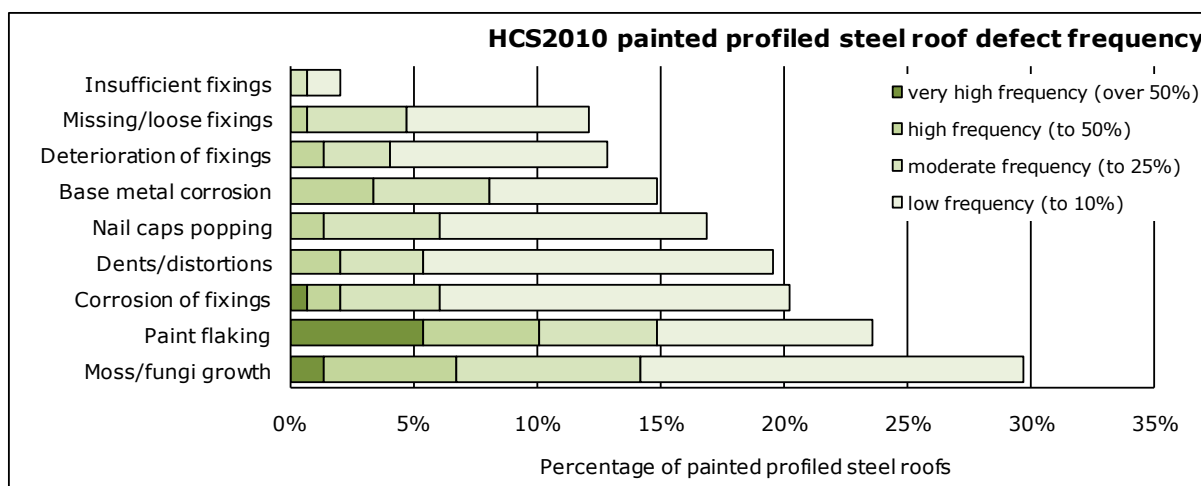
Figure 16: Defect frequency in painted galvanised steel

The most common defects for painted galvanised steel roofing were top-coat deterioration (36%), moss/fungi growth (30%) and paint flaking (24%). With coil-coated steel being a more modern material than galvanised steel, the roofs using it tend to be newer, and the most common defect is moss/fungi growth (30%). The frequency of defects in profiled steel roof cladding is shown in Figure 16.

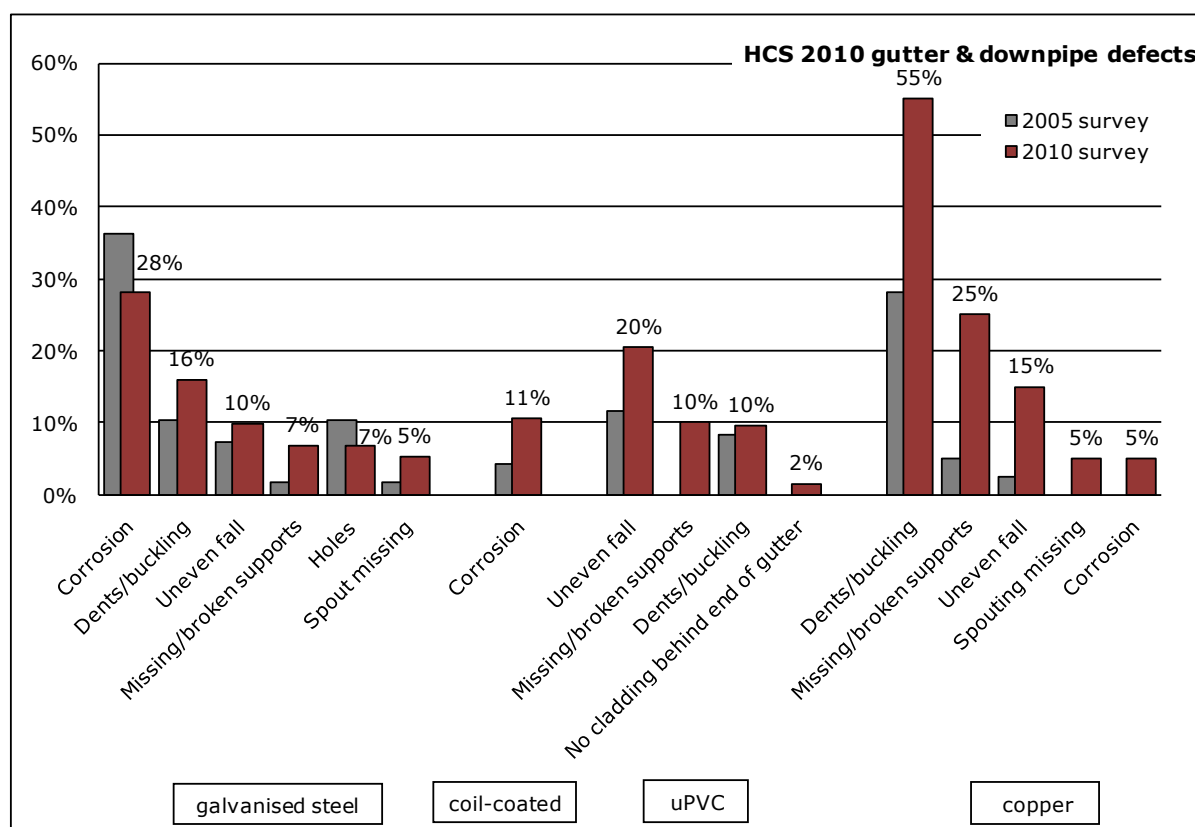
Figure 18: Defects in gutters and downpipes

The most common copper guttering and downpipe defect was denting/buckling, affecting 55% of the houses with this type of guttering to varying degrees, followed by missing or broken supports at 25%. Both defects may well be associated with age – copper guttering has become more popular since the mid 1990s, and with age comes the need for maintenance – which often includes ladders leaning on guttering. As copper is expensive, it tends to be a thin gauge and is highly malleable - dents and distortions will occur more readily than in coil-coated steel, whereas plastic deflects, or at worst breaks.

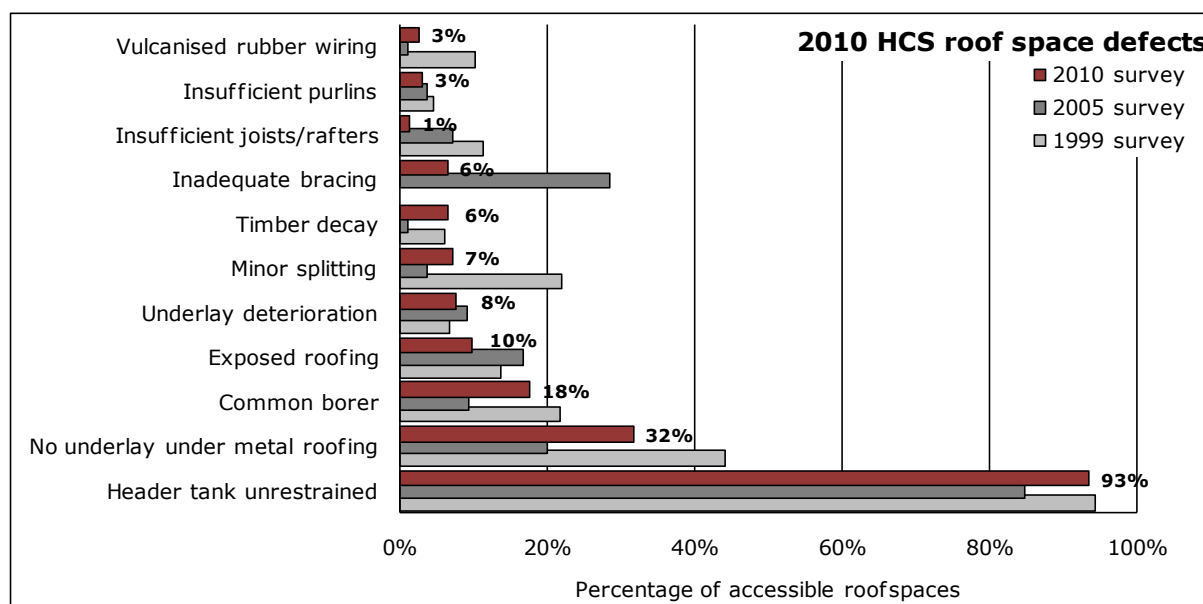
Figure 19: Roof space defects

By far the most common roof space defect was exclusive to houses with roof space header tanks, with 93% of them unrestrained, as seen in Figure 19. This was also the most common defect of the whole sample with accessible roof spaces (with and without header tanks), present in 20% of all homes.

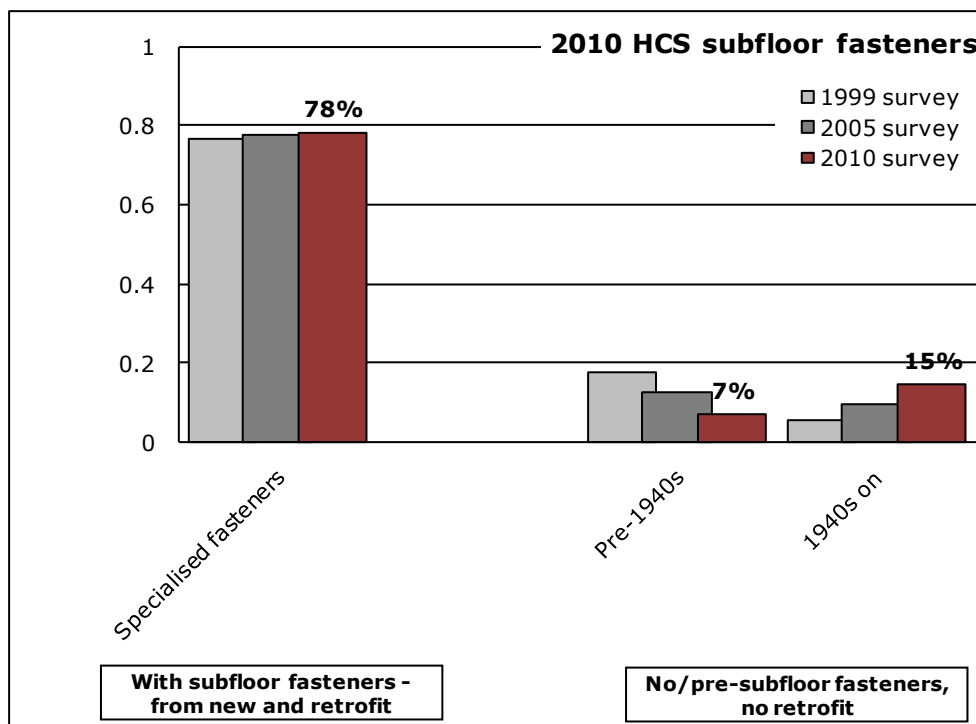
Figure 22: Subfloor fasteners

As seen in Figure 22, nearly one quarter of the houses in the 2010 *House Condition Survey* had no specialised fasteners in their subfloors in line with findings from previous surveys. Houses built before the 1940s were made before specialised fasteners were commonplace. Seven percent of the sample falls into this category and still do not have any or have inadequate subfloor fasteners. However, 15% of the sample was built after the 1940 and do not have specialised fasteners. The breakdown of the sample without adequate subfloor fasteners is shown below in Figure 23.

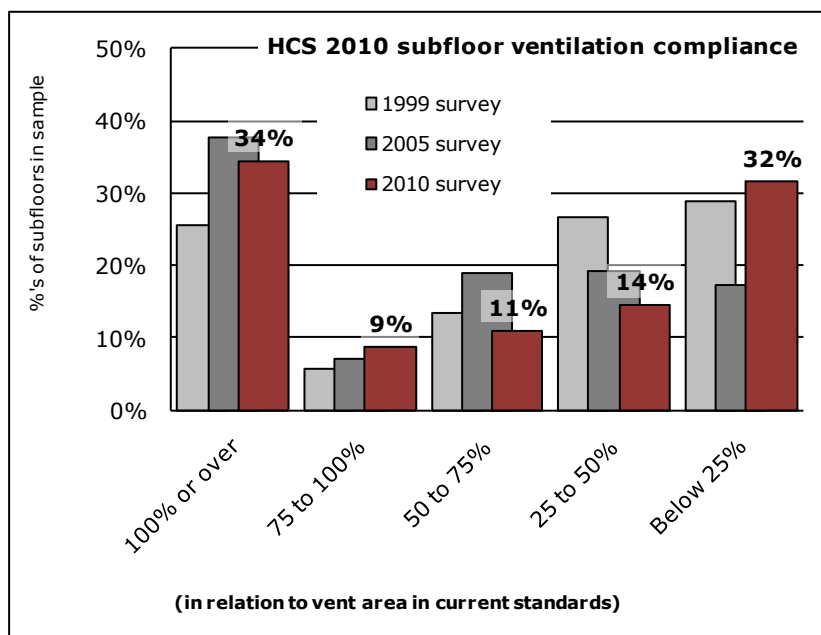
Figure 25: Percentage of current standard subfloor vent requirements

In the past surveys, inadequate subfloor ventilation was identified as a common issue with suspended timber floors in the samples. The results from 2010 are shown alongside those of 2005, 1999 and 1994 in Figure 25.

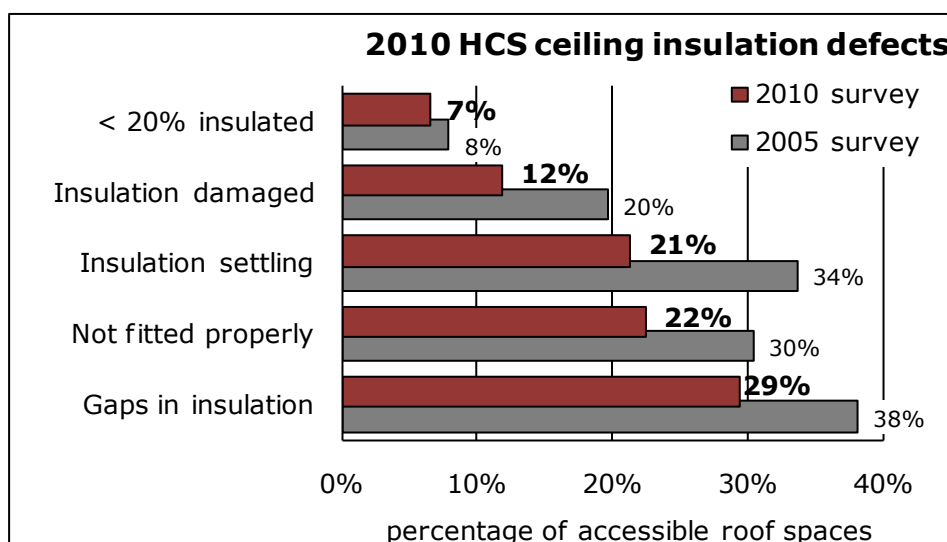
Figure 34: Defects in ceiling insulation

As seen in Figure 34, the percentage of homes with less than 20% ceiling insulation has remained around the same between 2005 and 2010, despite the aforementioned insulation subsidy schemes. The incorporation of rentals may be a prime cause of the lack of movement in this figure.
