STUDY REPORT

SR 273 (2012)

The Bracing Performance of Long Plasterboard-Lined Walls

BRANZ Study Report SR 273

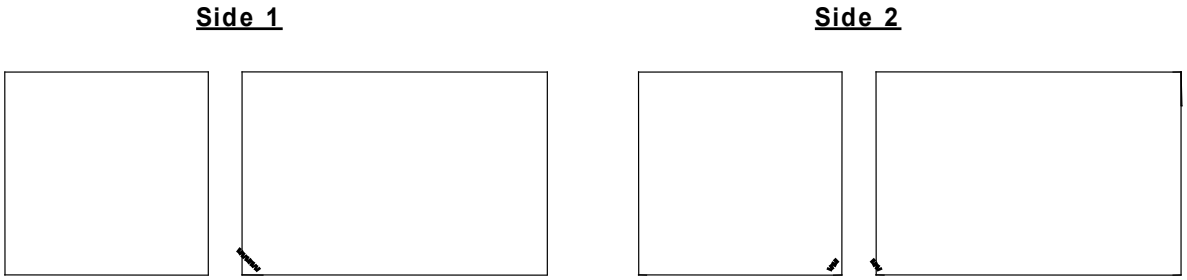
| Name | Wall displacement (mm) | Damage observed | Photographs in Appendix A |
|---|---|---|---|
| Long 3 | ±12.11 | Small diagonal cracks formed at the bottom of bracing elements at non-corner ends. | A.1, A.5 and A.6 |

(a) After Regime Long 3 (Nominal 12 mm)

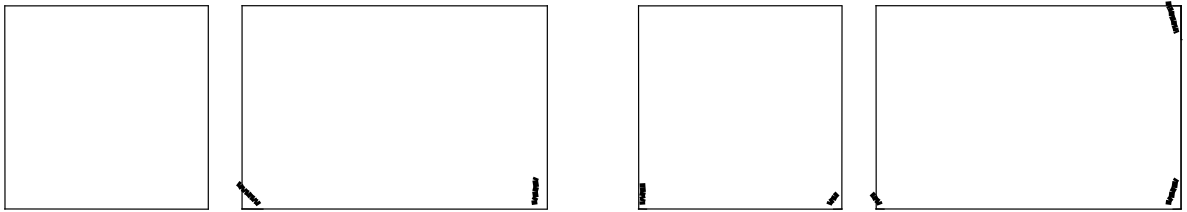
| Name | Wall displacement (mm) | Damage observed | Photographs in Appendix A |
|---|---|---|---|
| Long 4 | ±16.55 | Two further vertical cracks developed at the ends of bracing panels. | A.2, A.4 and A.8 |

(b) After Regime Long 4 (Nominal 16.5 mm)

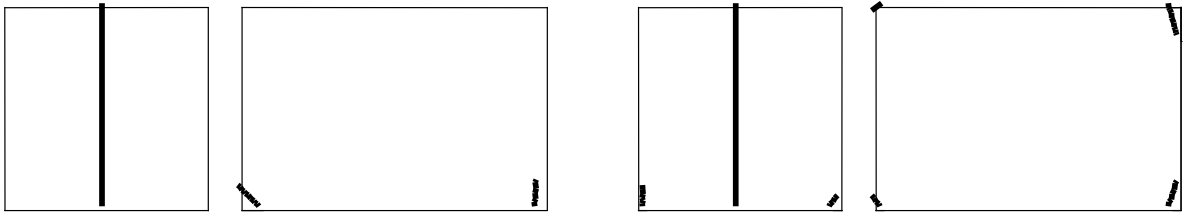
At ± 23.0 mm, two vertical joints cracked at the sheet junctions in the 2.4 m long bracing panels and these became more severe and bowed off the wall during cycling to ± 32.2 mm.

| Name | Wall displacement (mm) | Damage observed | Photographs in Appendix A |
|---|---|---|---|
| Long 5 | ±23.03 | Two vertical joints between sheets in the body of the bracing panels cracked. | A.3 and A.7 |

(c) After Regime Long 5 (Nominal 23 mm)

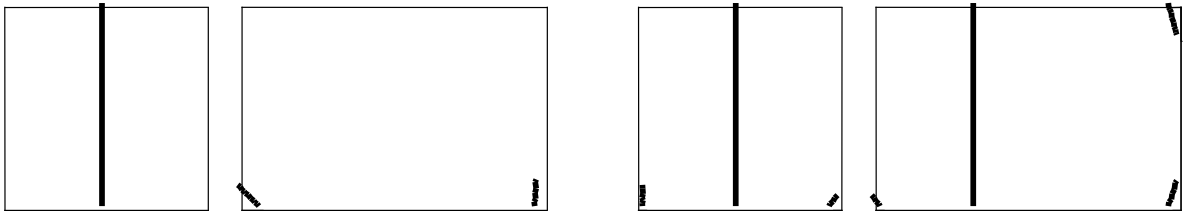
| Name | Wall displacement (mm) | Damage observed | Photographs in Appendix A |
|---|---|---|---|
| Long 6 | ±32.17 | Three vertical joints had now cracked and the sheets bowed out free from the framing at these locations. | A.9 to A.12 |

(d) After Regime Long 6 (Nominal 32 mm)

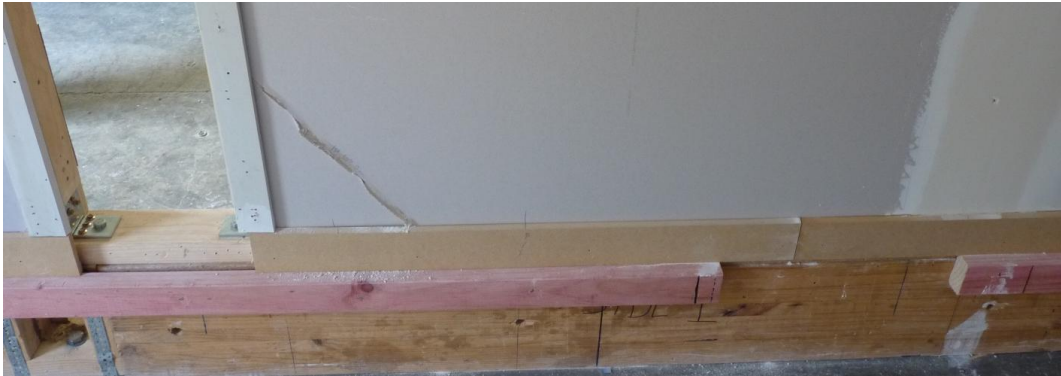
Photograph A.1. Plasterboard crack on the 3.6 m long wall on Side 1 formed after regime Long 3 (nominal 12 mm) taken after regime Long 5 (nominal 23 mm)

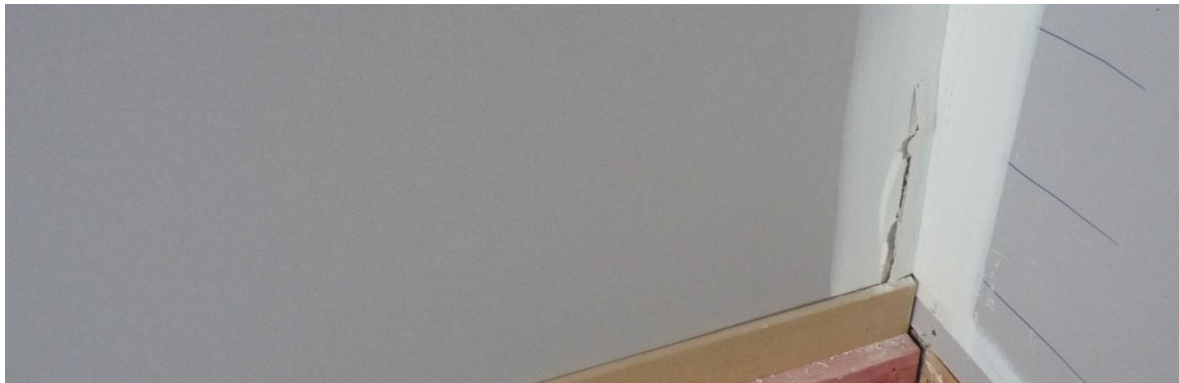
Photograph A.2. Plasterboard crack on the 3.6 m long wall on Side 1 formed after regime Long 4 (nominal 16 mm) taken after regime Long 5 (nominal 23 mm)

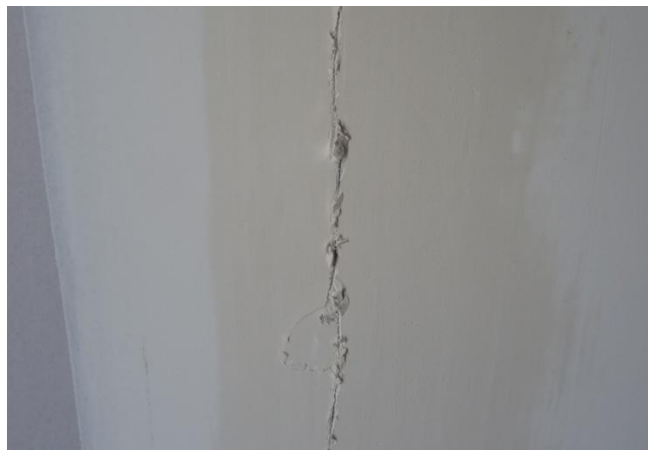
Photograph A.3. Plasterboard sheet joint crack on the 2.4 m long wall on Side 1 formed after regime Long 5 (nominal 23 mm) taken after regime Long 5 (nominal 23 mm)

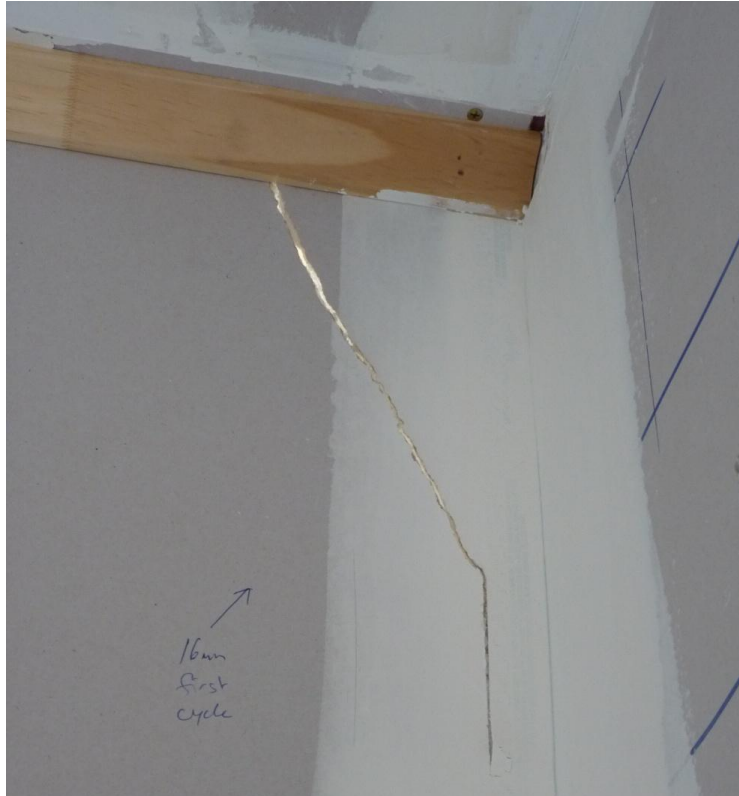
Photograph A.4. Plasterboard crack on the 3.6 m long wall on Side 2 formed after regime Long 4 (nominal 16 mm) taken after regime Long 5 (nominal 23 mm)

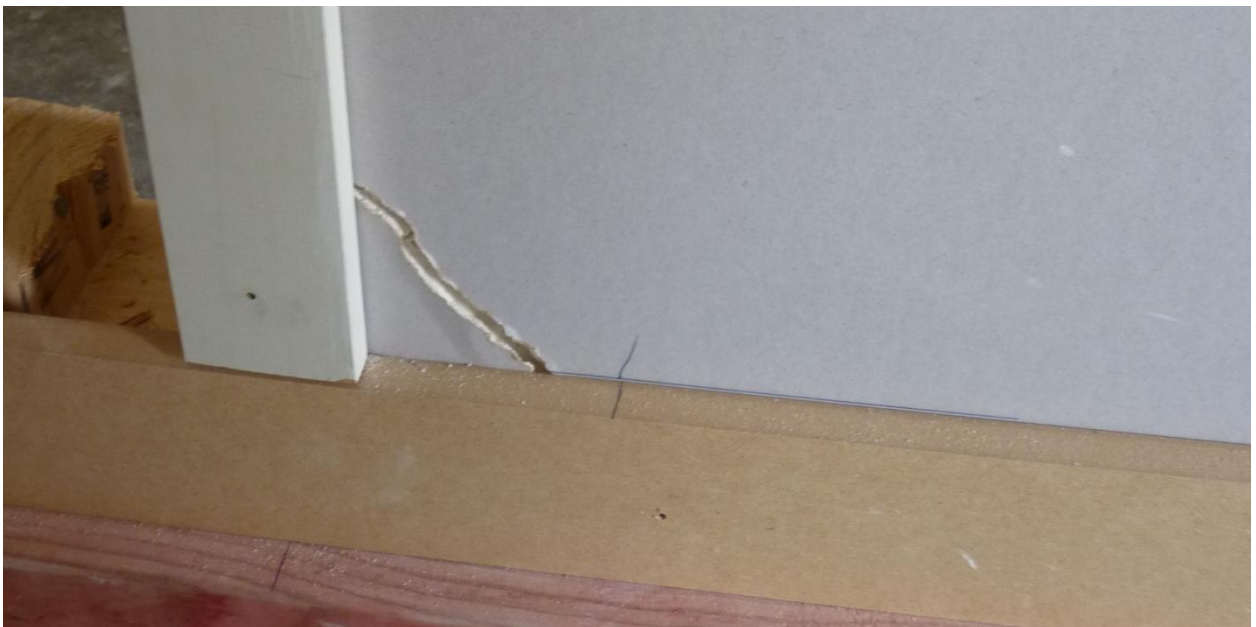
Photograph A.5. Plasterboard crack on the 3.6 m long wall on Side 2 formed after regime Long 3 (nominal 12 mm) taken after regime Long 5 (nominal 23 mm)

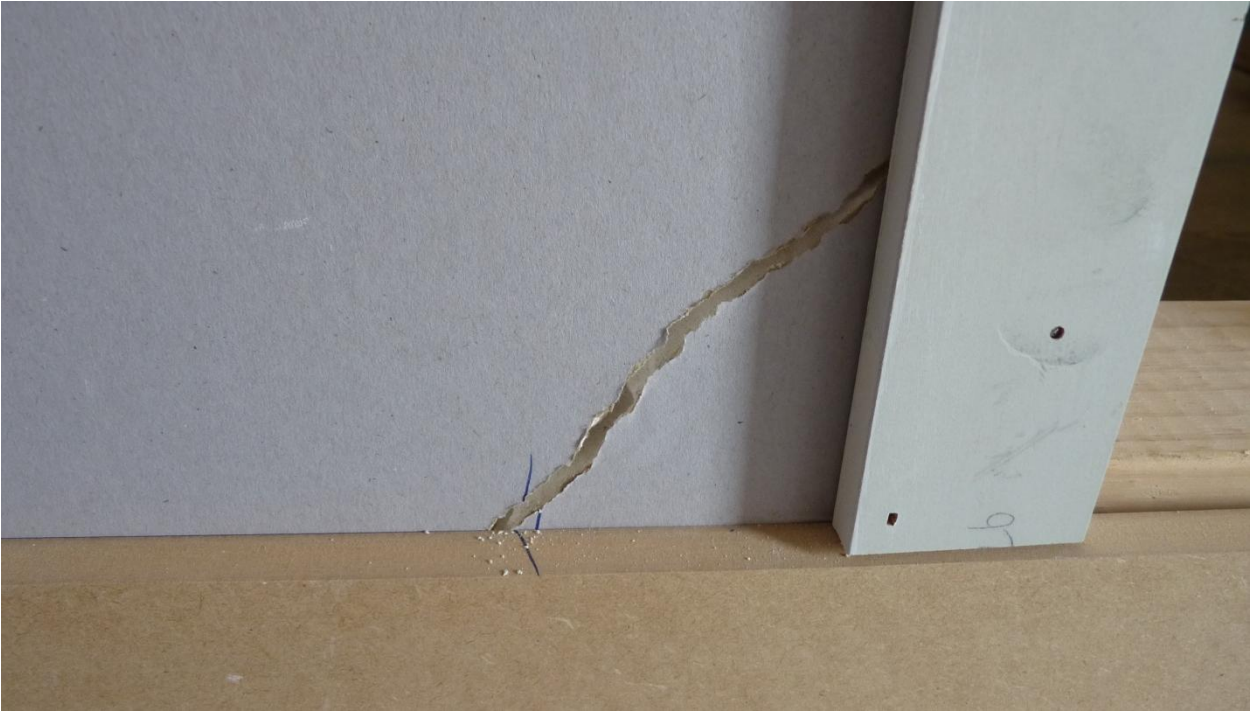
Photograph A.6. Plasterboard crack on the 3.6 m long wall on Side 2 formed after regime Long 3 (nominal 12 mm) taken after regime Long 5 (nominal 23 mm)

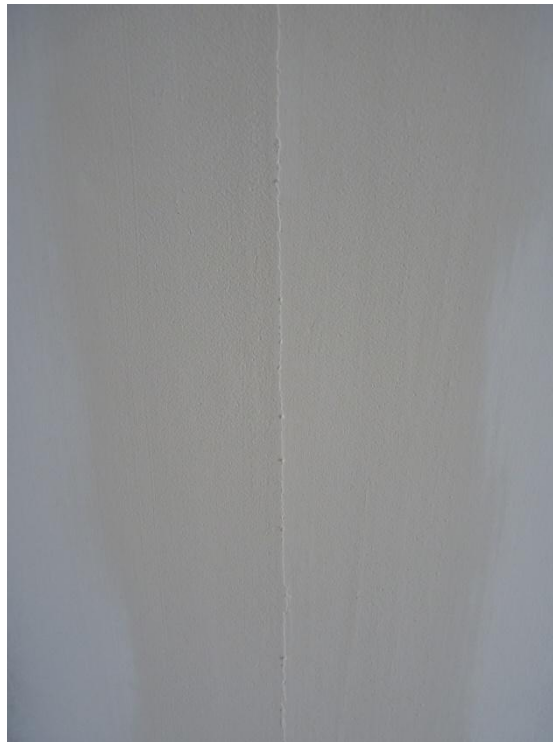
Photograph A.7. Plasterboard crack on the 2.4 m long wall on Side 2 formed after regime Long 5 (nominal 23 mm) taken after regime Long 5 (nominal 23 mm)

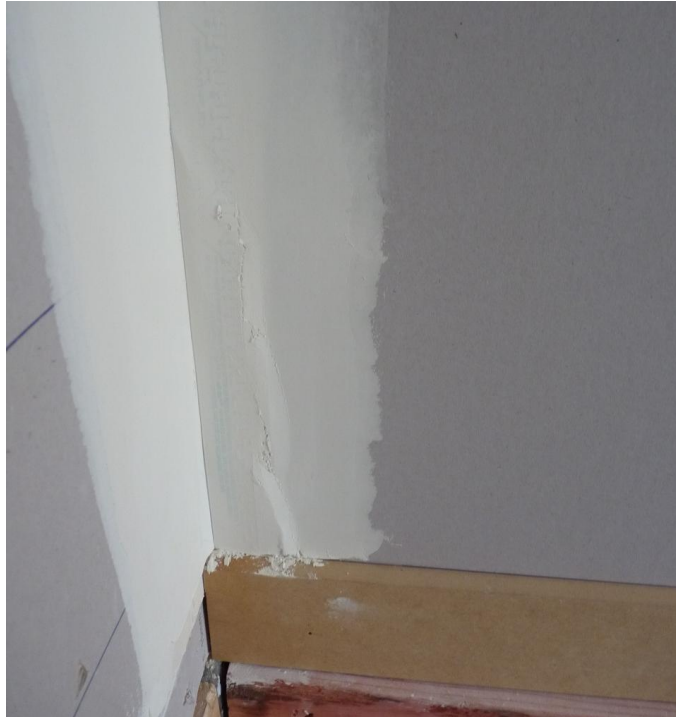
Photograph A.8. Plasterboard crack on the 2.4 m long wall on Side 2 formed after regime Long 4 (nominal 16 mm) taken after regime Long 5 (nominal 23 mm)

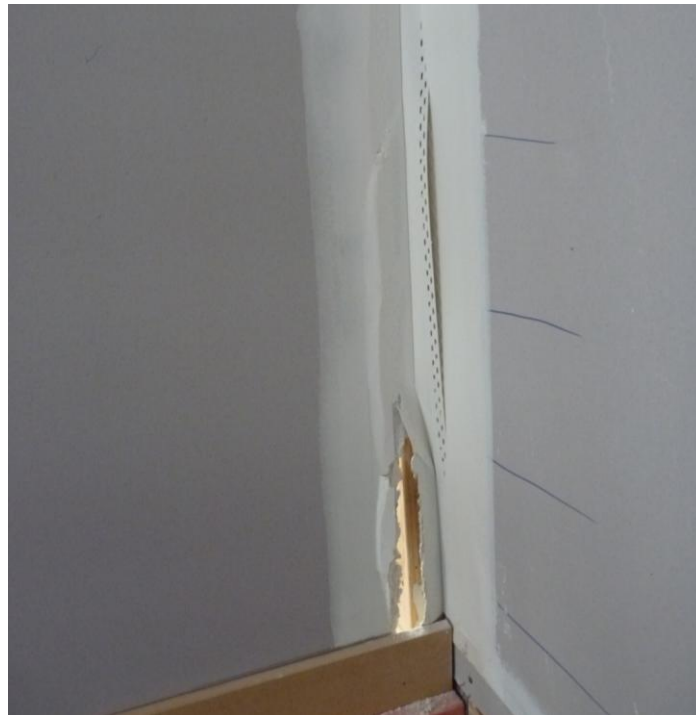
Photograph A.9. Plasterboard crack on the 3.6 m long wall on Side 1 formed after regime Long 6 (nominal 32 mm) taken after regime Long 6 (nominal 32 mm)

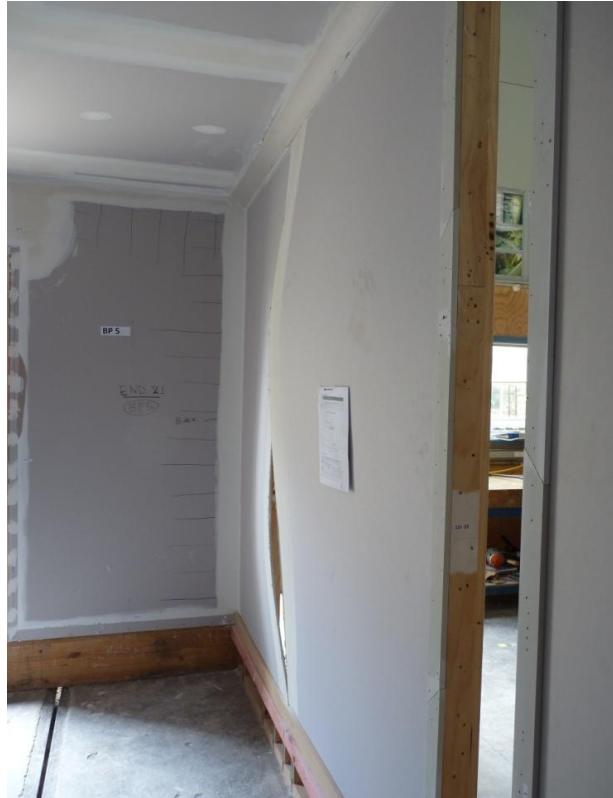
Photograph A.10. Plasterboard joint tear on the 3.6 m long wall on Side 1 formed after regime Long 6 (nominal 32 mm) taken after regime Long 6 (nominal 32 mm)

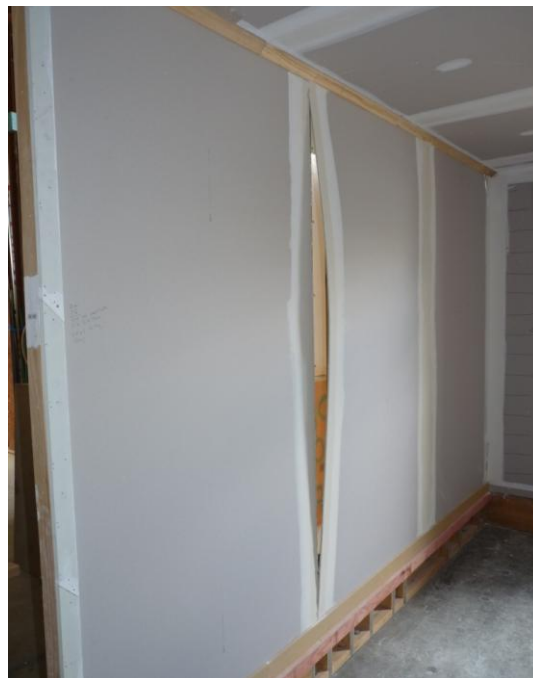
Photograph A.11. Plasterboard joint tear on the 3.6 m long wall on Side 1 formed after regime Long 6 (nominal 32 mm) taken after regime Long 6 (nominal 32 mm)

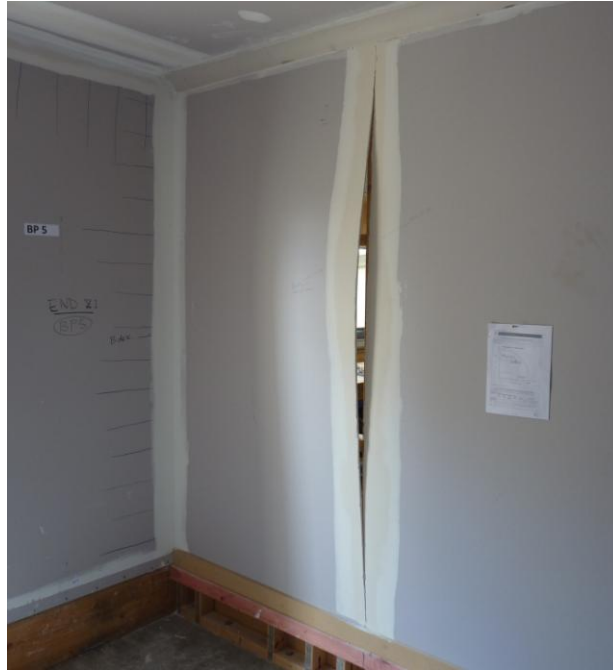
Photograph A.12. Plasterboard joint tear on the 2.4 m long wall on Side 1 formed after regime Long 6 (nominal 32 mm) taken after regime Long 6 (nominal 32 mm)

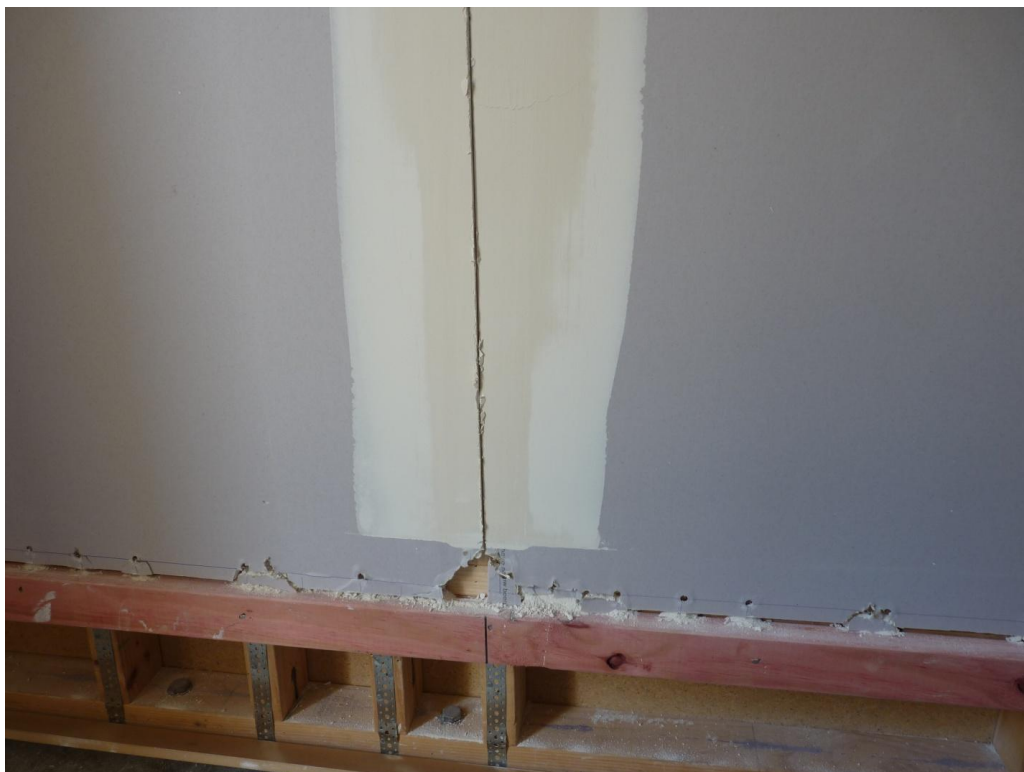
| Name | Wall displacement (mm) | Damage observed | Photographs in Appendix A |
|---|---|---|---|
| Long 7 | ±45.19 | Two sheets fell off the walls. The skirting, architraves and scotia were removed which revealed very severe damage at screw locations at the base of the walls, severe damage at bracing element ends which were not at corners, but no slip along joints or sheet damage at fastener locations at corners. There was moderate damage at screw locations at the tops of | A.13 and A.14 |

Photograph A.13. Plasterboard sheet damage at the mid-length of the base of the 2.4 m long wall on Side 1 formed after regime Long 7 (nominal 45 mm). Note that the skirting has been removed to show damage to bottom sheet fixings

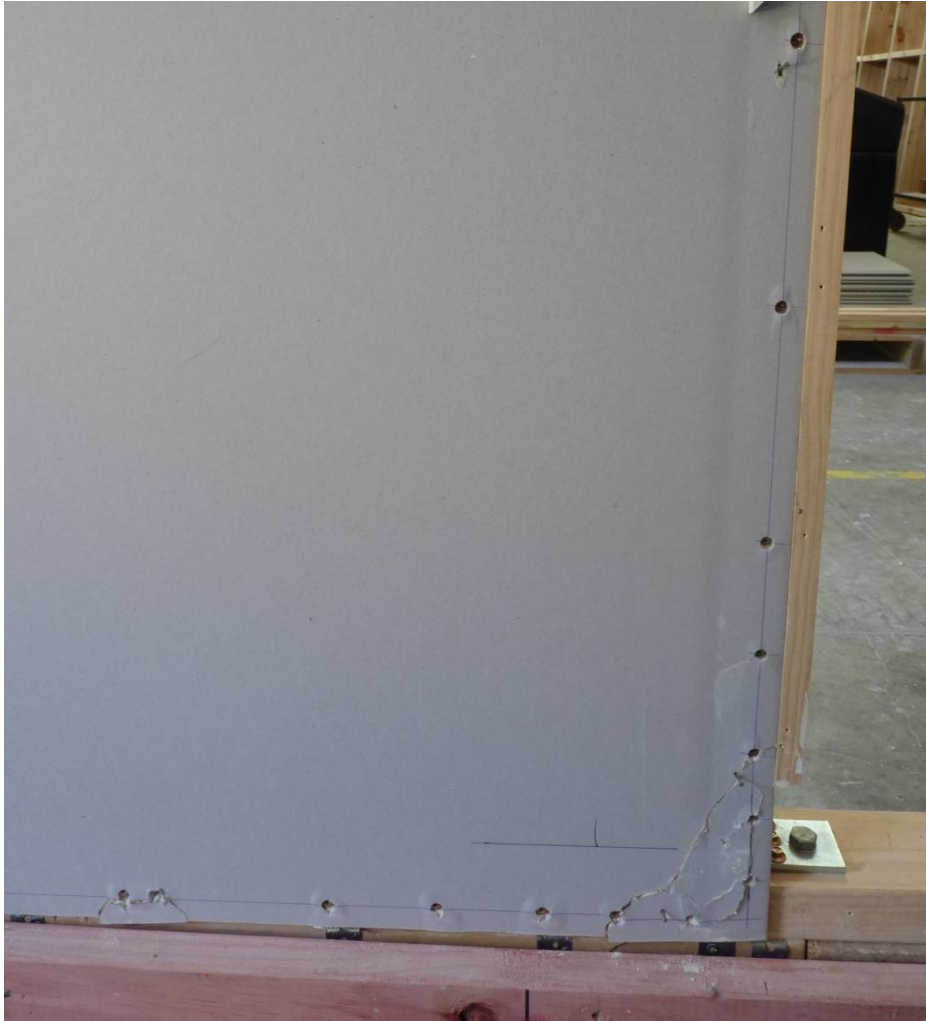
Photograph A.14. Plasterboard damage at the free end of the base of the 2.4 m long wall on Side 1 formed after regime Long 7 (nominal 45 mm)
