# Consent documentation quality for new housing

## BRANZ Study Report SR355

This is the third and final report on a study of new housing construction quality. In this project, it was decided to investigate the quality of the building consent documentation. A total of 52 sets of drawings were inspected – about 50% on site and the rest in the office of the building inspectors. The two main categories of concern were readability and completeness. The on-site inspections also checked whether the details on the drawings were followed in practice. The project found that quite a high percentage of drawings did not have adequate or complete details.

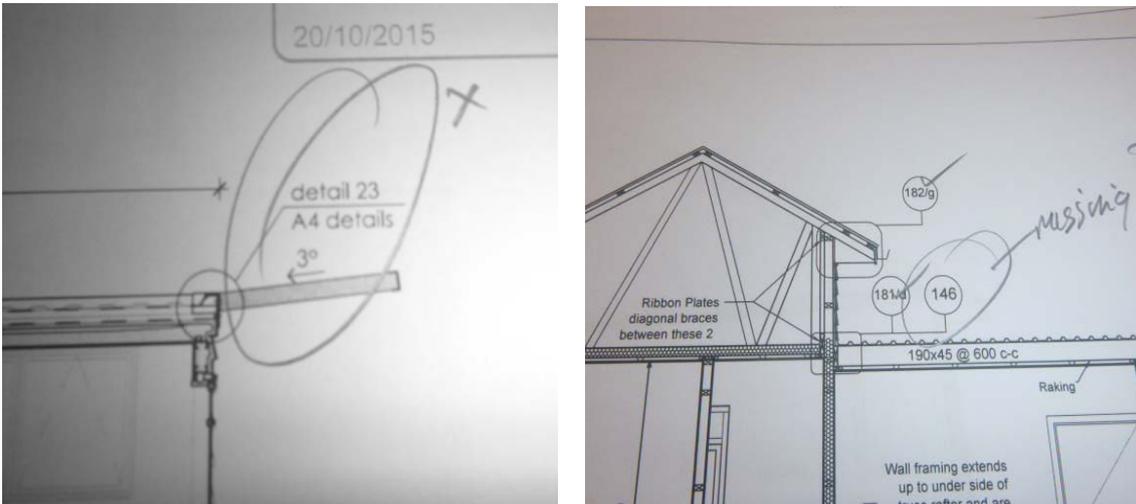
Details are referenced but are missing or are not applicable.

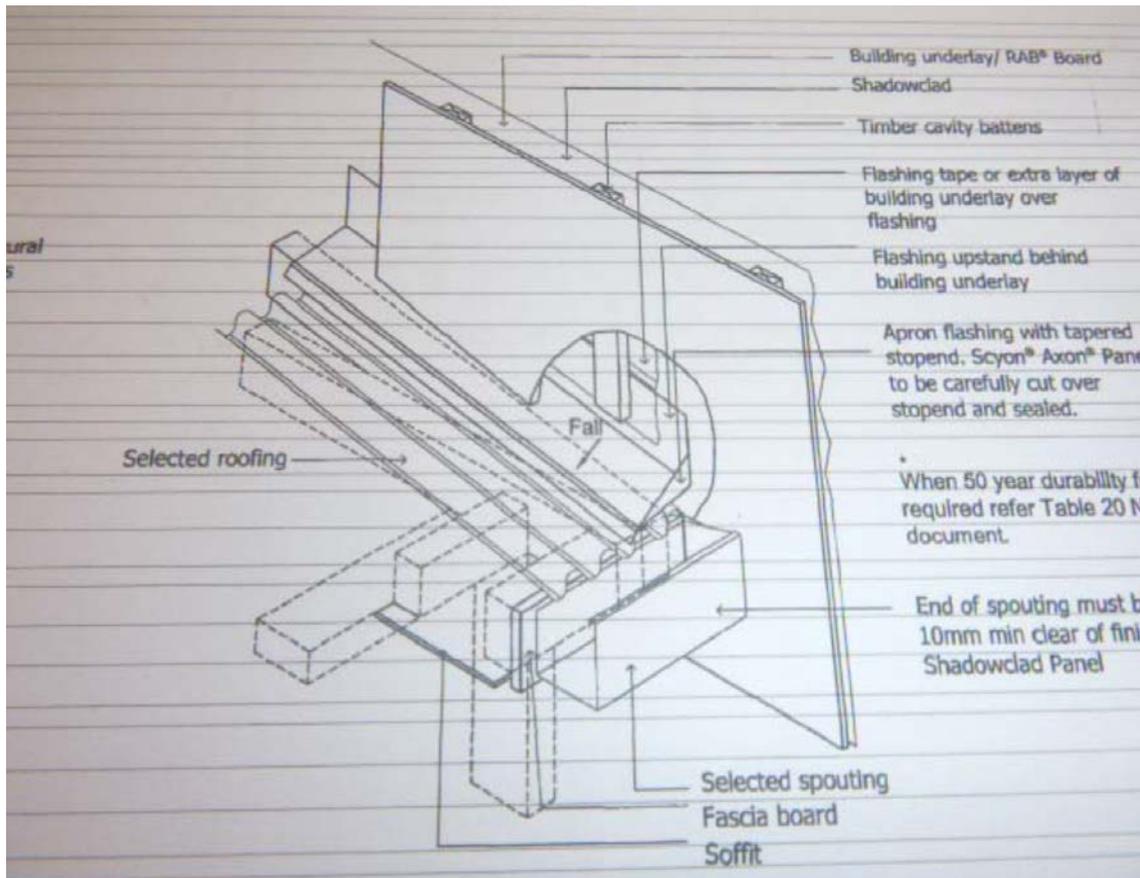
Helpful 3D detail, but clarity is adversely affected by the horizontal lines.

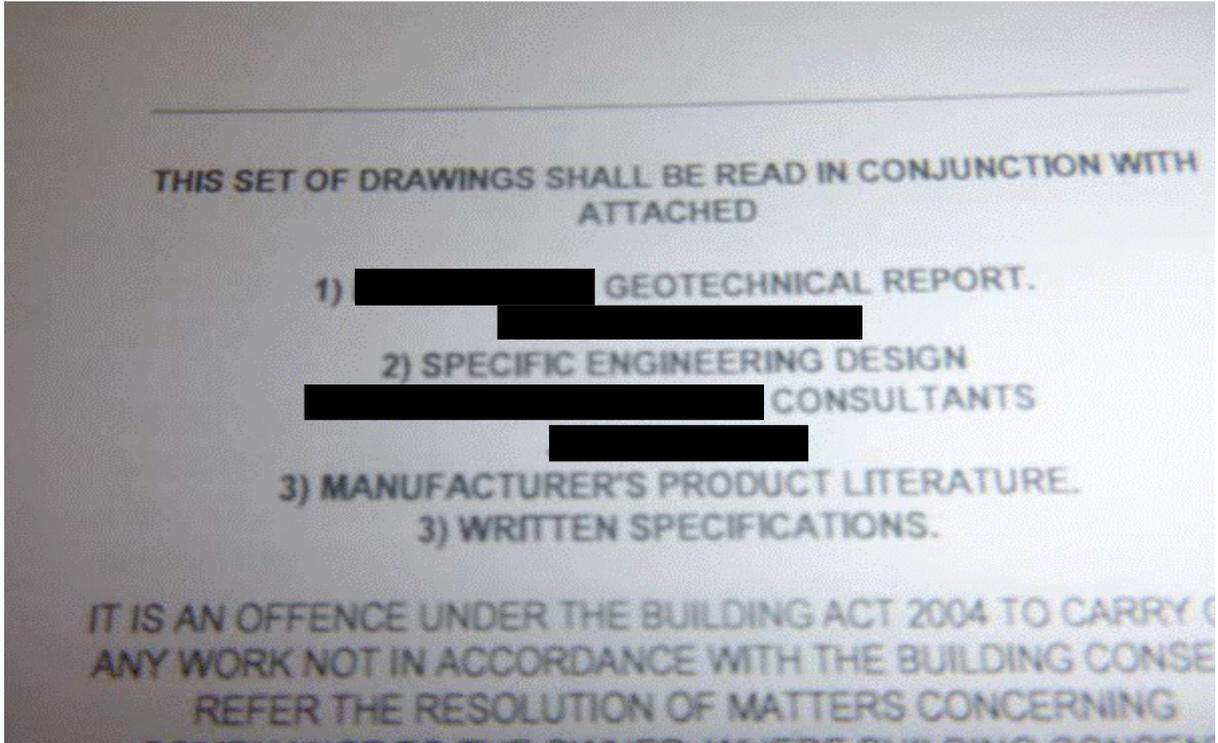
Not all of these references are helpful to the builder: What part of the geotechnical report does the builder need to read? What manufacturer's product literature applies?

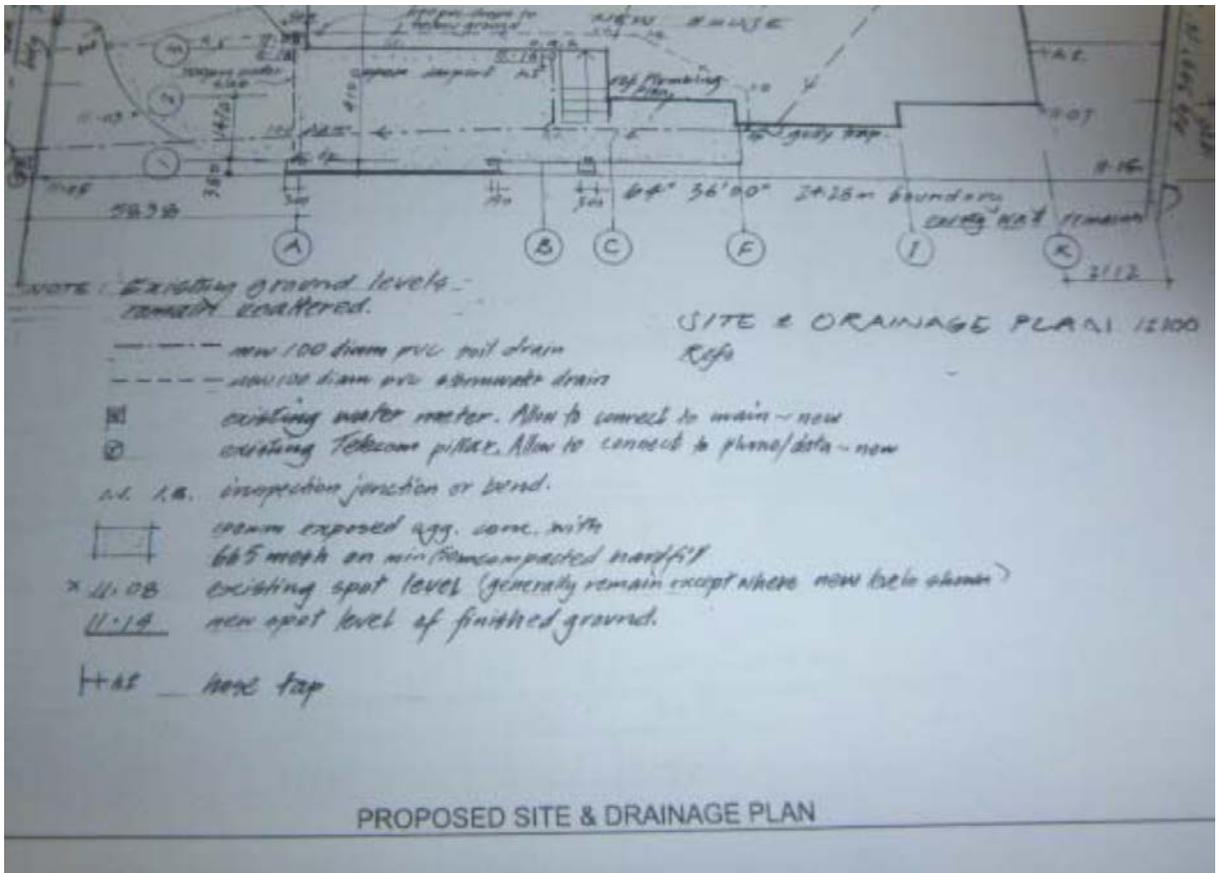
Handwritten notes can be difficult to read.

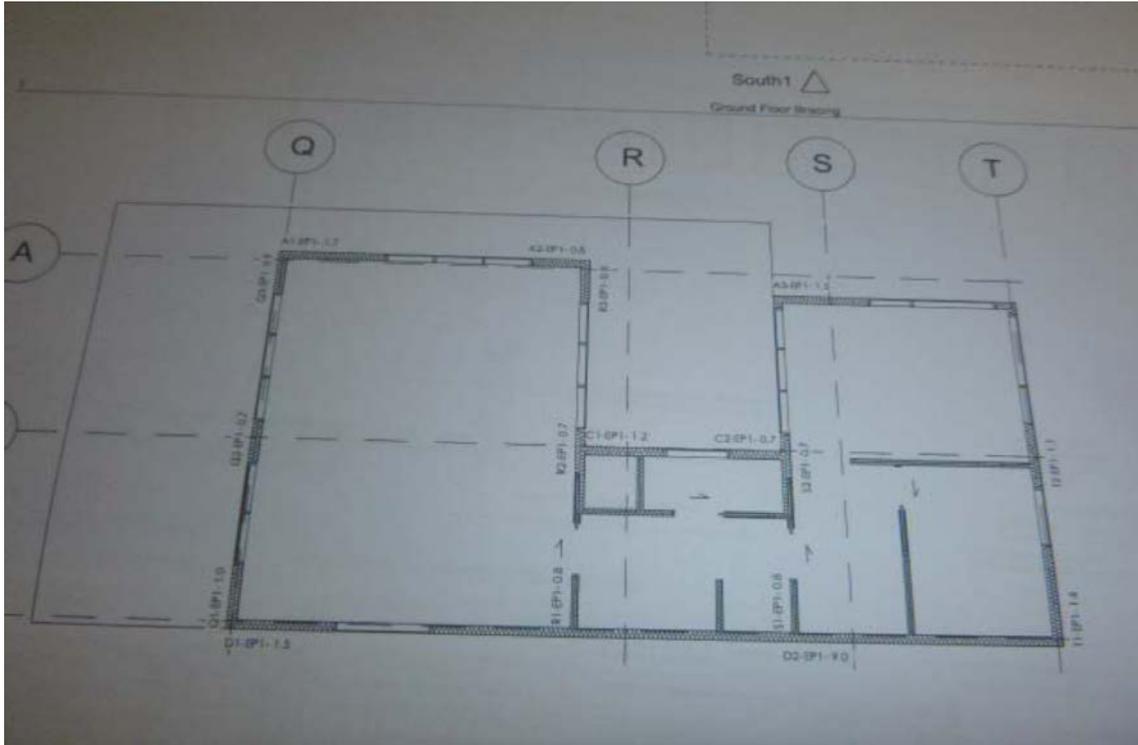
Bracing plan has no key to the bracing type.

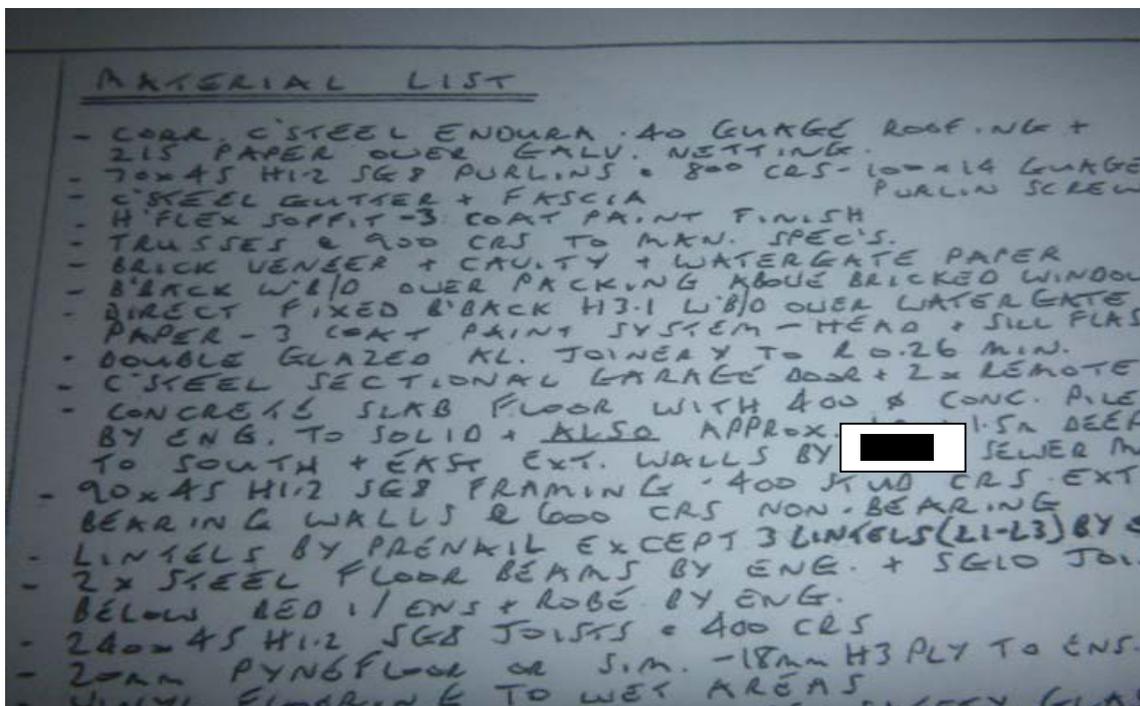
A materials list is good to have but can be difficult to read.

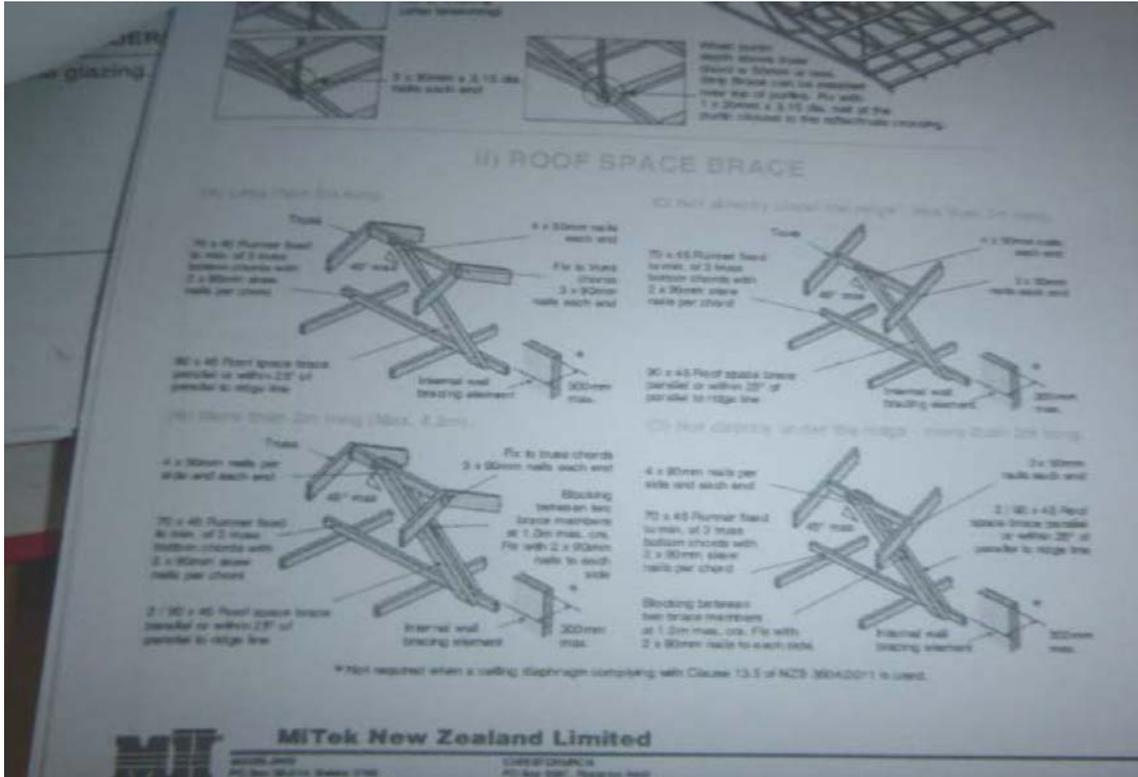
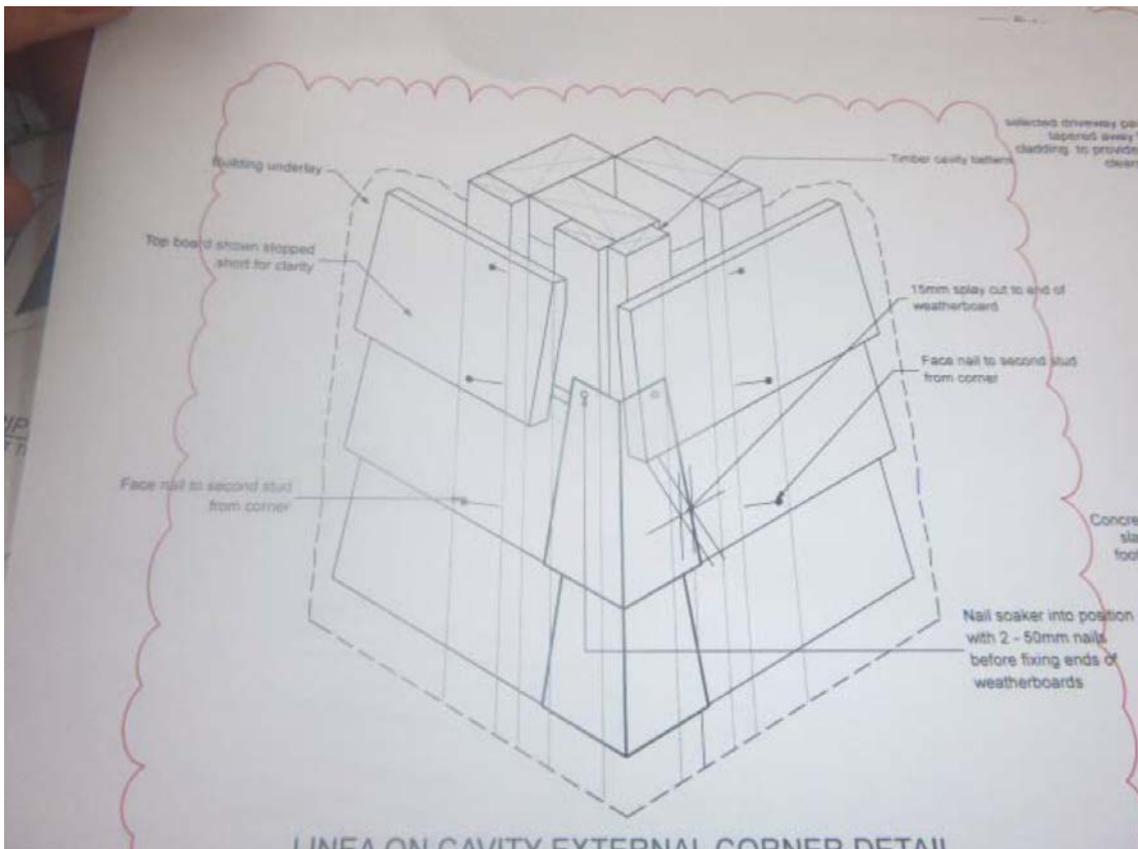
Typical examples of use of manufacturers' details – not all details are relevant for this house.

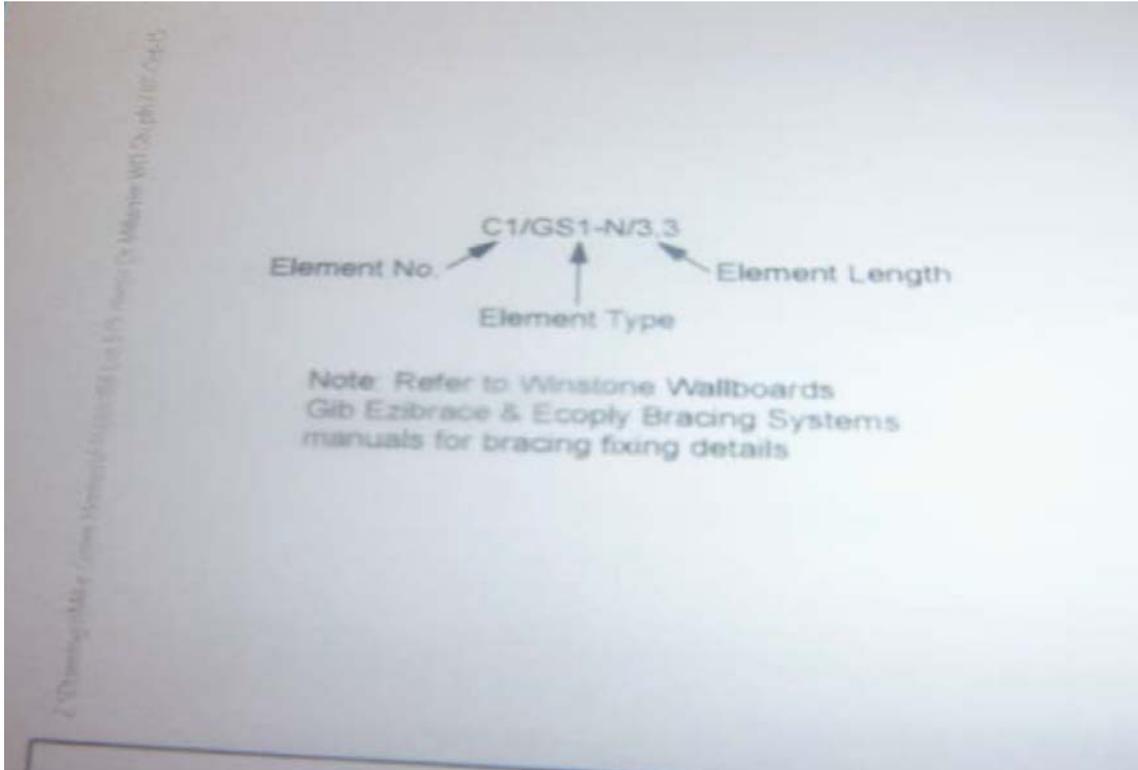
Typical example of reference to manufacturer’s literature for construction details.

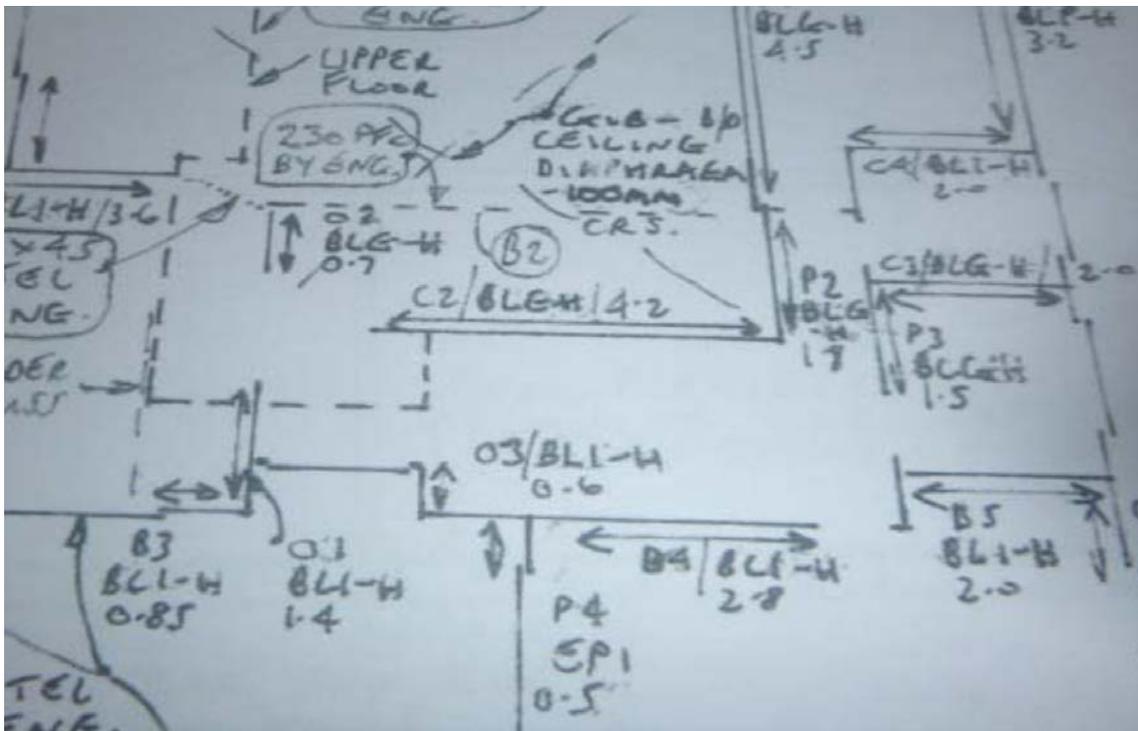
Bracing plan is very difficult to read.
