STUDY REPORT

SR234 (2010)

Investigation into the Performance of Brick Veneer Walls Installed with Urea Formaldehyde Foam Insulation – A Case Study

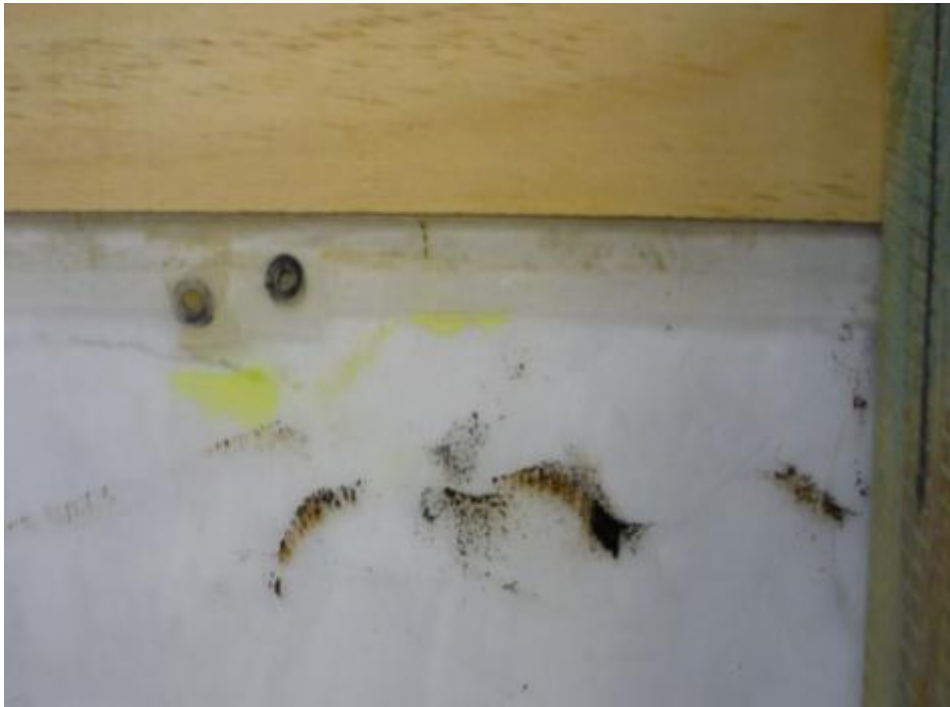
Figure 2 to Figure 4 show water reaching the wall wrap position only minutes after the start of water leakage down the back of the cladding. This is evidence that the foam fill in the water managed cavity has provided drainage paths to the wall wrap position.

Figure 2: Leakage observed 2 minutes after start of test (D4864)

The measurements described in this report show that the small cavity formed between the brick veneer and insulation by shrinkage was insufficiently continuous to prevent water bridging across to the insulation where it was transported to the building wrap position. The drainage cavity in the test wall did not provide a reliable drainage path for water leakage on the back of the brick veneer cladding.

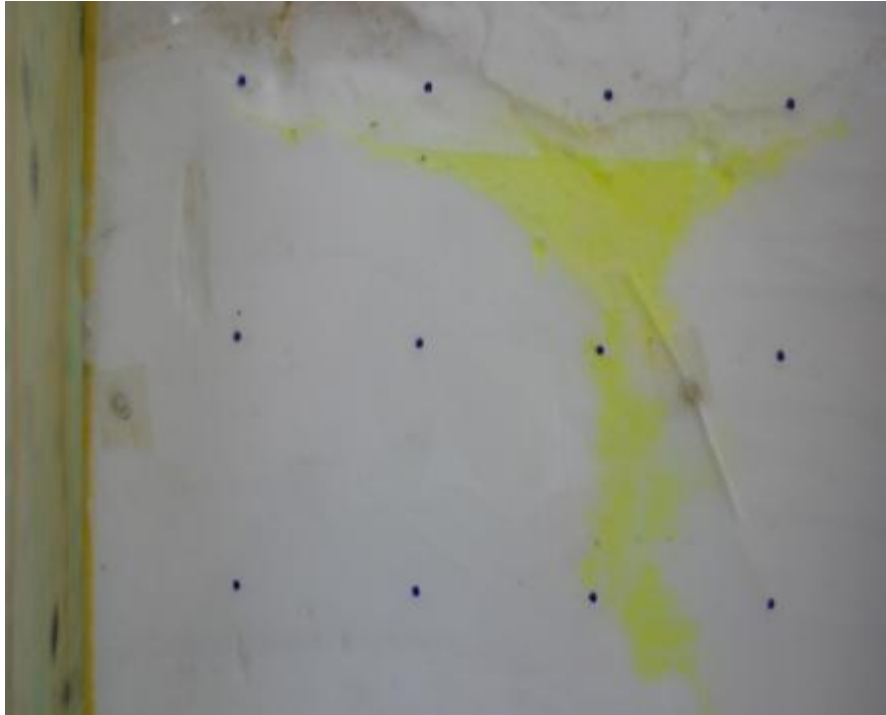
Figure 4: Leakage well established 43 minutes after start of test (D4864)

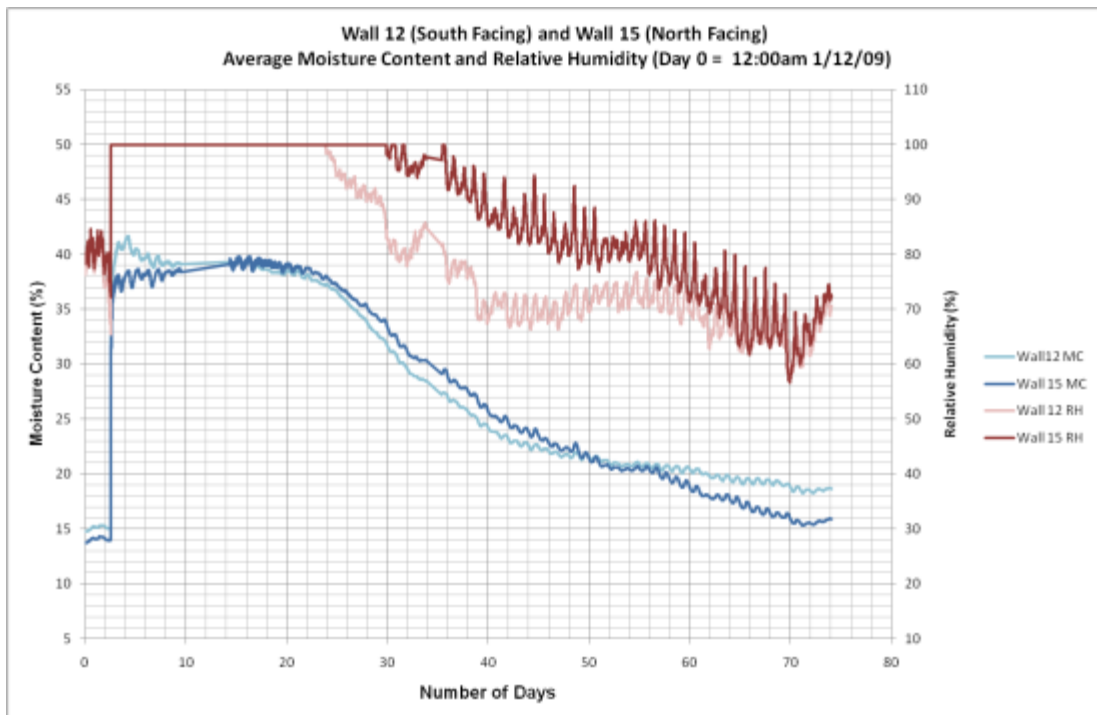
Figure 8: Average Results from Brick Veneer Walls in Test Hut

Figure 8 shows the results from both walls for the period from 1/12/09 to 13/2/10. The installation of the UFF insulation causes a rapid rise in both the relative humidity in the cavity and the moisture content of the framing.

The moisture content of the framing stayed roughly constant for about 2 weeks and then began to slowly dry out. In February 2010, several weeks after installation, the timber was still above the pre-UFFI levels. The results for both walls are similar, but past work indicates that had the UFFI been installed in the winter, the south facing wall would take considerably longer to dry and would be likely to stay wet for the whole of the winter.

The humidity measurements are representative of the moisture in the foam. The results show that the humidity is at 100% (free moisture) for 2-3 weeks before drying out. The foam in the north facing wall dried quicker (about 5 weeks) than its south facing counterpart (about 8 weeks), but in both cases the foam dried at a considerably quicker rate than the framing. Sustained high humidities have the potential to support mould growth and so should be avoided if possible.
