ISSUE 572 **BULLETIN**

AGGRAVATED THERMAL BRIDGING RESEARCH

June 2014

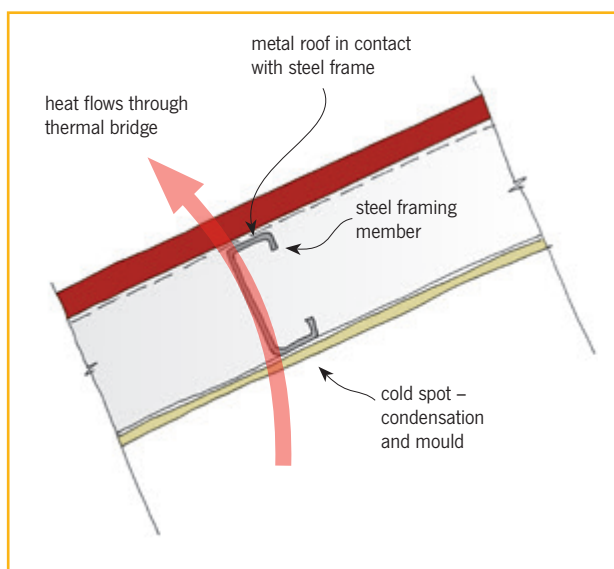
1.0.1 Thermal bridging occurs when a material that is a good conductor of heat directly connects a building's cladding and lining. Steel roof framing is a good example. It can directly connect the inside and outside of the building and provide a low thermal resistance heat flow path, increasing heat loss from a warm interior to the outside (Figure 1). Cold spots can form on the areas of ceiling directly under the framing, and condensation can form. A typical sign of thermal bridging is condensation, which can lead to mould growth along the colder and damper areas of ceiling, following the pattern of the framing.

Figure 1 Schematic drawing of thermal bridging (insulation omitted for clarity).

1.0.2 Traditionally, the problem of thermal bridging is addressed by inserting thermal breaks (materials such as polystyrene, timber or insulating board, which are poor heat conductors/good insulators) between building elements to reduce the transfer of heat.

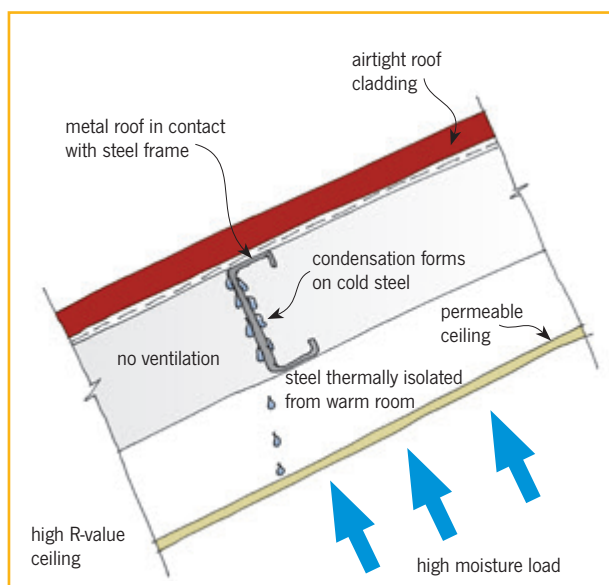
1.0.7 Warm moisture-laden air from below passes upwards through the ceiling and condenses on the cold framing steel (Figure 2). With no ventilation to reduce the problem, this can lead to excess condensation, affecting the durability of the roofing elements, corrosion of steel roof components and deterioration of roof underlays, ceiling linings and insulation. BRANZ research that is currently under way aims to provide guidance on how much ventilation should be provided for a range of roof constructions, but no recommendations are available yet.

Figure 2 Condensation forms on steel roof framing.

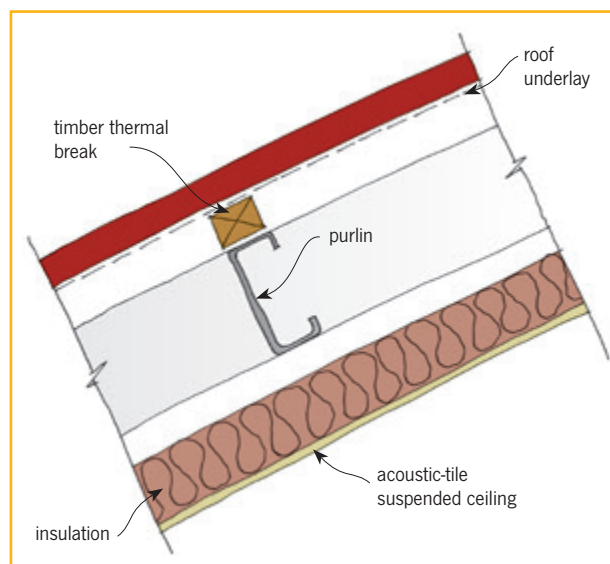
1.0.8 One possible solution to prevent aggravated thermal bridging would be to insert a thermal break of insulating material between the steel member and the roof cladding. However, BRANZ research has indicated that this thermal break is not always sufficient to solve the problem. The air in the roof space – and therefore the steel framing – can still be very cold, and condensation can occur.

Figure 3 Roof specimen 1: A timber thermal break between the purlin and roof underlay.

1. A timber thermal break between the purlin and roofing underlay under the roofing, with insulation above an acoustic-tile suspended ceiling (Figure 3). (Since this was known not to be particularly effective, it was regarded as a control.)

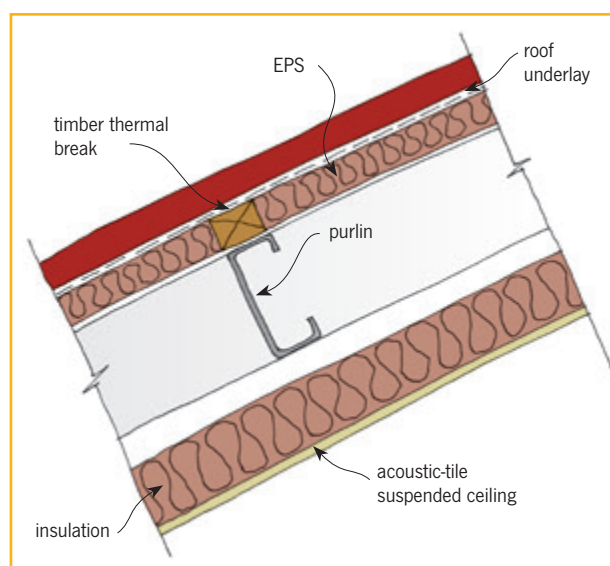
2. A timber thermal break between the purlin and roofing underlay under the roofing, with EPS polystyrene sheets immediately under the underlay between the thermal breaks, plus insulation above an acoustic-tile suspended ceiling (Figure 4). There are no structural requirements on the EPS in this case.

Figure 4 Roof specimen 2: A timber thermal break between the purlin and roofing underlay with EPS polystyrene sheets installed between the thermal breaks and immediately below the roof underlay. The EPS is not structural.

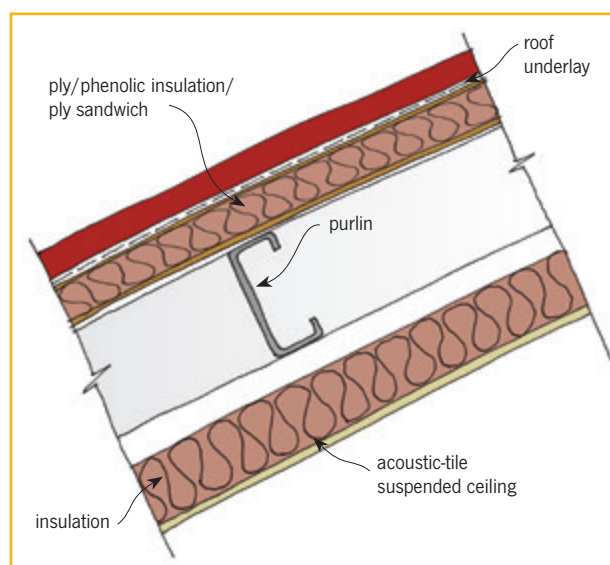
3. A continuous plywood/phenolic insulation/plywood structural insulated panel (SIP) installed over the purlins and below the roof underlay, with insulation above an acoustic-tile suspended ceiling (Figure 5).

Figure 5 Roof specimen 3: A plywood/phenolic insulation/plywood SIP installed over the purlins but below the roof underlay.

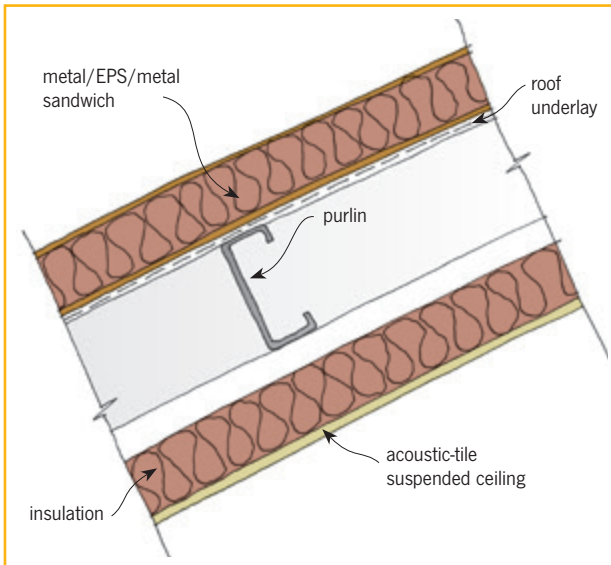
4. A continuous metal roofing/EPS polystyrene/metal SIP panel, installed over the roof underlay and purlins, with insulation above an acoustic-tile suspended ceiling (Figure 6). The panel is also the weathertight cladding in this case.

Figure 6 Roof specimen 4: A metal roofing/EPS polystyrene/metal SIP panel installed over the purlins and roof underlay. The roof panel is the weathertight building cladding.

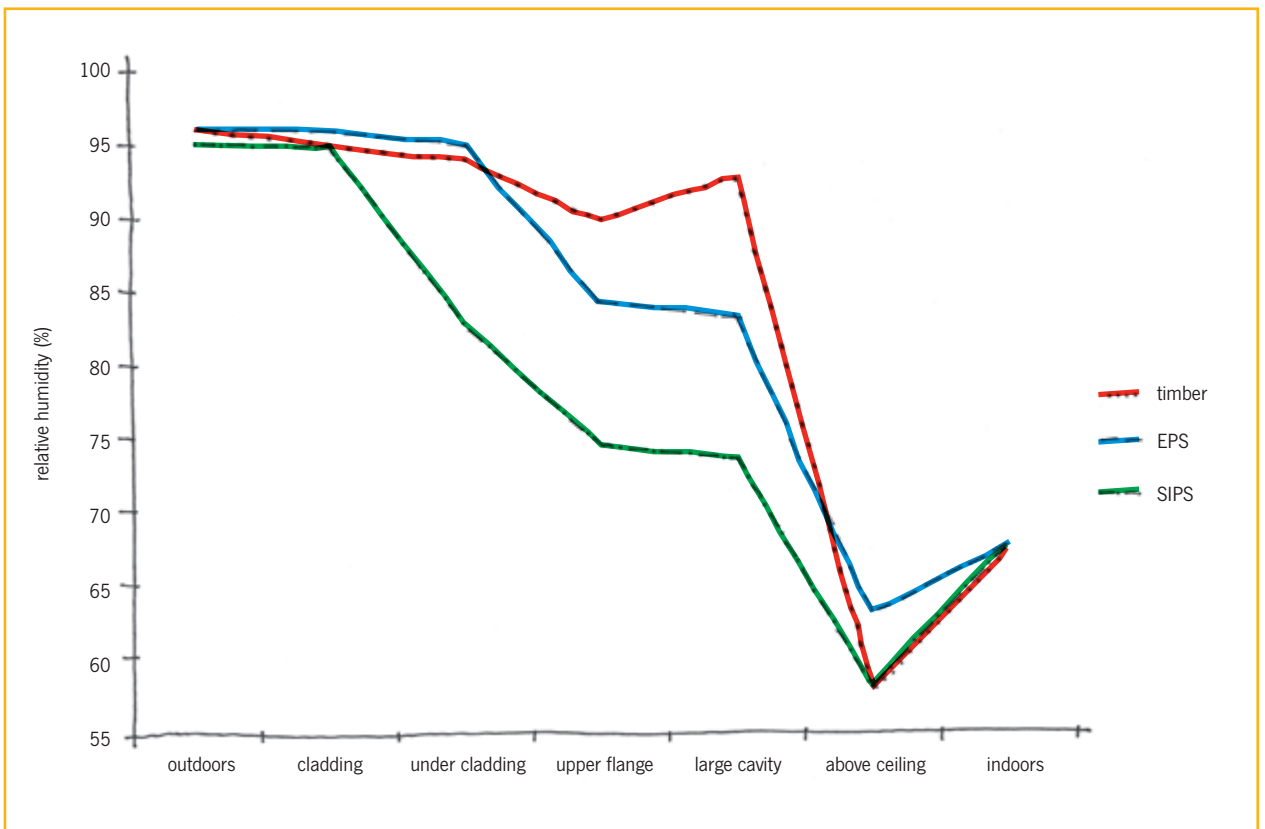
2.2.1 The relative humidity levels on a frosty night for a building with a high moisture load and a temperature around the flanges of around 0°C are shown in Figure 7. They show the following results:

- For the timber thermal break alone (roof specimen 1), the relative humidity was over 95% around the steel member – the ‘upper flange’ on the chart (relative humidity was over 97% for more than 17% of the time). This is high enough for substantial amounts of condensation to form and become a serious problem.
- For EPS (roof specimen 2), the relative humidity percentage was in the 80s – generally acceptable. (Although relative humidity rose to 97–98% on extremely cold nights, this happened for around only 1% of the time. The condensation that occurred on such nights would be unlikely to result in long-term problems.)
- For the SIPs (roof specimens 3 and 4), the relative humidity percentage was in the 70s – acceptable.

2.2.2 The research shows that a timber thermal break running along the top of steel framing members may not be enough in itself to reduce the relative humidity in the roof space and, therefore, to reduce the risk of condensation forming.

2.2.3 The research shows that sheet insulation under the whole of the roof cladding, whether it is EPS or a sandwich (SIP) of plywood/phenolic insulation/plywood or metal/EPS/metal, reduces relative humidity to an acceptable level.

Figure 7 For the roofs studied, a timber thermal break does not significantly reduce relative humidity around the steel framing (‘upper flange’). EPS and SIPs are more effective.

- non-structural EPS polystyrene sheet under the roof cladding
- plywood/phenolic insulation/plywood SIPs under the roof cladding
- metal/EPS/metal SIPs.
