BULLETIN ISSUE594

EXCESSIVE MOISTURE IN ENCLOSED SUBFLOOR SPACES

February 2016

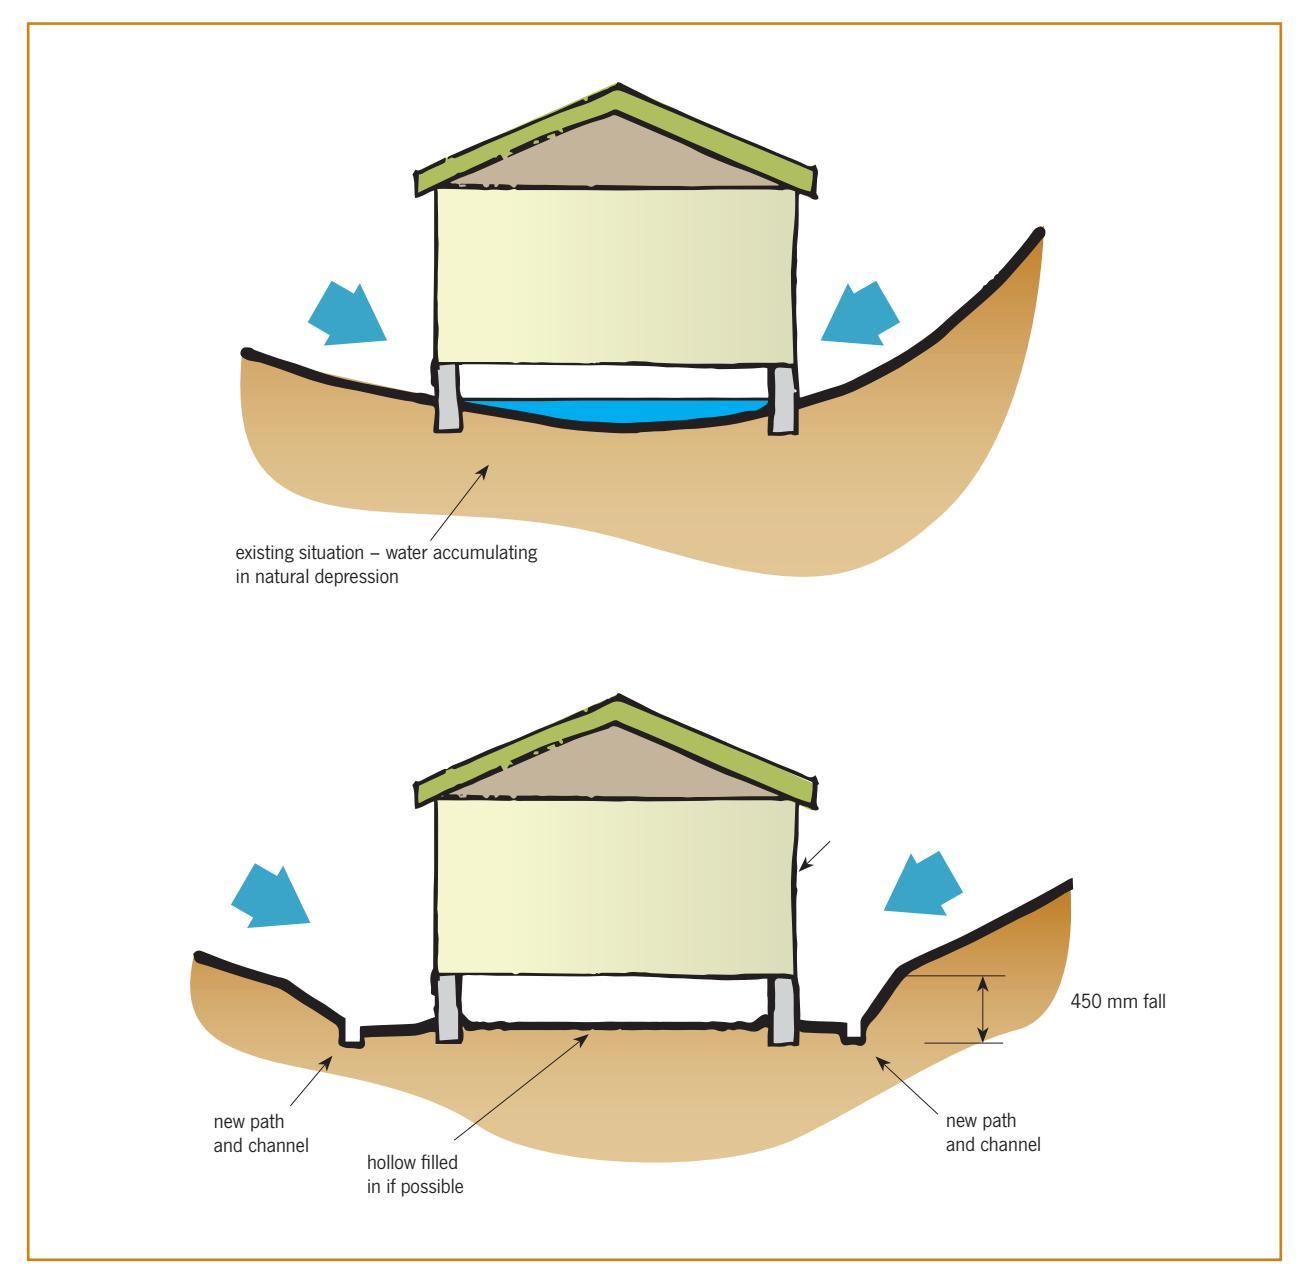
Figure 3. Water must not be allowed to pond under a house. Land or paving immediately around a house should be graded so rainwater runs away from the building. Ensure adequate drainage to a stormwater disposal system.

2.0.6 NZS 3604:2011 also states that water must not be allowed to accumulate in a building's subfloor (Figure 3).

- Deal first with any obvious causes of moisture under the house itself, for example, by fixing leaky pipes.
- If water is flowing under the house from outside or ponding under the house, consider the options for modifying the ground surface. The ground immediately around the house should be graded so rainwater runs away from the building. If hard paving around the house is causing run-off under the house, replace it or modify it.
- In some cases, new channels or subsurface drains that discharge to an approved stormwater drain or soakpit may be required, especially if surrounding land slopes down to the house and existing drainage is insufficient.
- Clear ventilators that have become blocked through soil or vegetation build-up outside the house or items stored inappropriately under the house.

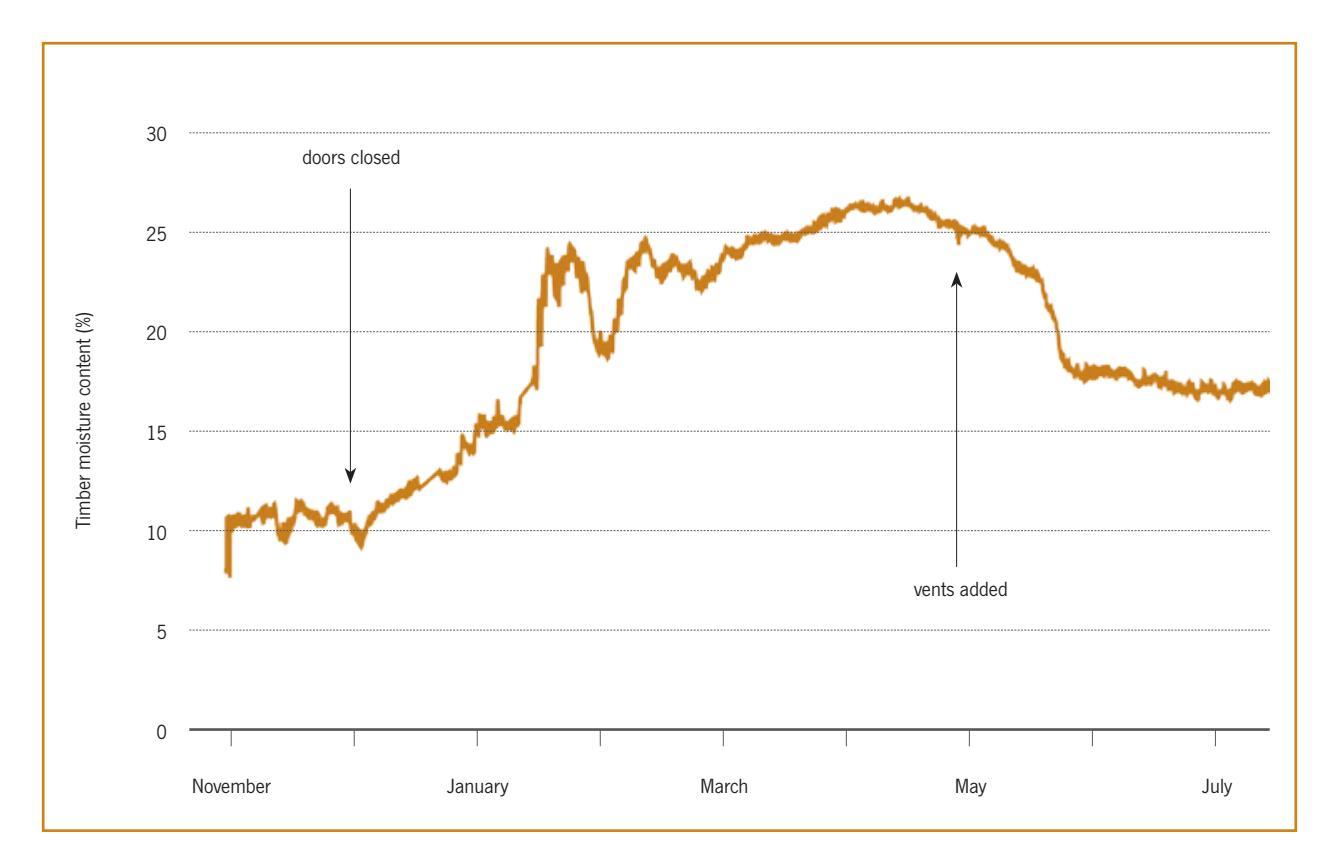
Figure 5. The moisture content of a floor joist on the south side of a BRANZ test house fell after subfloor vents were added.

3.0.6 A recent BRANZ project provides strong evidence of the effectiveness of ventilation. The moisture content of a floor joist fell significantly and relatively quickly once vents were added to the subfloor of a test house (Figure 5).

6.0.4 Moisture may be a problem even where the ground appears dry. A BRANZ research project on subfloors used a test house with very little ventilation (Figure 5). The moisture content of a floor joist doubled within 3 months, and heavy condensation formed on the underside of insulation. However, the ground under this was dry to the touch and but was very damp just 50 mm below the dry surface.
