HOUSE CONDITION SURVEY 2015

February 2018

BRANZ house condition surveys provide an independent study of the physical characteristics and condition of New Zealand's housing stock. This bulletin describes findings of the 2015 survey.

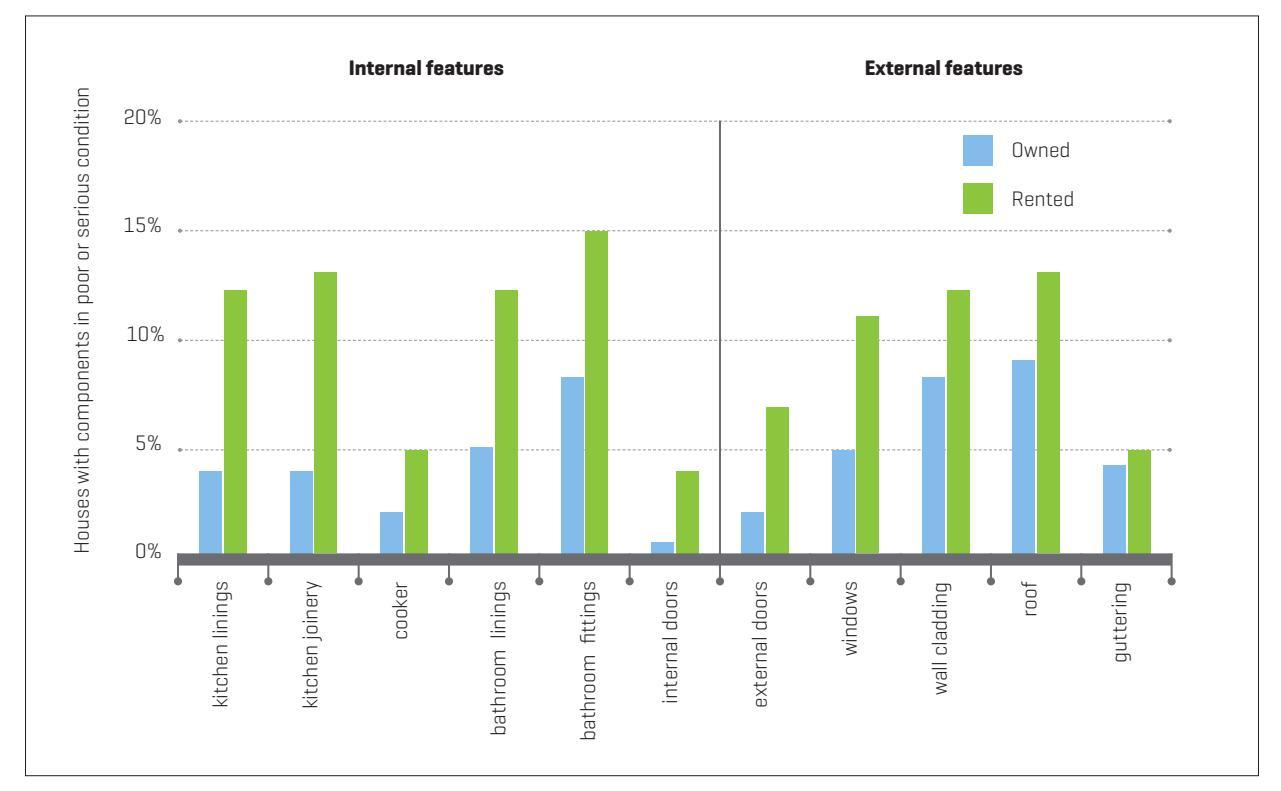
1.0.6 Rental housing stock was typically in a worse condition than owner-occupied houses (Figure 2). This was evident in the assessment of both interior and exterior property features.

Figure 2. Proportion of owner-occupied and rental properties with interior components in poor or serious condition.

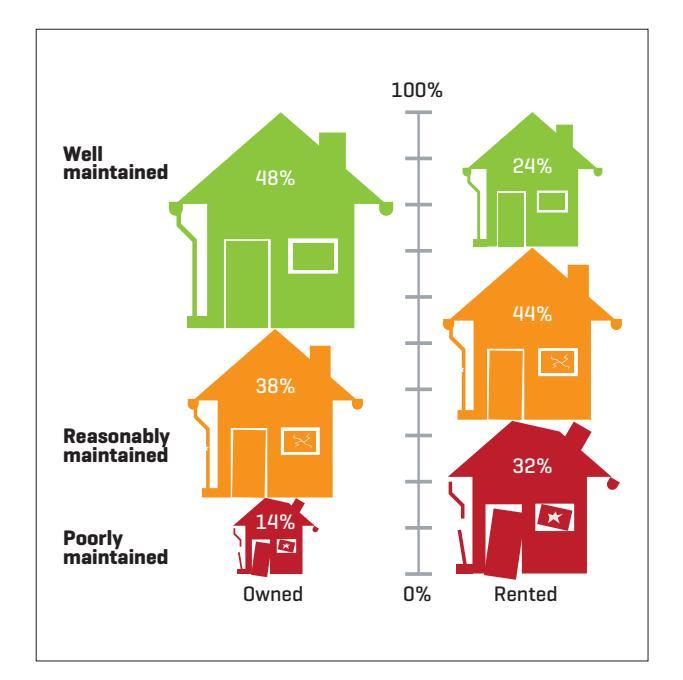
as poorly maintained compared to owner-occupied houses (32% compared to 14%). Rented houses were only half as likely to be assessed as well maintained (Figure 3).

Figure 3. Assessed level of maintenance of owner-occupied versus rented houses.

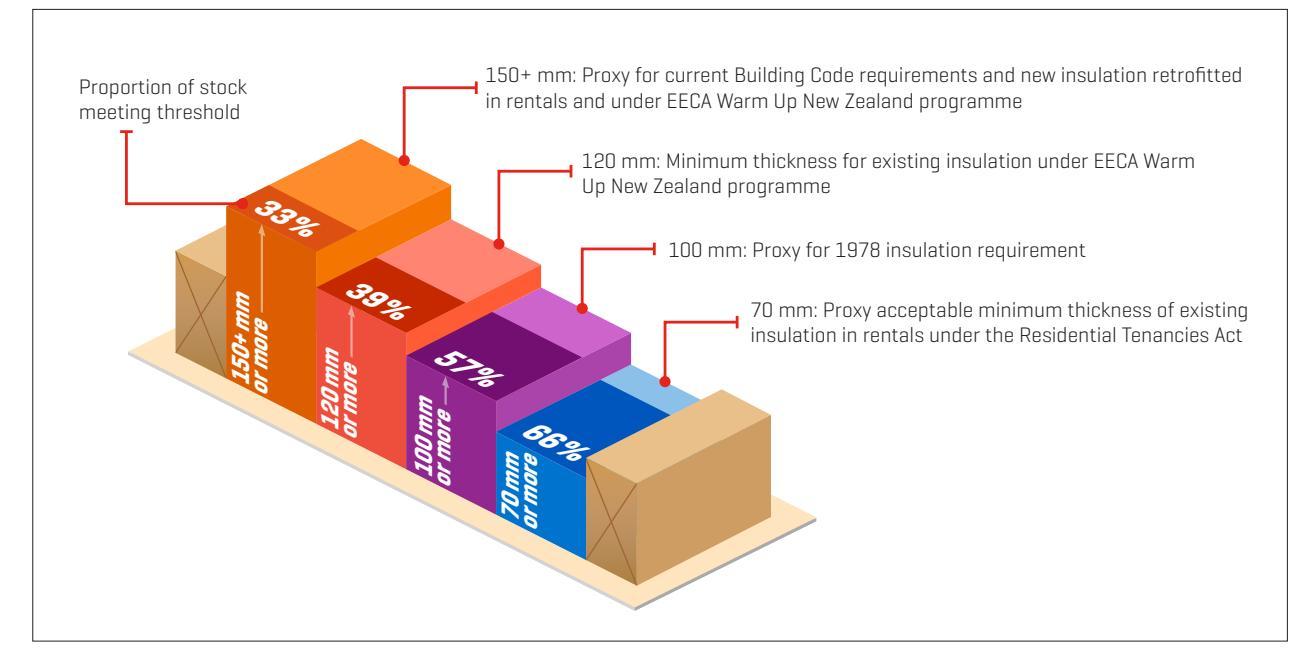
2.0.2 Just under two-fifths of the houses (39%) had at least 120 mm insulation covering at least 80% of the accessible roof space area. 120 mm is the minimum recommended by the government's home insulation retrofit programme and the Energy Efficiency and Conservation Authority (EECA) (Figure 4).

Figure 4. Ceiling insulation depth relative to different requirements and proportion of houses insulated to depth based on 2015 survey data.

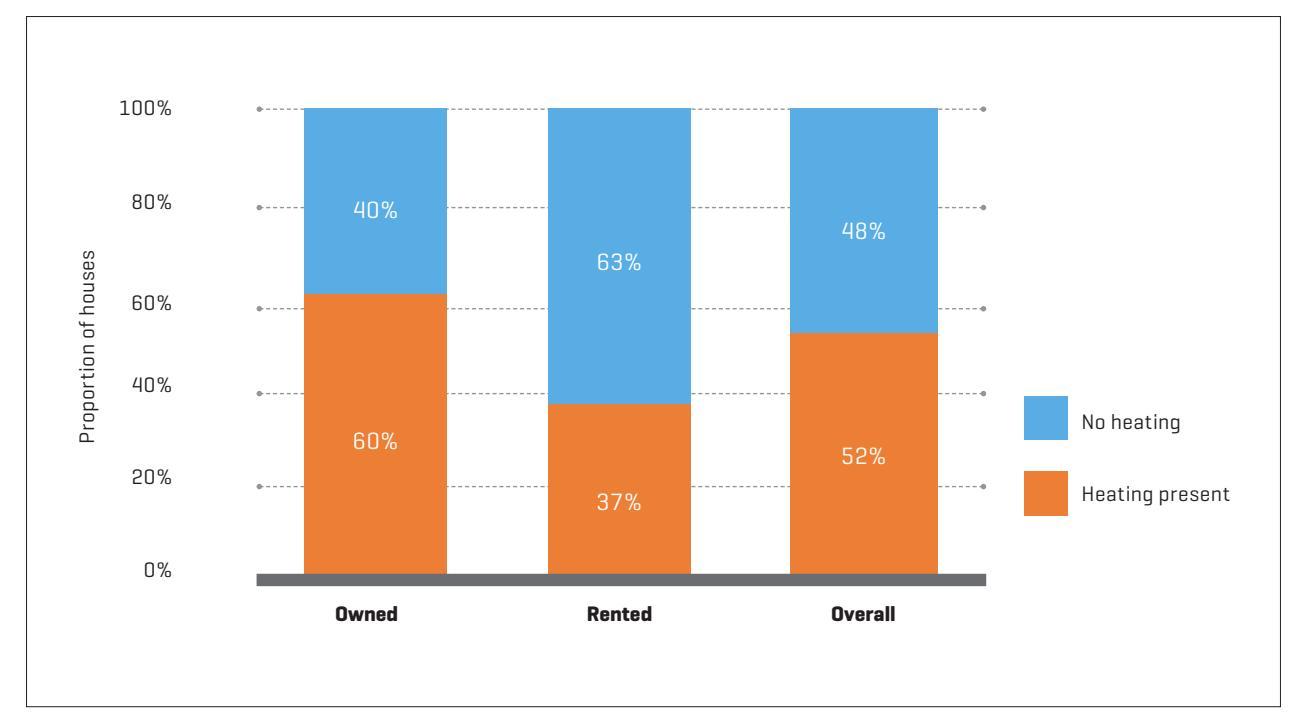
5.0.5 There was also a difference in the availability of heating in the bathroom between rented and owned houses (Figure 5). Owner-occupiers were much more likely to have heating in the main bathroom (60% versus 37%).

Figure 5. Rental houses were less likely to have heating in the main bathroom.

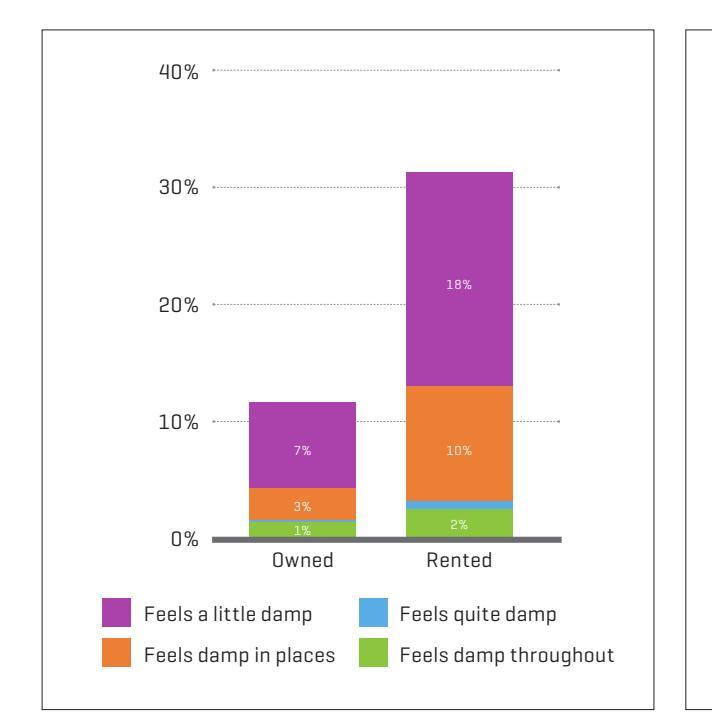
6.0.2 The surveyors found 31% of rentals felt damp ('a little damp' to 'damp throughout'). This is nearly three times the proportion of owner-occupied houses (11%) (Figure 6).

Figure 6. Subjective assessment of dampness in houses.

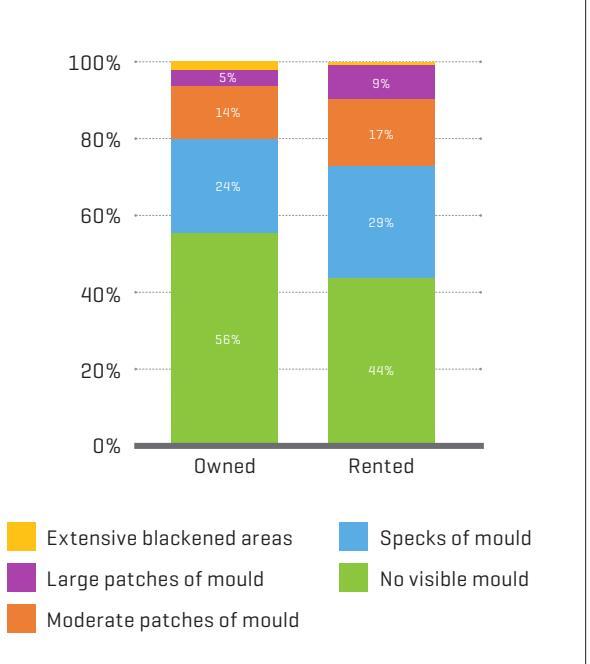
6.0.4 Overall, mould was visible in nearly half (49%) of all houses surveyed, breaking down to 43% of owneroccupied and 55% of rental properties (Figure 7). In most cases, this was just specks of mould. Mould was most commonly found in bathrooms.

Figure 7. Visible signs of mould anywhere in the house.

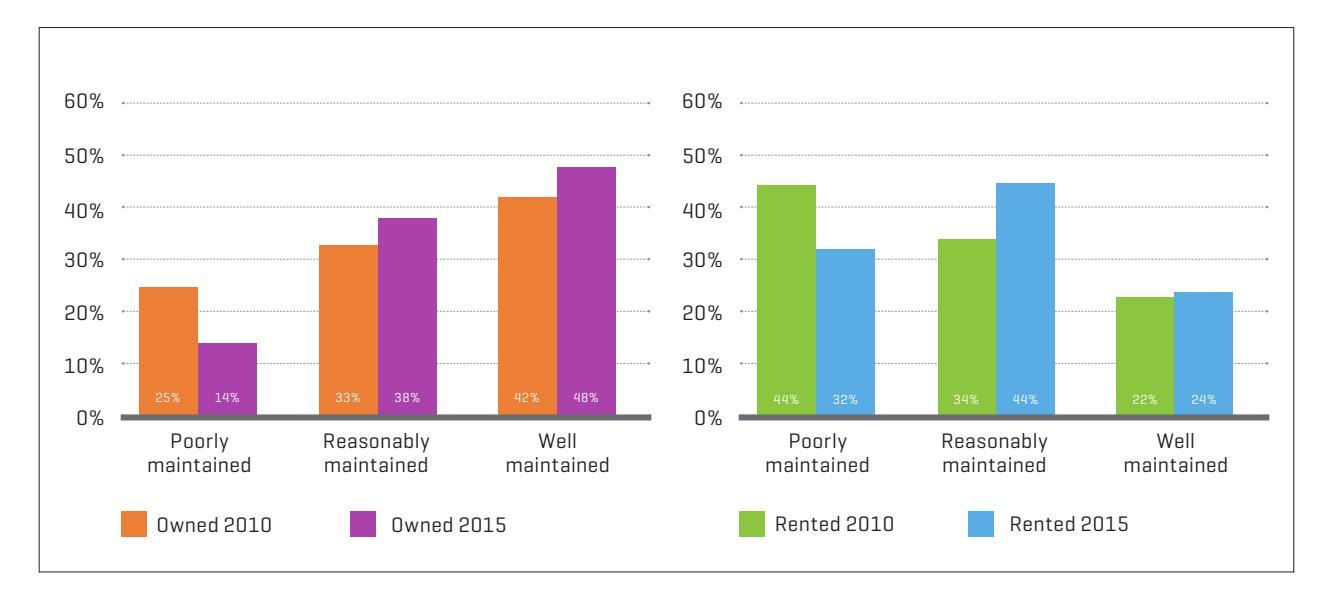
7.0.1 Using assessors' judgement of how well maintained properties were in 2010 and 2015 as a measure, there are indications that house maintenance may be improving across the whole housing stock (Figure 8).

Figure 8. Changes in overall assessed level of maintenance between 2010 and 2015.
