# ISSUE674 BULLETIN

# SEISMIC RETROFITTING HOUSES WITH PILED FOUNDATIONS ON SLOPING SITES

August 2022

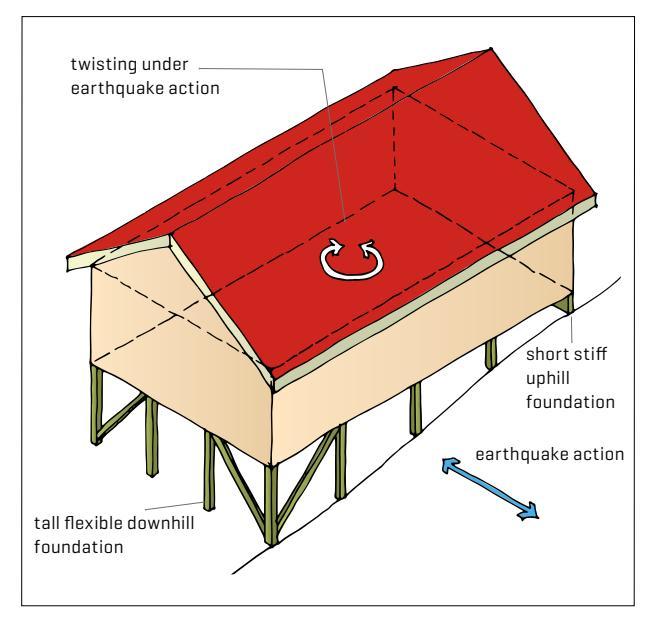
**2.0.1** The foundations of older hillside houses can be twisted in an earthquake as the taller downhill foundations see larger displacement than the shorter and stiffer foundation on the uphill side (Figure 1). These deflections add to any lateral displacement (sideways movement) occurring, potentially resulting in a progressive rotational failure. This can result in serious damage to the foundations of the house and subsequent damage to other elements of the building.

Figure 1. Twisting of the foundations of a hillside house under earthquake action.

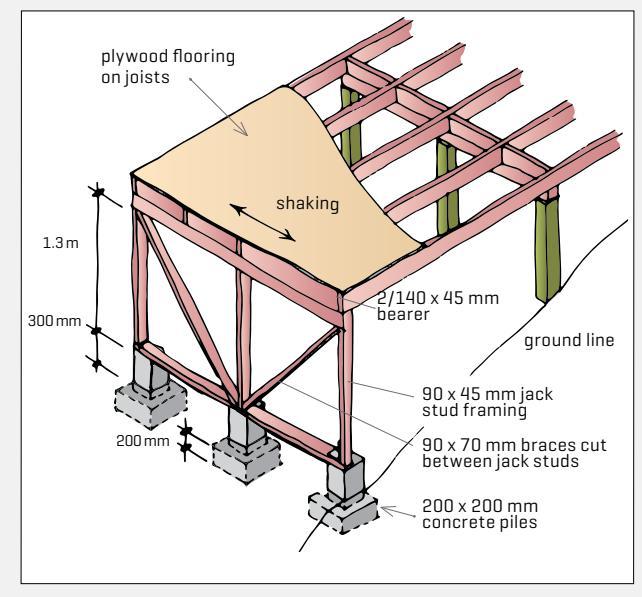
**3.0.4** The preliminary tests on the two pre-1960s floundations measured the stiffness and natural frequency of each floor. Deflections of the floors increased almost to the point of imminent collapse in one test. Floor 4 had up to 76 mm movement. The brace connections of Floor 3 became very loose, and the 8 g wires connecting the wall plate to the end piles fractured at a low level of shaking. All pile foundations rocked quite noticeably under the lateral loading, creating gaps between soil and concrete at the end of the tests. [This was also seen in the foundations of some Christchurch buildings after the earthquakes.]

Figure 2. Floor 3 – concrete piles and jack studs with cut between braces.

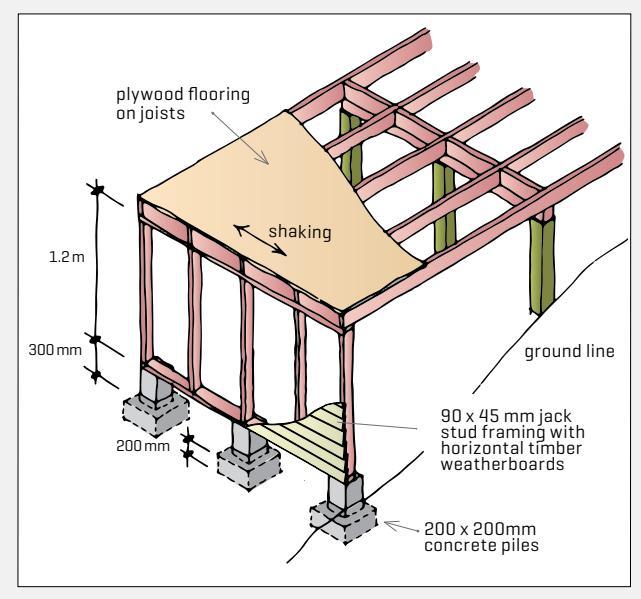
Figure 3. Floor 4 – concrete piles and jack studs clad with horizontal weatherboards.

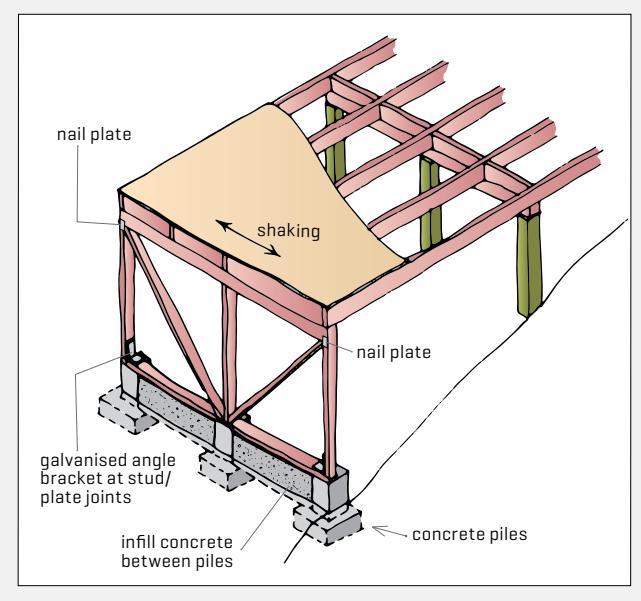
Figure 4. Floor 3 retrofitted – strengthened infill foundation walls, nail plate and galvanised angle brackets.

- The stiffness of Floor 3 improved from 0.30 kN/mm before retrofitting to 0.80 kN/mm afterwards.
- The stiffness of Floor 4 (with the plywood sheet bracing) improved from 0.07 kN/mm before retrofitting to 2.60 kN/mm afterwards.
- Top deflections that were up to 76 mm in Floor 4 before the work were reduced to 6 mm maximum after the sheet ply was installed.
- The infill foundation walls were effective at stabilising the isolated pile foundations.

- Floors 3 and 4 had infill concrete walls cast on the downslope side between the ordinary piles with M12 cast-in bolts fixing to the wall plate at 600 mm centres.
- As a result of observations made during the initial testing, Floor 3 had frame joints strengthened with the installation of galvanised brackets at both end stud-to-plate joints and nail plates added to reinforce the nailed brace connections (Figure 4).
- Floor 4 had sheets of 9 mm plywood nailed to the inside face of the jack stud wall with 50 x 2.8 mm flathead nails and galvanised angle brackets (Figure 5).

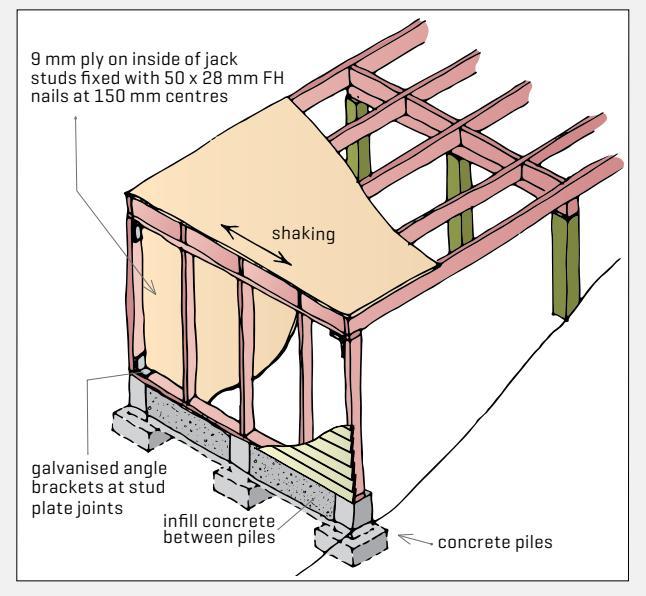
Figure 5. Floor 4 retrofitted – strengthened infill foundation walls, plywood sheet bracing and galvanised angle brackets.

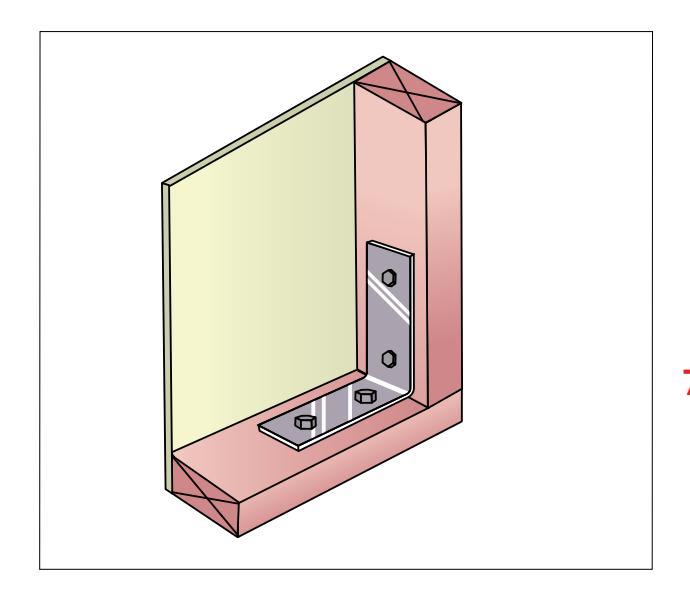
Figure 6. Bracket strengthening subfloor members.

**5.0.1** The retrofit testing found benefits from strengthening existing timber foundations with additional brackets and nail plates. These may be generic or proprietary products. Brackets added to provide additional strength and stiffness at the corners of connecting timber members are typically fixed with M12 x 150 mm galvanised bolts or coach screws (Figure 6).

Note: Also fix a bracket at the end of the stud/top plate junction if accessible or use a nail plate if a diagonal bracing member is present.
