FQ5011

Domestic Fire Sprinkler Systems – Report on Water Quality, Reliability and Application to Other Property

BRANZ Report FQ5011

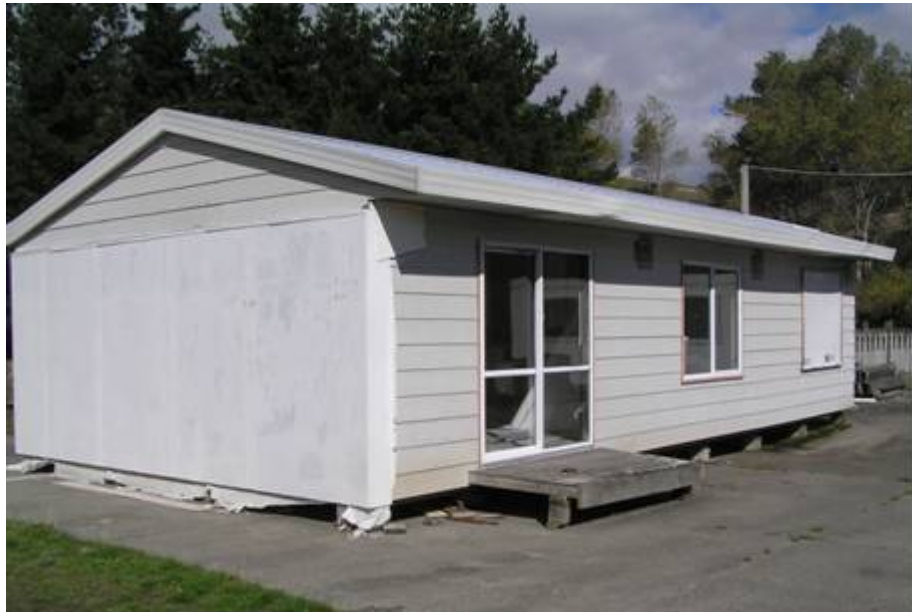
Figure 3: Fire test house – sprinkler pipework installed in roof space.

The water quality test was carried out on a simulated fire sprinkler system using three common domestic water pipe materials: copper (Cu), polypropylene (PP-R) and polybutylene (PB). The pipework was installed in the roof space of an uninhabited test house located on the BRANZ site. Figure 3 shows the fire test house.

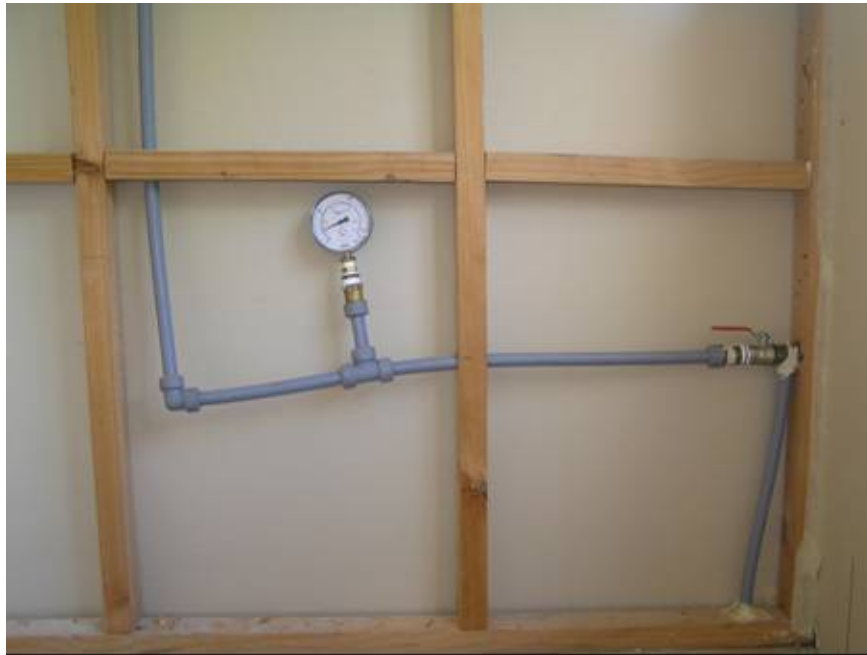
Figure 5: Inlet to house with pressure gauge.

Figure 5 shows the water inlet to the house with the pressure gauge and shut-off valve. Figure 6 shows the outlet with the solenoid valves which was used to activate the flow at fixed times to simulate domestic usage. Figure 7 and Figure 8 show the connections of the various range pipes to the main distribution pipe. There were a total of nine range pipes connected to a distribution pipe.

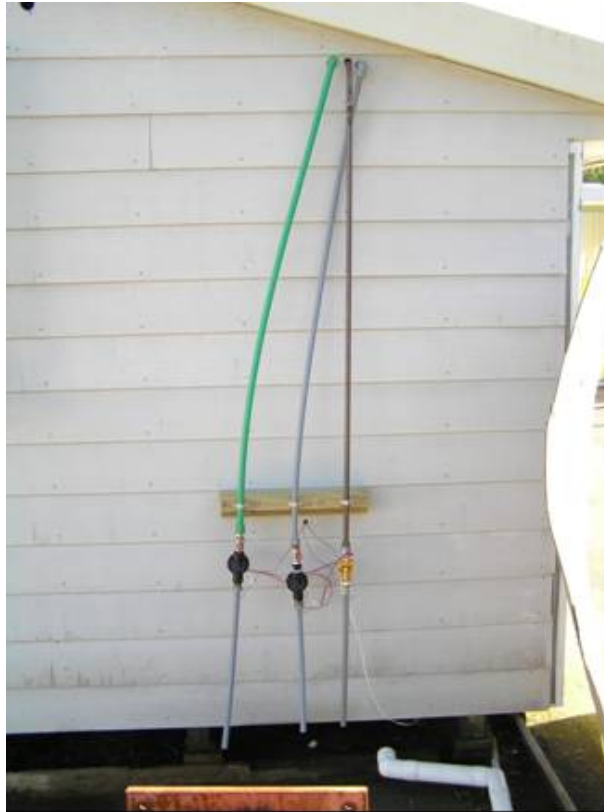
Figure 6: Outlet of the three distribution pipes with solenoid valves.

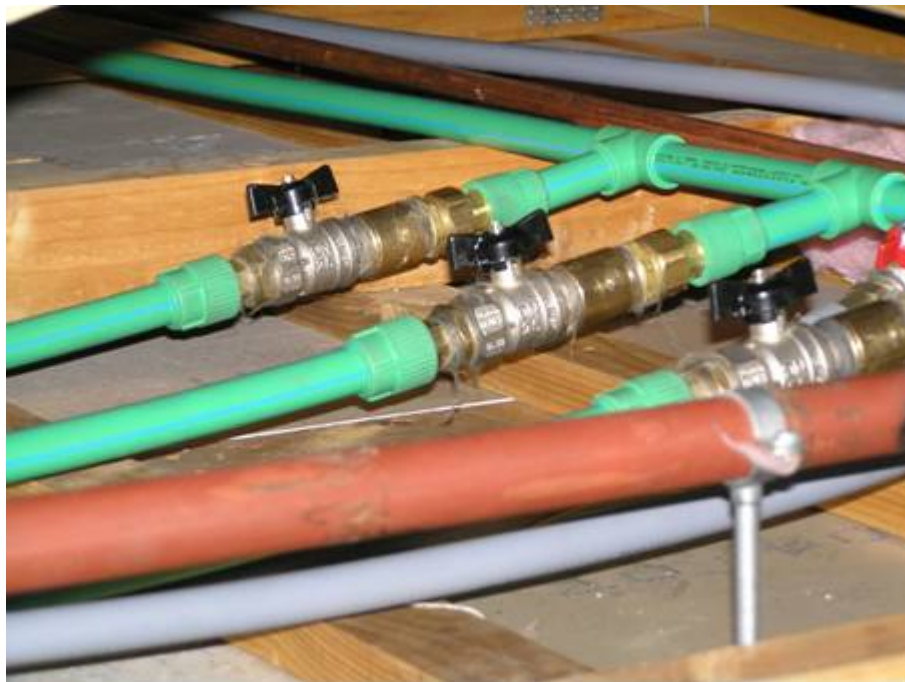
Figure 7: Range pipe connection to main distribution pipes for PP-R (green) and PB (grey) range pipes. Cu distribution pipe between PP-R and PB pipe (red pipe not part of this study).

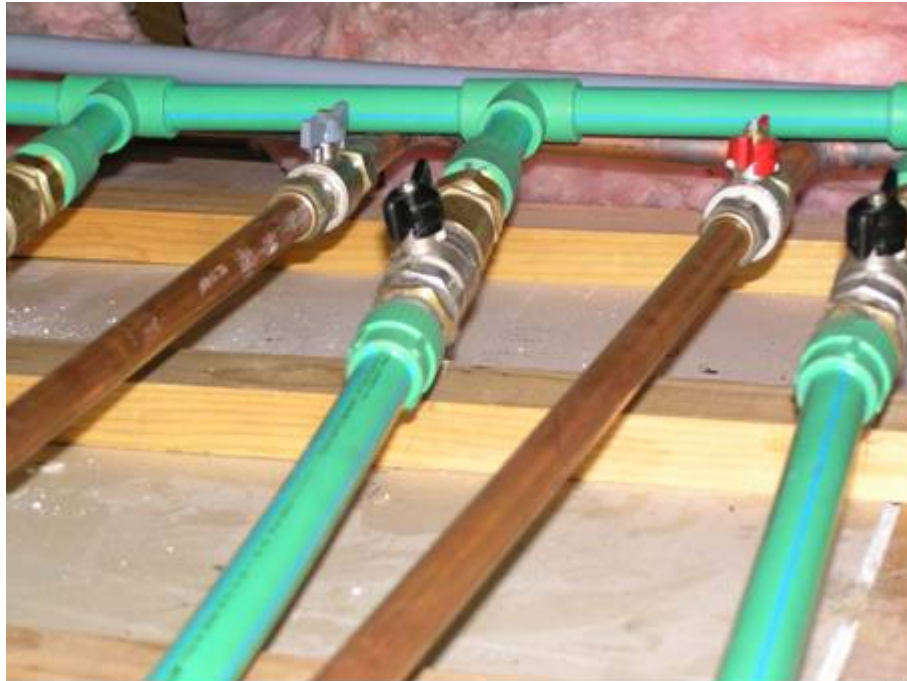
Figure 8: Range pipe connection to main distribution pipes for PP-R (green) and Cu (brown) range pipes. PB (gray) distribution pipe in background.

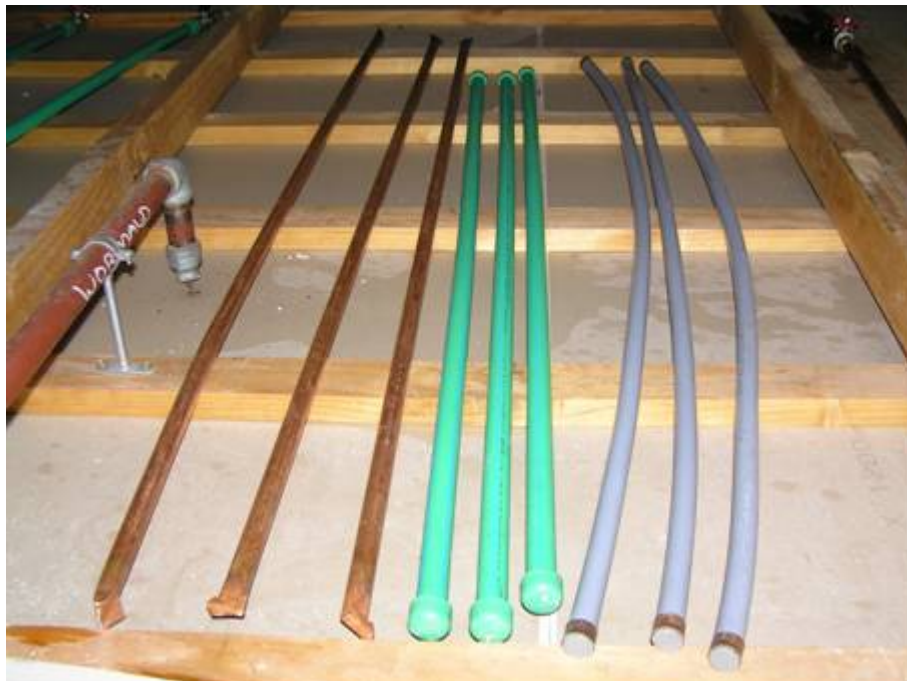
Figure 9: Pipes used for static water quality tests.

In addition to the flow testing, static pipes were filled with water and left in the roof space to investigate whether there was any difference in the water quality of these and those connected to the distribution pipes. Figure 9 shows the pipes used for the static tests.
