STRUCTURES TEST REPORT

ST11277-01-01

**TESTING OF IN-GROUND PIT LID TO AS 3996-2006
[2019]**

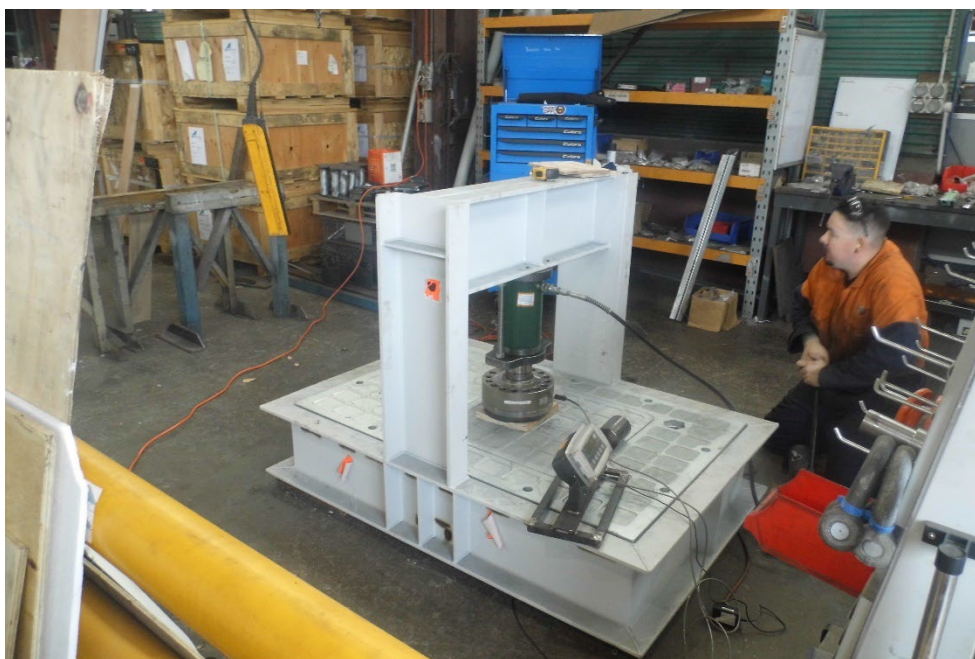
The assembled lid and surround were fitted into a steel frame. The frame was constructed with a rectangular base of 300 mm parallel flange channels (300PFC), with a shelf constructed from 70 mm wide x 25 mm thick mild steel plate to accept the outer edge of the lid assembly. On each of the long edges of the rectangular frame, vertical 300PFCs were welded and to these, a top cross beam of two back-to-back 300PFCs was welded to provide a reaction frame.

Figure 4. View of the specimen installed in the test frame

A view of the specimen installed in the test frame is presented in Figure 4.

Load was applied to the top of the lid assembly using a 100 tonne capacity ram and hand pump. The load was applied through a rigid steel test block onto a 240 mm x 240 mm x 25 mm thick section of structural plywood. The load was measured with a PT LPCH loadcell (Serial number 1366003) having a range of 100 tonne. The loadcell was connected to a PT 20X-F indicator (Serial number 3322448). The system of loadcell and indicator was calibrated on 6 November 2018 by Scentroid Scales Ltd. While not stated on the certificate, Scentroid Scales has separately confirmed that the loadcell and indicator achieved a Class 1 rating in accordance with International Standard EN ISO 7500-1:2004 [2] (calibration certificate appended). The deflection of the geometric centre of the lid was measured with a 10 mm displacement potentiometer for the serviceability load and for the ultimate load tests. The potentiometer outputs were captured by a Labview data logging program on a laptop computer and displayed on the computer screen. The potentiometers and logging equipment were calibrated to produce an output accurate to 0.1 mm.
