Investigative pull-out testing of anchors near corners of concrete house foundations formed with masonry header blocks

BRANZ Study Report SR357

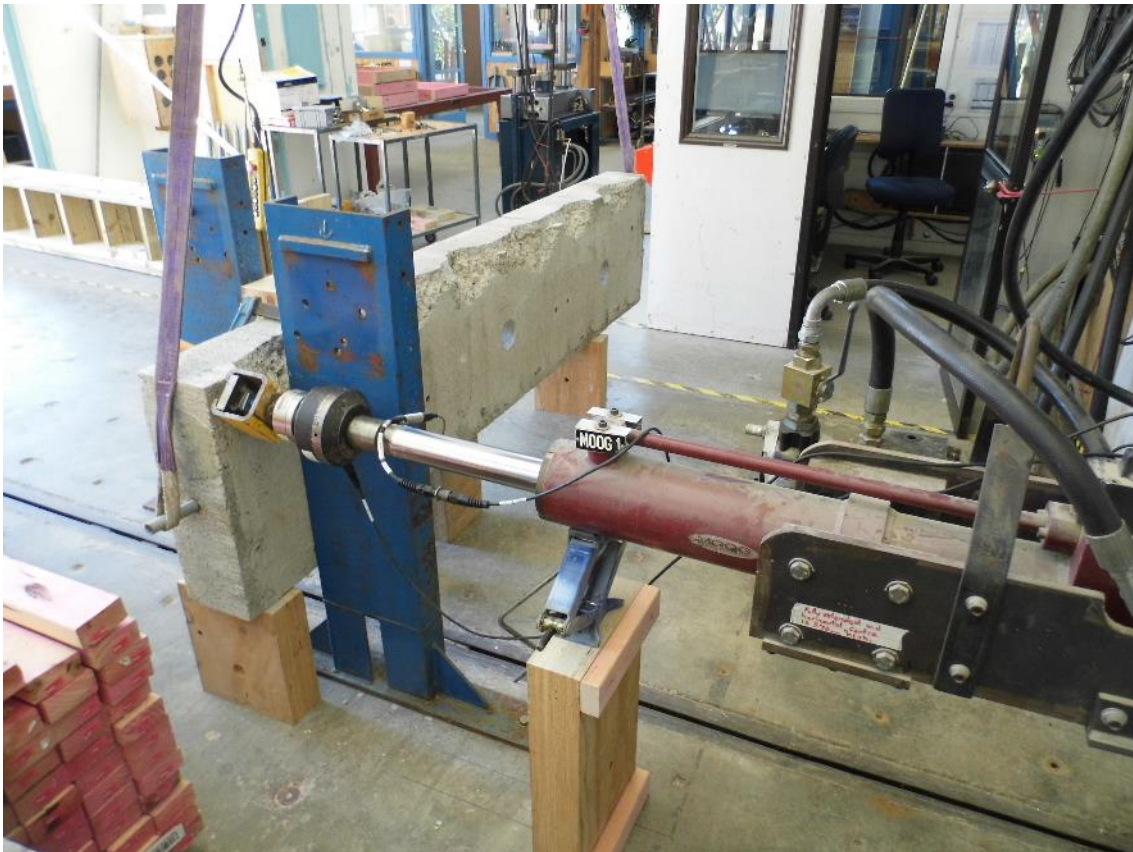
The slab was rigidly fixed against reaction frames, and the load was applied to the anchors with a 100 kN capacity closed loop hydraulic actuator and measured with a 50 kN load cell. The load cell used was within Grade 1 accuracy of international standard EN ISO 7500-1:2015 *Metallic materials – Calibration and verification of static uniaxial testing machines – Part 1: Tension/compression testing machines – Calibration and verification of the force-measuring system*.

Figure 7. View of the test set-up for the anchor testing.

Details of the tension test set-up are presented in Figure 6, and a view of the set-up is shown in Figure 7.
