WATER BALANCE OF A GREEN BUILDING

SAM TROWSDALE, JEREMY GABE, ROBERT VALE

Landcare Research, Private Bag 92 170, Auckland, NZ

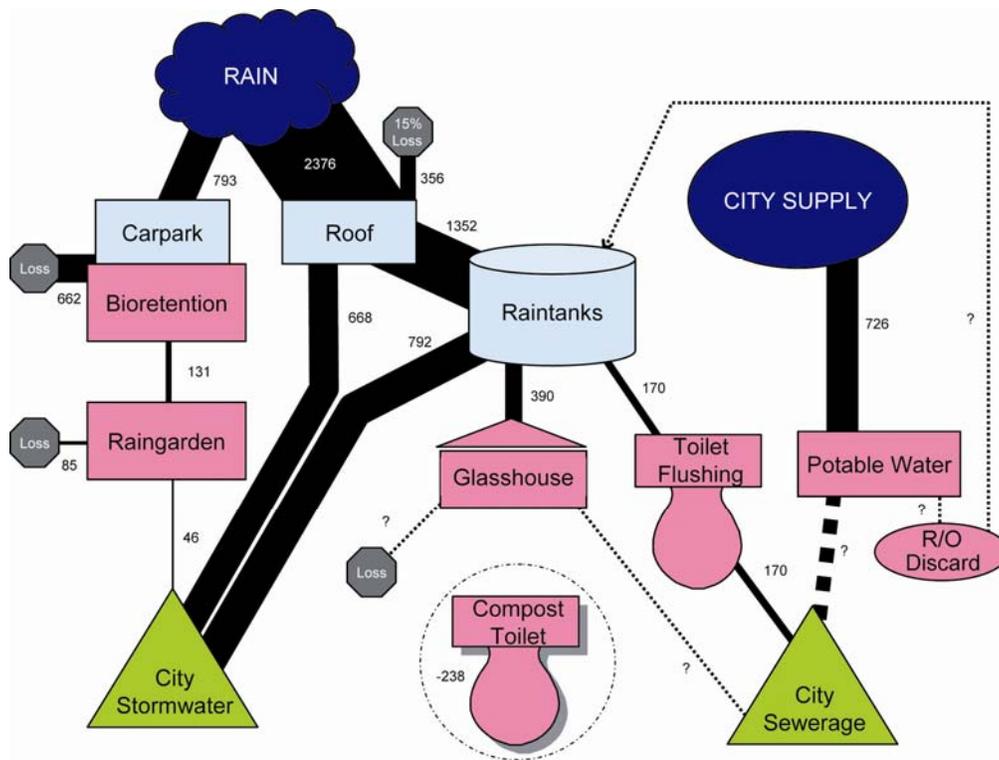
Figure 1 Water balance of the Landcare Research Tamaki Building. The thickness of the lines is proportional to the magnitude of flows, which are labelled and have the units m^3 / year ending 25 July 2007.

The building is connected to the mains water supply. In addition, runoff from 1512 m² of roof area drains through a syphonic drainage system to three 25 000-L rainwater storage tanks connected in series. The first two tanks are connected at their base and are in hydraulic equilibrium. Water is pumped from these tanks to header tanks for use in the building. The third tank collects overflow. A mains backup is available for prolonged dry spells and for fire fighting. The volume of water running off the roof and into the tanks was 1352 m³ in the period considered, assuming a 15% loss due to evaporation and storage on the roof. None of this water would be available for use if a conventional system had been used (Figure 2).

The core business operations of Landcare Research require laboratories and glasshouses that use a large volume of water. Rainwater harvesting, low-flow fittings and composting toilets reduce the water demand of the building (Figure 1 and 2).

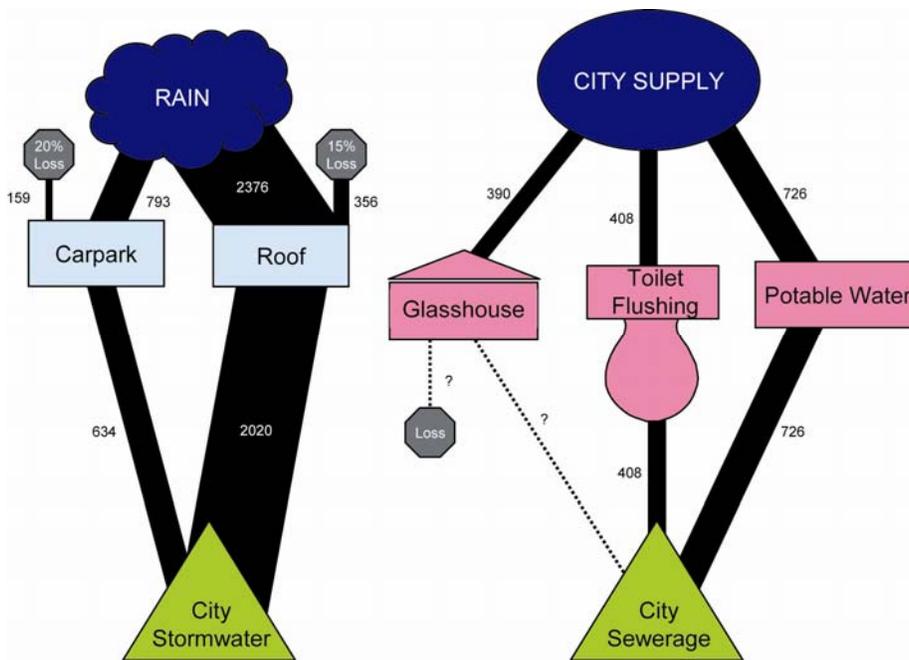
Figure 2 Water balance of a building similar to the Landcare Research building but using a more conventional system. The thickness of the lines is proportional to the magnitude of flows, which are labelled and have the units m^3 / year ending 25 July 2007.

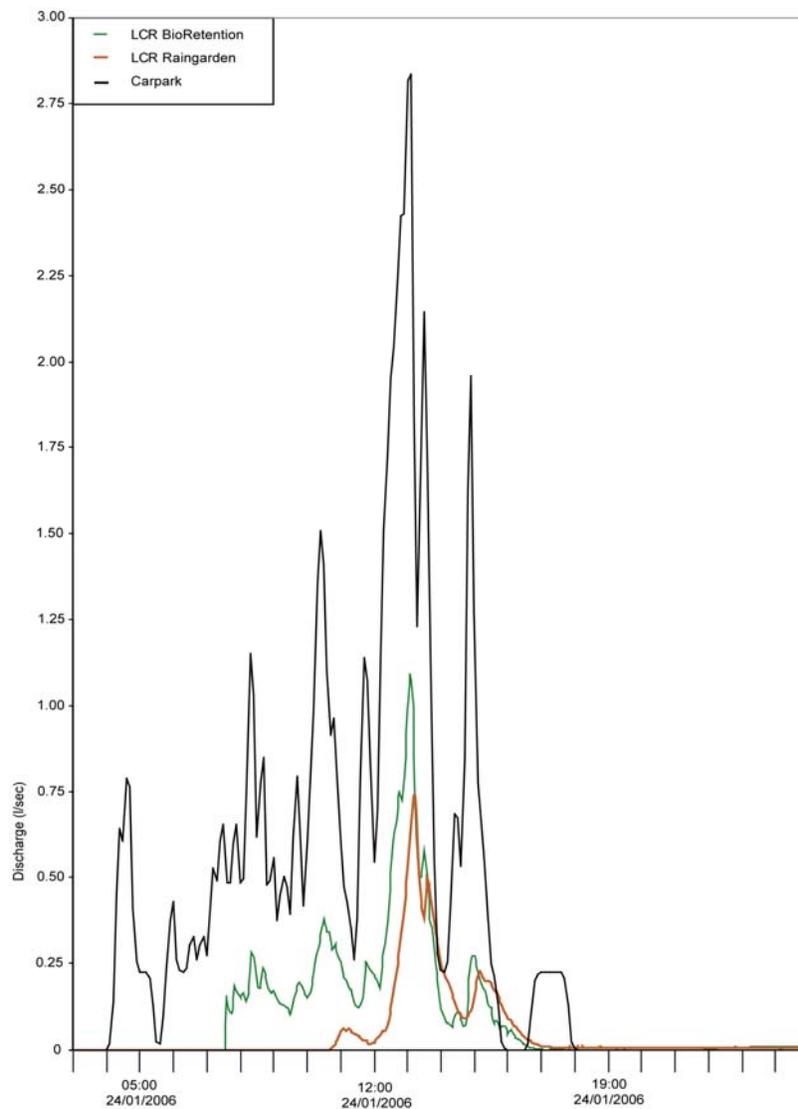
Figure 3 Hydrograph of discharge from the bioretention and raingarden at the Landcare Research Tamaki Building (brown and green lines respectively) and modelled discharge from a tarmac-sealed carpark (black line).

Figure 3 shows a well-characterised event that occurred on 24 January 2006, when 41.8 mm of rain fell in the 18 h between 3:09 a.m. and 5:45 p.m. Initial low-intensity drizzle was followed by heavy showers in which rainfall intensity peaked at 2.3 mm/10 min, and 10.1 mm/h. The event was large but not unusual. The 2-year return interval for the area is 70 mm in 24 h. Three weeks of predominantly dry conditions preceded the event, punctuated with only one small (<5 mm) rainfall event. With summer evapotranspiration rates of about 3 mm/d, it is expected that the stormwater devices had maximum water storage capacity available when rainfall began.

Once depressions in the carpark surface were filled and rainfall intensity was greater than the infiltration rate, it is likely that much of the rainfall onto the carpark became runoff. This runoff was stored in the mulch and soil of the bioretention strip for 4.5 h, during which time 7 mm of rain fell, before the bioretention started to discharge to the raingarden. A further 3 h passed, during which 2216 L of stormwater entered the raingarden, before the raingarden started to discharge. The total volume of water that fell on the catchment in the event was 31 800 L. The total discharge from the bioretention was 7889L and from the raingarden 3031 L, meaning that <10% of the water that fell on the catchment discharged to stormwater pipes. The peak flow was also attenuated. The peak flow measured exiting the bioretention device was 1.09 L/s and only 0.74 L/s from the raingarden.

The conventional system had a markedly different hydrograph (black line on Figure 3). The peak flow was nearly three times greater at 2.8 L/s, there was little lag time between rainfall and runoff, and the total volume discharged was much larger (23 400 L). There is a well-documented decline in habitat and water quality of urban streams (e.g. Paul and Meyer, 2001) due to increased runoff from directly connected impervious surfaces, such as roofs and roads, hydraulically efficient drainage systems, compaction of soils, and modifications to the vegetation. This can result in increased flood flows (Leopold, 1968), stream erosion (Hammer, 1972), and decreased baseflow through decreased groundwater recharge (Schueler, 1994). The effects of the building's stormwater treatment devices are masked at the stream habitat scale by the numerous other urban stormwater inputs to the stream, but presumably if we all treated our stormwater we would limit the degradation of stream habitat.
