No. 109 (1992)

## Sensitivity of Insulated Wall and Ceiling Cavities to Workmanship

H A Trethowen

From Journal of Thermal Insulation, Vol. 15, October 1991

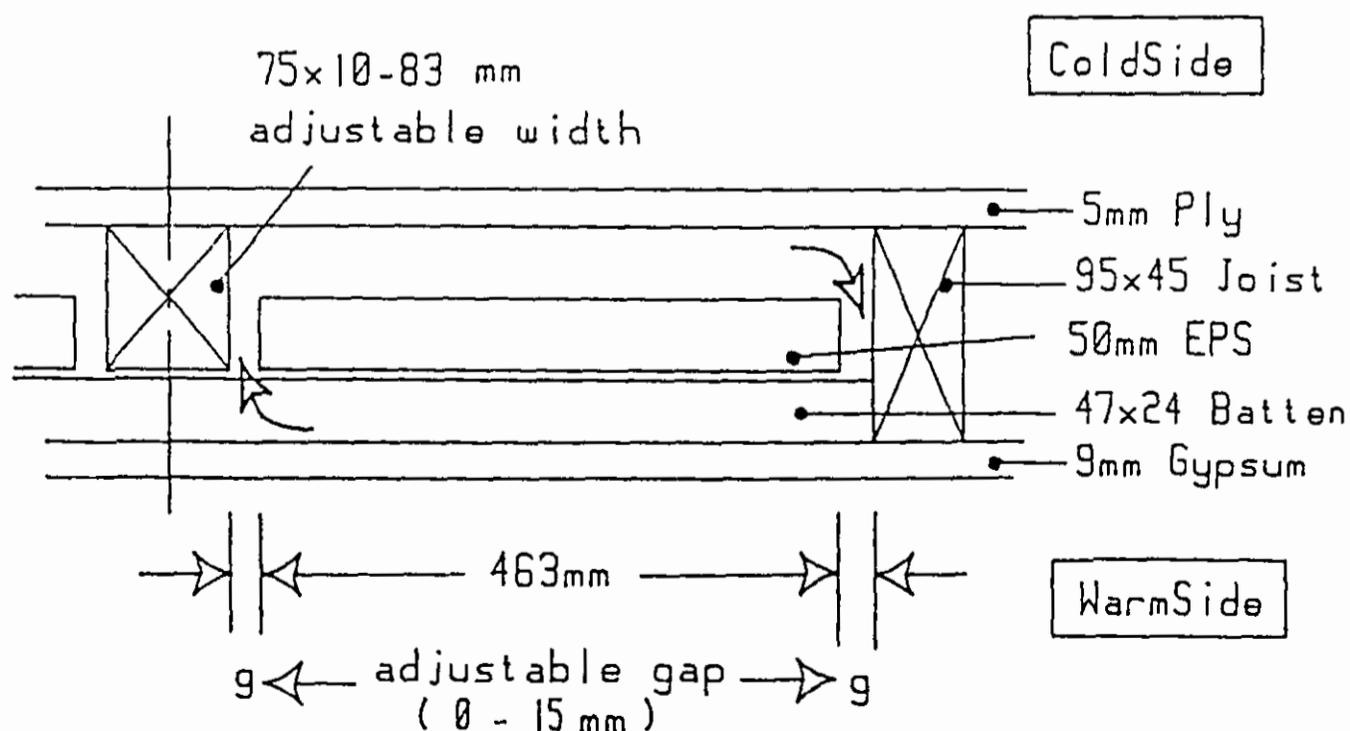
(a) *Ceiling.* For the upward heat flow case, samples of insulant were mounted in a test frame as illustrated in Figure 1. The insulant used was nominally 50 mm thick (actually 47 mm) fused bead EPS (Expanded Polystyrene) foam with aluminium foil facing bonded to both faces of the insulant. The R-value of the insulant was measured as  $1.25 \text{ m}^2\cdot\text{K}/\text{W}$ , corresponding to a thermal conductivity of  $0.0376 \text{ W}/\text{m}\cdot\text{K}$ , which is typical for the observed density of about  $17 \text{ kg}/\text{m}^3$ .

FIGURE 1. Detail of insulated ceiling cavity tested.

The two pieces of insulant were unchanged during the entire series, and the gaps were adjusted by removing or inserting strips of material from the central joist. The gaps were made all equal except in the last two runs.

It will be noted in both Figures 1 and 2 that any edge gaps will permit natural convective air circulation around the insulant. In the ceiling case, Figure 1, convection could take place either clockwise or anticlockwise.

All heat flow resistances were measured using a procedure following ASTM C 236-80, except that in the ceiling series the R-value was determined across the entire panel in the usual way, whilst in the wall series the R-value obtained was measured across the insulant and its surrounding cavities only. The ceiling results were then modified to correspond to those for the wall, in the following way. First the thermal resistances of the outer surfaces ( $0.12 \text{ m}^2 \cdot \text{K}/\text{W}$ ) and the surrounding lining and cladding ( $0.05 \text{ m}^2 \cdot \text{K}/\text{W}$ ) were subtracted from the total resistance, to give the "cavity thermal resistance" in Table 1. Then the effect of the timber framing was de-

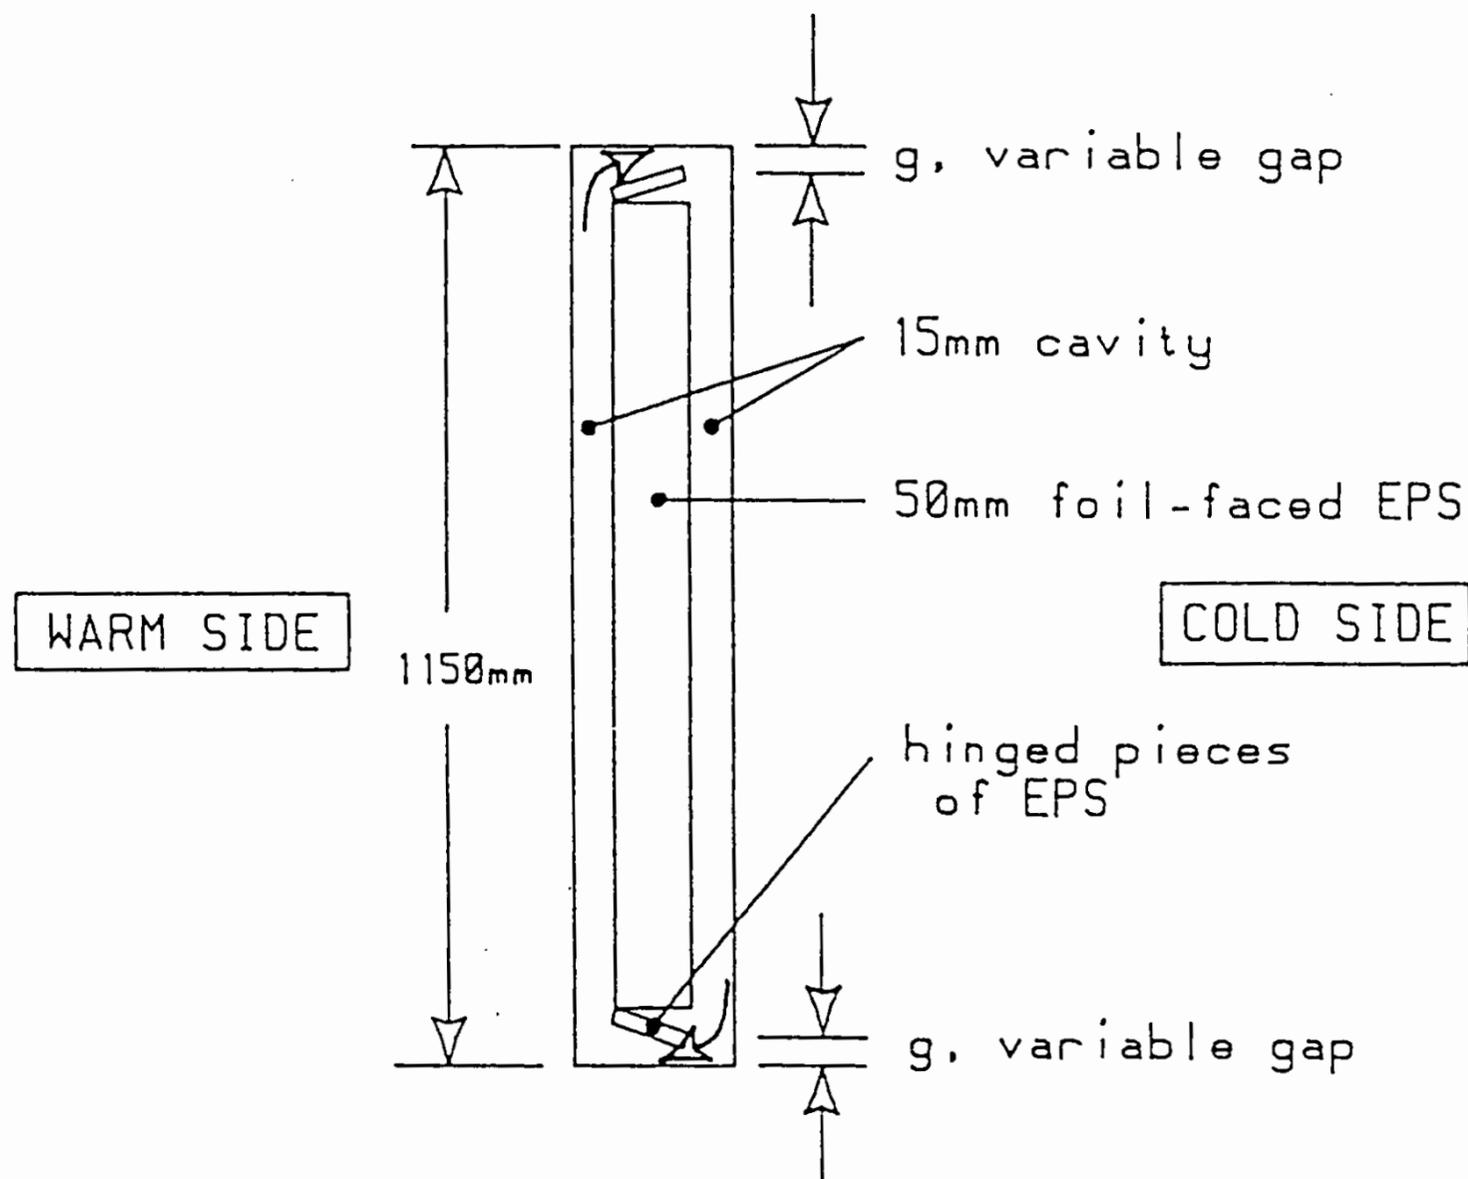
FIGURE 2. Detail of wall cavity tested.

(b) *Wall Panel.* In the horizontal heat flow case, Figure 2, no framing was present, and the edge gap was varied by hinging an edge strip of the EPS insulant, about 10 mm wide. The insulant was the same as for the ceiling case.

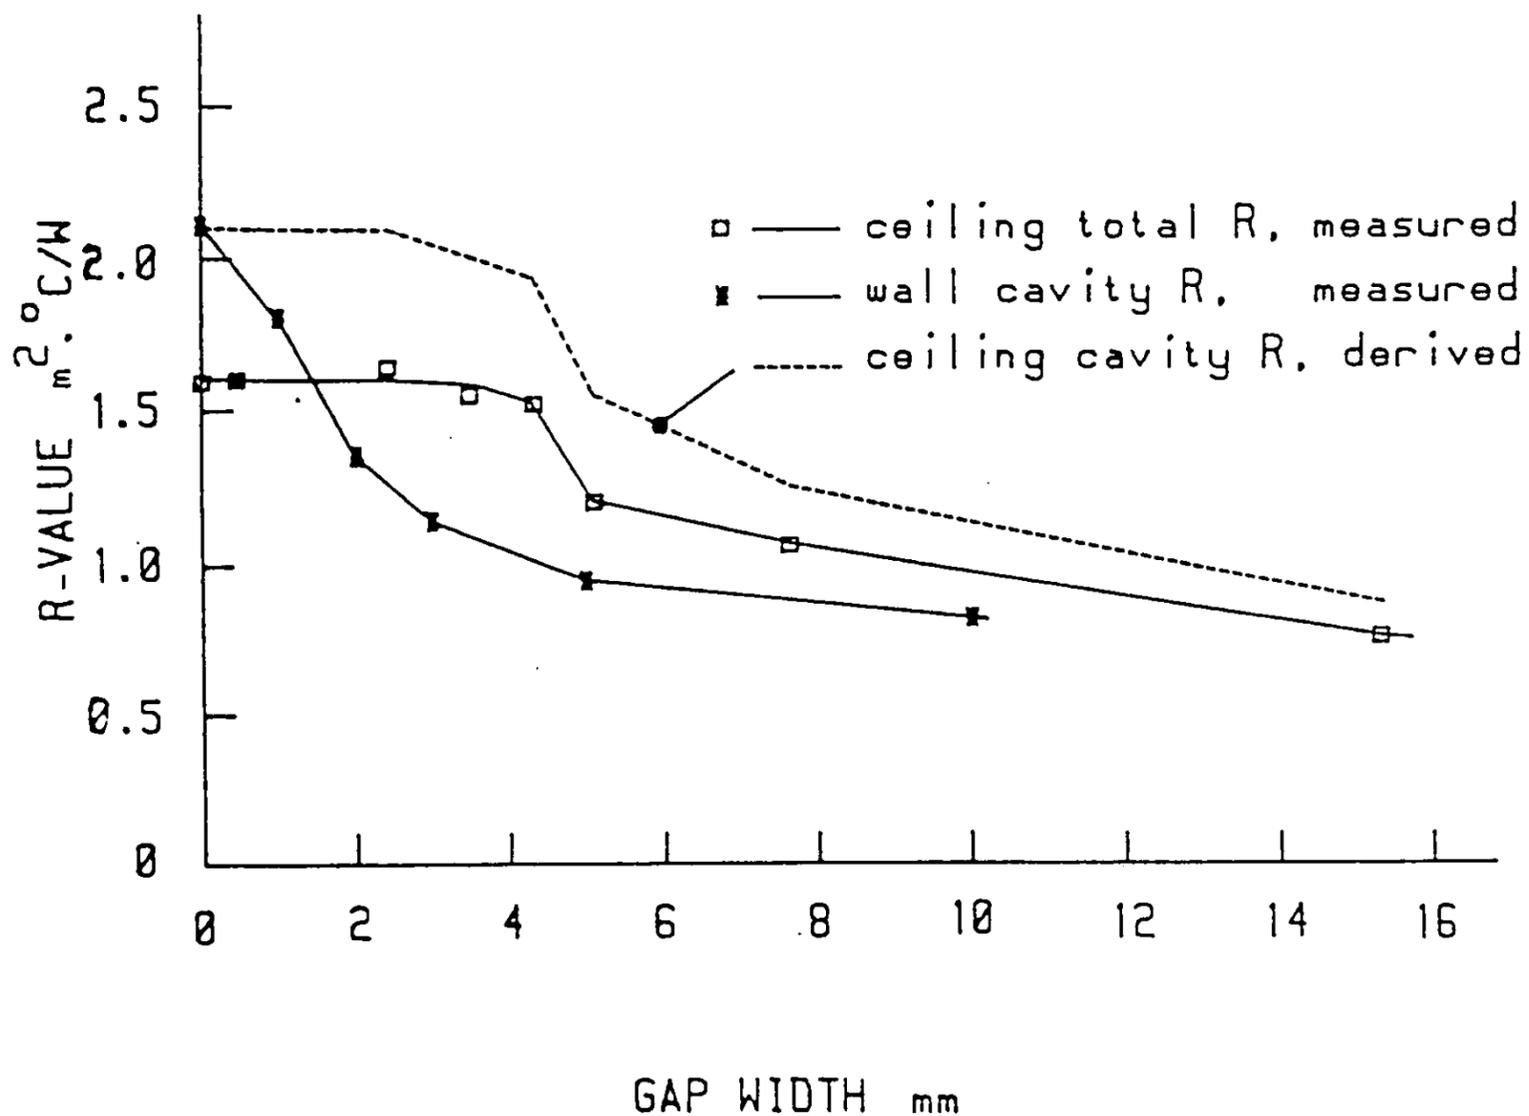
Results for heat flow upward through a horizontal ceiling assembly are shown in Table 1, and illustrated in Figure 3. The immediately evident be-

FIGURE 3. R-value with convective gaps.

haviour observed for this case was that no significant loss of thermal performance occurred until the width of edge gap exceeded 4 to 5 mm, at which point there was a fairly sudden and major drop of some 25% in the R-value. This feature is equally prominent in both as-measured resistance and the "estimated cavity resistance values in Figure 3. Further widening of the gap resulted in progressive further lowering of the thermal resistance. This continued up to the largest gap width tested, about 15 mm, at which point the resistance was some 40% of the initial value.

The results for horizontal heat flow through a vertical panel are shown in Table 1, and illustrated in Figure 3. No threshold effect is visible in these results. A sharp fall in thermal resistance is evident even for the smallest edge gap width (1 mm).

It is evident in Figure 3, in spite of the influence of the structural bridging effects, that a threshold effect is present for the ceiling case. This permits small fitting errors without significant loss of insulation value. However in the wall panel case no such threshold is present and there is no tolerance for workmanship imperfection.

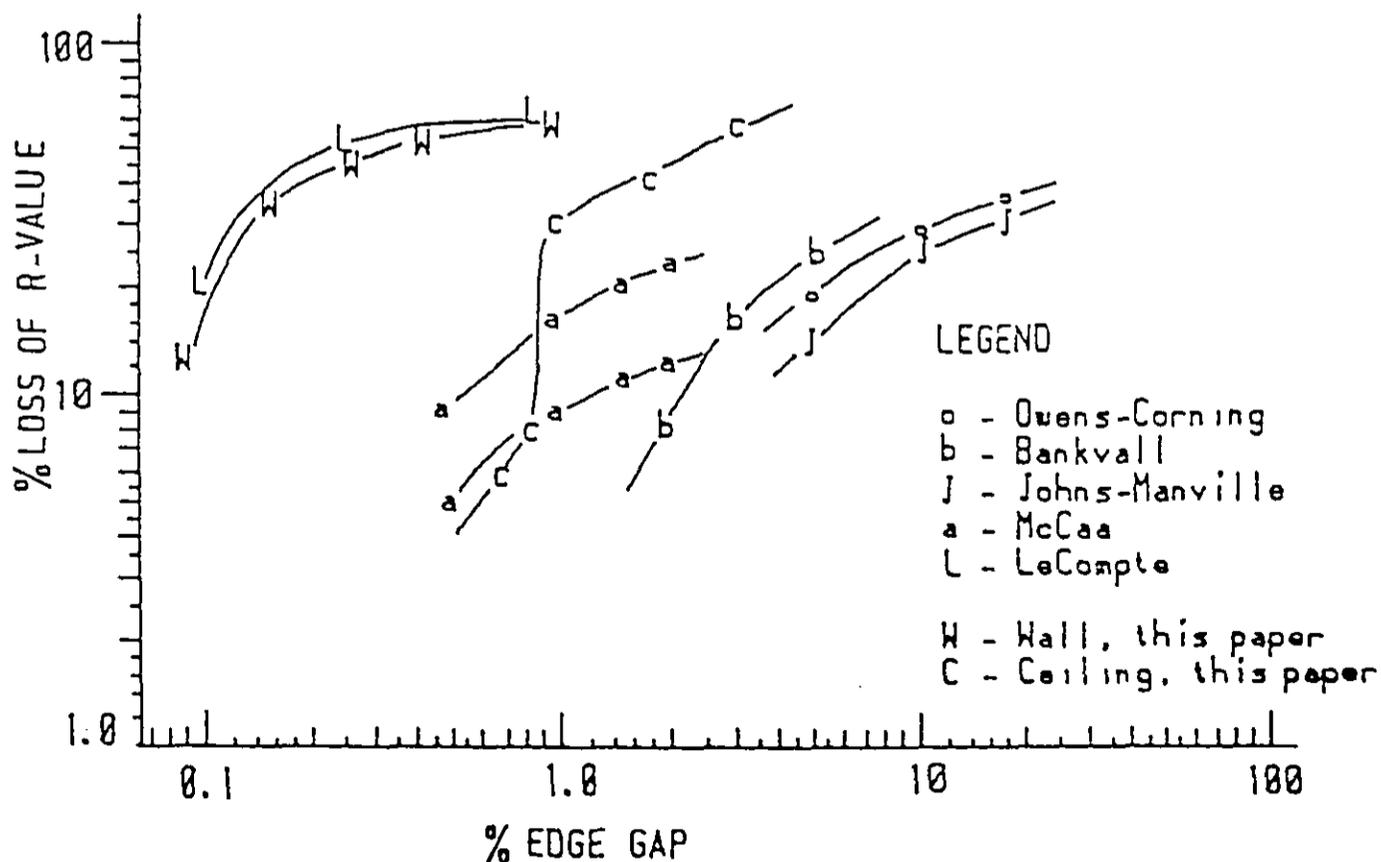
These results, along with previously reported measurements from various sources [2,3,5-8] are illustrated in Figure 4, as percentage drop in cavity thermal resistance against percentage gap edge width. This is present on a log scale to allow easier visualisation of the whole range of influence.

FIGURE 4. A comparison of measured insulation loss for various gap ratios.

From Figure 4 it may be seen that the present results, except for the below-threshold region in the ceiling case, show extreme sensitivity of thermal performance to very small edge gaps, compared with the results reported by Johns-Manville [5], Owens-Corning [6], and C. Bankvall [3]. Those all specifically exclude convective bypassing of the insulant. However results reported by LeCompte [7], which specifically included convective bypassing, agree in this acute sensitivity and his data and the present are almost identical.

It might be conjectured that the Johns-Manville, Owens-Corning, Bankvall, and McCaa data, along with the below-threshold portion of the ceiling data in this paper, might form one family for the nonconvecting gap case,

whilst that from the above-threshold results here, along with LeCompte's data, form another family for the convective bypass case.
