STUDY REPORT

SR332 (2015)

THE WEATHERTIGHTNESS OF FLASHING DOWNTURNS

**Mark Bassett and
Greg Overton**

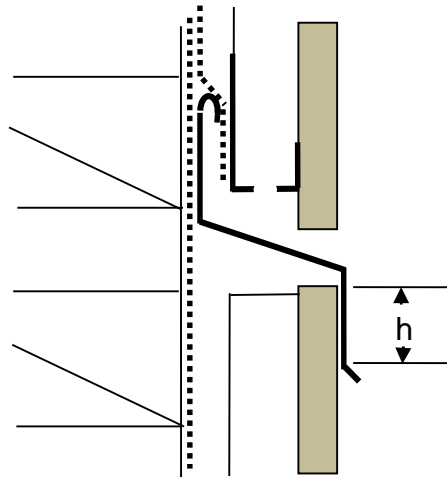
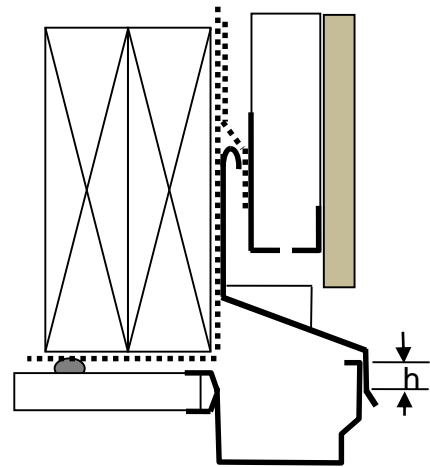
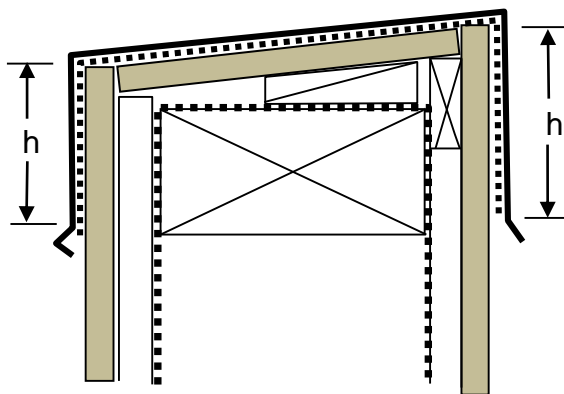
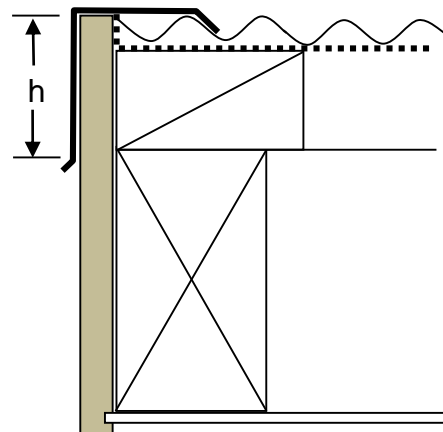
Figure 1. Examples of flashing downturns over cladding components taken from E2/AS1.

The most widely used New Zealand source of flashing shapes and dimensions for residential buildings is the compliance document E2/AS1 *External moisture* of the New Zealand Building Code (NZBC). A selection of flashings from this source along with downturn dimensions are given in Figure 1. It is clear that the downturn leg dimension depends on a variety of factors including wind zone, joint type and location on the building. The downturn dimensions in Figure 1 range from 10–90 mm.

Location of downturn	Wind zone	Downturn (h)
Window head flashing	All	10 mm
Inter-storey junction flashing	L, M, H, and VH	35 mm
	EH	60 mm
Barge flashing and capping	L, M, and H	50 mm
	VH	70 mm
	EH	90 mm

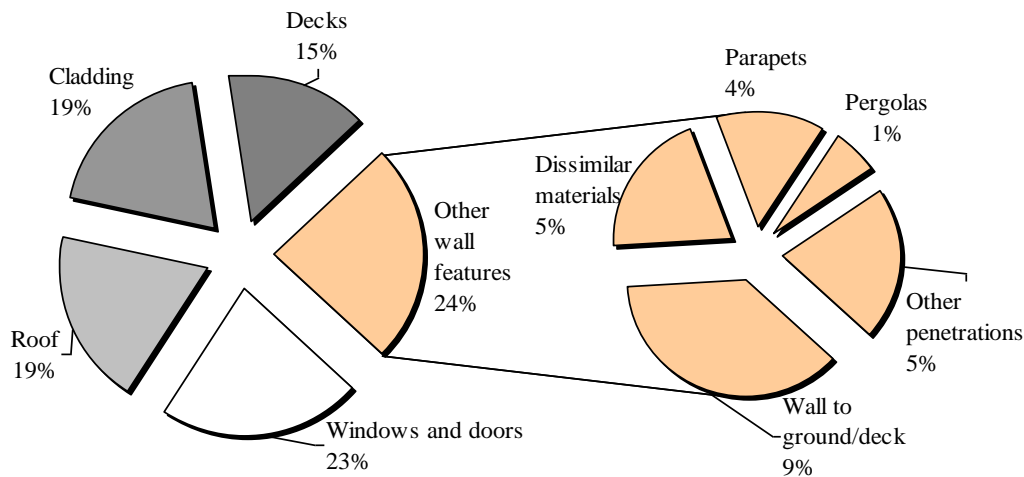
Junctions between claddings and components such as windows are known to be common sites for rainwater leaks. This was confirmed by a survey of leaking buildings in New Zealand (Bassett, Clark and Camilleri 2003) during the leaking building crisis in the late 1990s and early 2000s. Figure 2 shows over 60% of leakage sites in this survey were at junctions between claddings and other components, and less than 40% were in the field of roof and wall claddings.

Figure 2. Location of water entry in New Zealand leaking buildings.

Traditional metal flashings were found to have been replaced with sealants in this survey, and few of the leakage sites identified fundamental deficiencies in metal flashings. A similar fraction (26%) of water entry points in Canadian buildings were identified around window and door junctions with claddings in a survey of leaking buildings in British Columbia (Morrison Hershfield Limited 1996). In this survey, 90% of water leakage sites were found to be at junctions between materials and components or at penetrations through the cladding.

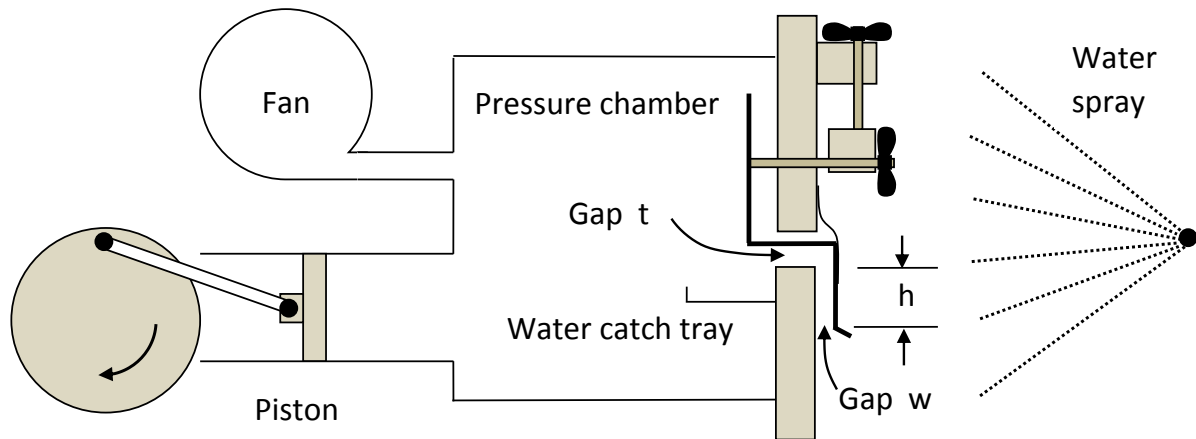
The weathertight properties of flashing downturns were measured in small scale using a 600 mm length of flashing. The equipment illustrated in Figure 3 consisted of a pressure chamber linked to a centrifugal fan and a fluctuating piston that together apply a steady pressure with a superimposed fluctuating pressure across the specimen. It has been used earlier to study the upstand leg of the flashings studied here (Bassett and Overton 2014). The pressure amplitude could be changed by adjusting the start and end points of the damper stroke. Where possible, it was adjusted to cycle the air pressure with an amplitude ratio of 2 and a frequency in the range 0–0.7 Hz. The flashing was mounted with screw adjustment of the lateral and vertical position. This meant the gap dimensions w and t could be adjusted to reflect various levels of fit

quality between the downturned leg and underlying cladding. Water was sprayed from the outside and water leakage rates measured gravimetrically using an absorbent pad placed inside the chamber at the point where leakage through the joint would have entered the wall cavity. This was removed and weighed to calculate the water leakage rate over a period of typically 1 minute. The absorbent pad was a commercial cleaning material (Wettex). The primary advantage of this small-scale equipment was that it gave good control over the joint geometry, in particular, the gap between the downturned flashing and the underlying cladding. Water sprays were set up to deliver rain loads in the range of 0.08–3.4 l/m².min, with the highest value corresponding to the minimum rain load called for in Verification Method E2/VM1 (2011).

Figure 3. Equipment for adjusting flashing and measuring water leakage rates through a downturned flashing.

equal or exceed the hydrostatic pressure equivalent of the downturned leg dimension h shown in Figure 3. Of course, there are building tolerances to consider, and the downturned leg may not always fit tightly as illustrated in Figure 1. With this in mind, the leakage onset pressures have been measured as a function of run-off rate for tight and loose-fitting joints and the results plotted in Figure 4. The joint in this case had a downturn length of $h = 35$ mm and included a kick-out end. Figure 4 also appears to show a weak relationship between run-off rate and leakage onset pressure, but it is mostly lost in experimental uncertainty.

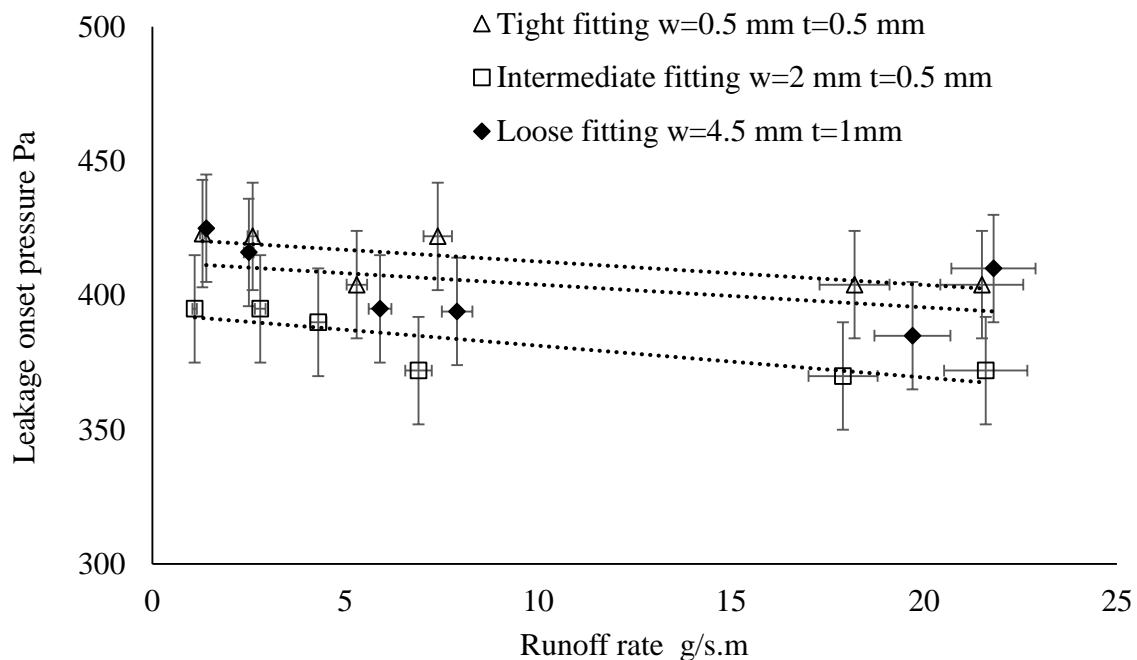
Figure 4. Leakage onset pressures as a function of run-off rate for a 35 mm flashing downturn and a kick-out end.

The run-off rate over joints in claddings has been previously shown (Bassett and Overton 2014) to be an important factor in air-carried water leakage past the upstand of vented window head flashings. This earlier study found that high run-off rates partially bridged the vented opening, resulting in higher velocity air flows carrying an aerosol of droplets deep into the joint. Even higher run-off rates were found to bridge the opening, closing off the ventilation path and allowing the full wind pressure difference to sit across the wet joint. In steady wind conditions, this flooded the joint, but it quickly drained out when the wind pressure relaxed. The downturned legs of flashings are different from these window head junctions because they are not expected to be vented. However, the trend away from bespoke flashings to standard sizes means that these joints may need to be sized as though they are vented joints. Normally, the flashing is expected to fit tightly against the cladding or against other components such as a barge or window. Therefore, the leakage onset pressure should

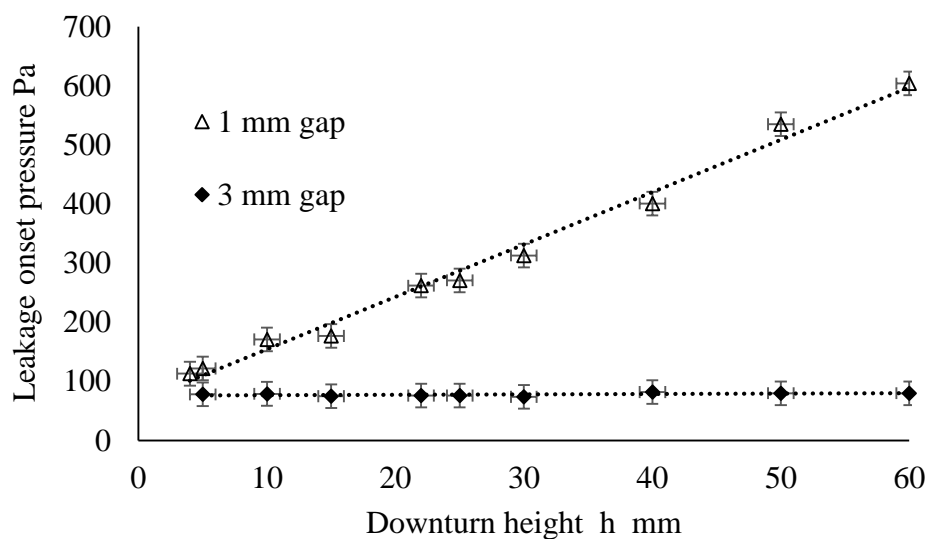
The effect of changing the downturn length h is explored in Figure 5 for flashings with a kick-out end. These experiments required flashings with downturn lengths in the range 20–70 mm to be fixed in place with w values of 1 and 3 mm representing tight and loose-fitting joints. The value of t was always much greater than w so as to not be a rate-limiting variable. As expected, the leakage onset pressure for the tight joint tracks with the hydrostatic head equivalent of the downturn length, and for the loose-fitting joint, there was no dependency on h . The leakage onset pressure changed little as the flashing length h was changed in steps from 5 mm to 60 mm. This indicated that, for the case where $w = 3$ mm and $t > 3$ mm, the leakage process depended on air speed through the joint. The results are characteristic of two-phase flow of air and water droplets.

Figure 5. Leakage onset pressures as a function of downturn height (h) for a 35 mm downturned flashing with a kick-out and two values of gap width (w).

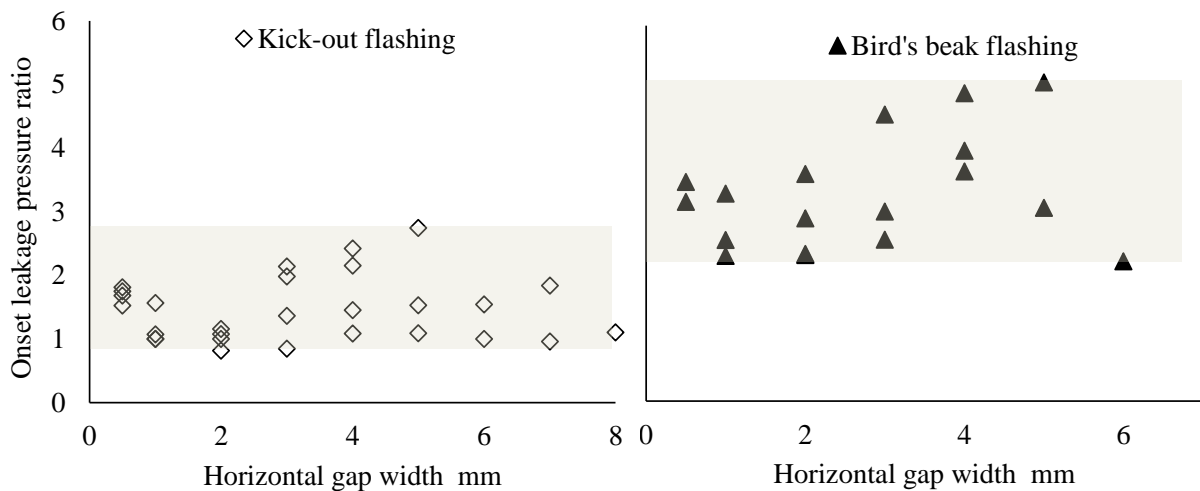
This has been plotted in Figure 6 against w for the bird's beak and kick-out flashings. Here, the value of P_{mod} is the leakage onset pressure for the kick-out or bird's beak terminations. $P_{plainend}$ is the leakage onset pressure for the plain-ended flashing with identical values of w and t . Values of R_p range from 1 to 3 for the kick-out flashing and 2 to 5 for the bird's beak case, indicating both of these terminations improve the weathertight performance of downturned flashings. There is no obvious reason why the bird's beak is better than the kick-out. They both deflect water from the junction.

Figure 6. Onset leakage pressure ratios for kick-out and bird's beak flashings compared with a plain-ended downturned flashing.

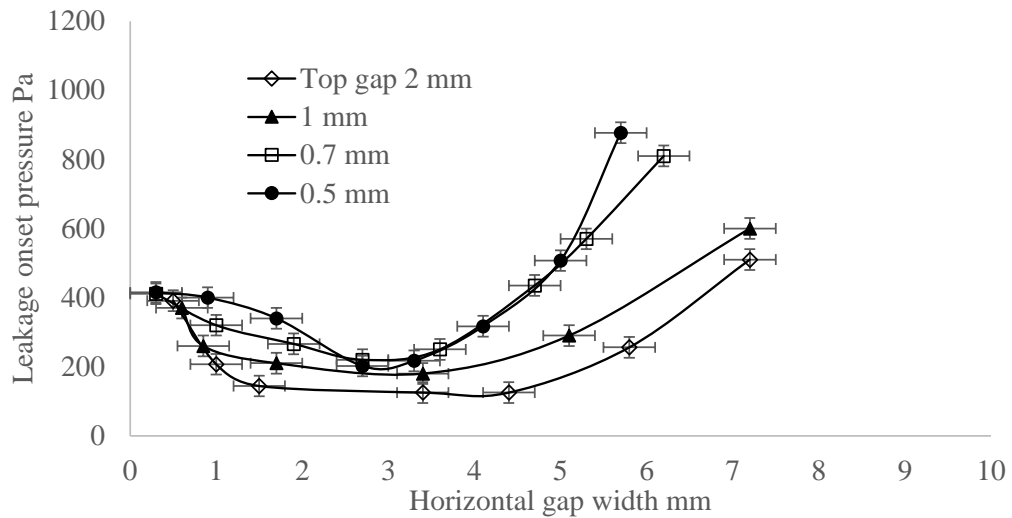
Plain-ended flashings. Figure 7 gives leakage onset pressures for the plain-ended flashing as a function of w and t . This shows that, for a significant range of fit quality, the leakage onset pressures are below the hydrostatic pressure equivalent of the joint (about 350 Pa). When $w > t$, the leakage onset pressures are shown to increase above the equivalent hydrostatic head. The illustration in Figure 8 records observations of

Figure 7. Leakage onset pressures for a 35 mm flashing with a plain leg as a function of downturn gap (w) and top gap (t) dimensions.

The leakage onset pressures for tight-fitting flashing downturns are shown in Figure 7, Figure 9 and Figure 11 to be sensitive to the w and t dimensions and to the presence of a plain, kick-out or bird's beak termination. The measurements were made with a run-off rate over the joint of 18 g/m.s (approximately 3 l/m².min for a small sample area). With the 450 mm length of joint fitting as tightly as possible (w and t in the range 0–0.3 mm), the onset leakage pressures for 35 mm downturns varied. This ranged from 400 Pa with plain-ended flashings to above the experimental limit of 1200 Pa for bird's beak flashings. The kick-out and bird's beak terminations were clearly effective at rainscreening the joint and keeping water away from the tight-fitting outer sections of the joint where capillary attraction would take over and carry water into the joint. It is generally accepted that sub-millimetre tolerances cannot be relied upon in a building context and therefore the following observations for less tight-fitting flashings are more relevant.

Where w and t were about 1 mm, the leakage onset pressures for all of the flashings were equal to or exceeded the hydrostatic pressure equivalent of the downturn dimension. (This was 350–400 Pa for a 35 mm downturn and plain ending.) This result is consistent with earlier results for flashing upstands fitting tightly against the cladding (Bassett and Overton 2014). The leakage onset pressures will include a component due to surface tension, but in general, this has not been resolved in these experiments. The leakage onset pressures for the kick-out flashing were similar to the plain-ended flashing but were much higher for the bird’s beak end. There is no obvious reason for this difference.

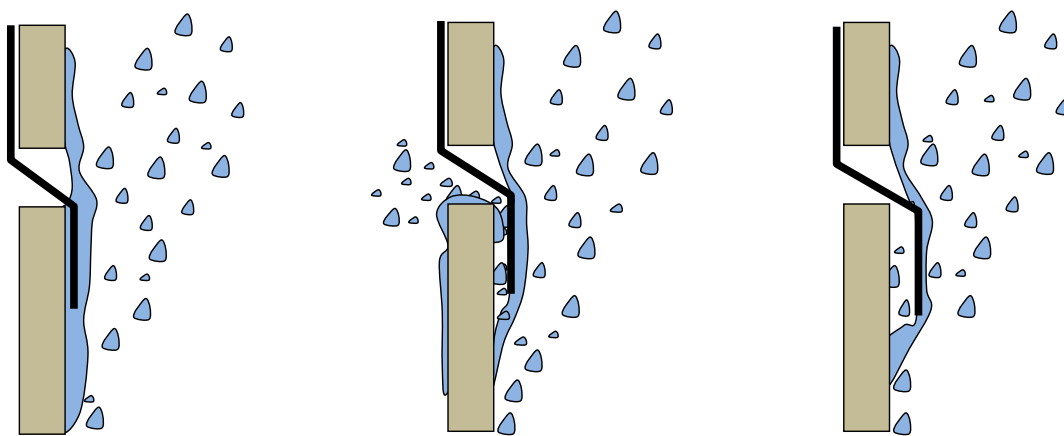
water leaking through the plain-ended flashing. Where $w < 0.5$ mm, the path for run-off stayed close to the wall and surface tension partially filled the joint with water. The leakage path changed little with an airtight but loose fit ($w > 2-3$ mm), and the leakage onset pressures changed little. To make any real progress towards higher leakage onset pressures required a relatively airtight joint ($t < 0.7$ mm) and a large well drained rainscreen formed by the downturned leg standing out from the cladding ($w > 5$ mm).

Flashing with a plain end		
Airtight case with tight fit	Loose fit allowing air flows	Airtight but with loose fit
$t \& w \leq 0.5$ mm	$t > 0.5$ mm & 4 mm $> w > 1$ mm	$t = 0$ & $w > 2-6$ mm

Figure 8. Illustration of water run-off and leakage through a downturned flashing with a plain end.

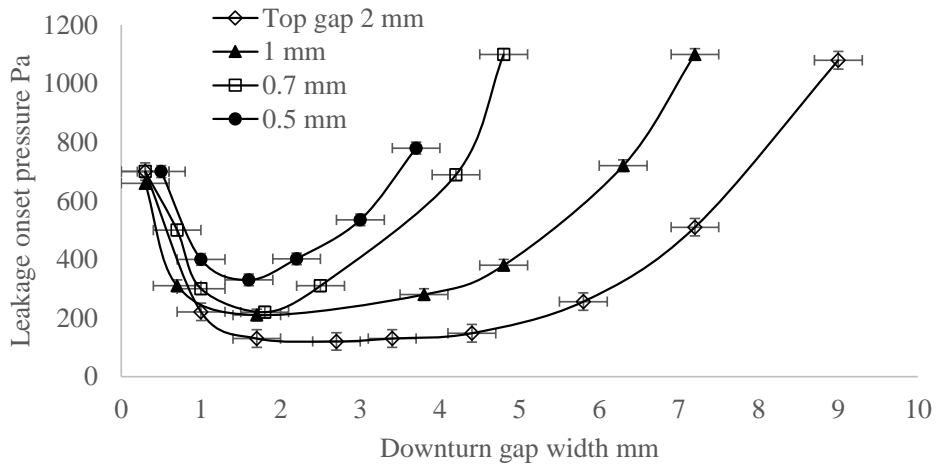
Flashings with a kick-out end. Figure 9 gives leakage onset pressures for the kick-out flashing as a function of w and t . This shows a significant improvement in performance over the plain-ended flashing except for the high t and w range where air flows drive the leakage process. Outside this range, the leakage onset pressures are well above the hydrostatic pressure equivalent of the joint. The illustration in Figure 10 shows the kick-out flashing deflecting water from the junction with the cladding. Where $w < 0.5$ mm, the joint remained dry until high wind pressures partially filled the joint with water. The kick-out appeared to effectively increased the size of gap w , reducing air

speed and hence air-carried water into the joint. With an airtight but loose fit ($w > 2-3$ mm and $t < 0.7$ mm), the joint drained water leakage, and the leakage onset pressure exceeded 400 Pa. Figure 10 shows the loose-fit case allowed air-entrained water to pass through the joint at onset leakage pressures well below 400 Pa.

Figure 9. Leakage onset pressures for a 35 mm flashing with a kick-out leg as a function of downturn gap (w) and top gap (t) dimensions.

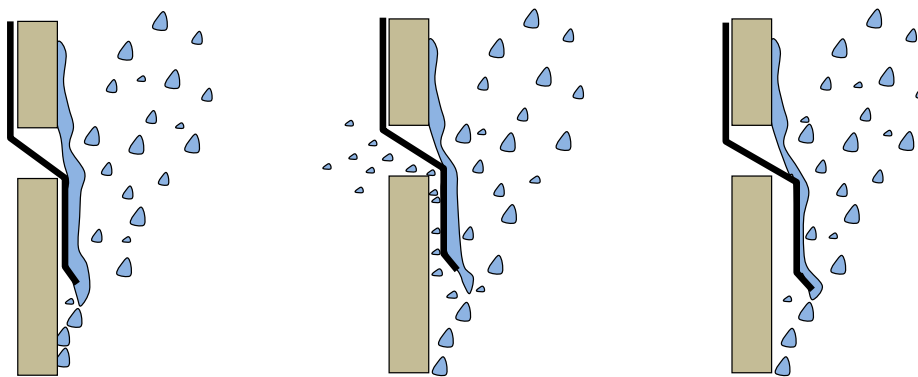
Flashing with kick-out at the bottom edge		
Airtight case with tight fit	Loose fit allowing air flows	Airtight but with loose fit
Tight fitting t & $w \leq 0.5$ mm	$t > 0.5$ mm & 4 mm $> w > 1$ mm	$t = 0$ & $w > 3$ mm

Figure 10. Illustration of water run-off and leakage through a downturned flashing with a kick-out end.

Perhaps the best arrangement of a flashing that is wider than ideal is for it to fit tightly against the top of the window or cladding ($t = 0$) and for the flashing leg to protrude significantly from the cladding (w might be a few mm). In this case, the tight-fitting part of the joint controls air and water entry, while the protruding flashing leg acts as a rainscreen. This fits with the observations by Herbert and Harrison (1974) of weathertight joints having an airtight inner section and an open and sloped drainage path to drain water from the joint. Adding a kick-out or bird's beak end is shown in Figure 8 and Figure 10 to further improve the performance of the joint.

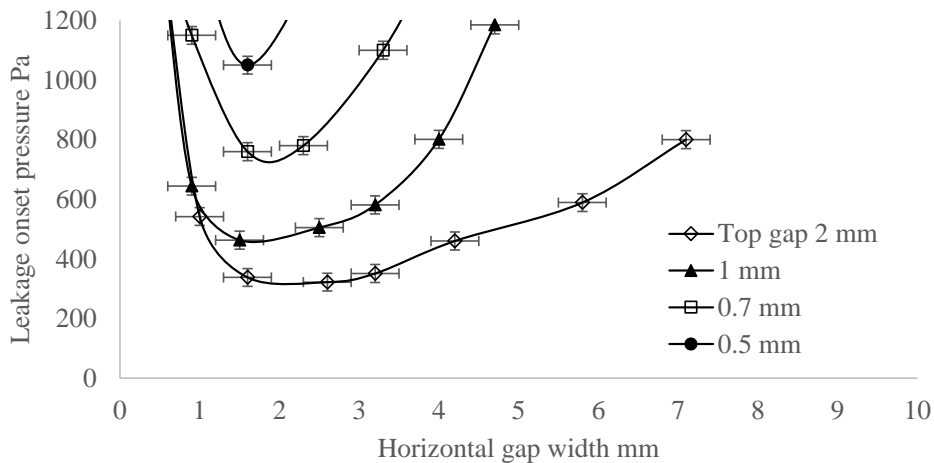
Flashings with a bird's beak end. Figure 11 gives leakage onset pressures for the bird's beak flashing as a function of w and t . This shows another performance improvement over the kick-out flashing throughout the experimental range of w and t . In fact, the leakage onset pressures were well above the hydrostatic pressure equivalent of the joint throughout the range of w and t except for a region where $w = 2$ mm. The illustration in Figure 12 shows the bird's beak flashing deflecting water from the junction with the cladding. It proved to be a more effective rainscreen than the kick-out, but there were no visible differences other than the bird's beak projecting further out and therefore shedding water more effectively from the cladding. Figure 12 shows the loose-fit case allowing air-entrained water to pass through the joint when $t = 2$ mm and with w in the range 1–4 mm. Outside this range, the leakage onset pressures were well above 400 Pa.

Figure 11. Leakage onset pressures for a 35 mm flashing with a bird's beak leg as a function of downturn gap width (w) and top gap (t) dimensions.

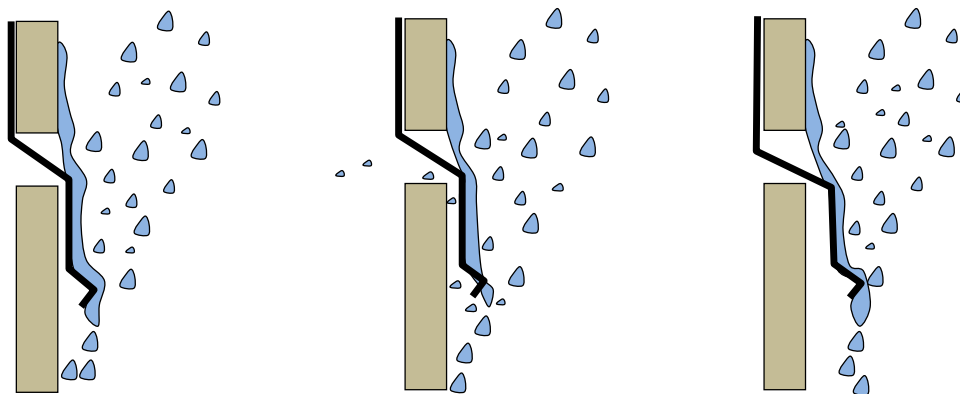
Flashing with bird's beak at the bottom edge		
Airtight case with tight fit	Loose fit allowing air flows	Airtight but with loose fit
Tight fitting t & $w \leq 1$ mm	$t \geq 2$ mm & 4 mm $> w > 1$ mm	$t < 1$ mm and $w \leq 2$ mm

Figure 12. Illustration of water run-off and leakage through a downturned flashing with a bird's beak end.

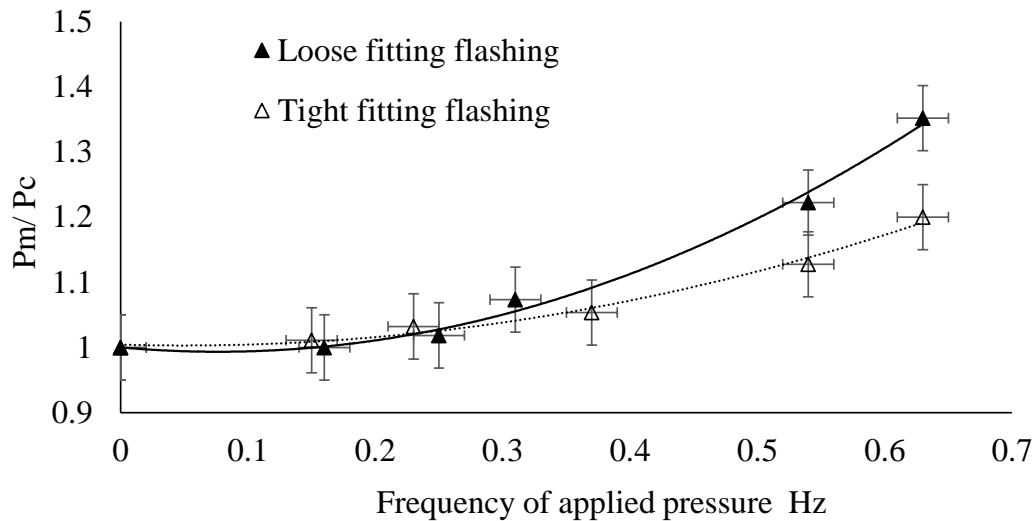
The ratio of the measured onset leakage pressure P_m (the pressure at which the leakage rate is 0.05 g/m.s) and the calculated onset leakage pressure P_c using equation 2 is plotted in Figure 13. It is clear the leakage process can be described as exhibiting little inertial or storage effects at frequencies below 0.4 Hz. However, above 0.4 Hz, the calculated leakage rates are not as good a fit to the measured leakage rates. Similarly, the loose-fitting downturned leg is much less weathertight ($P_m = 110$ Pa) than the tight-fitting flashing ($P_m = 420$ Pa), largely because it allows air-carried water to pass relatively freely through the joint. It takes some time for water to accumulate in the joint compared with the tight-fitting joint where water appears to be retained by capillary attraction and not draining out completely when the applied pressure relaxes.

Figure 13. Ratio of measured onset leakage pressure (P_m) and the calculated onset leakage pressure (P_c) plotted against the frequency of applied air pressure.

The data in Figure 13 can be compared with the P_m/P_c ratio for two flashing upstands from earlier studies (Bassett and Overton 2015) in Figure 14. These are a window head flashing in a cavity wall, and a Z flashing in an inter-storey junction, and both incorporated 35 mm upstands. The window head was a vented joint, much like the loose-fitting downturned flashing, and the onset leakage pressures were higher than could be predicted from steady pressure leakage data at frequencies above 0.4 Hz. Similarly, the tight-fitting Z jointer has behaved like the tight-fitting downturned flashing in exhibiting little effect due to storage or inertia.

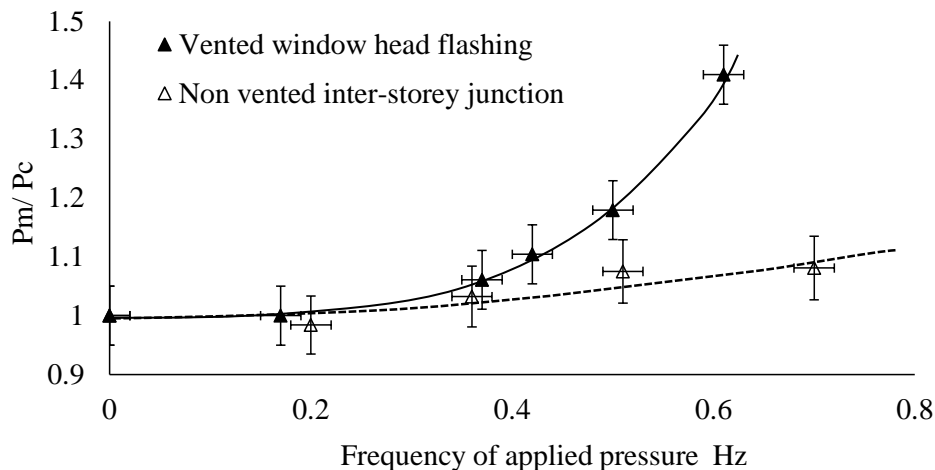
Figure 14. Ratio of measured onset leakage pressure (P_m) and the calculated onset leakage pressure (P_c) plotted against the frequency of applied air pressure. This data is for a window head flashing and a non-vented inter-storey junction.

Once again, this simplified model does not fit the data, suggesting a more sophisticated model is required. This would involve the inertia of water in the joint and the storage capacity of the joint along with surface tension in order to predict leakage rates through joints with significant enclosed volumes.

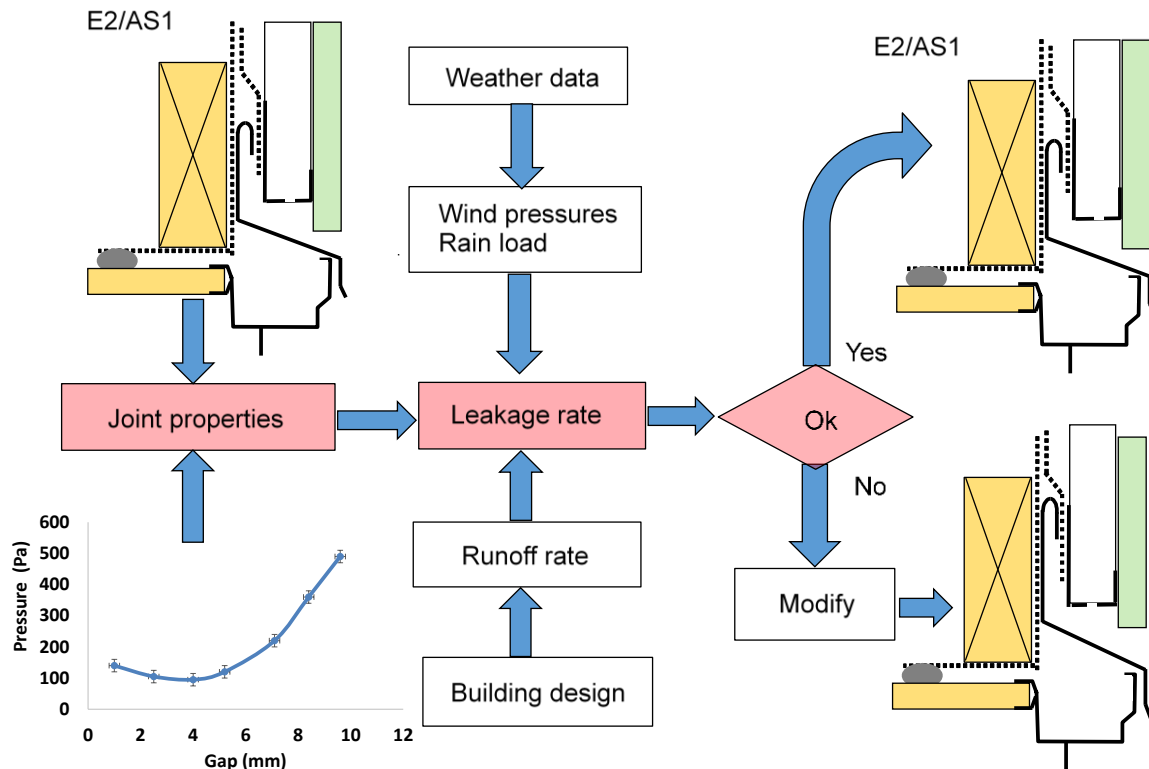
This experimental study is a small part of the work needed to put junction design on a scientific footing. For a start, the junction leakage characteristics will have to be combined with wind pressures, rain loads and surface run-off rates to calculate leakage rates. This step of the process is illustrated in Figure 15 using a head flashing as an example. It shows the steps that would have to be taken to apply a modified detail to a building falling outside the scope of E2/AS1. Secondly, there will be additional consideration due to the junctions between panels having to cope with deflections from wind and seismic loads. In fact, the facing covers required to cope with deflections may exceed the cover required for weathertight performance.

Figure 15. Schematic of the process for modifying a junction detail to take account of high wind and rain loads on a façade.
