The impacts of natural elements on different parts of the building envelope

BRANZ is researching the impact of natural elements such as sun, rain, wind and wind-blown sea salt on different positions on a building. Early results show that micro-environments around a building can be very different from each other and from the surrounding environment. Understanding this can lead to a better understanding of material degradation and ultimately to improved building durability.

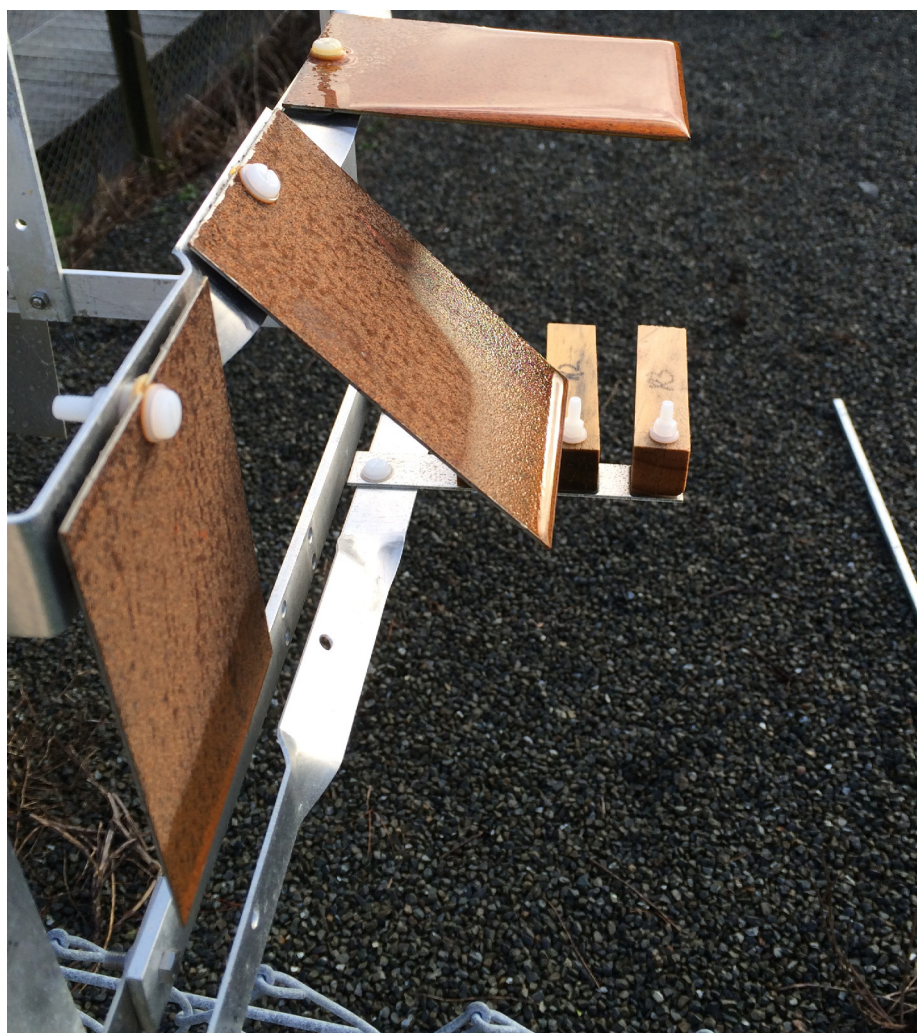
Salt deposits were measured on stainless steel plates installed on the building

horizontally (0°), vertically (90°) and at 45° to the ground. Plates were also installed away from the building. Measuring was done monthly during fine days.
