# **STUDY REPORT**

**SR 305 (2013)**

## **Bracing ratings for non-proprietary bracing walls**

## **BRANZ Study Report SR 305**

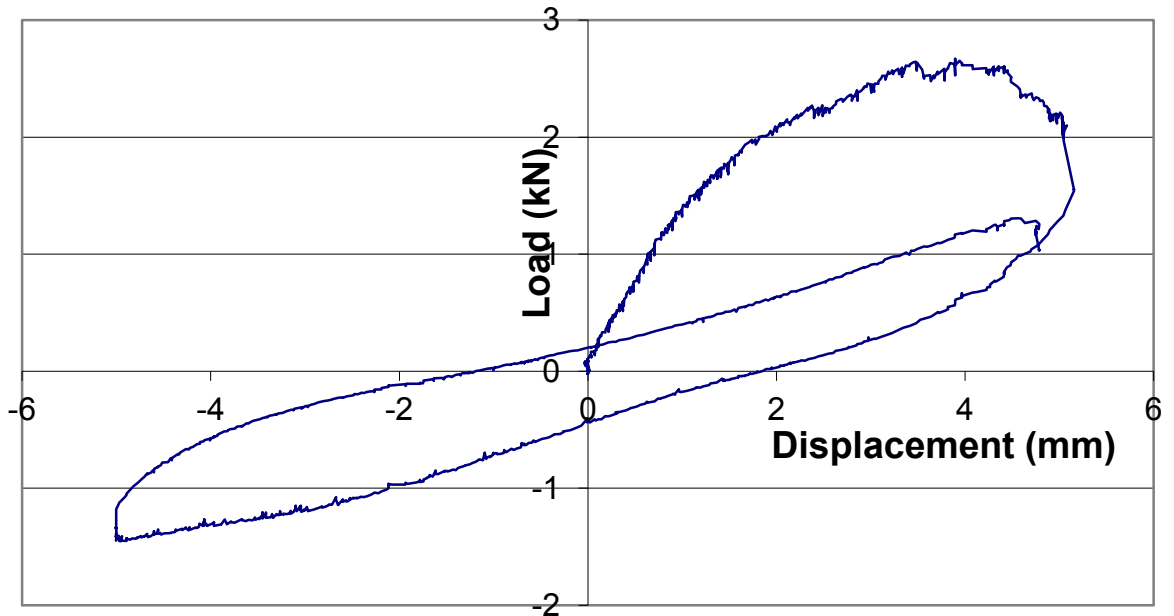
Figure 4. Beattie (2006) racking hysteresis loops for the 2.4 m wide lath and plaster wall

The hysteresis loops measured by Beattie are shown in Figure 4. The average of the push and pull peak strength was 2.66 kN or 1.11 kN/m for this lath and plaster wall lined on one side only. However, as the wall reached peak strength at such a low displacement (approximately 5 mm) it is doubtful if any bracing strength can be utilised.

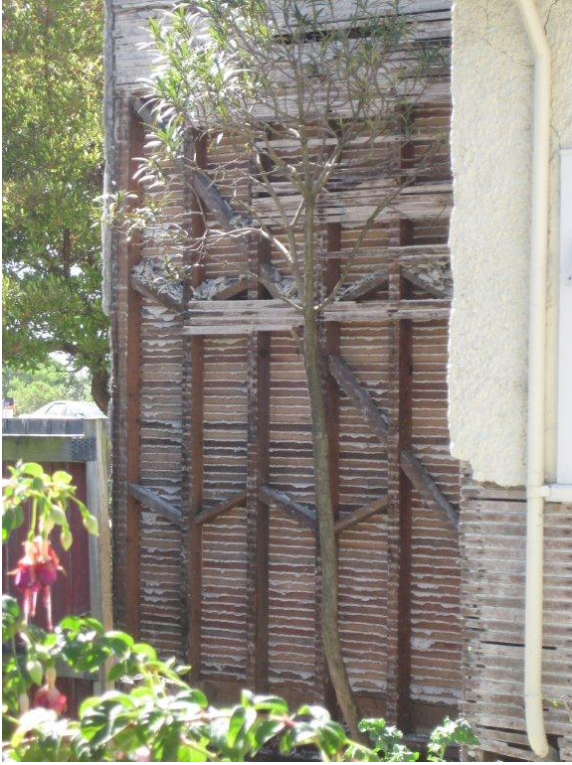
**Figure 5. View of an earthquake-damaged lath and plaster exterior wall (Buchanan et al 2011)**

Buchanan et al reported on damage from the February 2011 Christchurch earthquake. They noted that the use of lath and cement plaster on the exterior of houses was common in the early 1900s for producing a stucco style exterior finish. They considered that the product was very stiff but could not be relied upon for strength. They had observed cases where sheets of the plaster had detached cleanly from the lath (Figure 5). In this photograph the main diagonal timber bracing for the house can be seen where both the plaster and the lath have broken away from the wall.

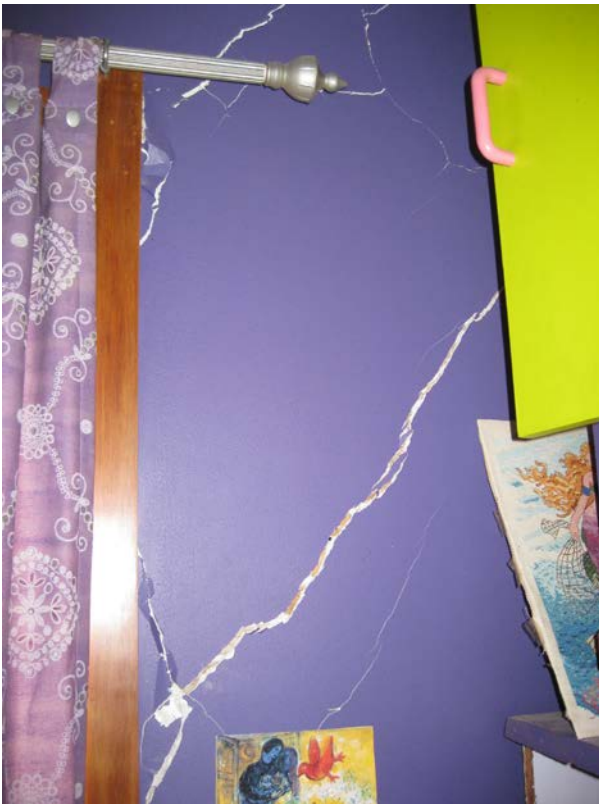
**Figure 6. View of an earthquake-damaged interior lath and plaster wall (Buchanan et al 2011)**

From their observations they concluded that wall linings of trowelled plaster on closely-spaced wood lath had sustained considerably more damage than plasterboard sheet linings. There was a concentration of damage around window and door corners. Because it is not a panel system like plasterboard, the pattern of cracks was sometimes more distributed and not localised around seams in panels, as shown in Figure 6.

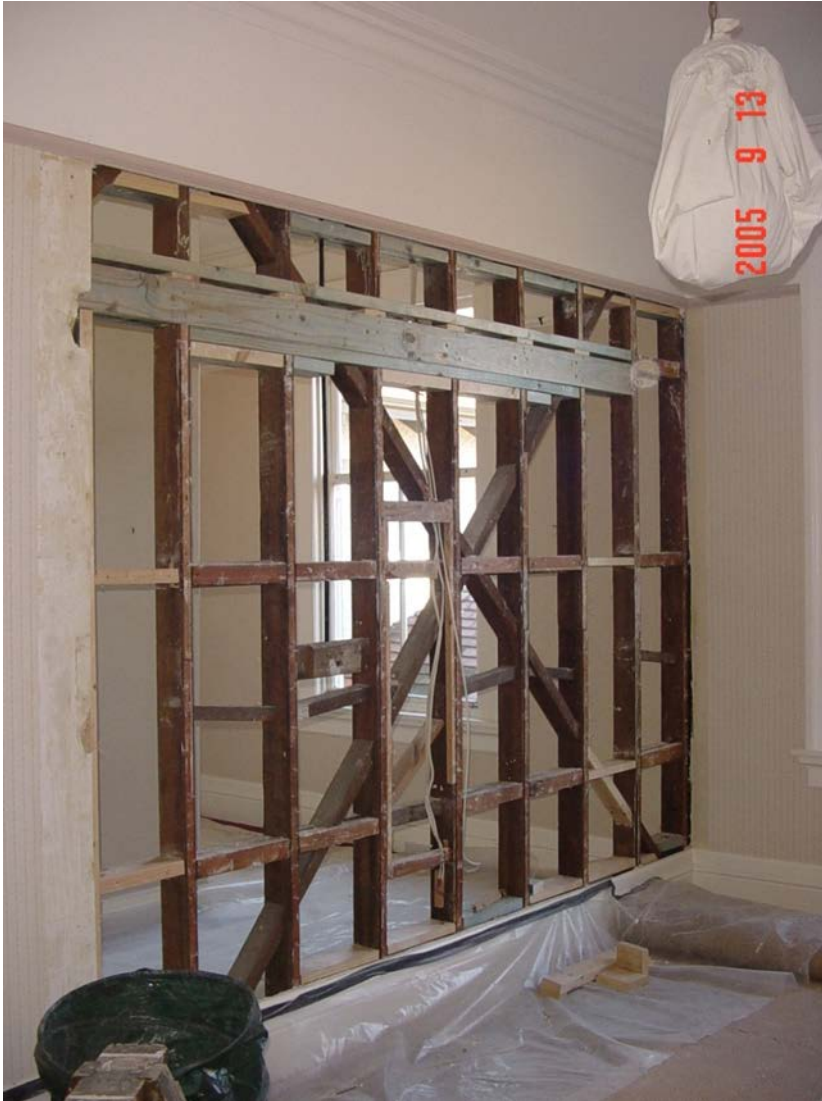
**Figure 7. Wall 1 framing in the insitu fibrous plaster wall tests**

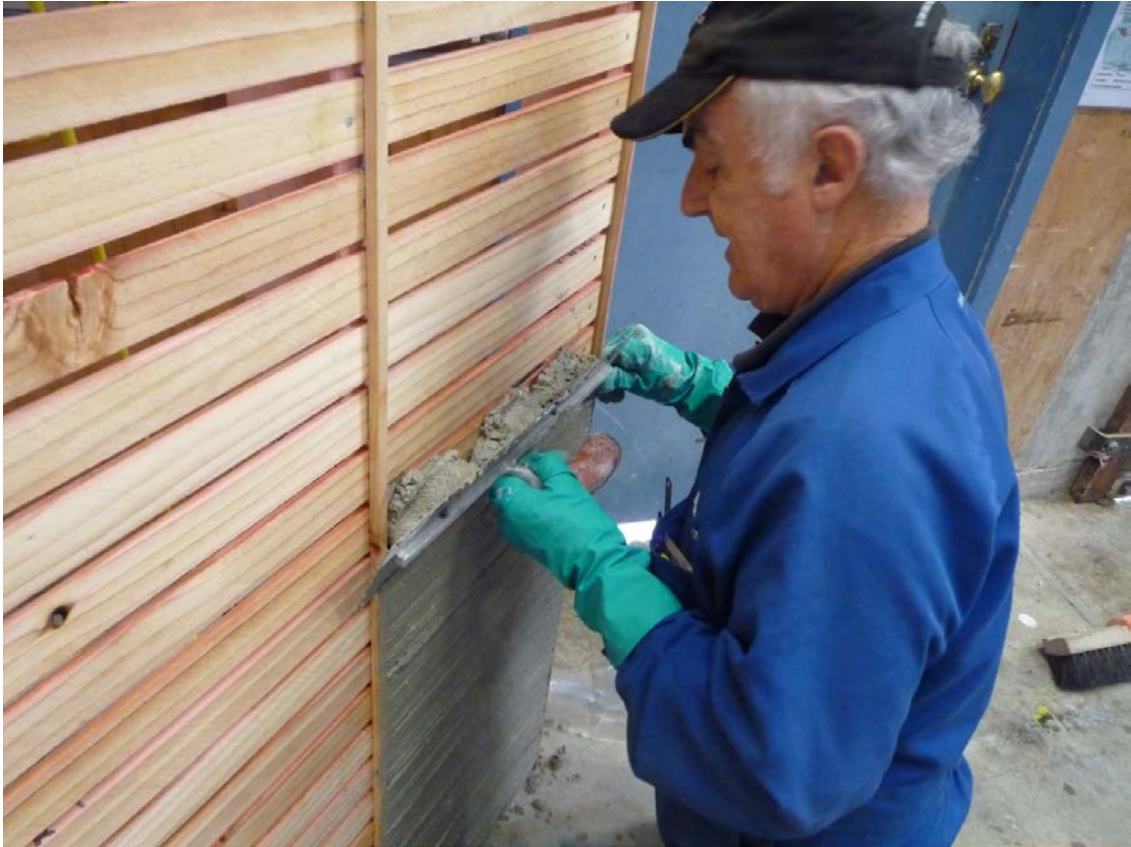
**Figure 10. Applying plaster to the lath and plaster test wall**

The plaster coat consisted of 12 parts with four parts hydrated lime and one part cement by volume. Water was added to achieve the required consistency. The coat was applied to an approximate thickness of 6 mm using a screeding action from the outside face of the timber laths as shown in Figure 10. The plaster was squeezed between the laths to form a key, with the wall structure as shown in Figure 11.

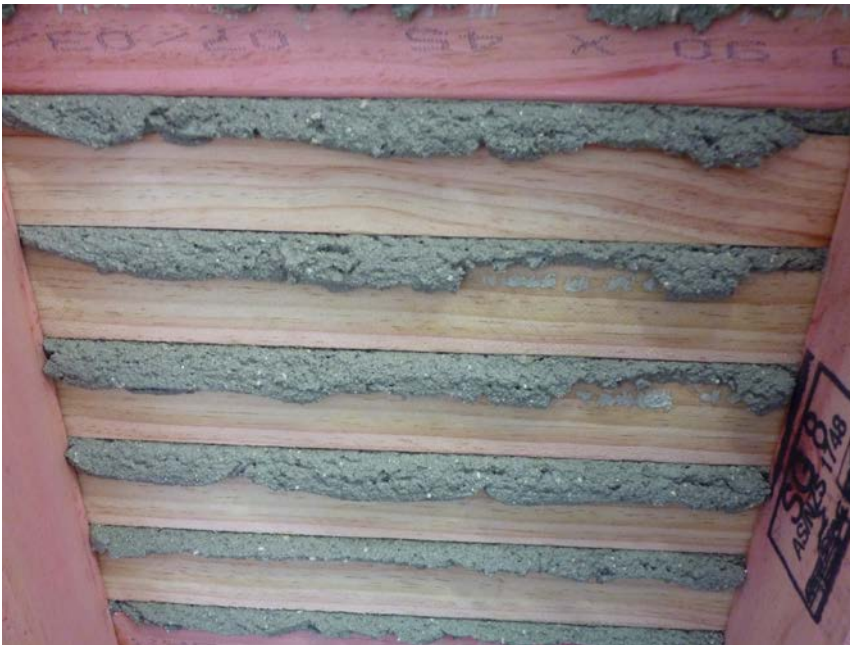
**Figure 11. Plaster squeezed between laths**

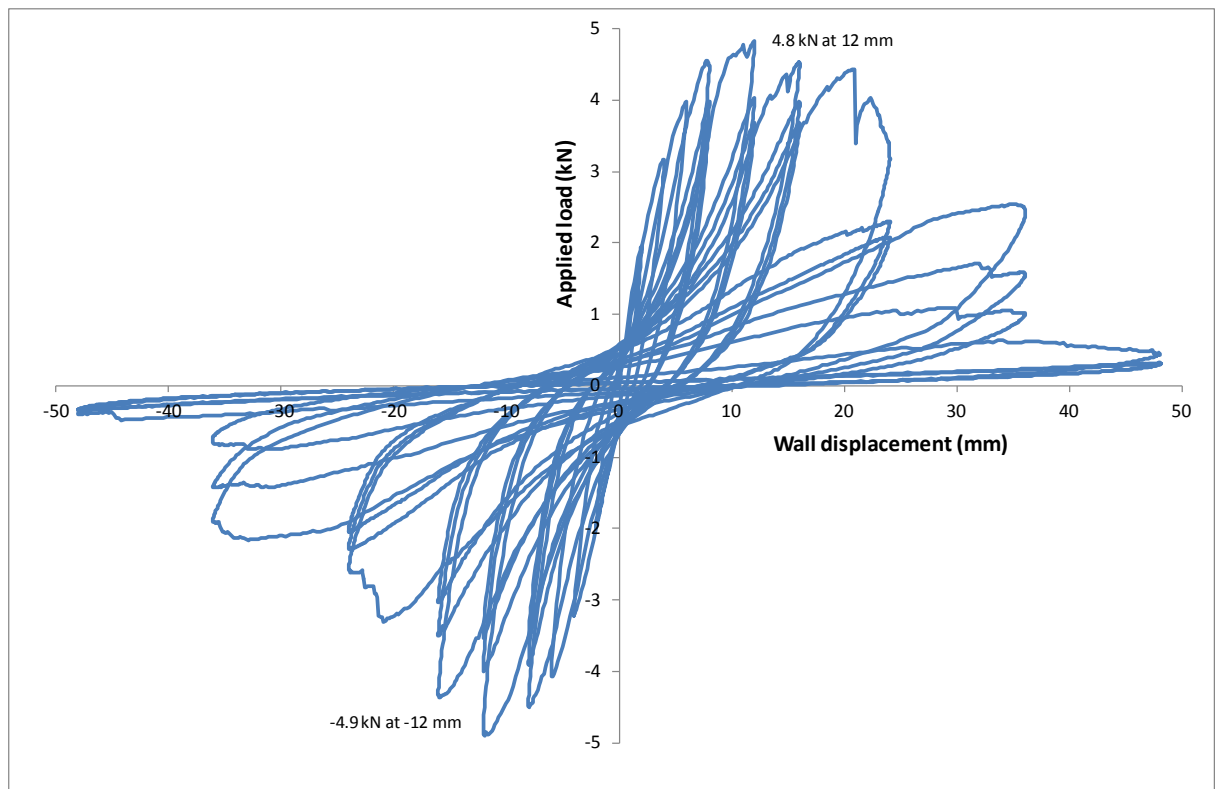
Figure 12. Racking hysteresis loops for the 2.4 m wide lath and plaster wall

The hysteresis loops measured are shown in Figure 12. The average of the push and pull peak strength was 4.9 kN at 12 mm displacement (2 kN/m) which is approximately twice the strength achieved by Beattie but still only 50% of the design strength of 4 kN/m recommended by NZSEE (2006). The difference may be due to the hair used in the old mixes which is likely to have helped resist the curls (also called keys) from falling off. Thus, before the values in the NZSEE (2006) recommendations are used, the plaster should be examined to ensure it contains a good proportion of such hair.

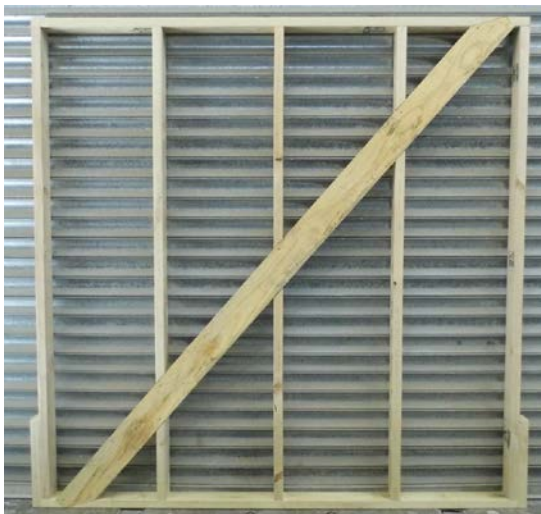
**Figure 13. Specimen for 150 x 25 let in brace at 45°**

The 150 x 25 mm timber brace was fitted into slots cut into the timber studs and plates as shown in Figure 13 to Figure 14. Three 75 x 3.15 mm galvanised flat-head nails were used to connect the brace to the top and bottom plates as shown in Figure 14 and two of these nails fixed the brace to intermediate studs as shown in Figure 15. The brace was in compression during the push cycle and lifted the top plate as shown in Figure 16. This was clearly limiting the specimen strength as shown in Figure 17. A repair was performed, which conceivably could be done during building renovations. The joint still failed as shown in Figure 18 but the resisted strength was significantly greater as shown

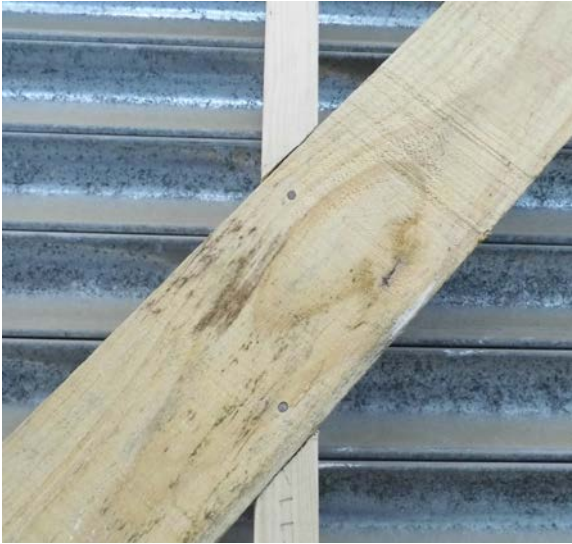
Figure 15. Joint at intermediate studs in specimen for 150 x 25 let in brace at 45°

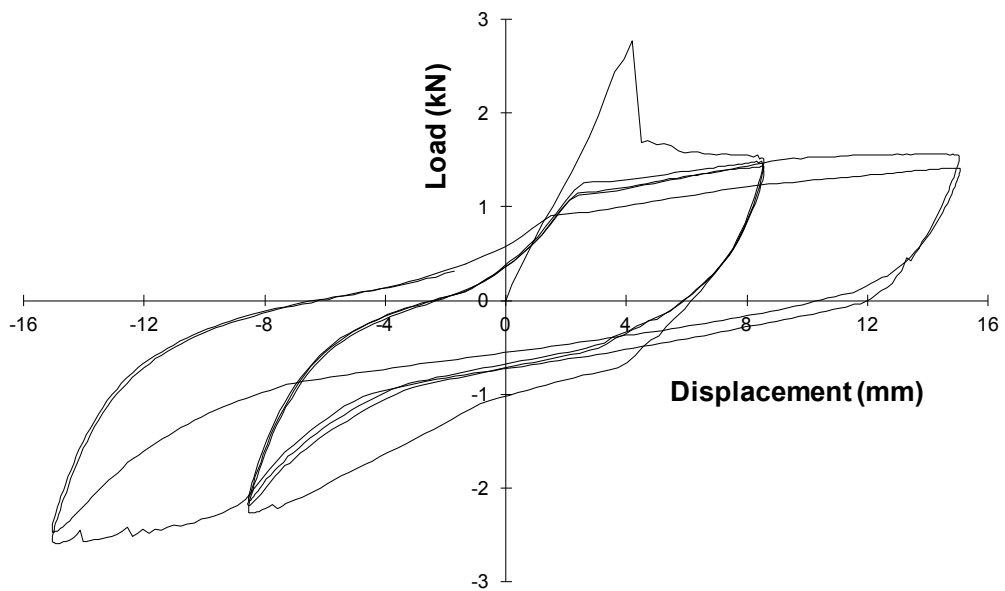
Figure 17. Hysteresis loops for 150 x 25 let in brace at 45° before connection strengthening

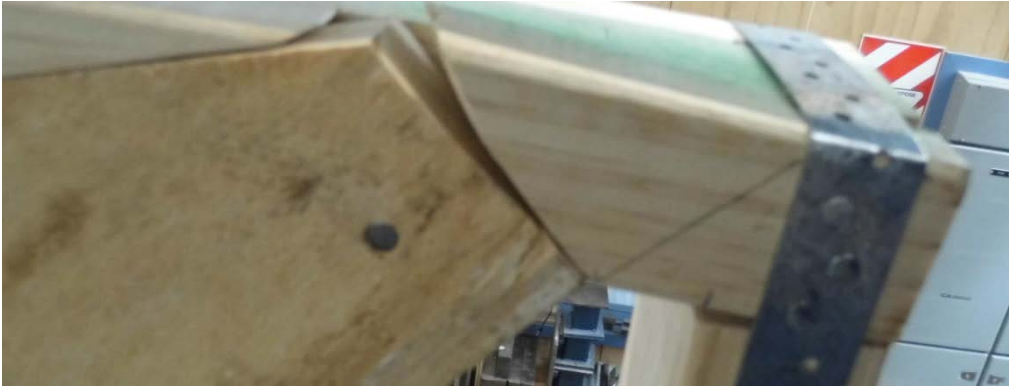
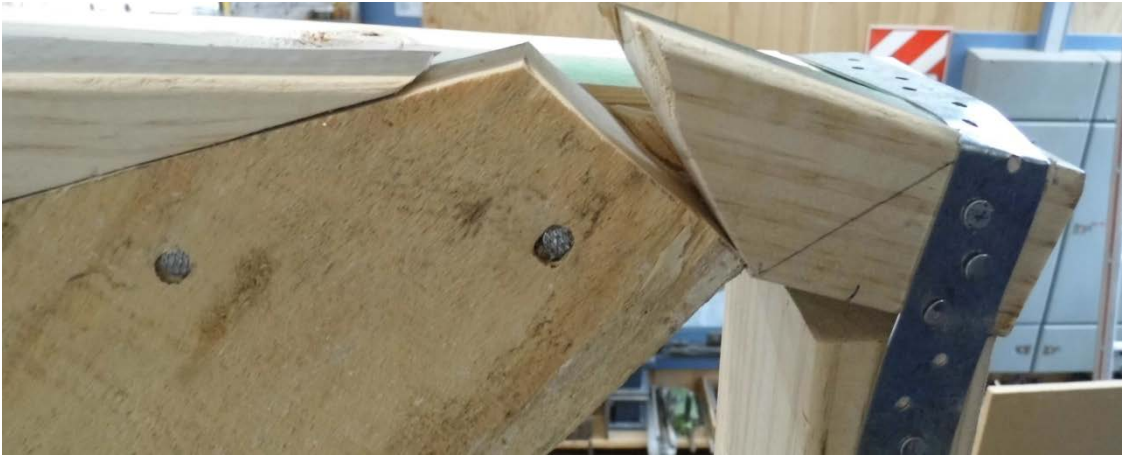
**Figure 18. Diagonal brace lifts top plate in tests after connection strengthening**

**Figure 19. Nails pull out of diagonal brace connection**

At large displacements the nails pulled out of the timber framing and diagonal brace as shown in Figure 19. This limited the maximum tension force in the brace. The maximum bracing force in the pull direction (brace in tension) was approximately 2.6 kN and the strength was limited by the nailed fixing of the diagonal brace to the wall framing. The maximum compression force in the brace was greater due to the load transfer at the top and bottom of the brace. However, when this failed the resisted load dropped and plateaued to 1.56 kN – i.e. less than for the brace in tension. Peak loads resisted are given in Table 4.

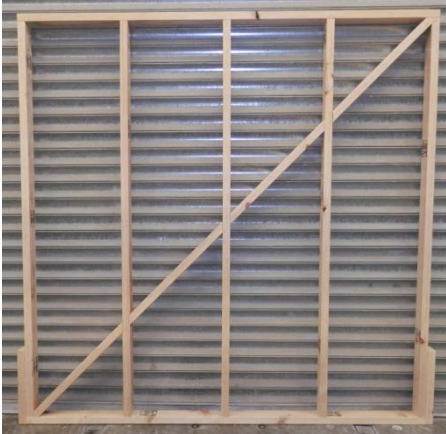
**Figure 21. Specimen for single brace at 45° cut between studs**

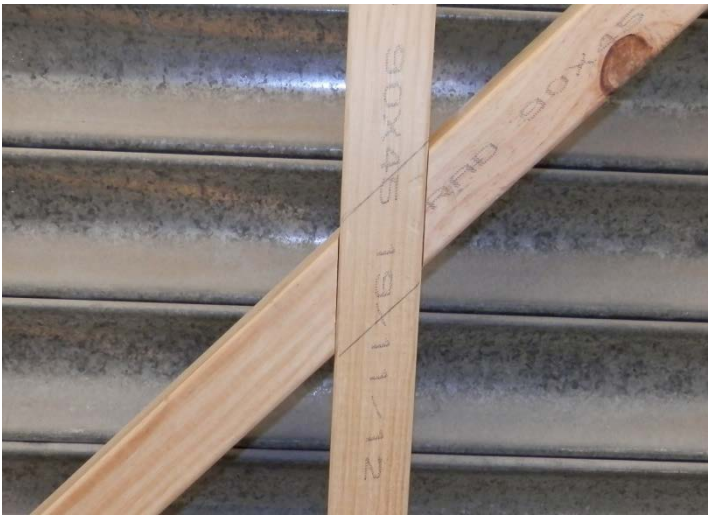
**Figure 22. Centre joint in specimen for single diagonal braces cut between studs**

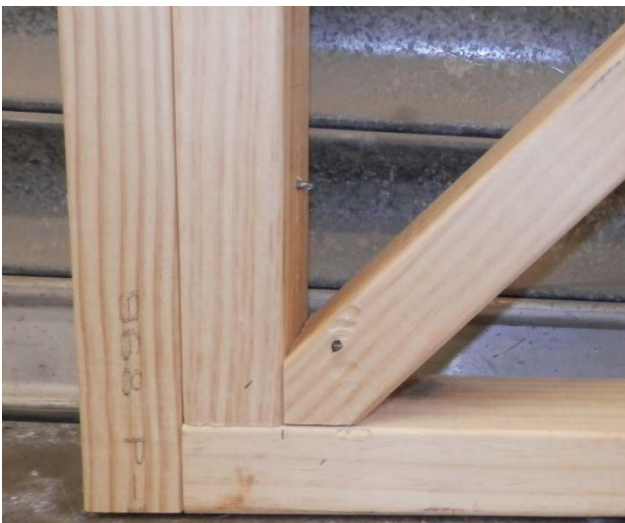
**Figure 23. Bottom joint in specimen for single brace at 45° cut between studs**

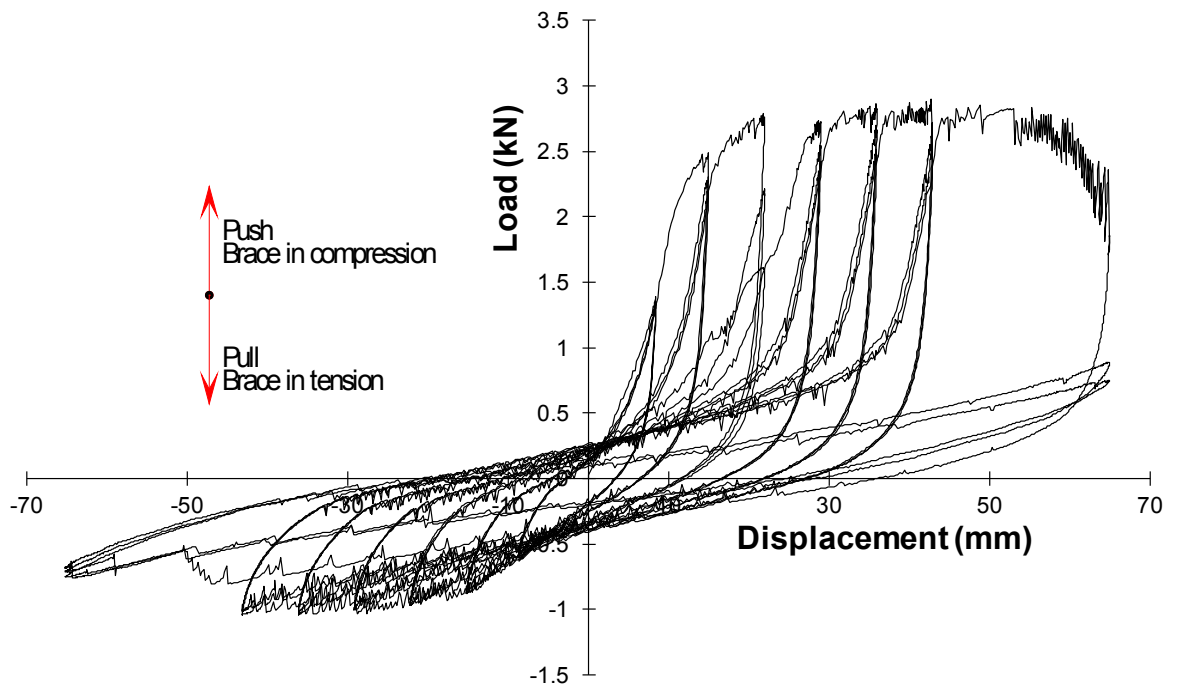
Figure 25. Hysteresis loops for specimen with single brace at 45° cut between studs

The load versus displacement hysteresis loops are shown in Figure 25. The peak resisted push load (brace in compression) was 2.90 kN and the peak resisted pull load was 1.04 kN. The diagonal brace joints opened in tension as shown in Figure 26 and slipped vertically in compression as shown in Figure 27. They finally almost fully separated in tension and then were pushed apart in compression.

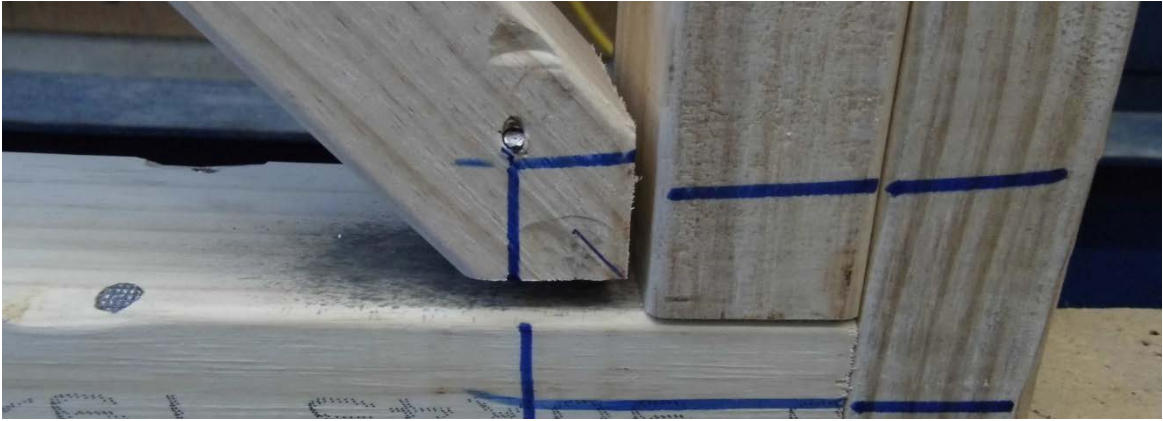
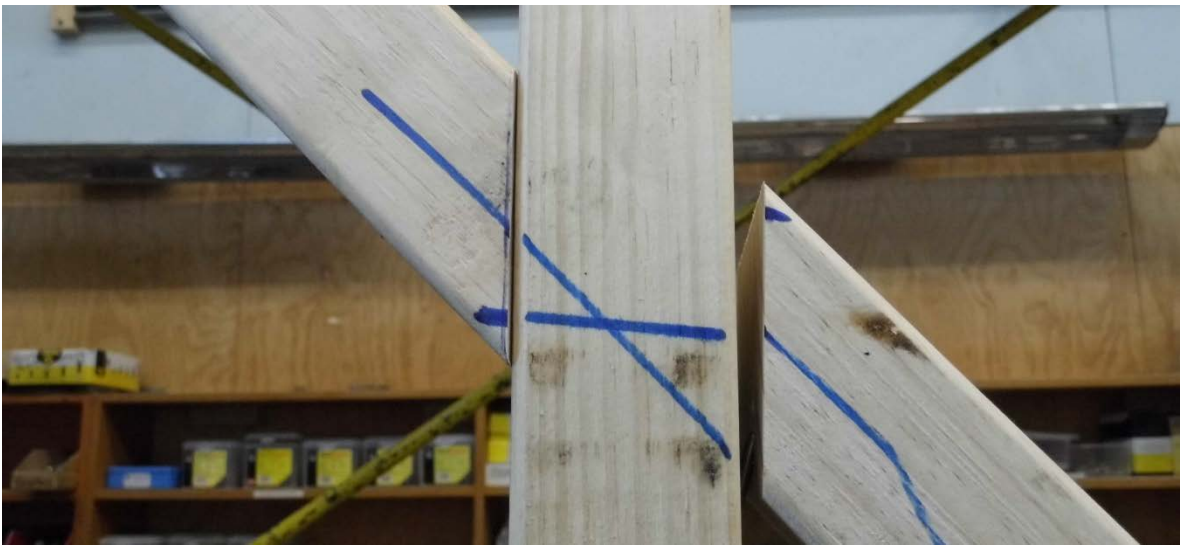
Figure 26. Brace in tension

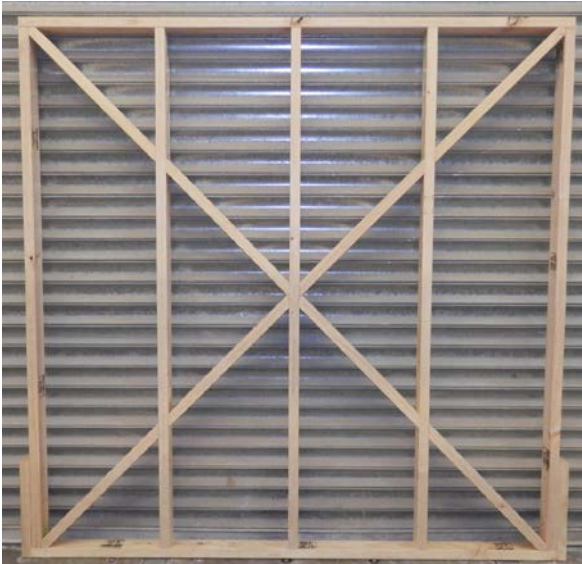
Figure 28. Specimen for double diagonal braces cut between studs

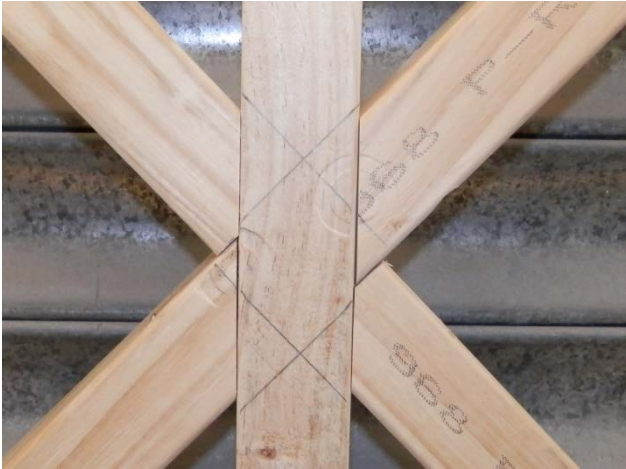
Figure 29. Centre joint in specimen for double diagonal braces cut between studs

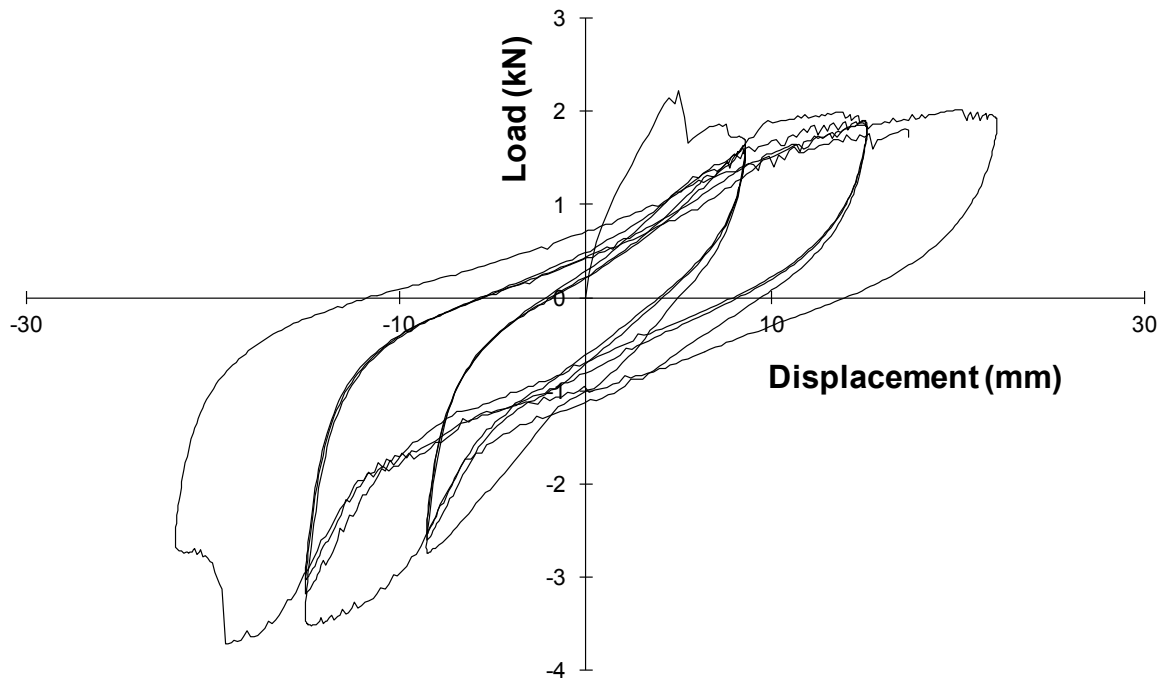
**Figure 31. Hysteresis loops for Brace 3 before strengthening**

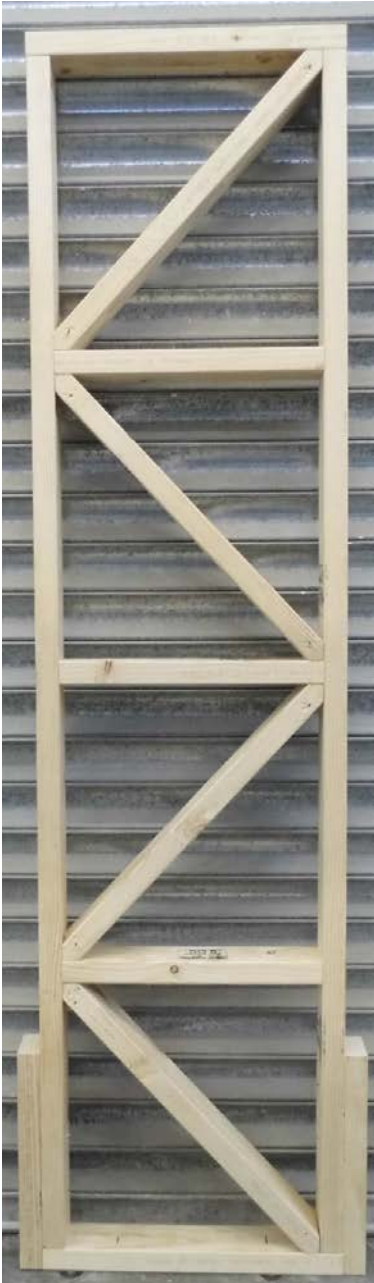
**Figure 36. Dogleg-braced specimen**

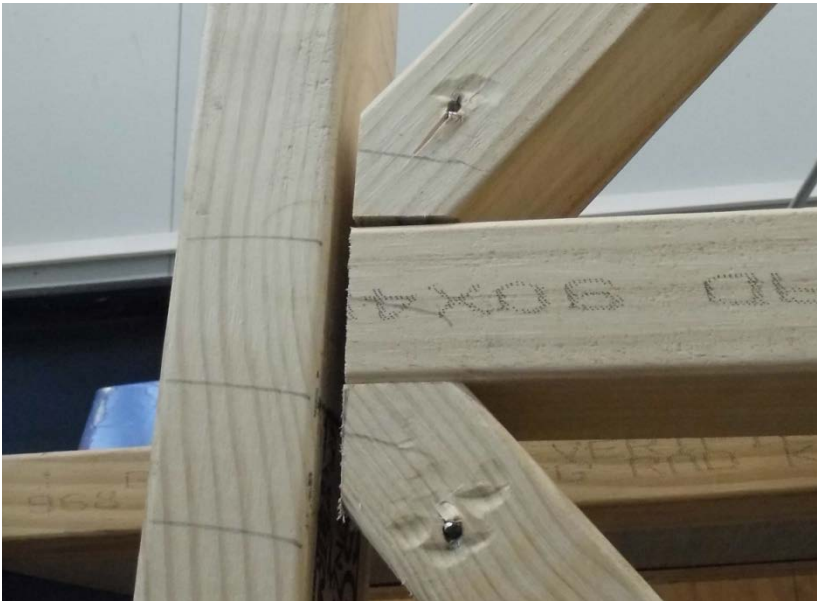
**Figure 39. Gaps opened at intermediate joints in Brace 4 during testing after strengthening**

The joints separated in a similar fashion to other diagonal brace test specimens as shown in Figure 39.

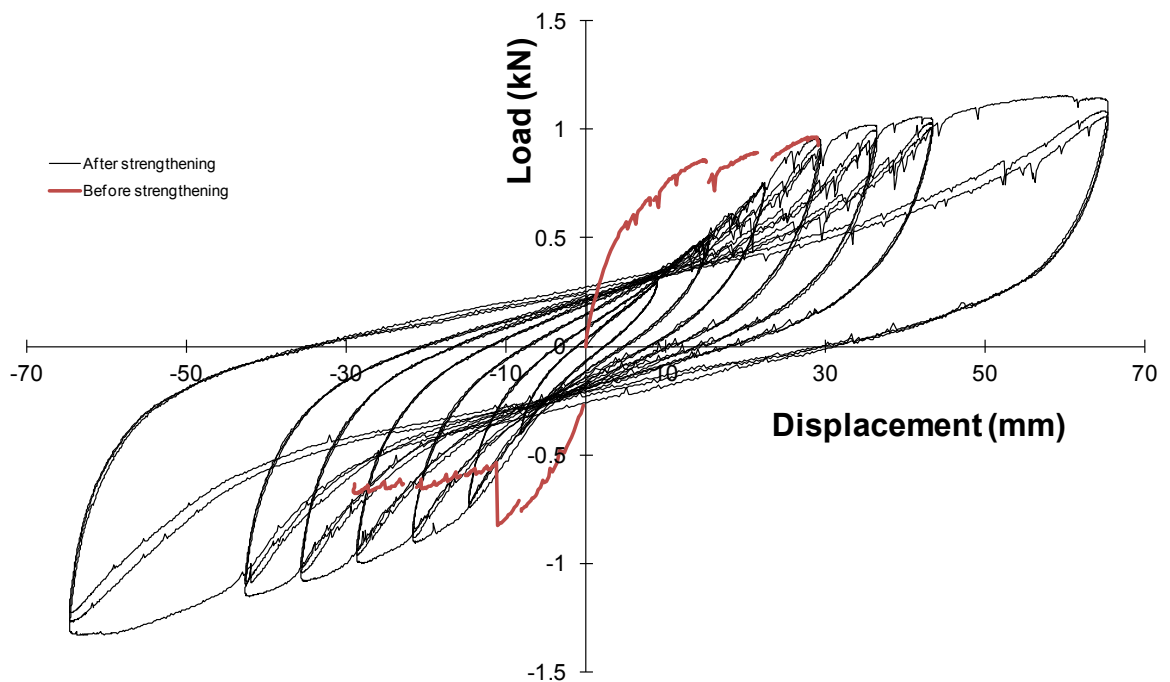
**Figure 41. Hysteresis loops for Brace 4 after strengthening**

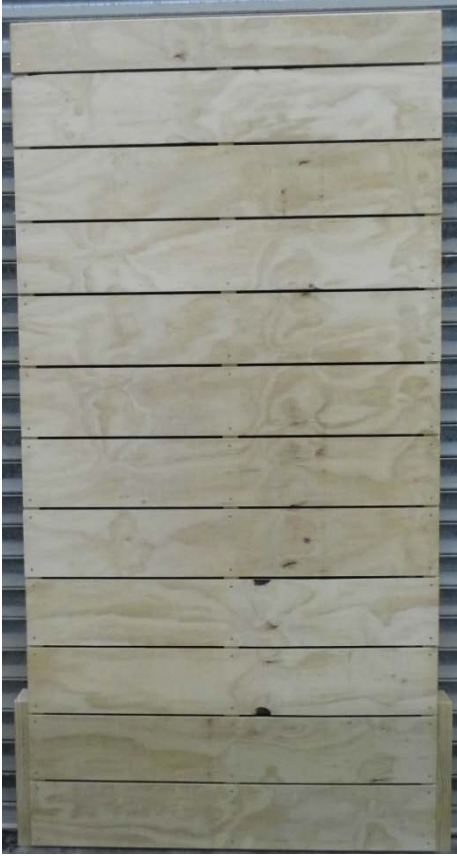
**Figure 42. Specimen for horizontal boarded wall**

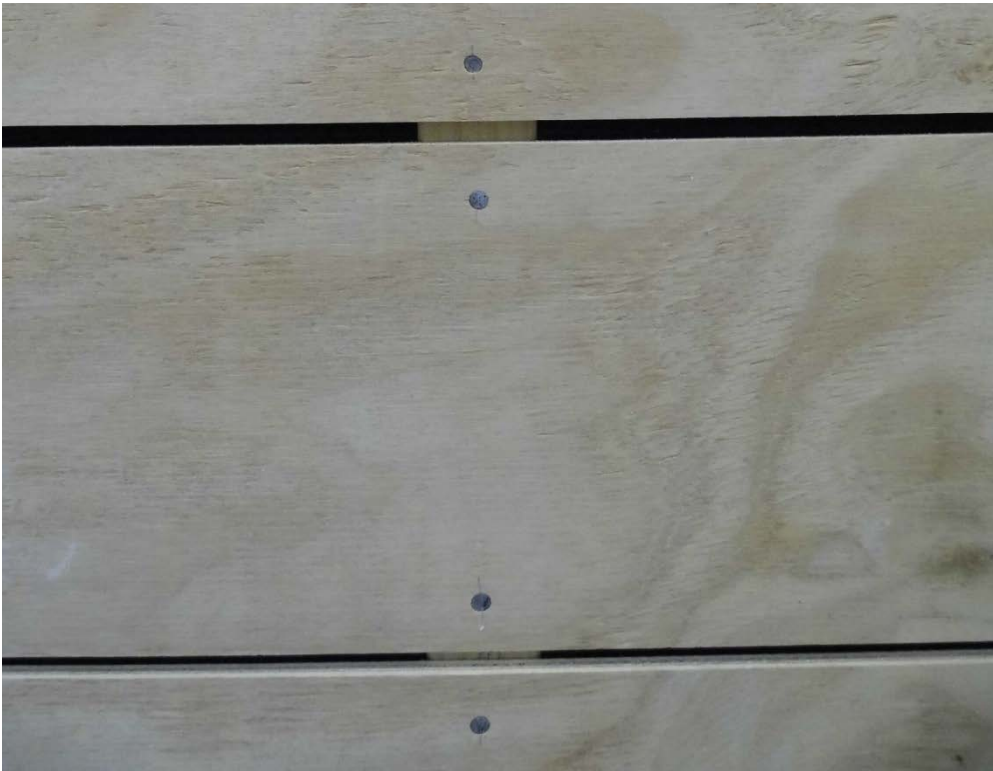
**Figure 43. Nailing at stud for horizontal boarded wall**

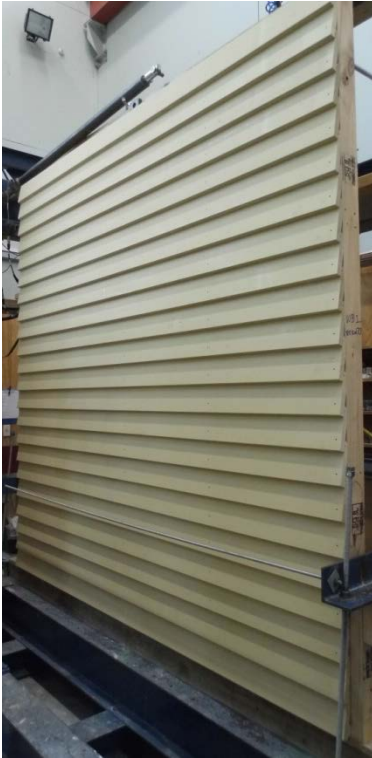
**Figure 45. Specimen for weatherboard wall Board 2**

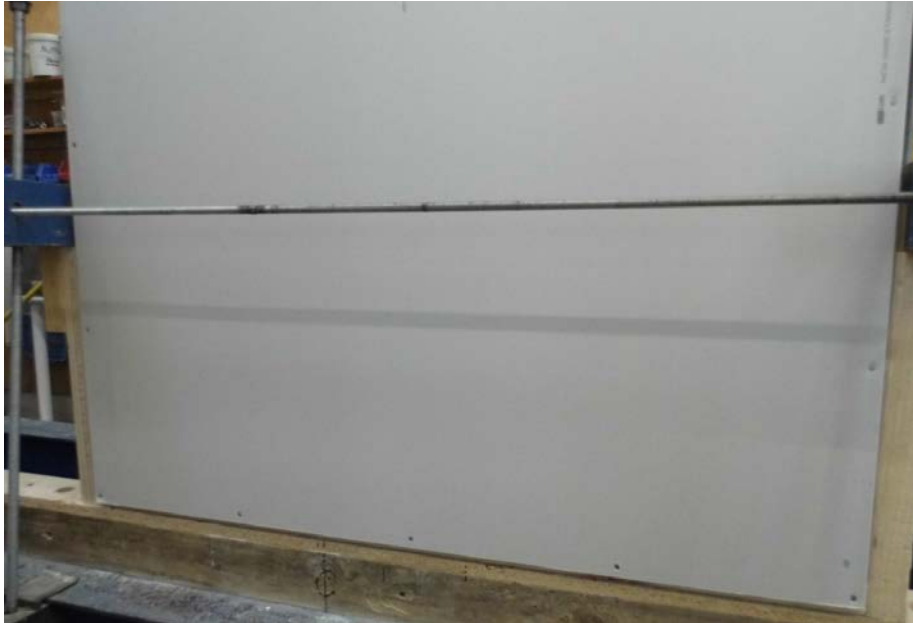
Figure 48. Sheet 1 plasterboard single-lined specimen

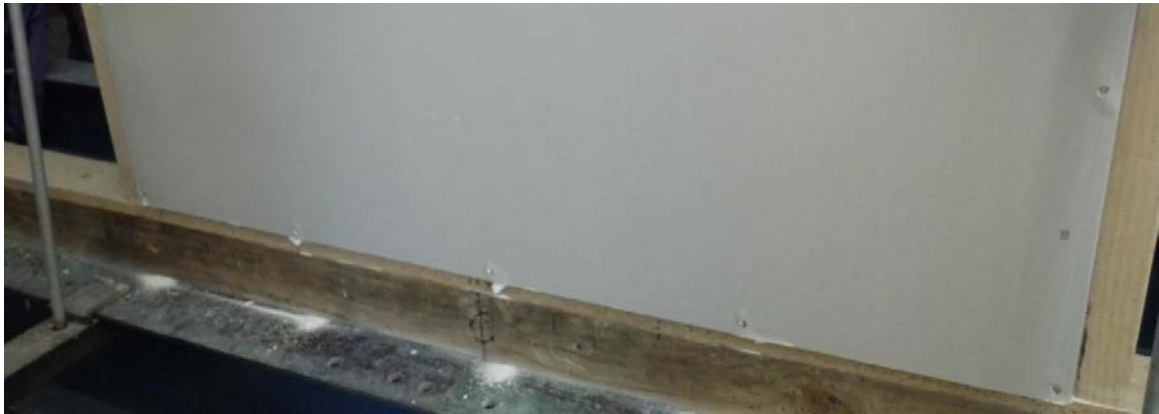
Figure 50. Sheet 2 standard plasterboard lined on both sides of specimen

The observations were similar to the single-lined system. The only damage was at nail locations and the nails progressively sunk into the plasterboard and gouged out a slot in the plasterboard. Eventually the sheets became loose and almost fell from the wall.

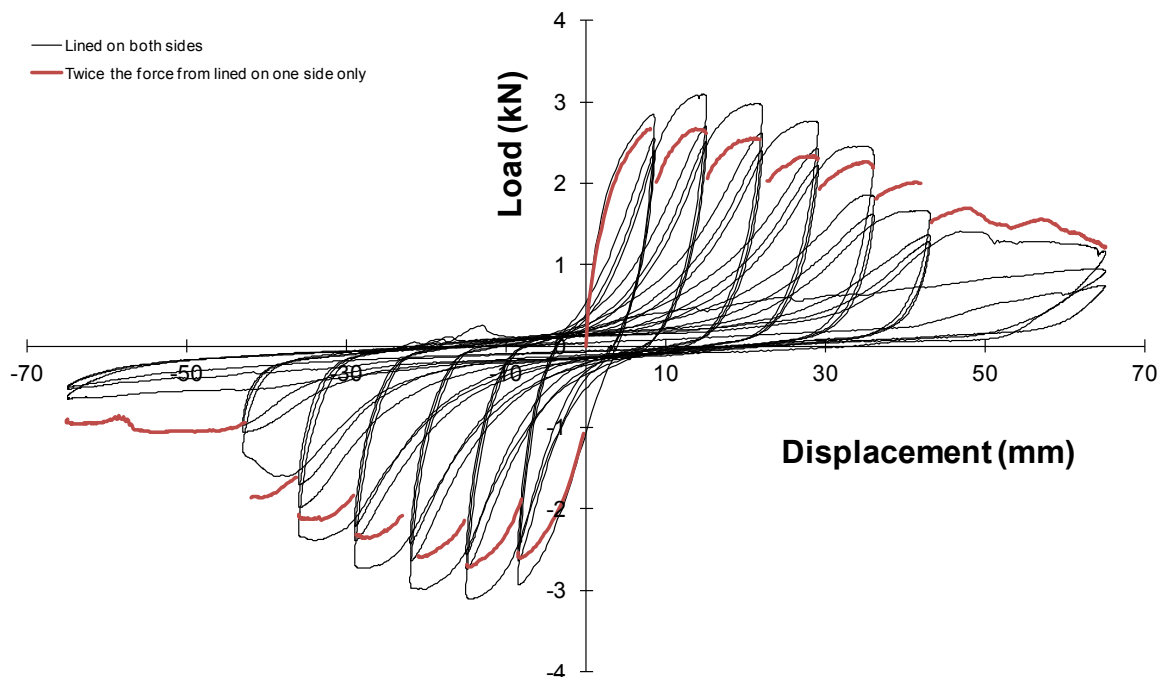
Figure 51. Hysteresis loops for Sheet 2 – standard plasterboard both sides

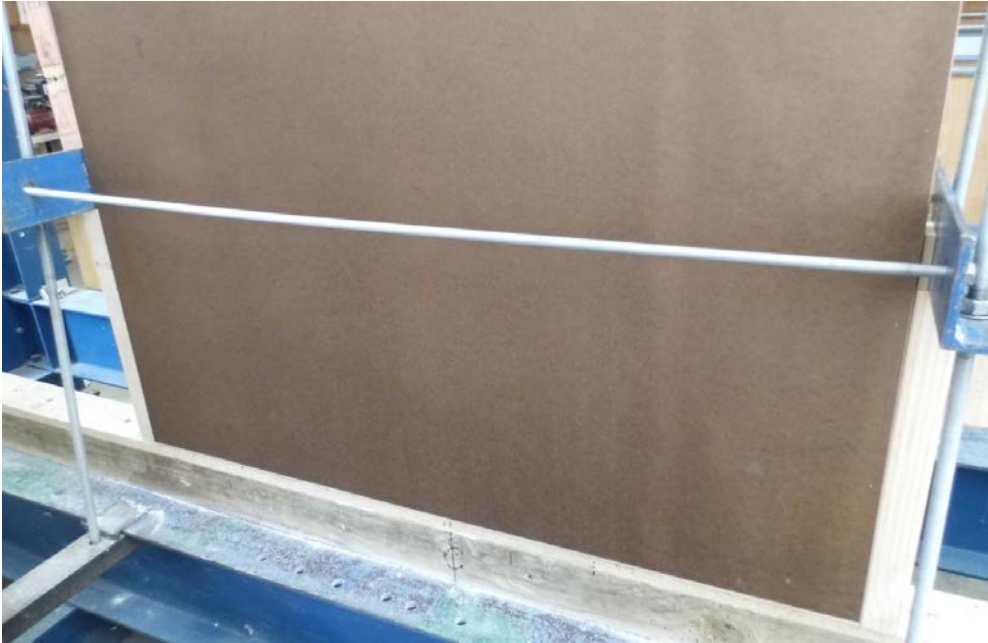
Figure 52. Sheet 3 hardboard single-lined specimen fixed with panel pins

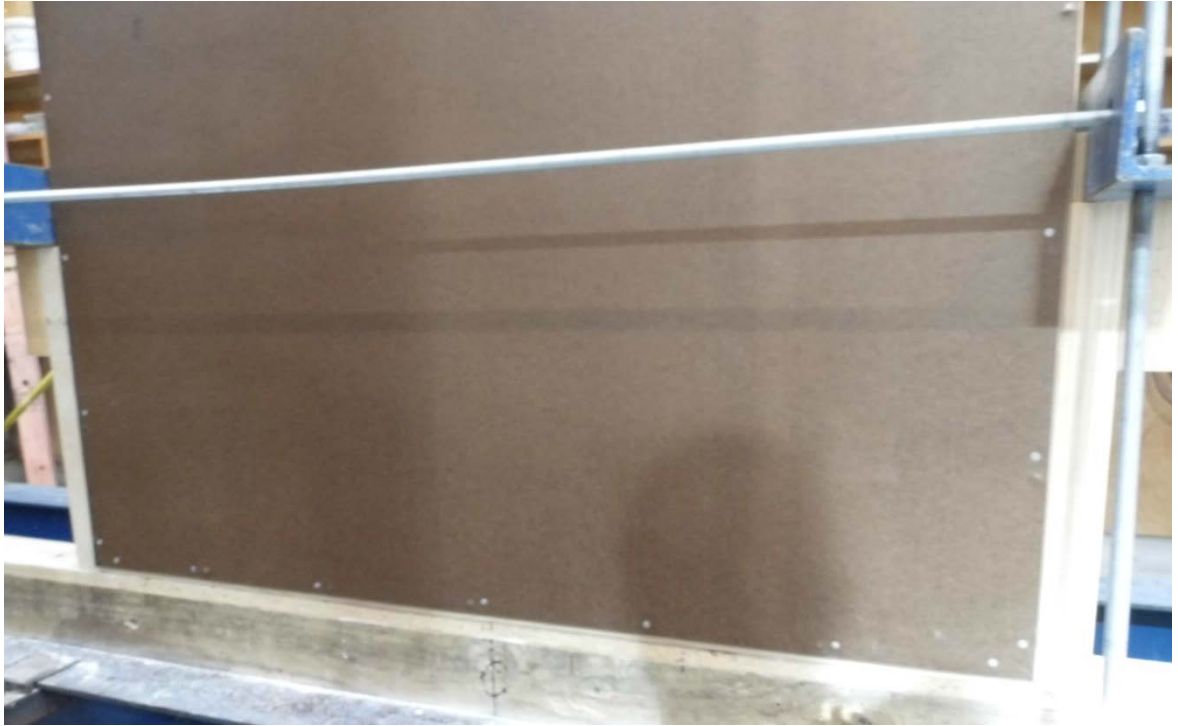
Figure 54. Sheet 3 hardboard single-lined specimen fixed with clouts

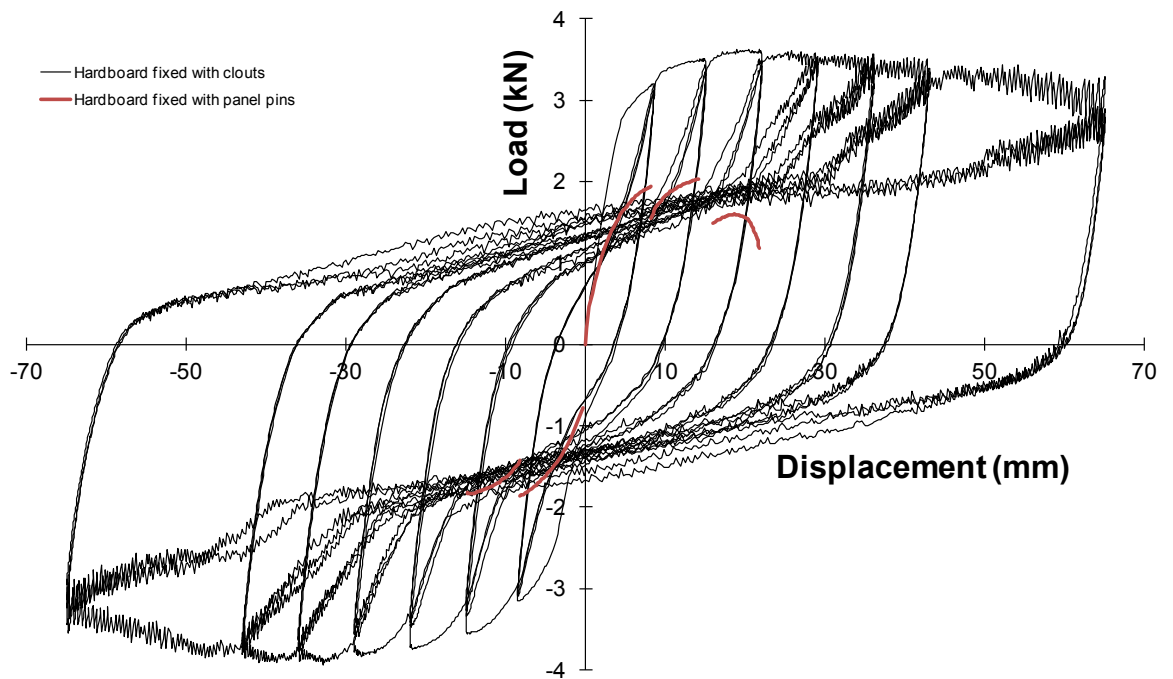
Figure 55. Hysteresis loops for Sheet 3 – tempered hardboard one side fixed with clouts and no extra hold-downs

The plots in Figure 57 also show the backbone of the hysteresis loops of Figure 55 to illustrate that this specimen was stronger but less ductile than the specimen with the hardboard fixed using the same fixing (clouts), but with rocking allowed.

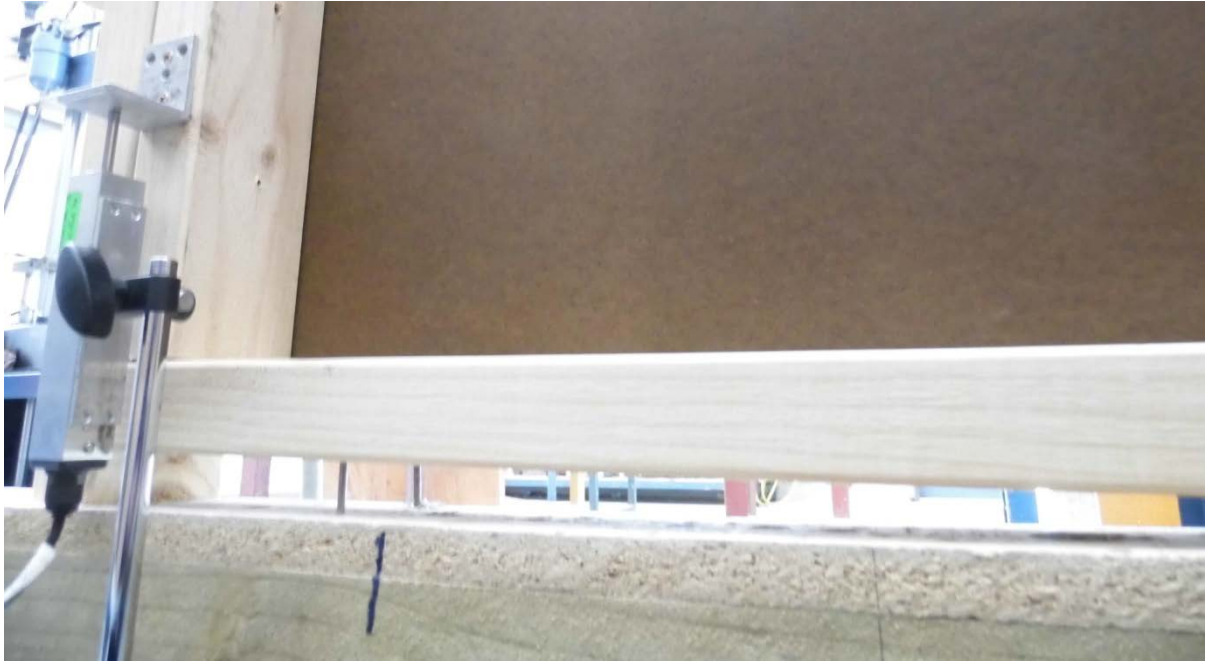
Figure 56. Sheet 3 bottom plate lifting in hardboard-lined specimen fixed with clouts and no extra hold-down

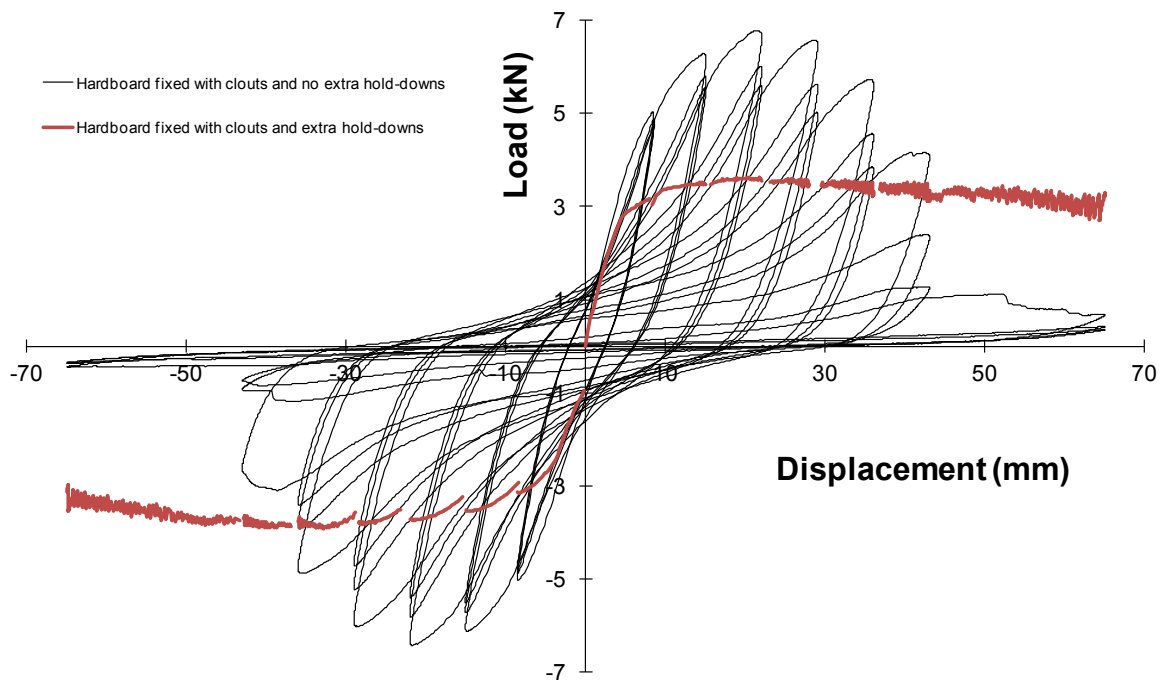
Figure 57. Hysteresis loops for Sheet 3 – tempered hardboard one side fixed with clouts with extra hold-downs

The hysteresis loops for the panel with these extra hold-downs are given in Figure 57. The peak resisted push and pull loads were now 6.78 and -6.43 kN respectively. The panel bulged out of plane at peak loads but the only damage was at nail locations where the nails heads tore holes in and eventually pulled through the hardboard. At the test completion the sheet became loose and almost fell from the wall.

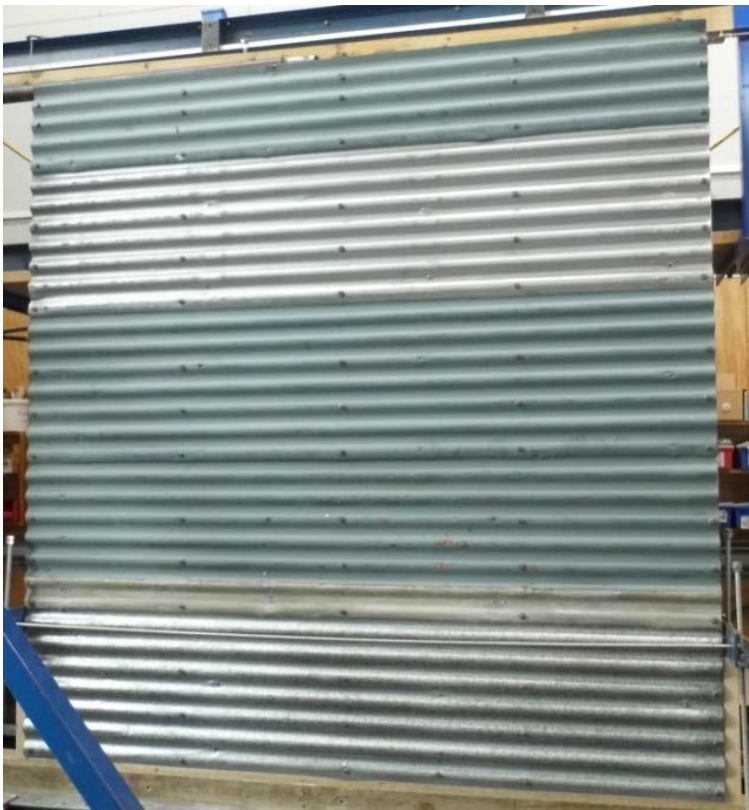
**Figure 58. Front view of Sheet 4 – horizontal corrugated steel**
