# **STUDY REPORT**

**SR 305 (2013)**

## **Bracing ratings for non-proprietary bracing walls**

## **BRANZ Study Report SR 305**

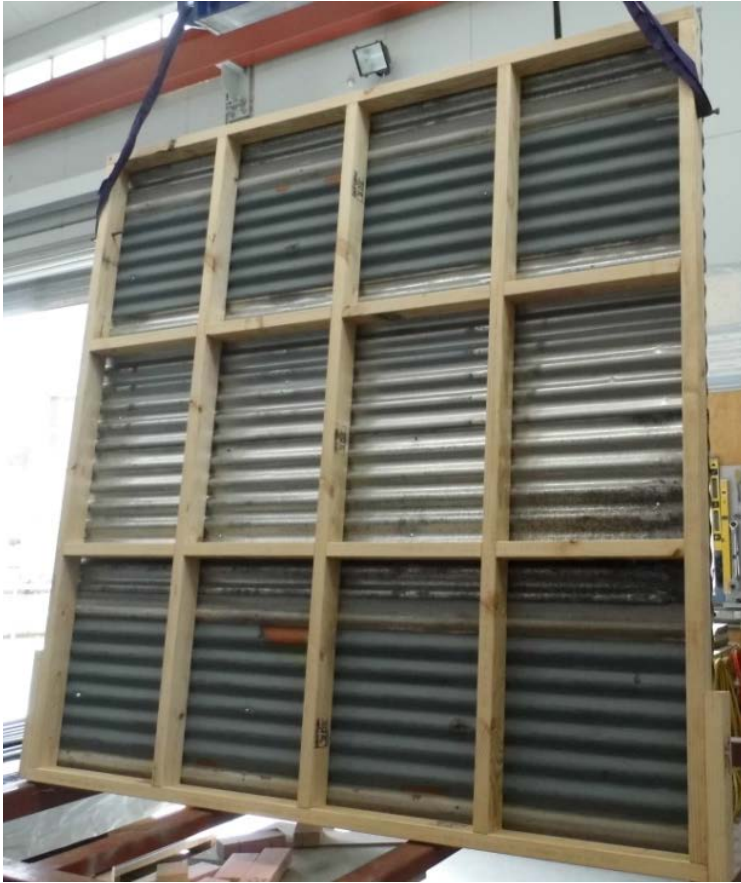
**Figure 59. Back view of Sheet 4 – horizontal corrugated steel**

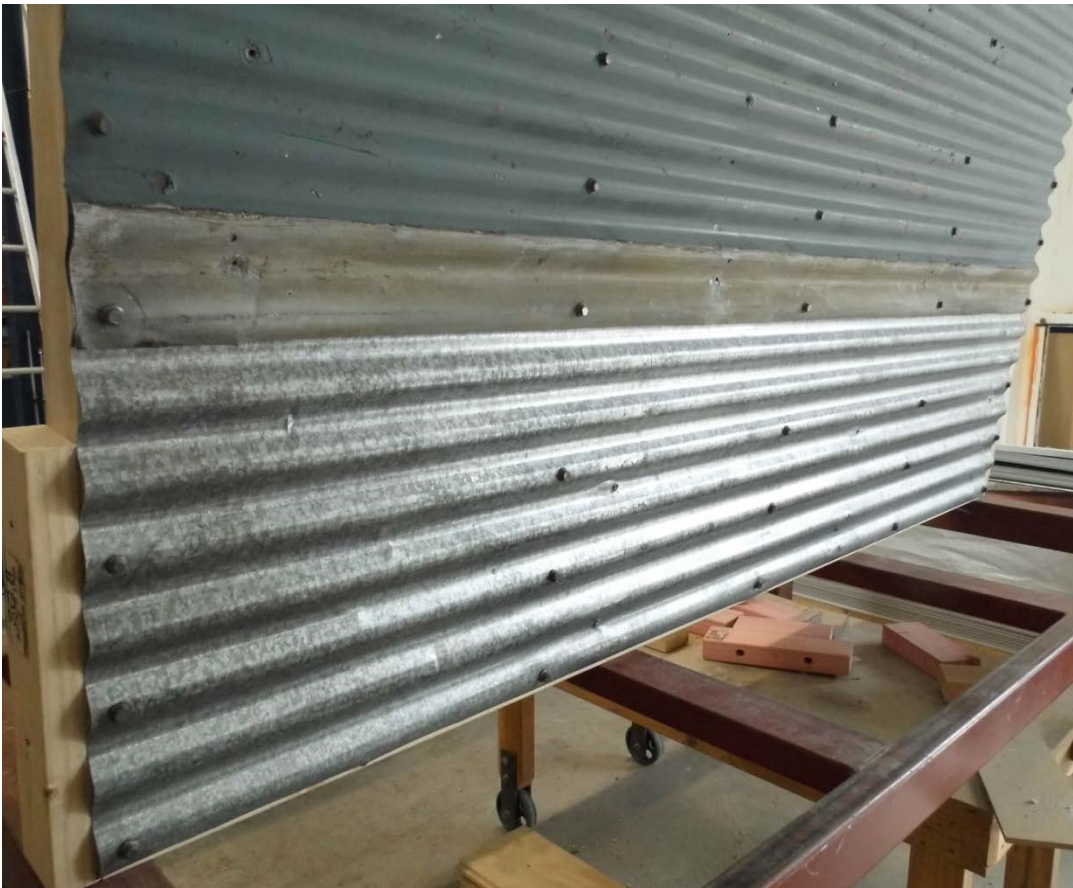
**Figure 60. Views of pattern of lead-head nails – horizontal corrugated steel**

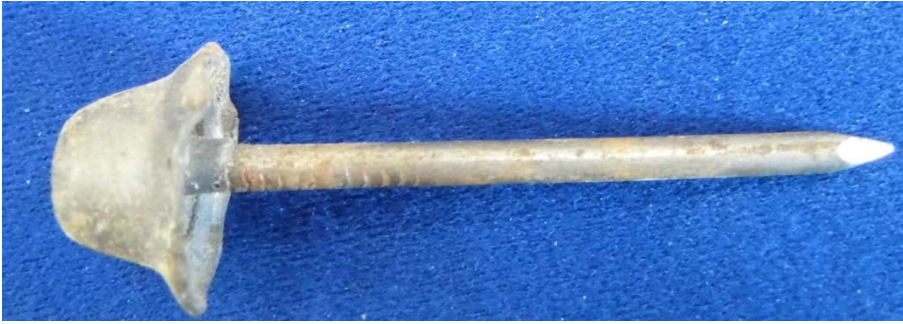
**Figure 61. Lead-head nails used for Sheet 4 and Sheet 5**

and the metal was low tensile compared to that used in current galvanised steel roofing. The sheets were fixed horizontally with pre-used lead-head nails with 3.5 mm galvanised (somewhat rusty) 60 mm long shanks and lead heads 19 mm diameter at the base and 11 mm high cast over an 8 mm steel flat-nail head. A photograph of the nails is shown in Figure 61.

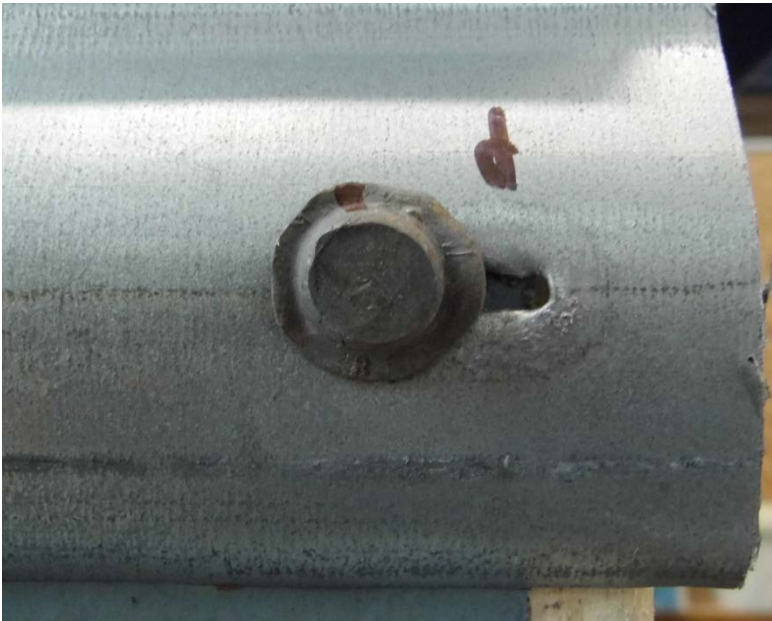
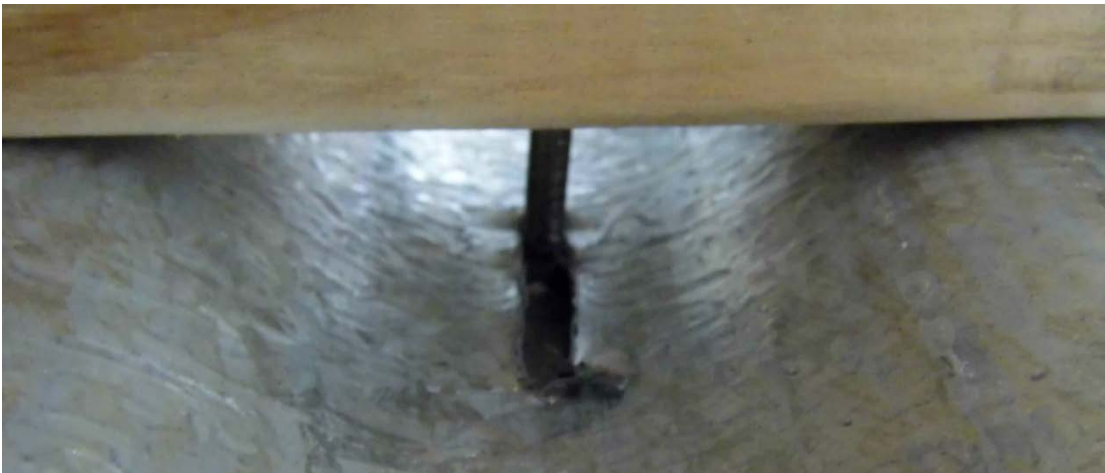
**Figure 62. Views of sheet slotting at lead-head nails – horizontal corrugated steel**

Adjacent sheets slipped horizontally relative to one another. The only damage was at nail locations and the nail shanks progressively slotted the steel sheet as shown in Figure 62.

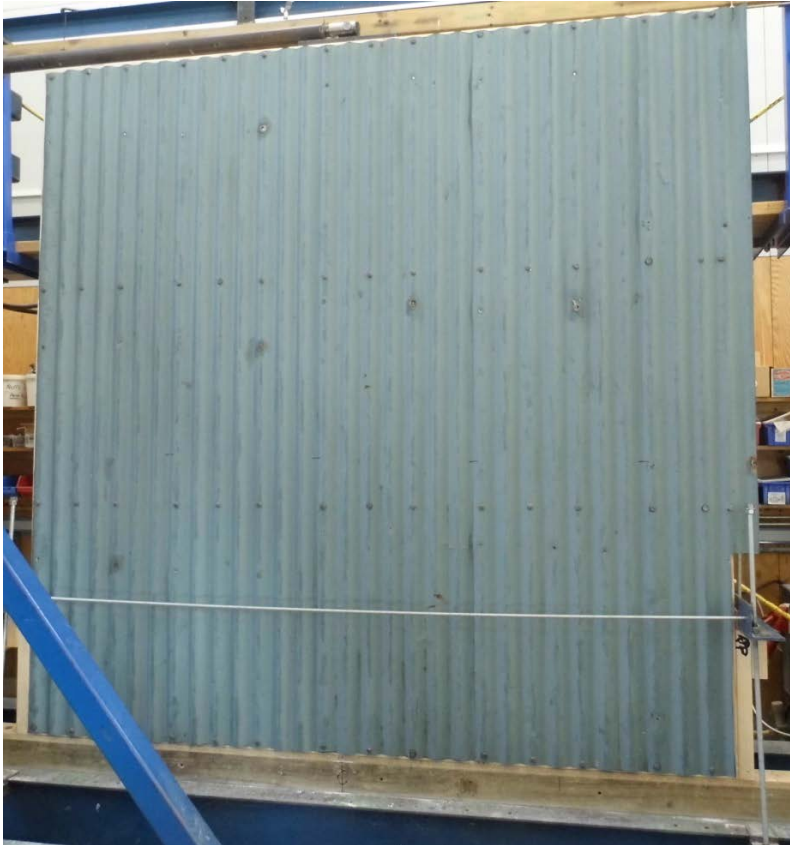
**Figure 64. Front view of Sheet 5 – vertical corrugated steel**

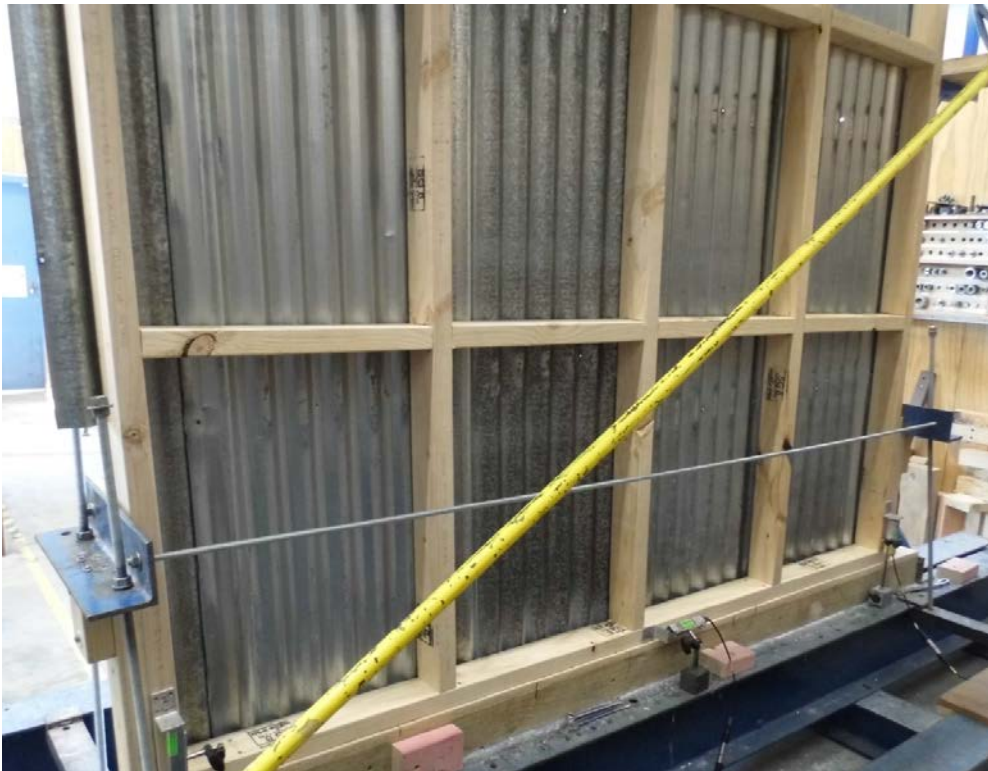
**Figure 65. Back view of Sheet 5 – vertical corrugated steel**

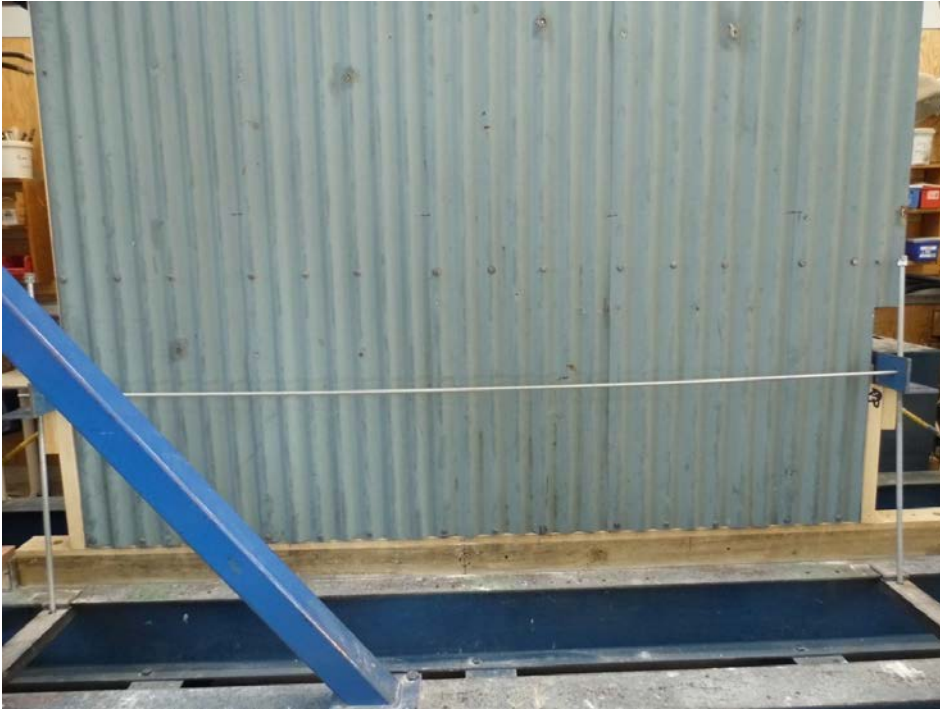
**Figure 66. Views of pattern of lead-head nails – horizontal corrugated steel**

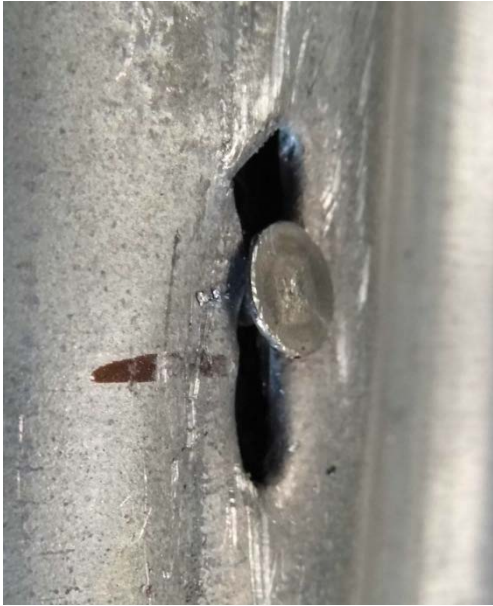
**Figure 67. Views of sheet slotting at lead-head nails – vertical corrugated steel**

Adjacent sheets slipped vertically relative to one another. The only damage was at nail locations where the nail shanks progressively slotted the steel sheet as shown in Figure 62. The heads of a few lead head nails also popped off.

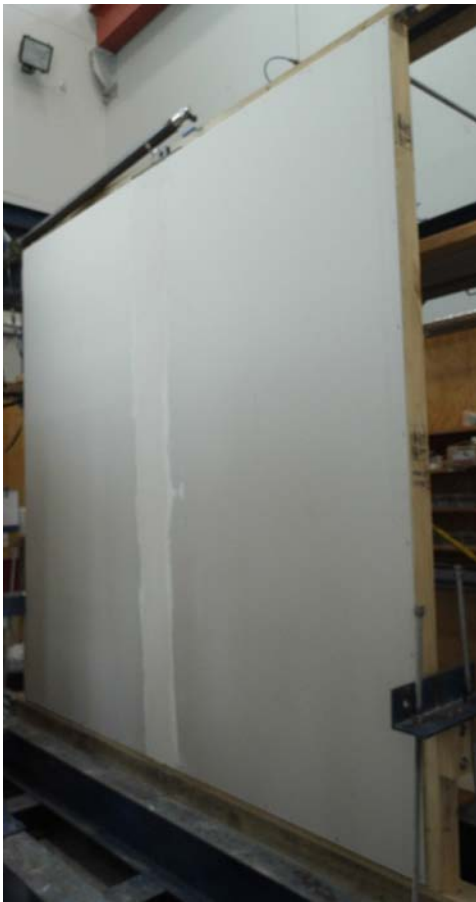
**Figure 69. Combo 1 – a combination of Sheet 1 and Brace 3**

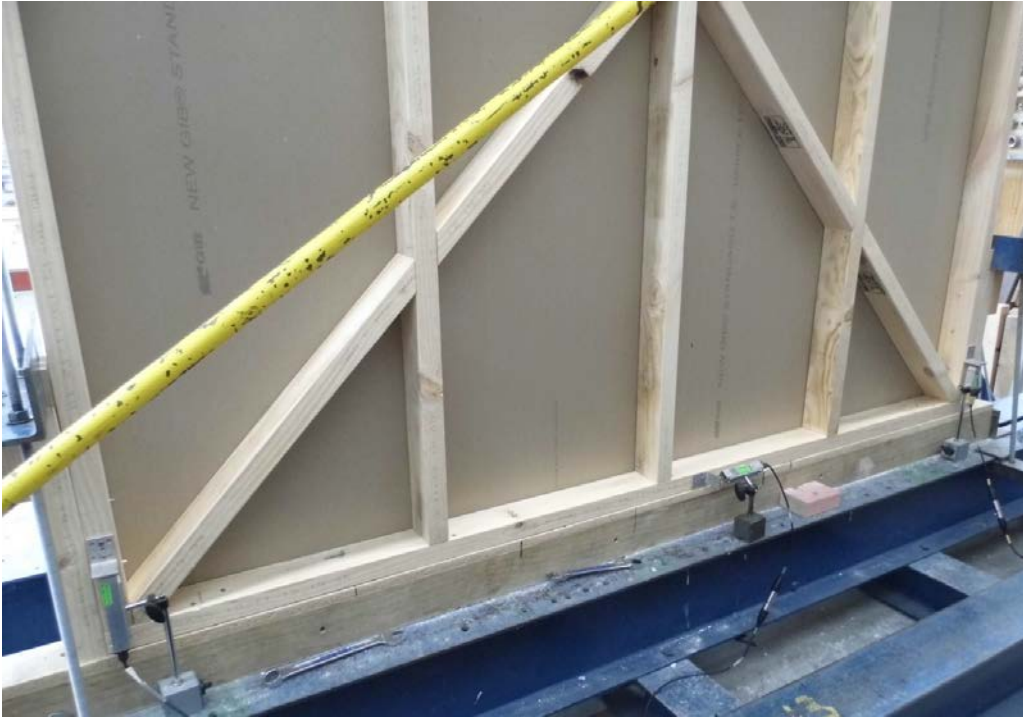
Figure 70. Double diagonal brace in Combo 1

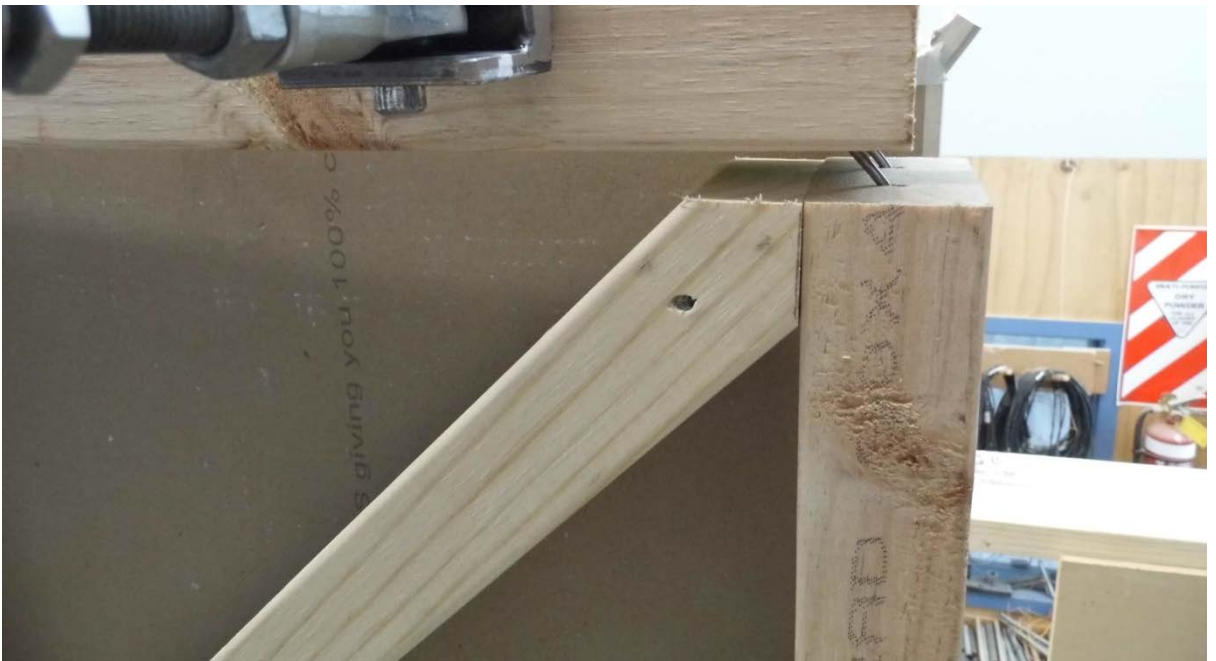
Figure 71. Top plate lifting in Combo 1

Early in the test the nails pulled through the plasterboard at the top plate connection near the wall ends, the top plates were lifted by the diagonal braces (Figure 71) and then the braces formed gaps in tension (Figure 72 and Figure 73). Three studs lifted from the bottom plate (Figure 74). Eventually the sheets became loose and almost fell from the wall.

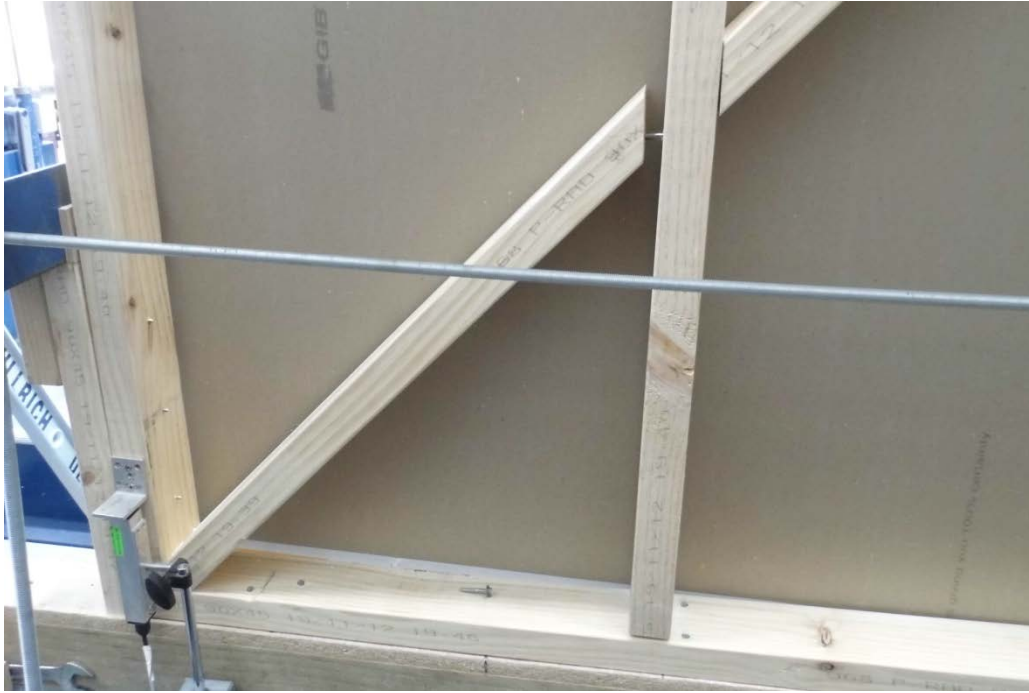
**Figure 72. Diagonal braces separating in Combo 1**

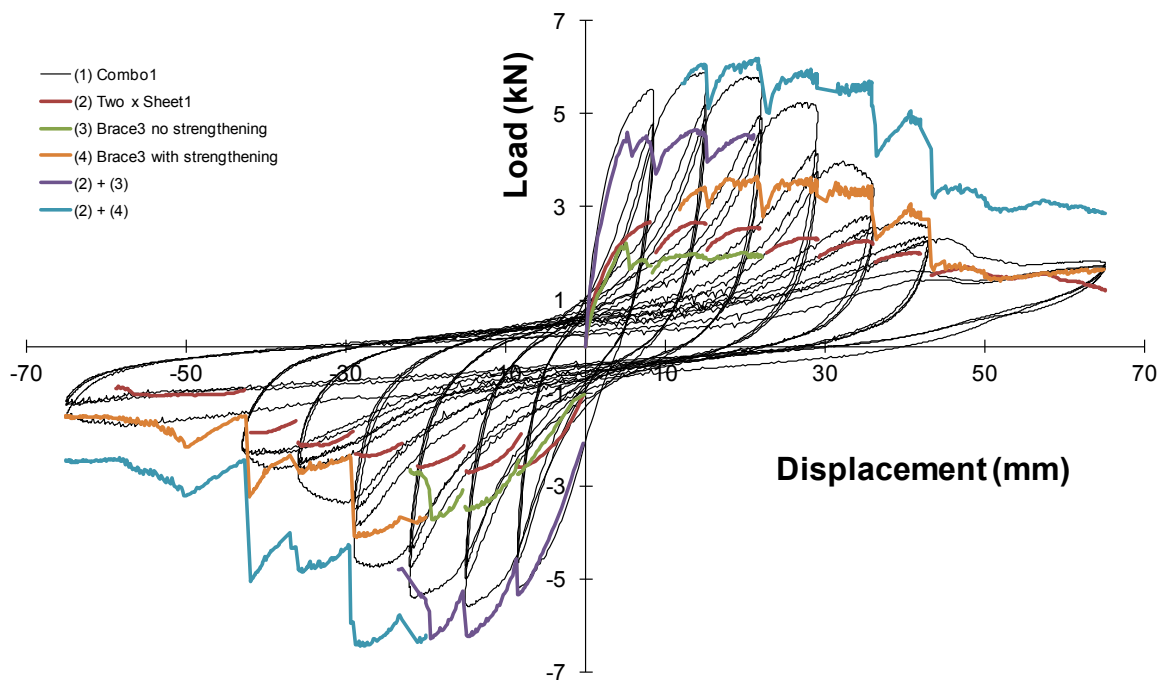
Figure 76. Component hysteresis loops for Combo 1 – a combination of Sheet 1 and Brace 3
