**STUDY REPORT SR 323 [2014]**

# **LEARNINGS FROM THE BRANZ REFURBISHMENTS**

## BRANZ Study Report SR 323

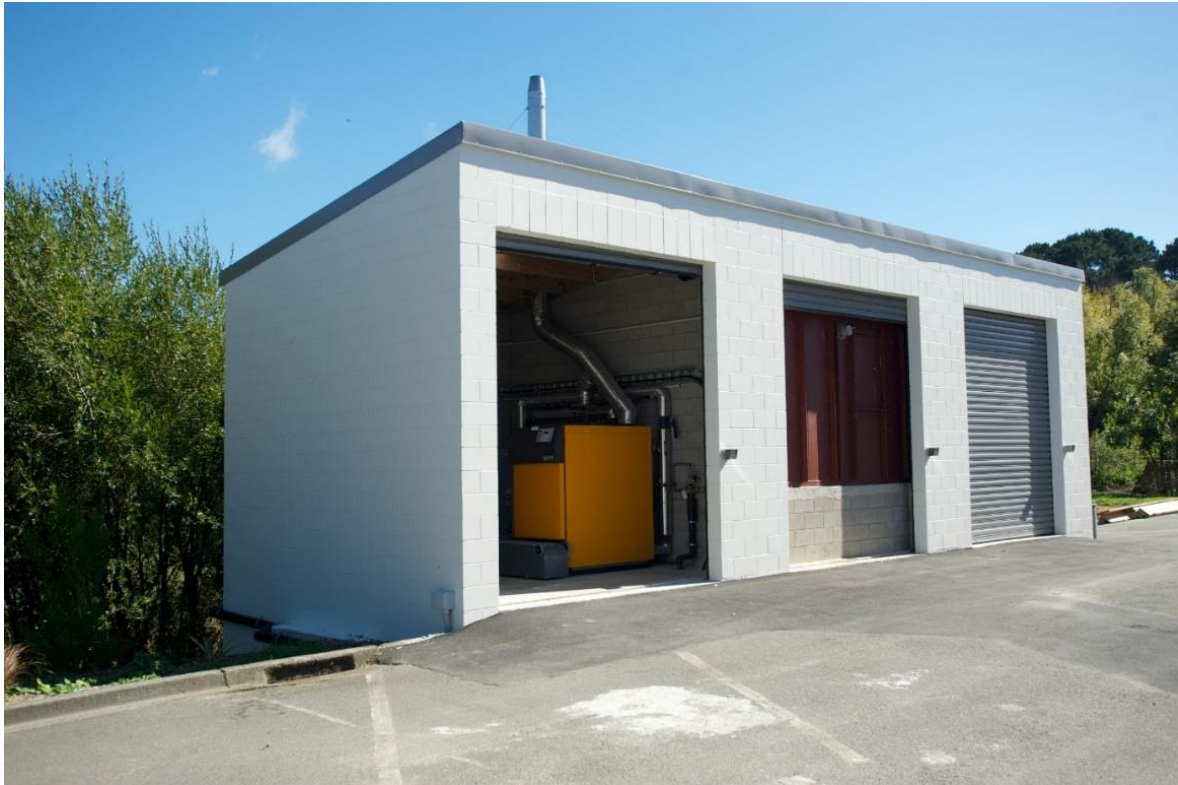
**Figure 6 The new wood pellet boiler (left) and the hopper (centre)**

The new Nikau and refurbished Rimu and Totara buildings replaced most of the electrical heating with a radiator heating system which was feed from a wood pellet boiler (see Figure 6). A solar water heating (SWH) system (see Figure 7) also contributes to the energy mix in the new buildings. In addition to the new building additional electricity meters were installed as part of the Building Management System (BMS) to record the electricity use within each area of the refurbished buildings in more detail.

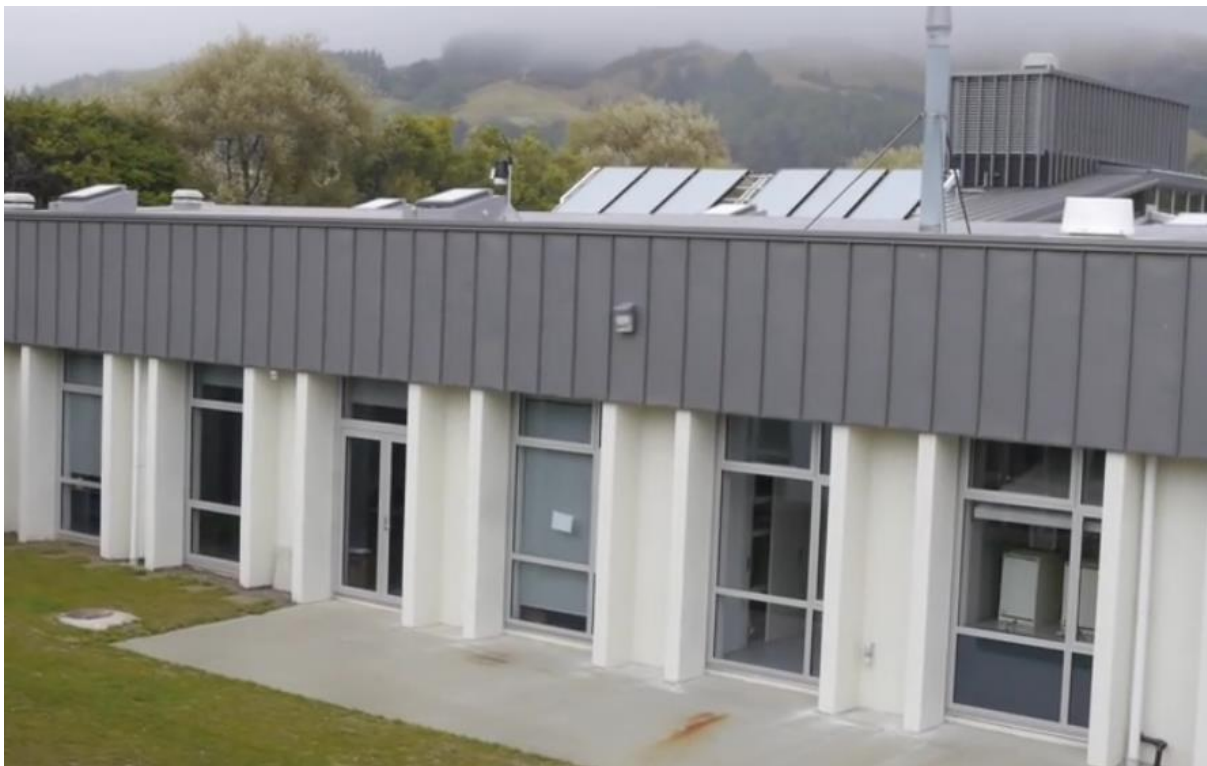
**Figure 7 The Solar Water Heating panels on the Rimu building**

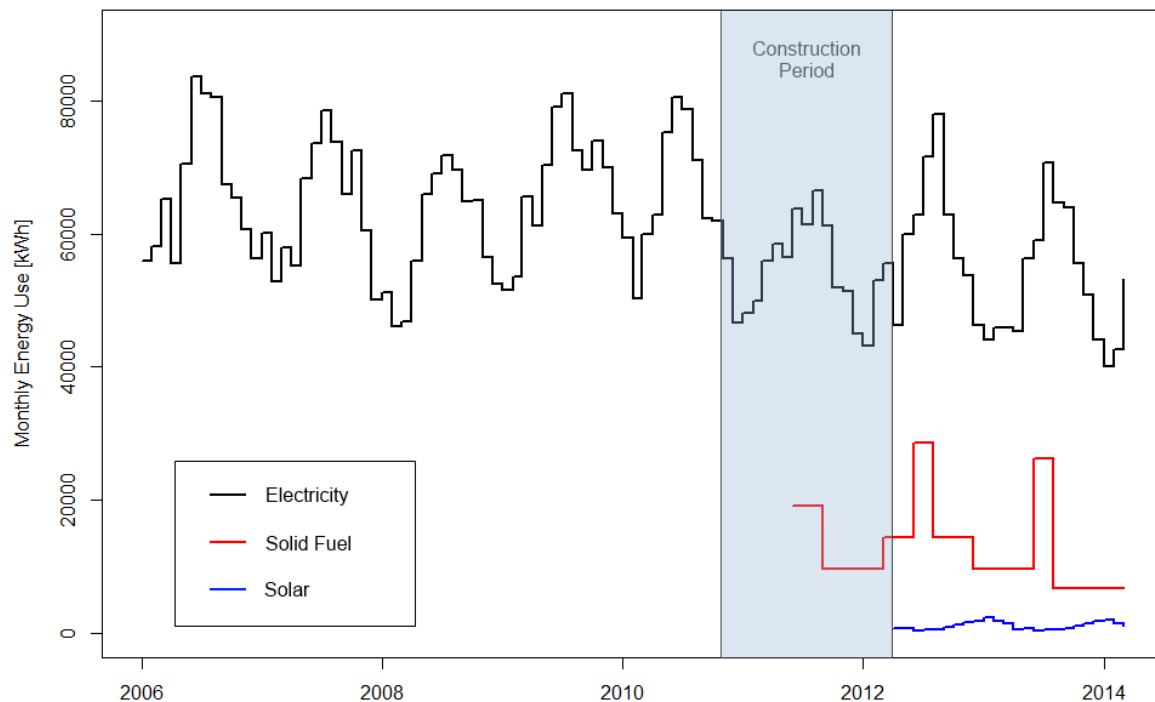
**Figure 8 Total BRANZ energy use before and after the refurbishments**

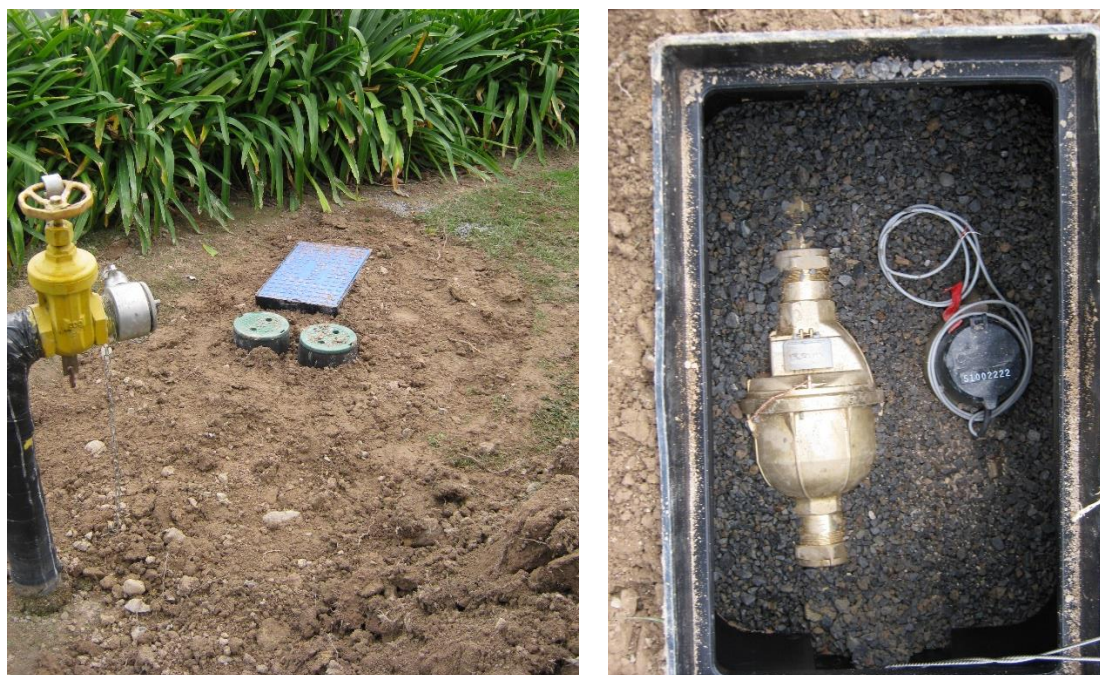
Figure 14 Water metering for the Fire and Structure Lab's and the Kauri building

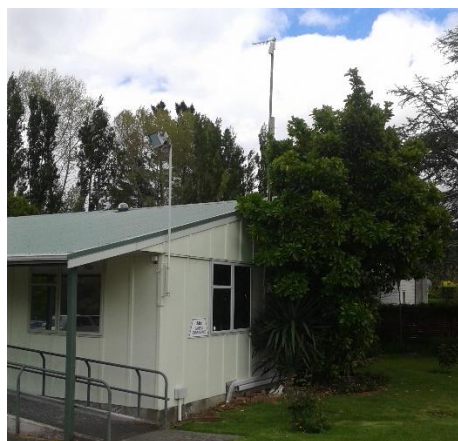
**Figure 16 Antenna for the receiver unit atop of the Prefab office building**

Rather than attempting to run permanent cables from these meters, a wireless metering system (MonitOr) provided by Arthur D Riley was trialled. This system involved attaching a transmitter to the pulsed output of the water meter and installing a receiver unit at the convenient location. The receiver unit was located in the vacant Prefab offices as this location provided a good signal level from the transmitter (see Figure 16).

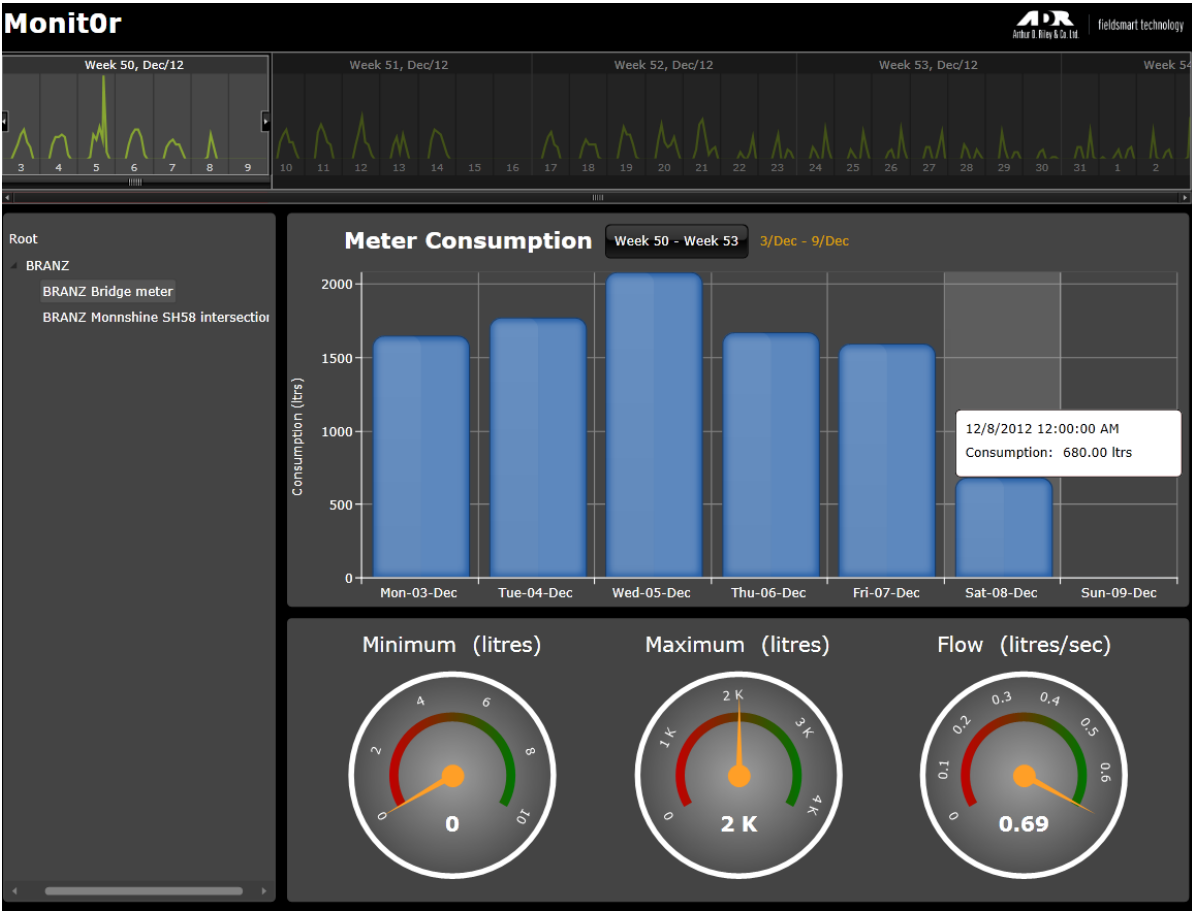
Figure 17 Overall view from the MonitOr system

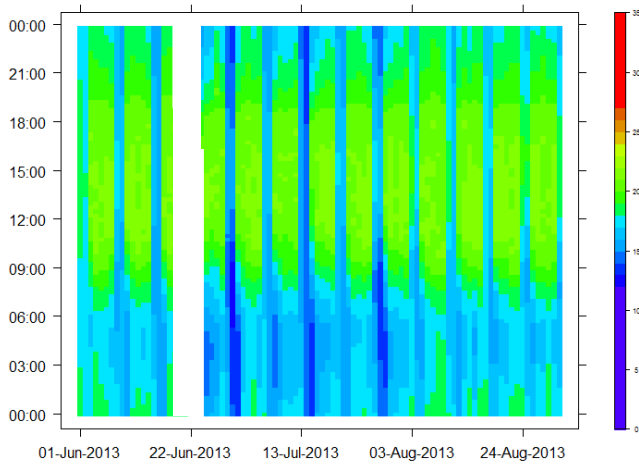
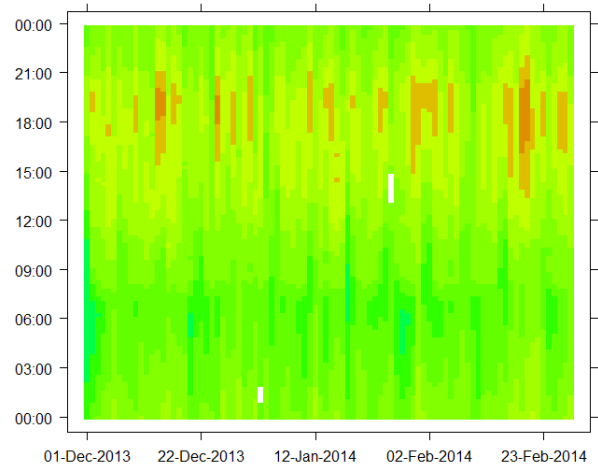
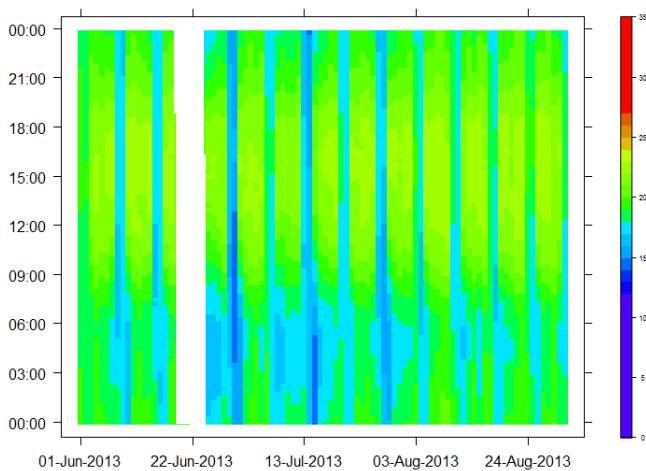
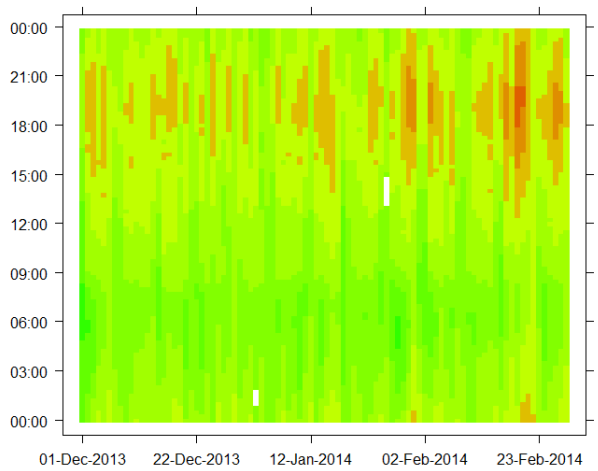
**Figure 20** Temperatures in the Nikau building (North side) during winter (white is missing data)

**Figure 21** Temperatures in the Nikau building (North side) during summer

**Figure 22** Temperatures in the Rimu building (North side) during winter after refurbishments (white - missing data)

**Figure 23** Temperatures in the Rimu building (North side) during summer after refurbishments

**Figure 24** Temperatures in the Totara building (central) during winter after refurbishments (white – missing data)

**Figure 25** Temperatures in the Totara building (central) during summer after the refurbishments

The colour scale for the measured indoor temperatures shown in Figure 20 to Figure 25 is shown in the centre of the page. The colour scale ranges from shades of red when the temperature is over 27°C and shades of orange over 24°C. Shades of green relate to generally acceptable temperatures of between 18°C or 24°C while temperatures below 18°C are shown as light blue colours than deepen in colour as the temperature drops. Periods of the graphs that are shown in white indicate periods of missing data.

The temperatures in all three locations are warmer than 18°C over summer as there are no blue colours in Figure 21, Figure 23 or Figure 25. During the mornings all three of the locations are in the acceptable green range (18-24°C) however the afternoon temperatures have shades of orange in all three buildings and some red shades in the Rimu building indicating warm temperatures and some overheating in the afternoons.
