STUDY REPORT

SR 340 (2015)

Revisiting concrete ground floor slabs

R.H. Shelton

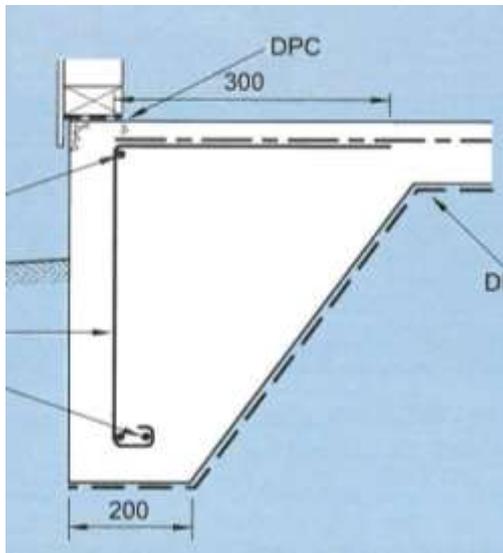
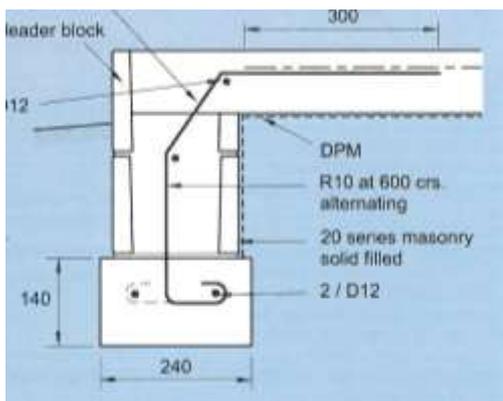
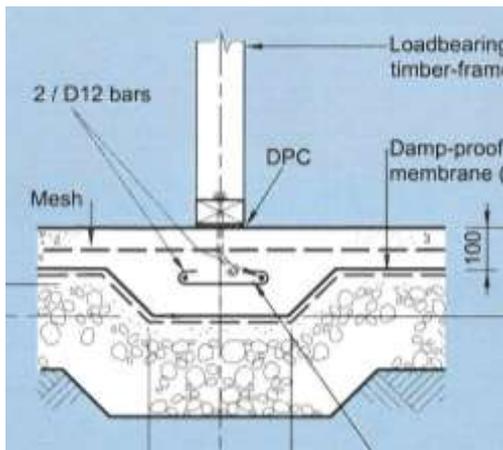
Figure 1. Typical slab foundation details (provided by Standards New Zealand under licence 001175).

These typical details are shown in Figure 1, reproduced from NZS 3604.

Slab edge formed as slab thickening

Slab edging formed with masonry blocks

Support of load-bearing internal walls

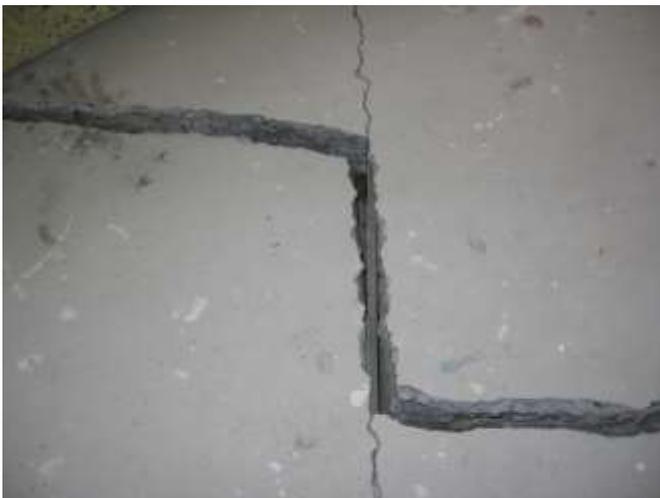
Figure 2. Slab cracking as a result of lateral spreading (the Z-shaped crack). Note that part of the crack follows a crack inducer (the fine vertical line).

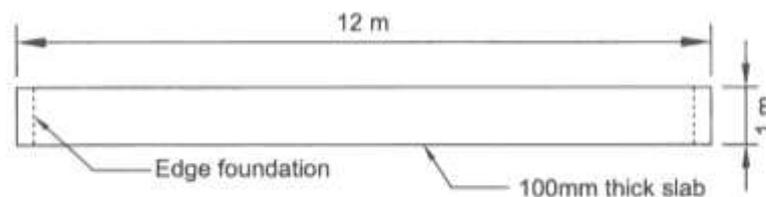
Figure 3. Slab used for analysis.

To illustrate the effects of these phenomena, the simple floor slab in Figure 3 was analysed. This represents a typical New Zealand ground floor slab of the maximum width for a trussed roof. NZS 3604 would require a saw cut control joint in the middle, but this was omitted for simplicity of analysis.

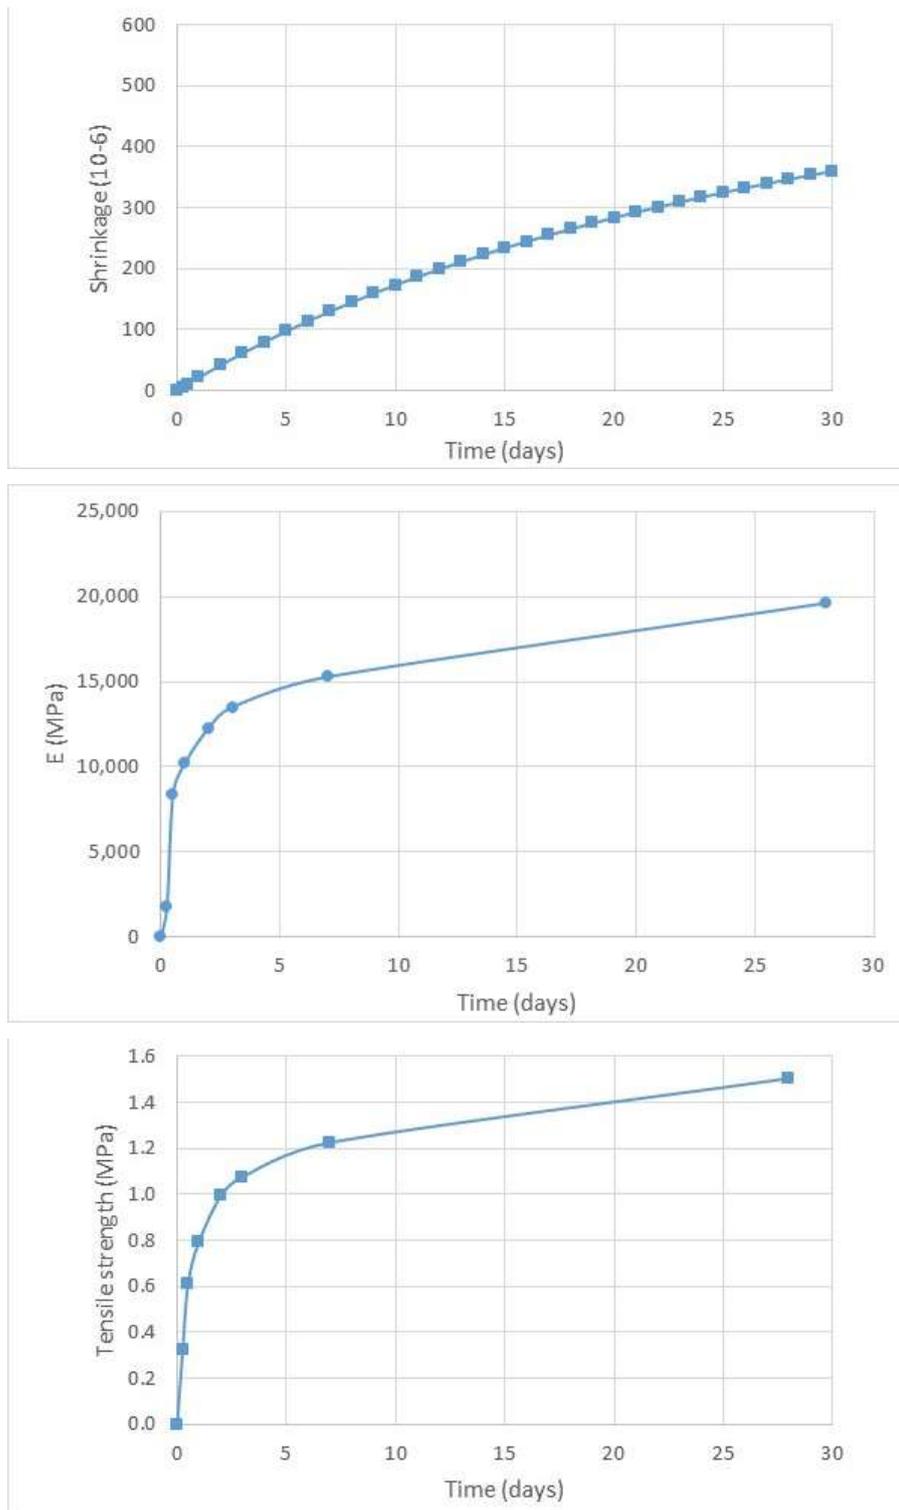
These time-dependent relationships are plotted in Figure 4.

Figure 4. Time-dependent concrete properties – shrinkage (top), modulus of elasticity E (middle), tensile strength (bottom).

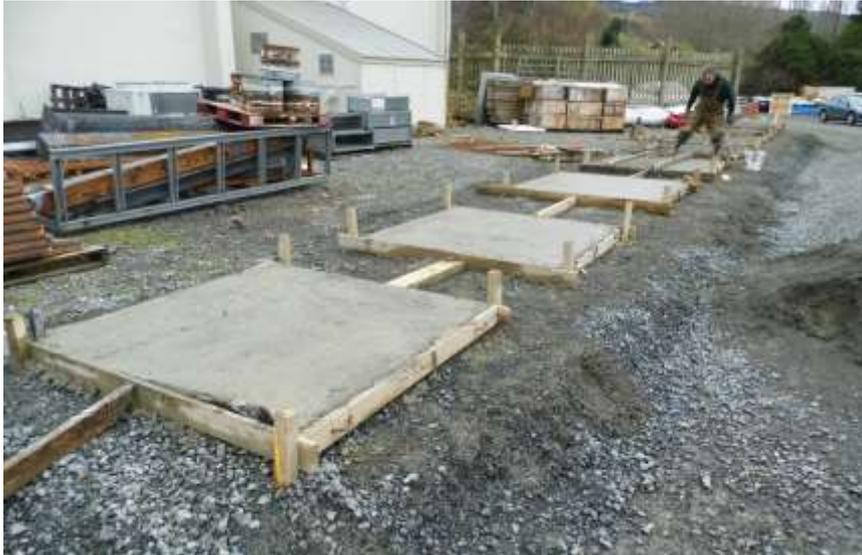
For the friction tests, six test slabs were constructed by a building contractor on a gravel carpark in the BRANZ yard (see Figure 5).

Figure 5. Friction test specimens

The test slabs were 1,500 mm x 1,500 mm x 100 mm thick and were founded on a 100 mm bed of compacted basecourse. All construction details followed the provisions of NZS 3604:2011.

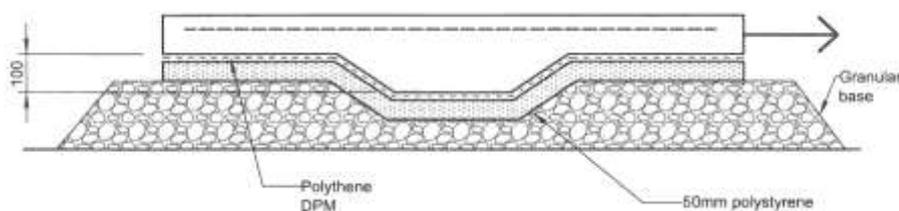
- Two slabs were laid on a 0.25 mm polythene membrane directly on the basecourse.
- Two slabs were laid on a 0.25 mm polythene membrane with a sand blinding layer on the basecourse.
- Two slabs were laid on a double layer of 0.25 mm polythene membrane on a sand blinding layer on the basecourse.
- Two additional slabs were constructed incorporating the slab thickening detail of Figure 7.20 of NZS 3604. One of these specimens was laid on a 50 mm layer of polystyrene (see Figure 6).

Figure 6. Slab with loadbearing thickening.

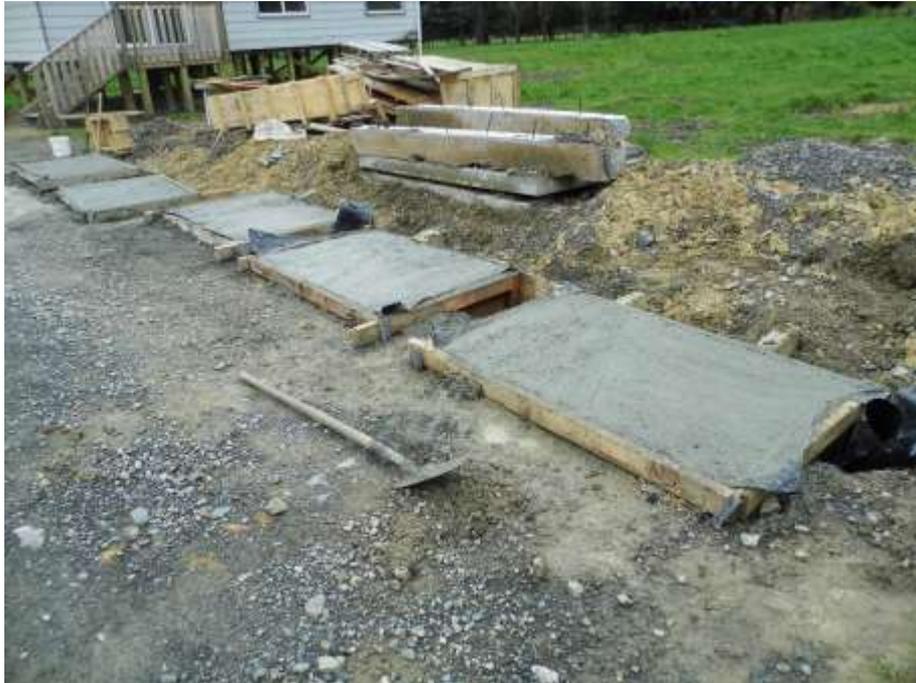
For the slab edging tests, four slabs were constructed by a building contractor on a cleared site in the BRANZ yard. They were 1,500 mm x 1,000 mm x 100 mm thick with integral edging. All details followed the provisions of NZS 3604 (see Figure 7).

Figure 7. Slab edge specimens after casting.

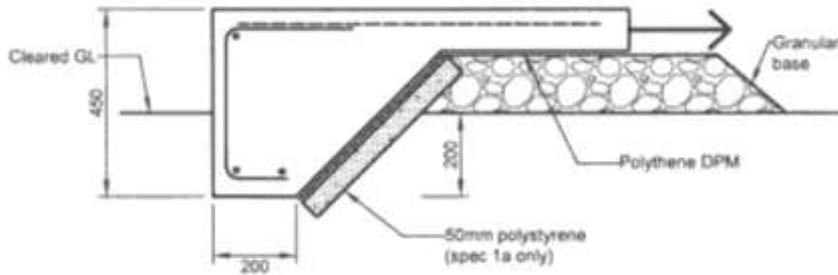
Three specimens followed Figure 7.13 of NZS 3604. One of these included a 50 mm layer of polystyrene on the sloping ground surface (see Figure 8).

Figure 8. Slab edge specimens 1 and 1a.

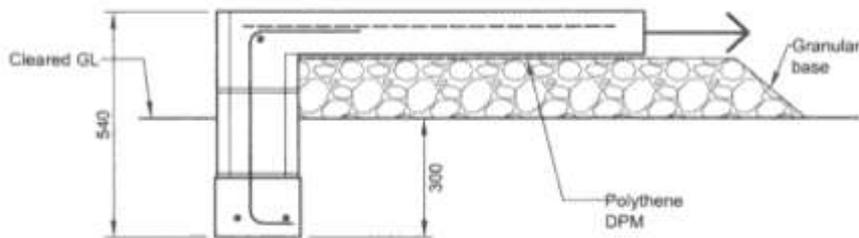
One specimen followed Figure 7.14 of NZS 3604 (see Figure 9).

Figure 9. Slab edge specimen 2.

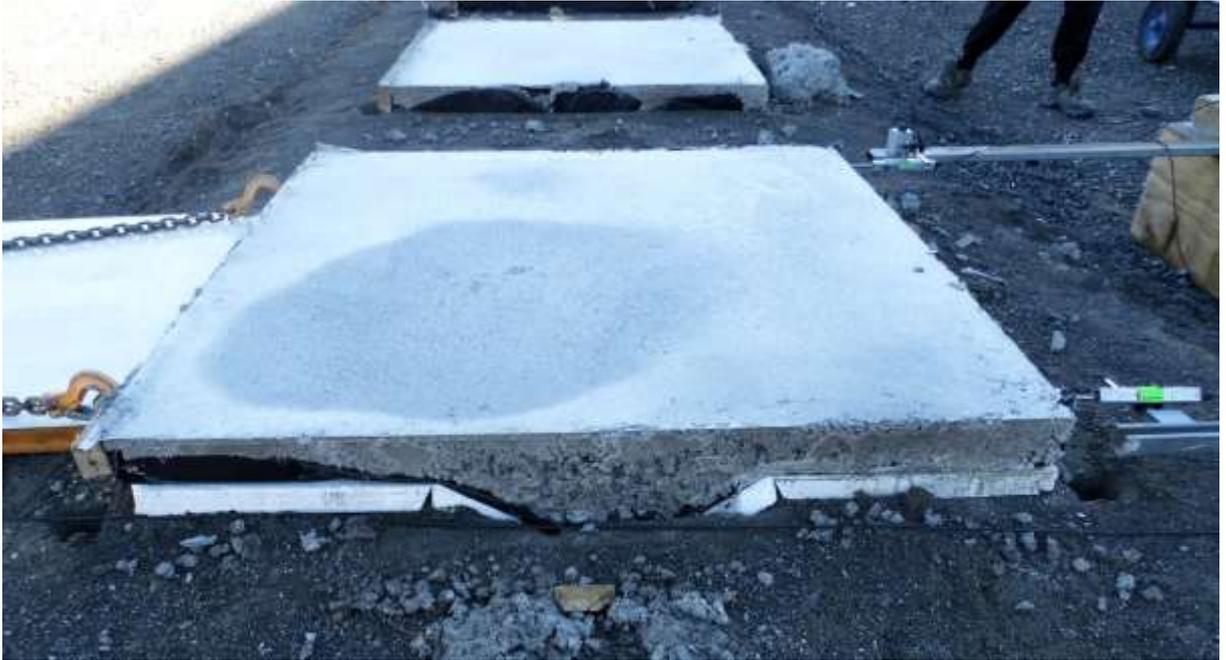
All specimens incorporated attachments at one edge so they could be loaded in the plane of the slab (see Figure 10).

Figure 10. Slab with loadbearing thickening under test.

Applied load was measured with a load cell, and displacements at two corners were measured with potentiometers. All measurements were recorded in text file format for subsequent processing by spreadsheet.

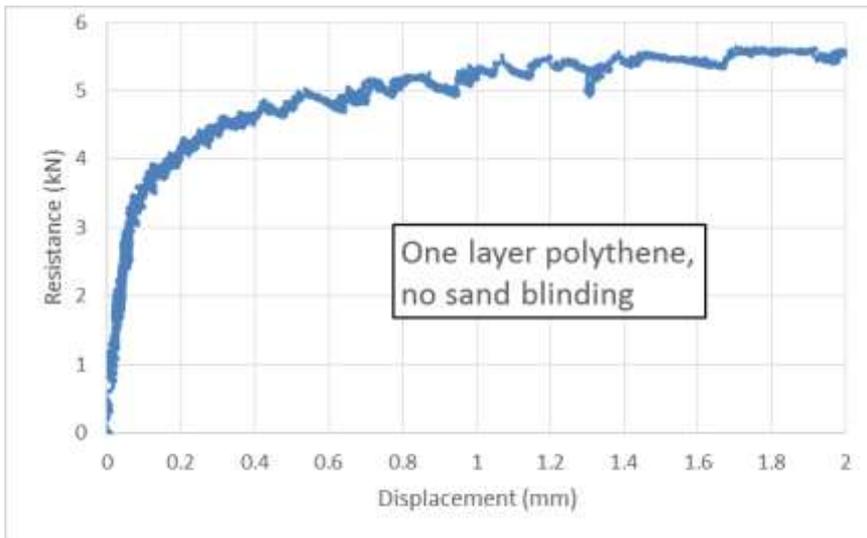
Figure 11. Representative load/displacement plot for slab without sand blinding.

Slabs with sand blinding showed behaviour similar to classical sliding friction, with a rapid build-up of resistance then near constant resistance with increasing displacement. The slab without sand blinding showed a more rounded plot shape due to the roughened interface causing interlock. The slabs with thickening had a gradual build-up of resistance as they were forced up the sliding surface. A much lower resistance for the specimen with polystyrene layer shows the 'bedding in' effect and compression of the polystyrene.

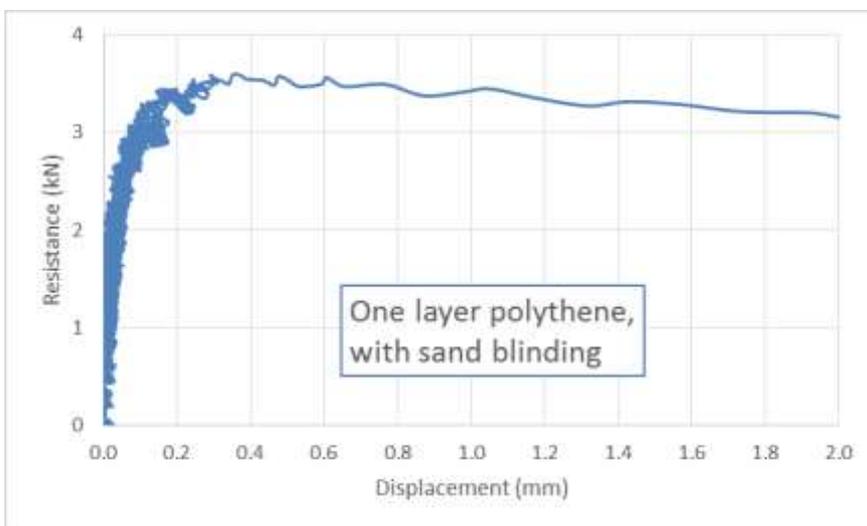
Figure 12. Representative load/displacement plot for slab with sand blinding.

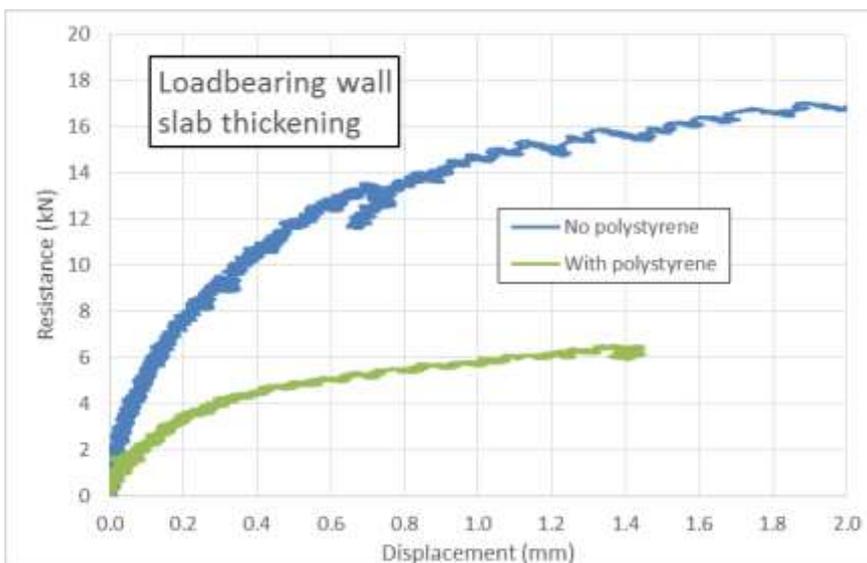
Figure 13. Load/displacement plots for slabs with loadbearing wall thickenings (with and without polystyrene).

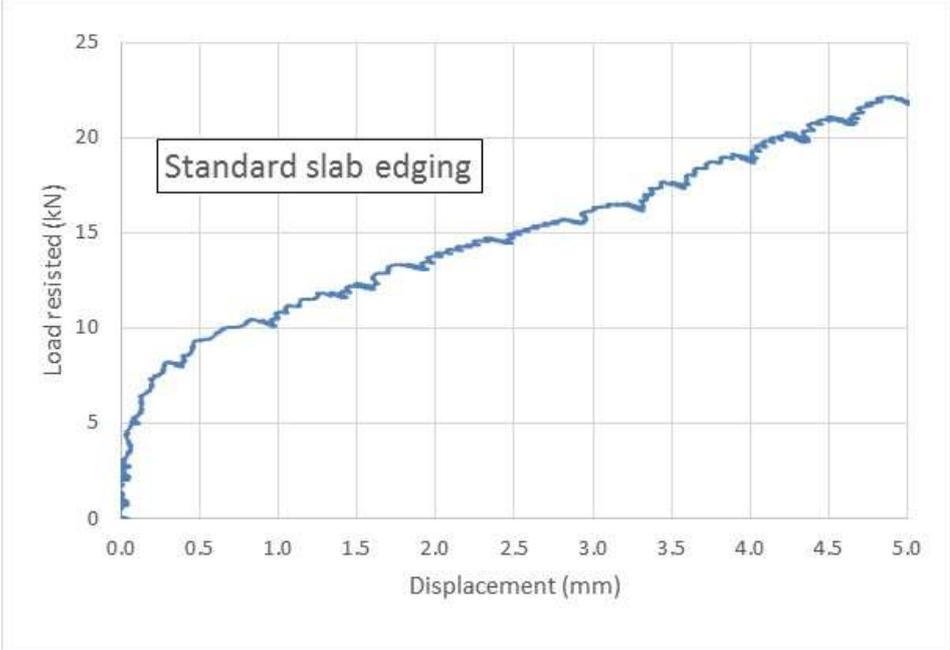
All specimens canted up at the outside (foundation) edge because of the eccentricity of load and resistance.

Figure 14. Representative load/displacement plot of standard slab edge.

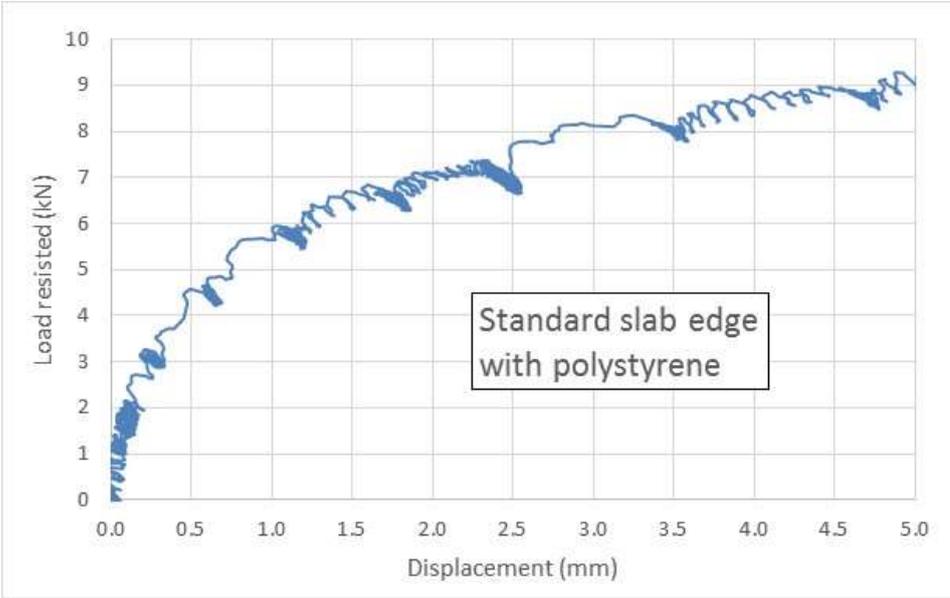
Figure 15. Representative load/displacement plot of slab edge with polystyrene.

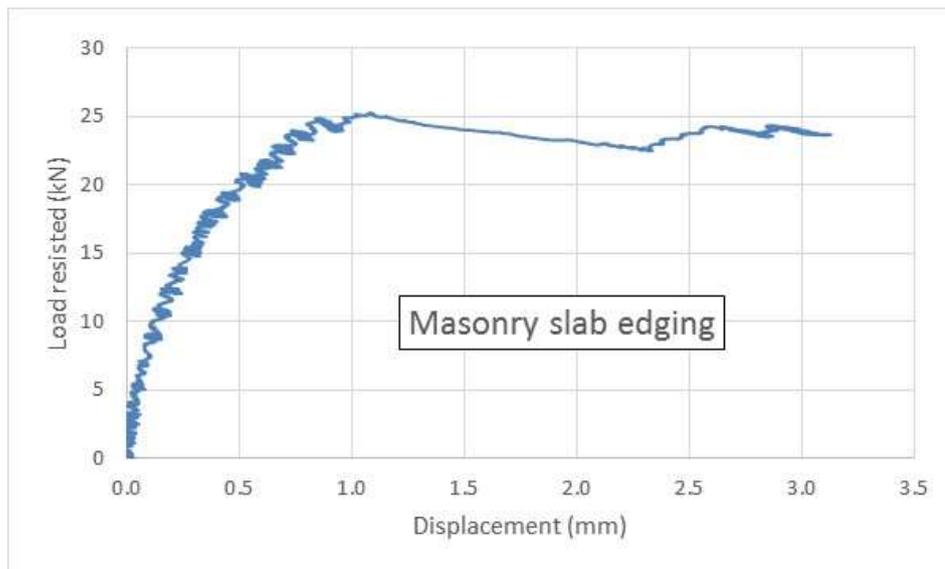
Figure 16. Load/displacement plot of slab with masonry edge.

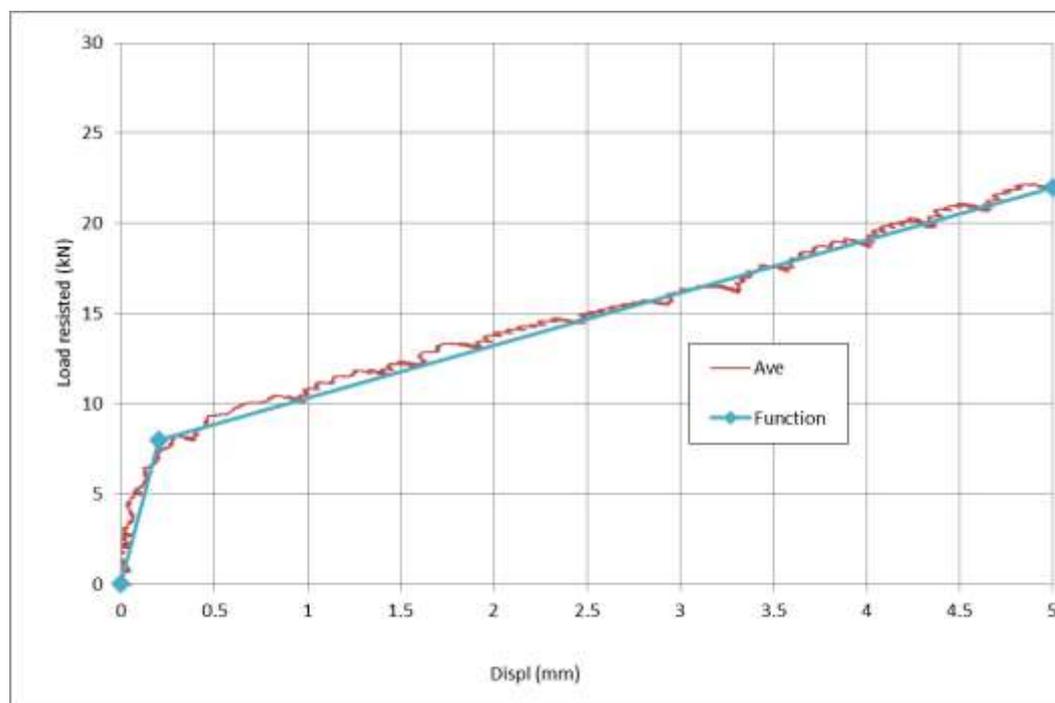
A study of the plots suggested that a bi-linear relationship would be suitable for subsequent analysis. A bi-linear function was superimposed on the plots and the data points manually manipulated to best fit the plot. An example is shown in Figure 17.

Figure 17. Example best fit function.

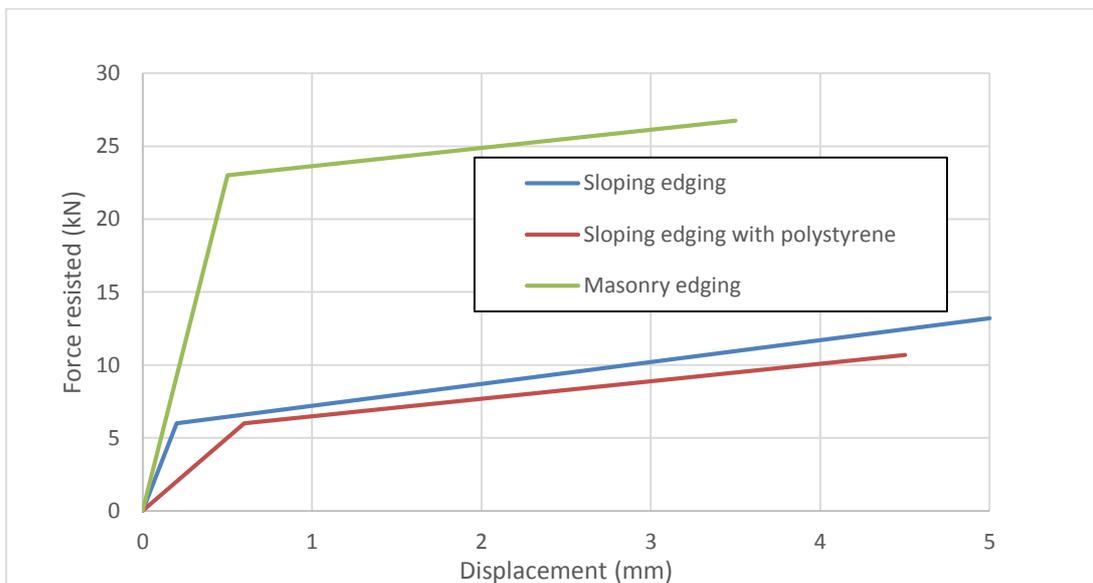
Sloping edging with polystyrene $F = 10 \delta$ for $\delta < 0.6$ mm,
 $= 6 + 1.2(\delta - 0.6)$ $\delta > 0.6$ mm.

Masonry slab edging $F = 46 \delta$ for $\delta < 0.5$ mm,
 $= 23 + 1.25(\delta - 0.5)$ $\delta > 0.5$ mm.

Figure 18. Force/displacement relationships for NZS 3604 slab edging options.

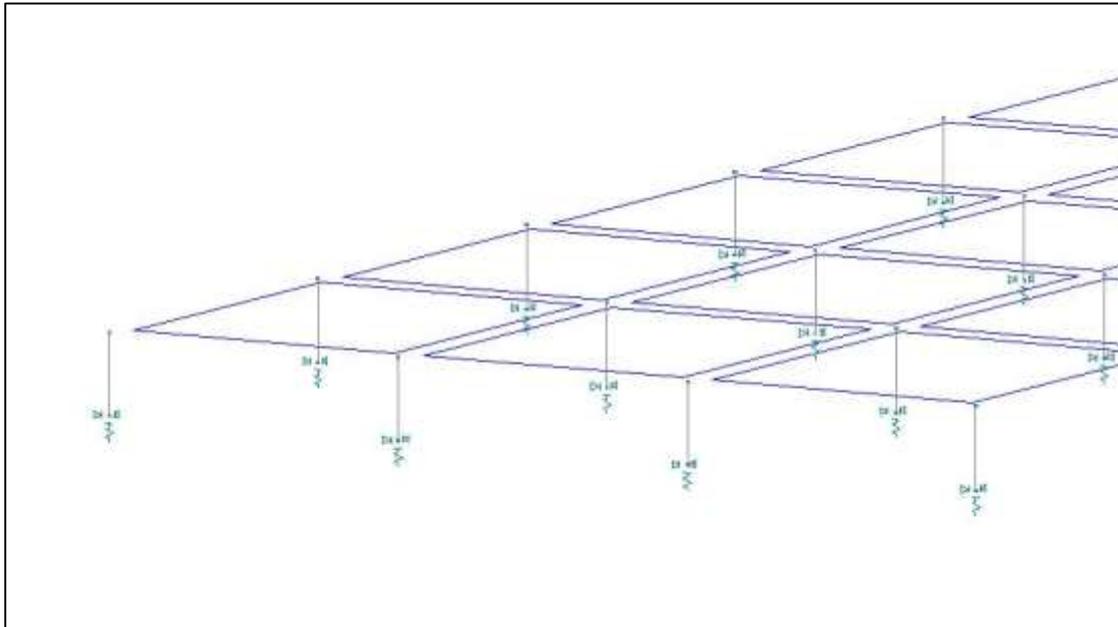
To simulate realistic slab bearing on the foundation, the slab elements were supported on compression only members with spring supports (see Figure 19).

Figure 19. Space Gass model showing plate elements, compression only elements and spring supports.

The spring stiffness was adjusted to represent a range of soil stiffnesses, as quantified by modulus of subgrade reaction, k . The values of k ranged from 5 kPa/mm for loose sand (5,000 kN/m³) up to 200 kPa/mm for firm rock.

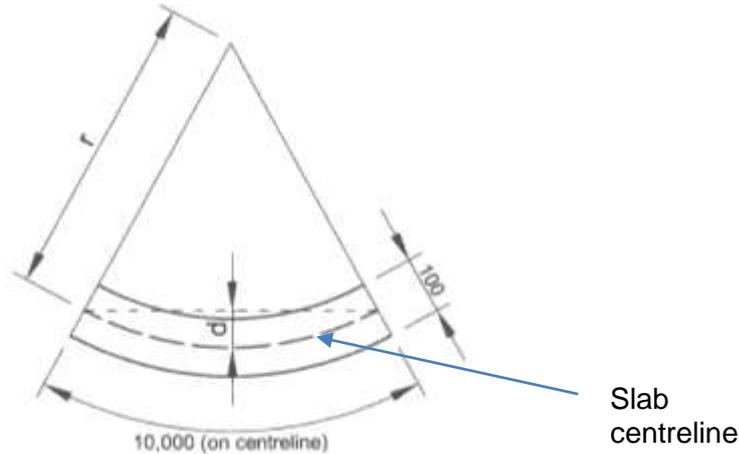
Differential shrinkage strain was modelled using the differential temperature loading feature built in to the software. To calibrate this loading condition, the deflection of the ends of an equivalent slab was calculated under a strain on one surface of 300 μ strain (0.0003 mm/mm):

$$\text{Radius of curvature } r = \text{slab thickness} / \text{strain} = 100 / 0.0003 = 333,000 \text{ mm.}$$

$$\text{Deflection } d = \text{length}^2 / (8 \times \text{radius}) = 10,000^2 / (8 \times 333,000) = 37.5 \text{ mm.}$$

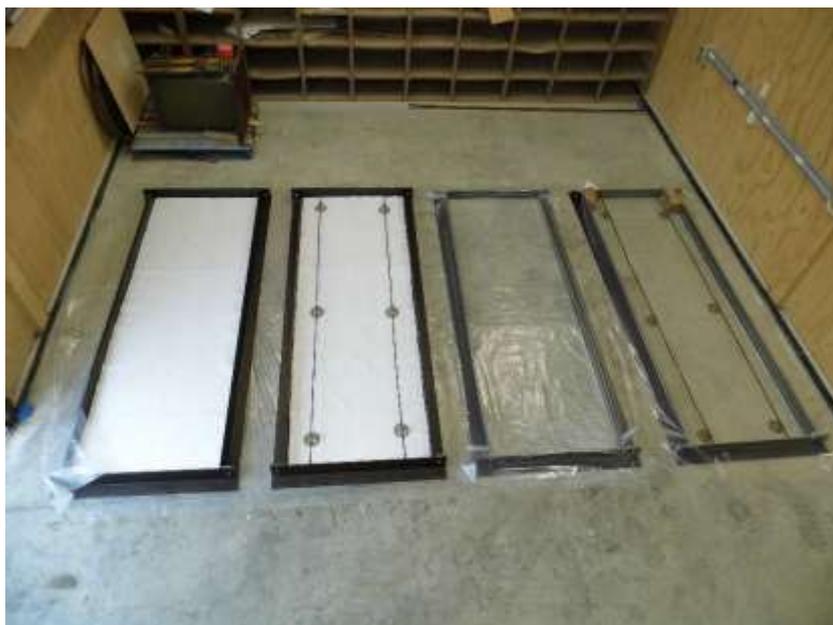
Four slabs were cast, each 3.0 m x 1.0 m x 100 mm thick, as shown in Figure 20. The relevant details are presented in Table 10.

Figure 20. Slabs ready for casting – specimens D, C, B and A.

Slab	Reinforcement	Base
A	2 – D12 bars	Polythene DPM
B	None	Polythene DPM
C	2 – D12 bars	Drainage layer
D	None	Drainage layer

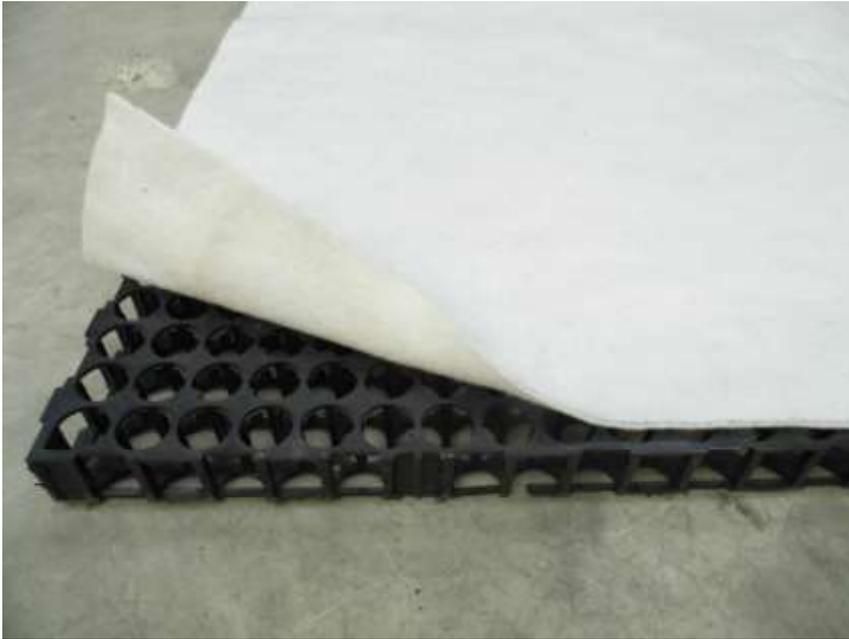
The drainage layer consisted of a proprietary modular drainage system. This consisted of interlocking 30 mm thick cellular plastic grids 1 m x 1 m, together with a 1.2 mm filter fabric on top. The components are shown in Figure 21.

Figure 21. Drainage layer used for the curl tests.

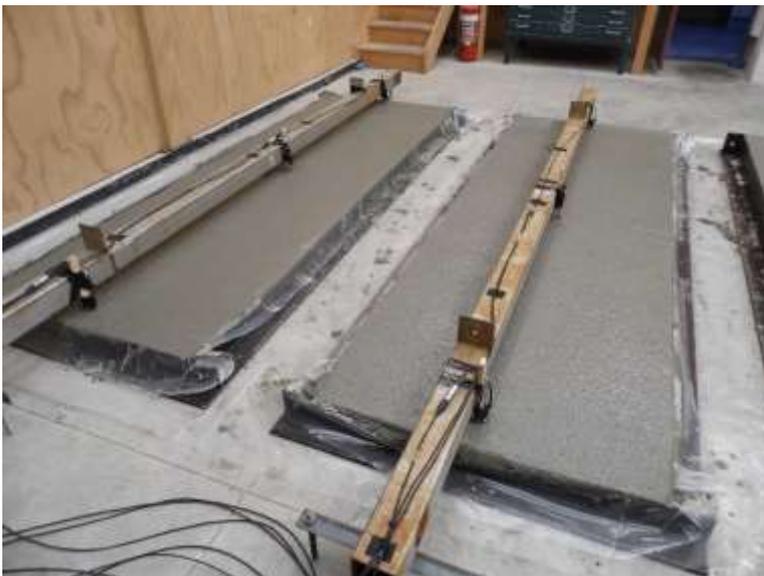
Slab curl was measured by potentiometers placed at the midpoint and ends of each slab, as shown in Figure 22. The target for each potentiometer was a bolt with a square-faced head set in the wet concrete as shown in Figure 23. The data was recorded by datalogger and stored on a laptop PC at hourly intervals. An uninterruptable power supply was used to guard against power failure.

Figure 22. Slabs with curl-measuring equipment after casting concrete.

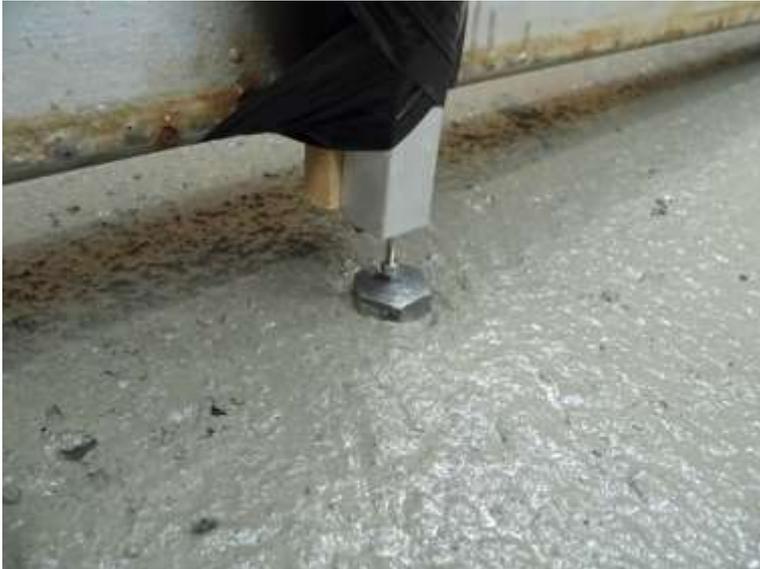
Figure 23. Potentiometer target.
